Seismic Walkdown Checklist (SWC)

Project: Byron 1 SWEL

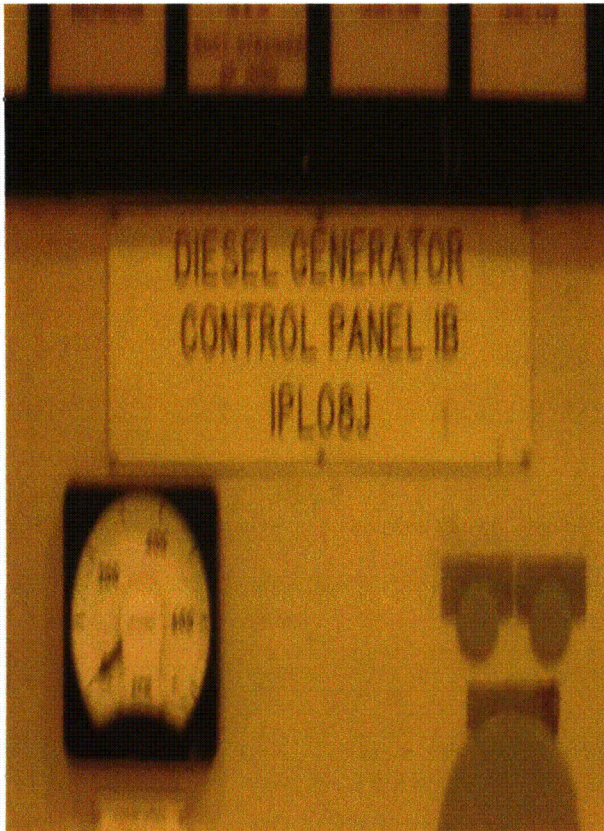
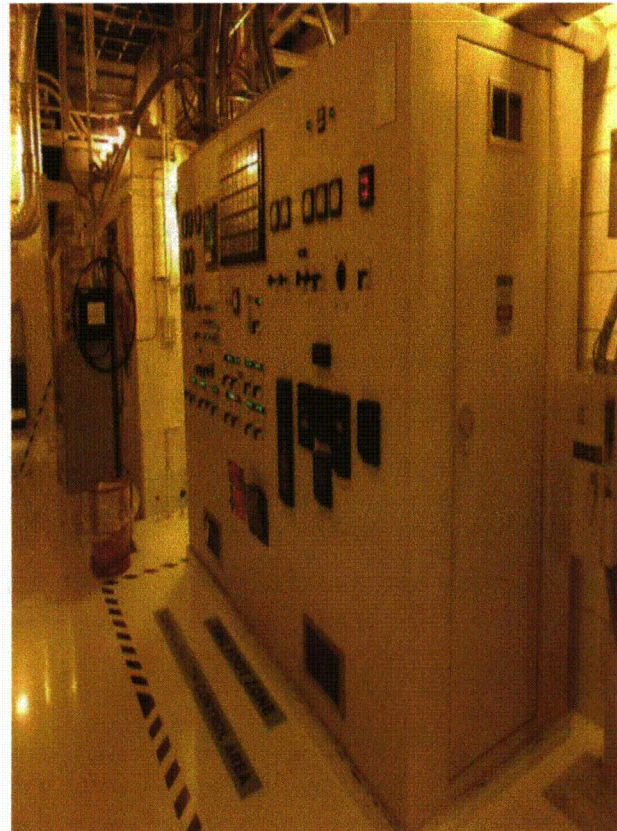
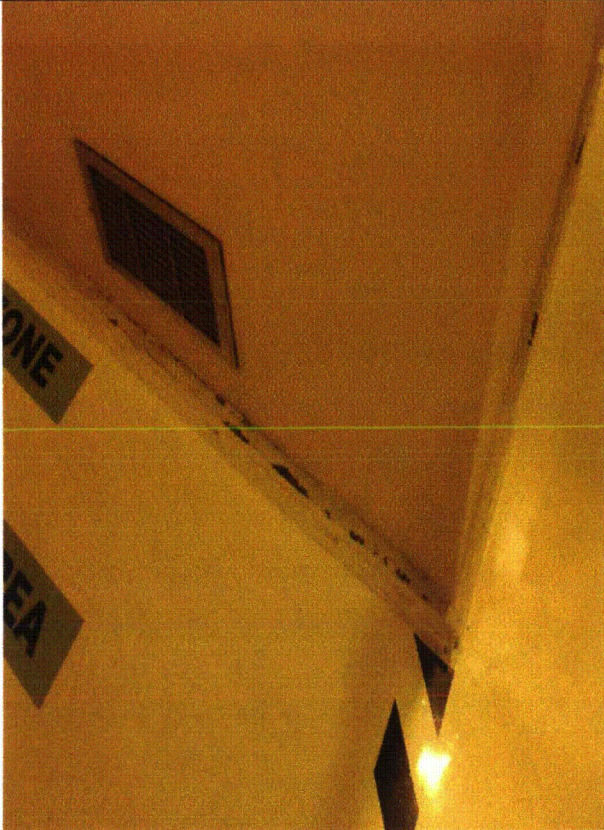
11. Have you looked for and found no adverse seismic conditions that could adversely affect the safety functions of the equipment? Yes
Loose screws on panel back were tightened by equipment operator.

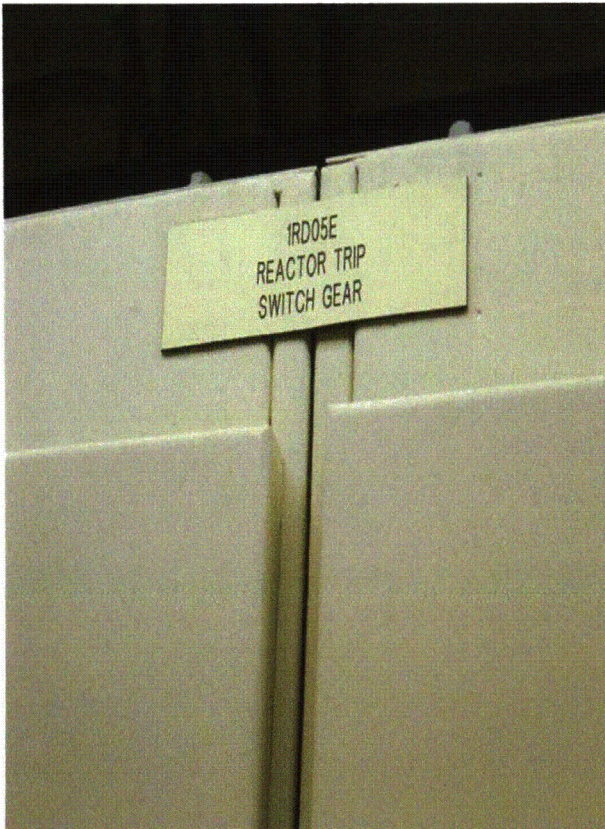
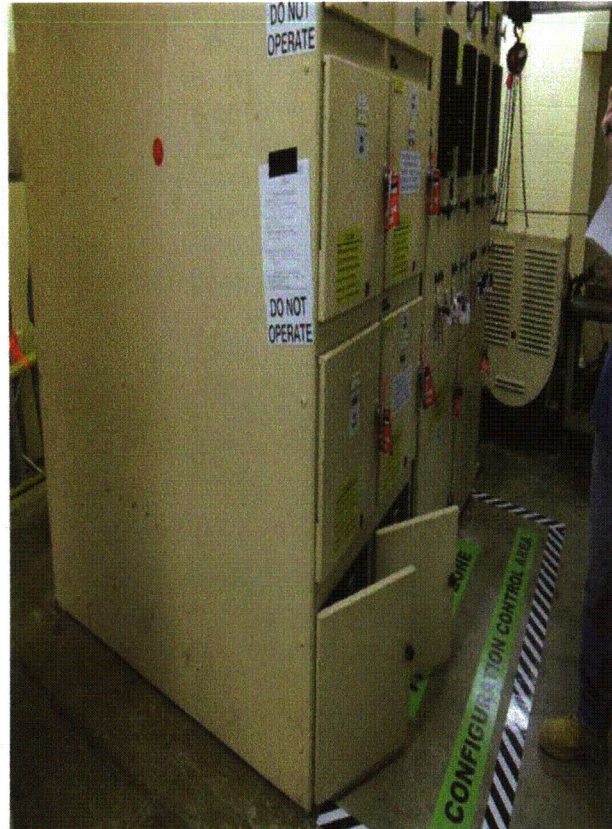
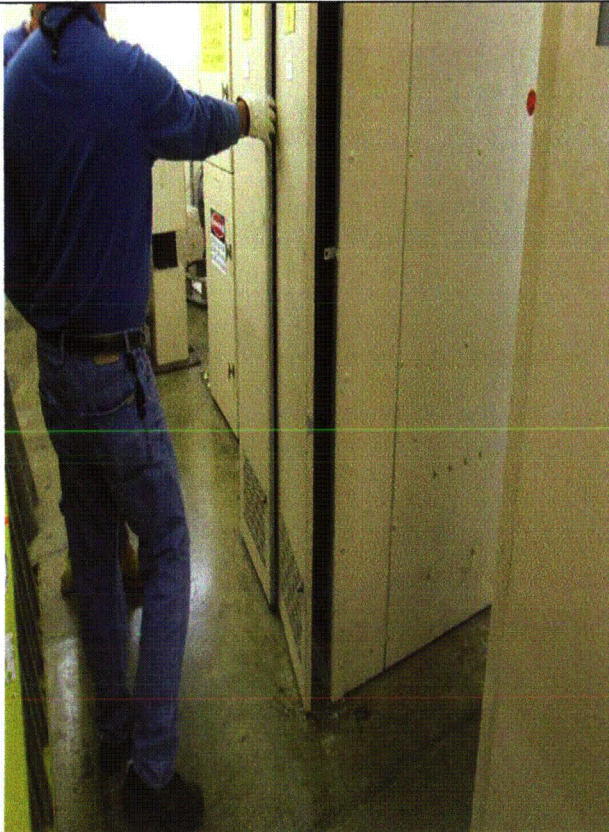
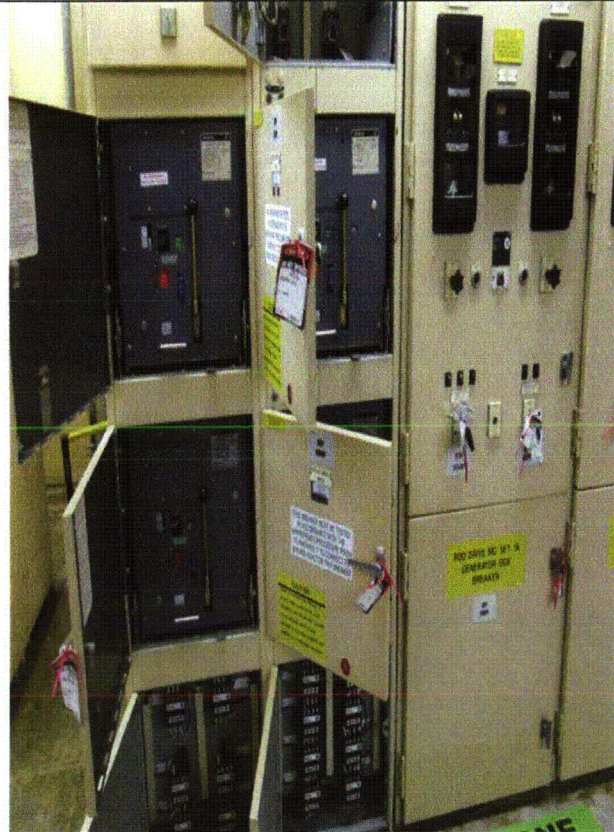
3. Is the anchorage free of corrosion that is more than mild surface oxidation? Yes
4. Is the anchorage free of visible cracks in the concrete near the anchors? Yes
Crack in grout at 2 bolts. Bolts are embedded in pier where there are no cracks. Not a structural/seismic issue - acceptable. IR 1403131 was written to document condition.

11. Have you looked for and found no adverse seismic conditions that could adversely affect the safety functions of the equipment? Yes
Boric acid on bolts. Not a structural/seismic issue. IR 1403165 written.

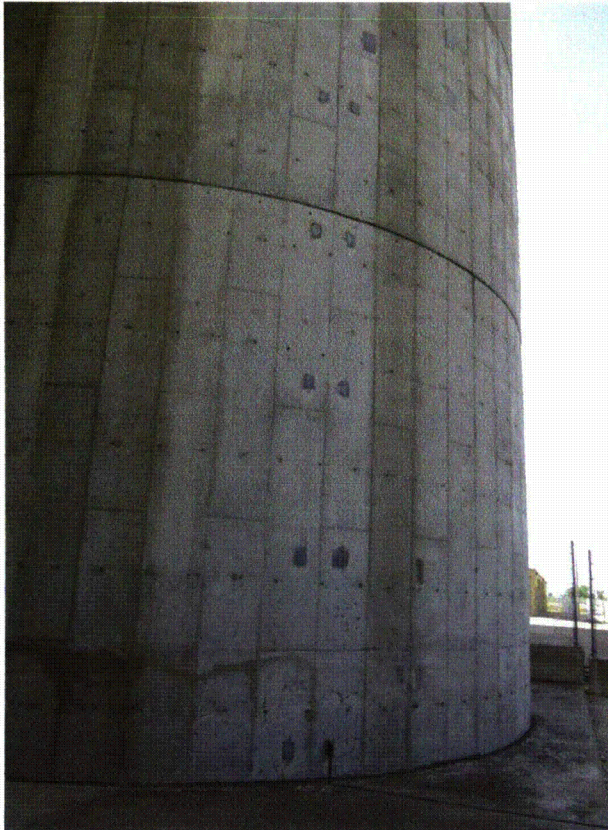
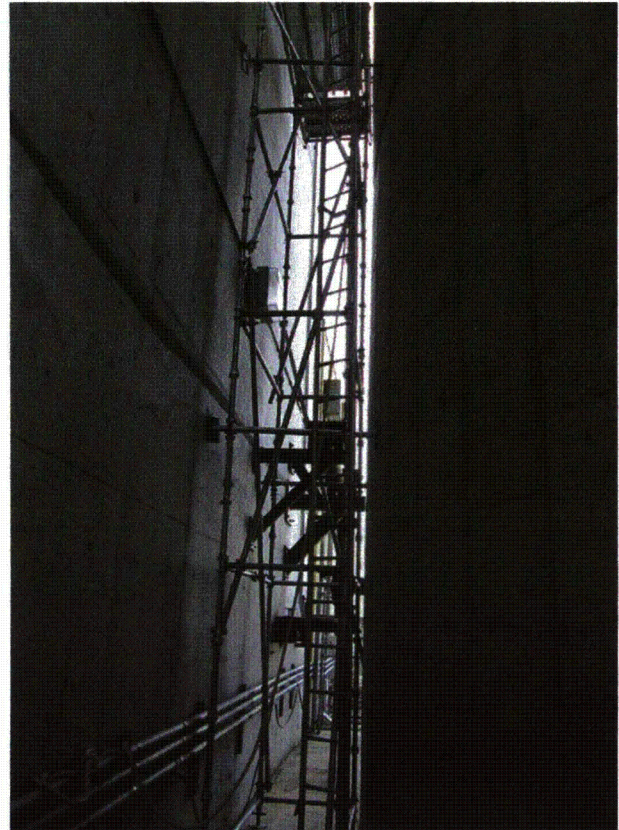
6. Based on the above anchorage evaluations, is the anchorage free of potentially adverse seismic conditions? Yes
Very large reinforced concrete tank - anchorage not visible (anchored into concrete with reinforcing steel). Judged to be acceptable since there is no deterioration at the joint between the tank and the foundation.

11. Have you looked for and found no adverse seismic conditions that could adversely affect the safety functions of the equipment? Yes
Minor concrete cracking/spalling and judged to have no structural impact.

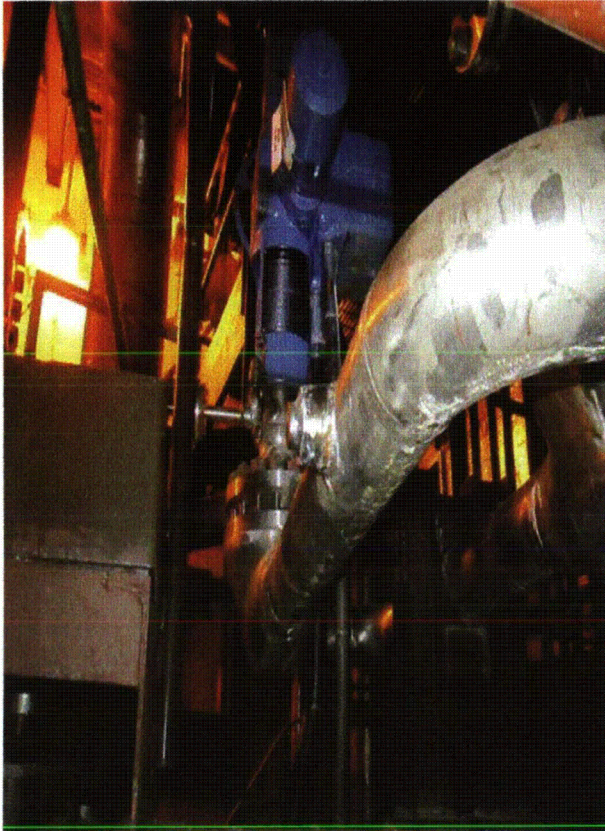
1SI8801B Byron 1 & 2 8-8-12 062

11. Have you looked for and found no adverse seismic conditions that could adversely affect the safety functions of the equipment? Yes
Check valve on this pipe is close to north wall but laterally braced to south wall so this is not an issue.
