**ESI REFURBISHED EMERGENCY DIESEL GENERATOR CYLINDER HEAD WITH FOREIGN MATERIAL IN INTAKE PORT**

**Report No. 10CFR21-0107**

**10CFR21 REPORTING OF DEFECTS  
AND NON-COMPLIANCE**

**COMPONENT:** KSV Cylinder Head with Foreign Material in Intake Port  
Part Number 13-KSV-11-6-RR

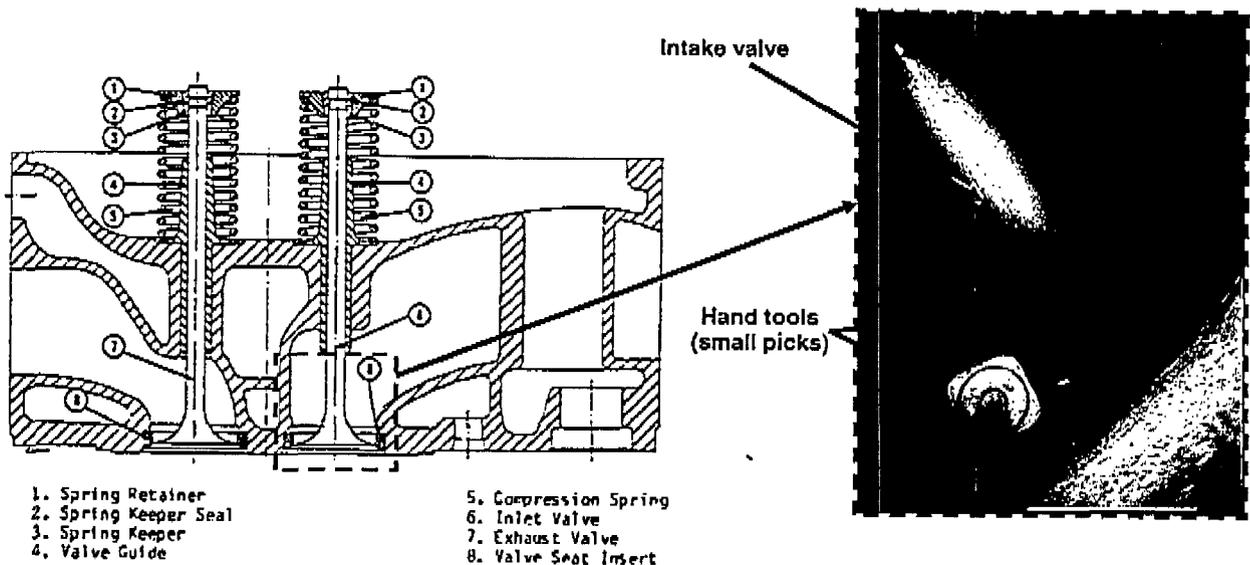
**FIGURE 1: KSV CYLINDER HEAD CROSS SECTION**

ESI supplied a refurbished cylinder head for a Cooper-Bessemer KSV diesel engine to the Cooper Nuclear Station (part number 13-KSV-11-6, serial number 6K2201) in August 2010. On October 22, 2012, the customer was installing the cylinder head and was not able to properly adjust intake valve lash. Upon further inspection, two (2) small tools were discovered in the intake port of the cylinder head. The tools were between one of the intake valves and the valve seat, thereby preventing the intake valve from closing completely.

**LOCATION OF HAND TOOLS**

The picks found within the cylinder head are the type used to position the valve spring keeper seals (item 2 of Figure 1) during assembly of the valves within the head. The refurbishment activity was performed at the OEM's facility (Cameron Compression) in Casper, Wyoming. The most likely scenario is that the cylinder head was oriented with the inlet port facing up during installation of the valve spring keeper seals. After installation of the seals, the tools were placed on top of the cylinder head (in this case, the inlet port surface). It is presumed the tools fell into the inlet port and settled near the intake valve seating area. Because of the geometry of the intake port, the tools remained in this area after the head was rotated. The tools are small in size (approx. 5" long with 5/8" wide handles) and therefore they remained within the intake port cavity and were not visible from the exterior of the head.

The presence of the tools in the intake port interfered with operation of an intake valve; specifically the valve was not allowed to close completely. This would have reduced the available compression in the affected cylinder thereby reducing the load carrying capability of the emergency diesel generator. If the tools were to have become dislodged during engine operation, it is possible that cylinder components could have been damaged, resulting in engine shutdown. In either scenario, the ability of the diesel generator to perform its safety related function could have been impacted.

This condition was discovered during installation of the cylinder head and was subsequently corrected by the customer prior to completing the diesel generator maintenance activity; therefore, no further action is required by the customer.

To prevent recurrence of this issue, ESI has added a step to the dedication process to perform an inspection of the cylinder head intake and exhaust ports upon completion of the assembly process and just prior to covering the ports for shipment.
