ATTACHMENT 9.6

SEISMIC WALKDOWN CHECKLIST FORM

IP3

Seismic Walkdown Checklist (SWC) SWEL1-092

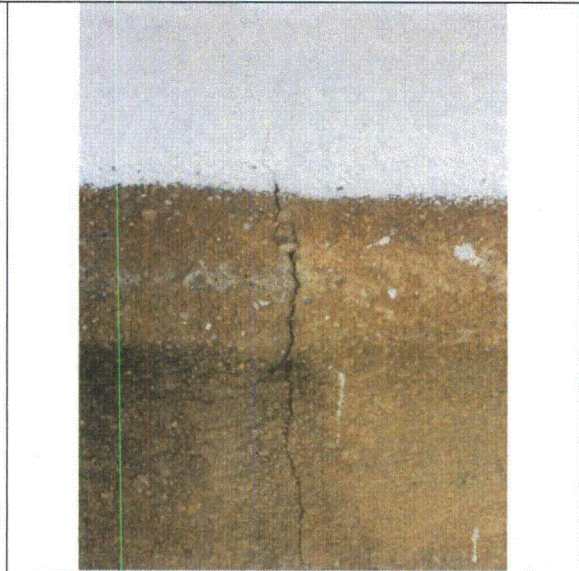
*Local concrete cracks are found in the concrete base at and away from the locations of anchor bolts. The cracks are noticeable and generally tight and closed. Structural monitoring maintenance program per EN-DC-150 for CST tank under license renewal will track these cracks.*

**Note:** Crack profile at location intermediate between anchor bolts. Note that the crack continues through the coating indication that the crack has been active since the coating was applied.

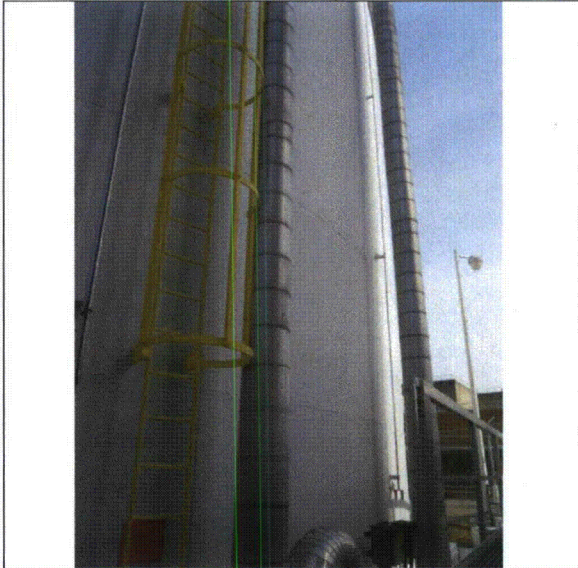
**Note:** *Pipes which span the height of the tank without intermediate support.*

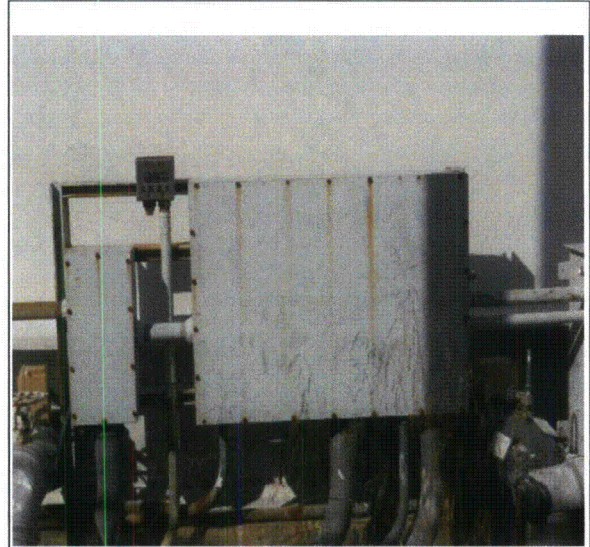
**Note:** *Cabinet which is missing bolts in face plate.*

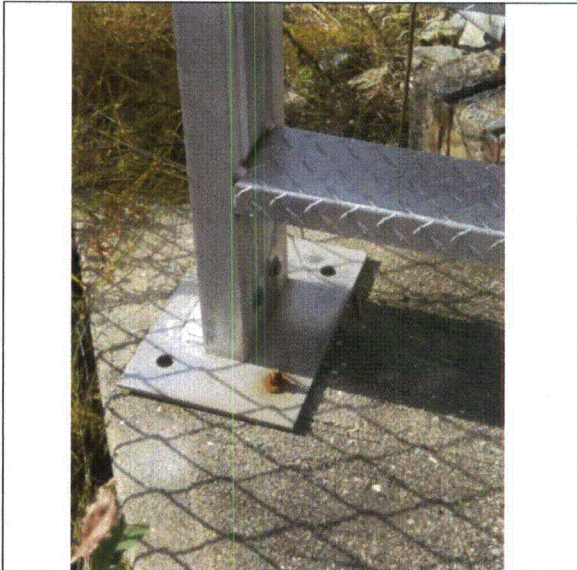
**Note:** Platform base plate with two bolts and four holes.

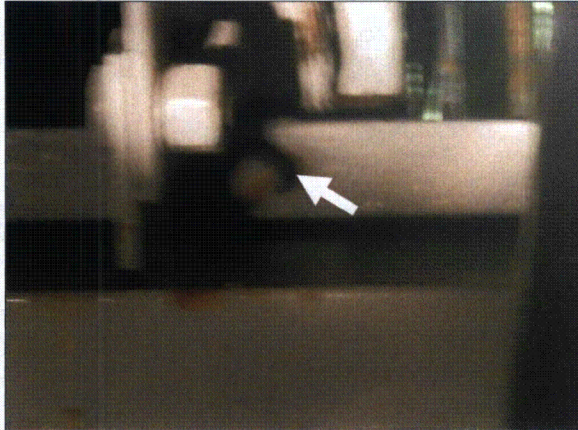
*There are two saddles supporting the tank, each with 4 bolts. Two of bolts on the north saddle are missing nuts (see attached photo). This is documented in CR-IP3-2012-03382.*

**Note:** *bolt with missing nut.*

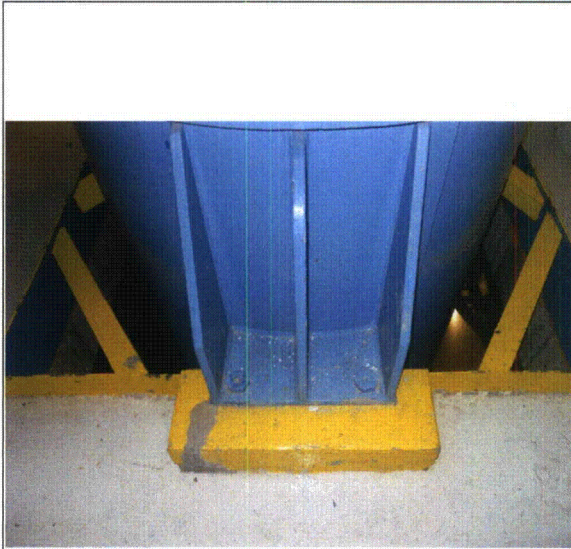
*Two of four anchor bolts are not fully engaged, missing 1/16" threads. Per calculation IP3-CALC-MULT-00734, page 6 for bolt size of 1/2" diameter and over, 0.136" recess is allowed.*

*Two of four anchor bolts are not fully engaged, missing 1/16" threads.*

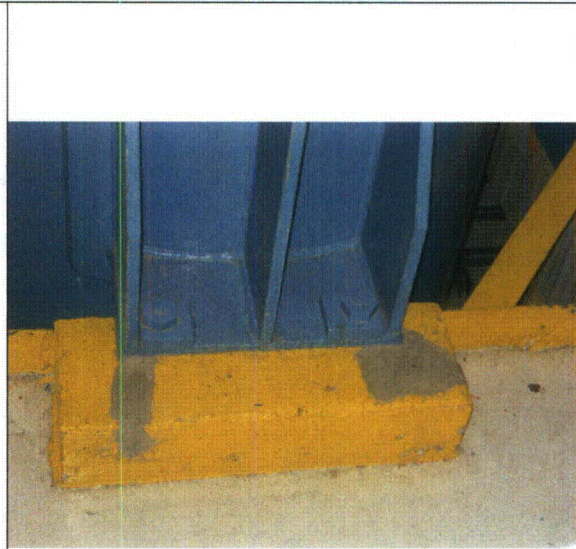
*There are indications that previous cracks have been repaired. See photo.*

*There are indications of repaired cracks.*

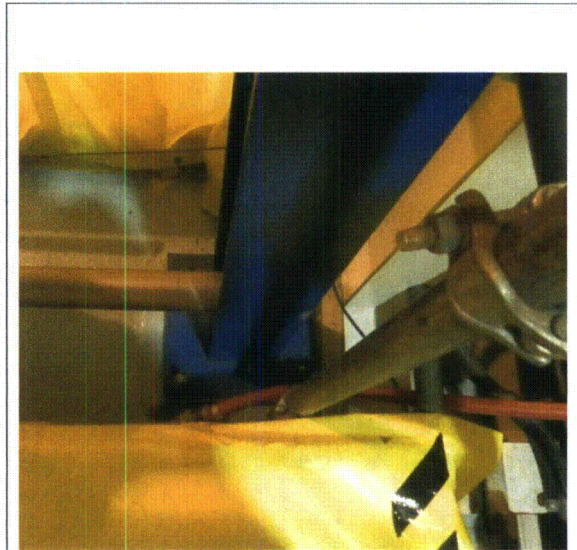
**Note:** base plate with 3 additional bolts.

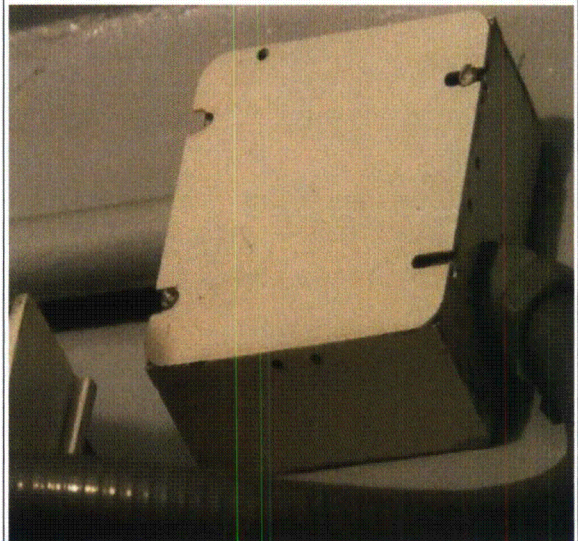
<p><b>Note:</b> <i>Junction box cover adjacent with 2 missing screws.</i></p>	<p><b>Note:</b></p>

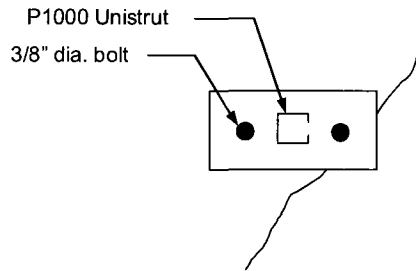
*Observed a crack crossing the east bolt of a conduit support on the north wall for conduits coming out of Relay Box TR-2 K00. The conduit support consist of a P1000 Unistrut with two 3/8" diameter bolts supporting ≈1½" and ≈¾" diameter conduits (see attached photos). A sketch of the crack and the support is shown below for clarification. This is evaluated in LB-16.*

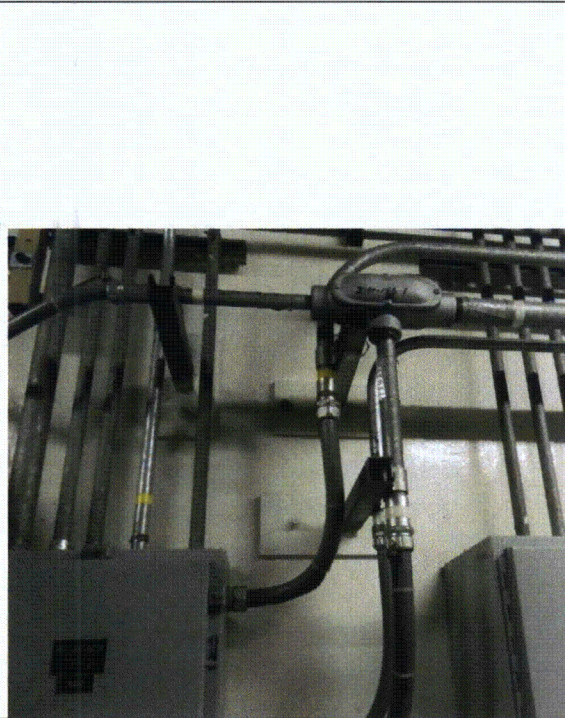
**Note:** conduit support east of Relay Box TR-2 K00

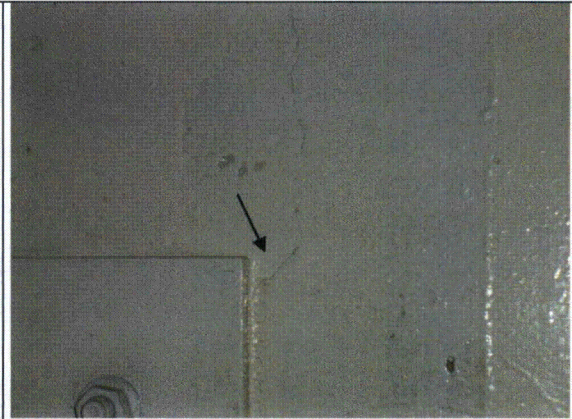
**Note:** crack near the east bolt

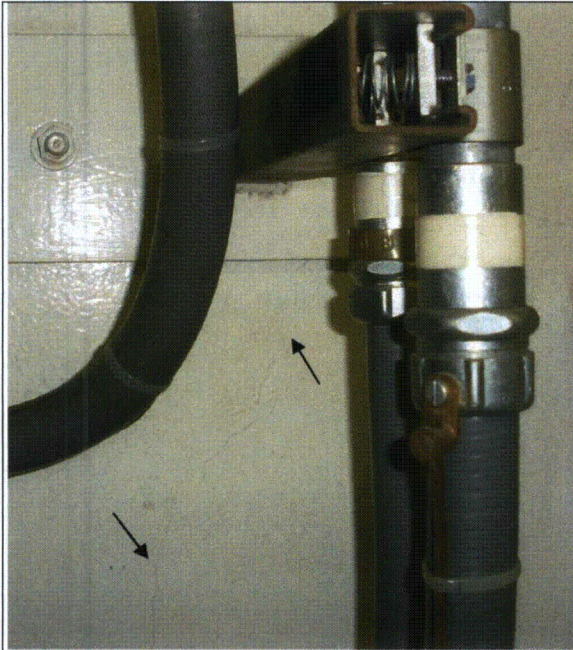
**Note:** crack going through the east bolt

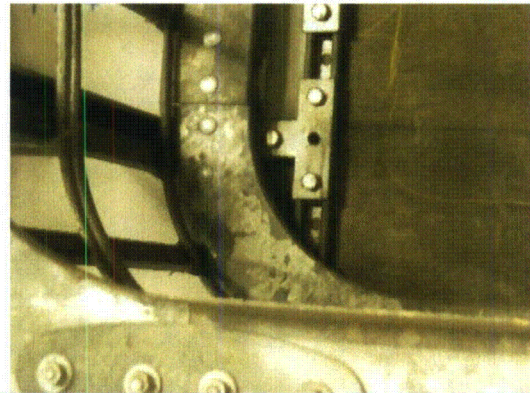
**Note:** Missing anchor in center for cable tray 34k

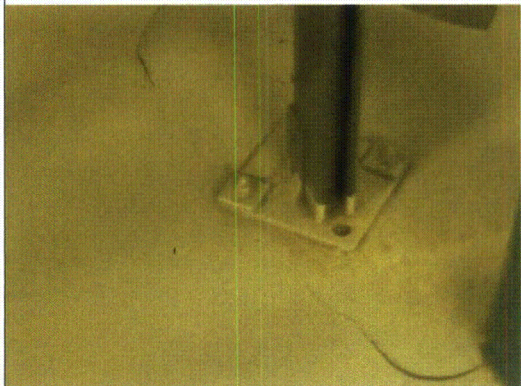
<p><b>Note:</b> <i>Missing two anchors from DS-LP501 Disconnect Switch for LP501</i></p>	<p><b>Note:</b> <i>Unrestrained equipment near 34MCC</i></p>

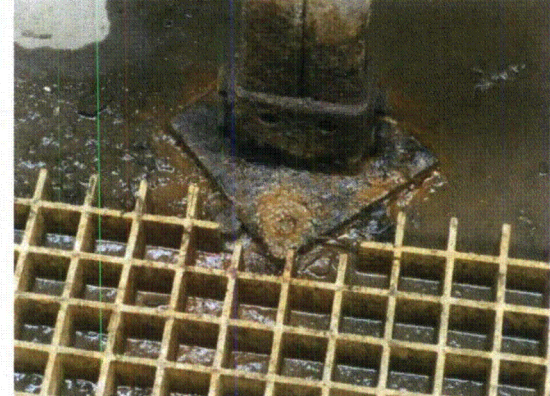
<p><b>Note:</b> Control Panel TWS #31</p>	<p><b>Note:</b> Missing three anchor bolts</p>

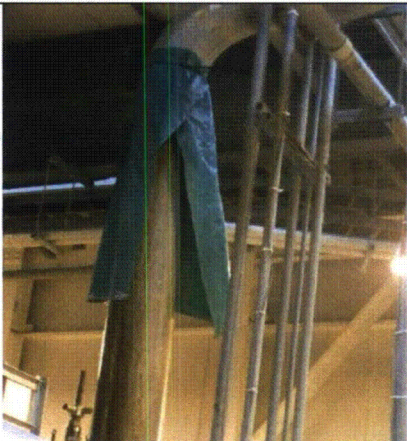
<p><b>Note:</b> Leaking pipe near Screen Wash around column line 18</p>	<p><b>Note:</b></p>

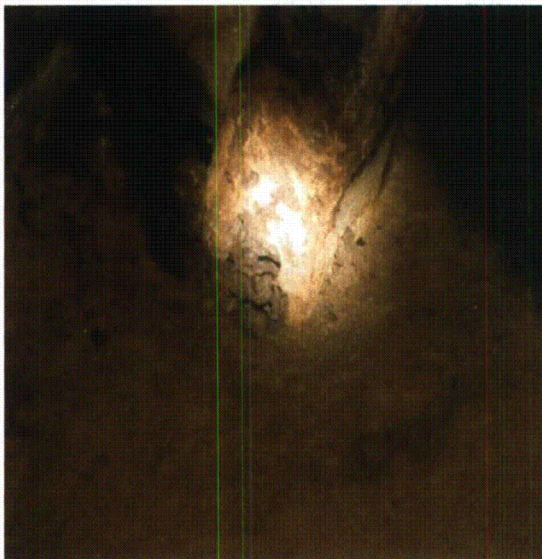
**Note:** Corroded and broken Unistrut near door.

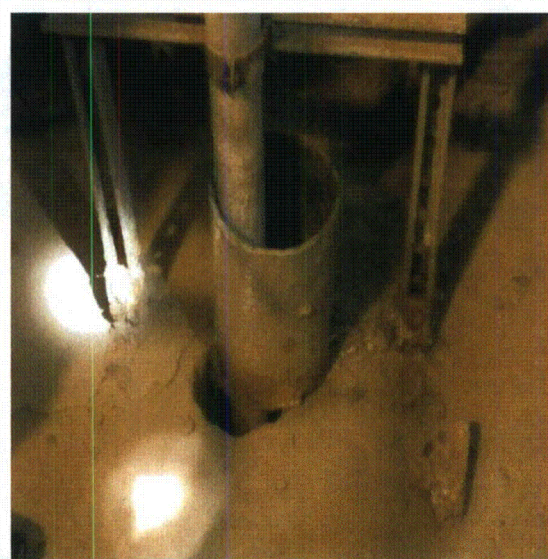
**Note:** Corroded and broken Unistrut near door and a loose pipe protection cover between the Unistrut legs

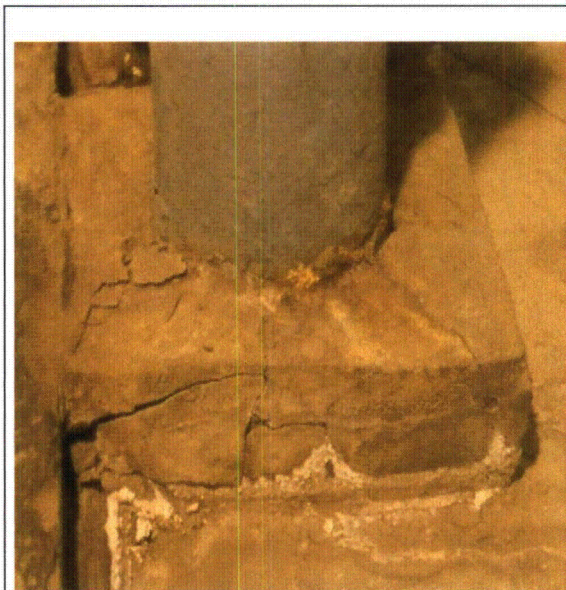
**Note:** Cracked grout penetration protection

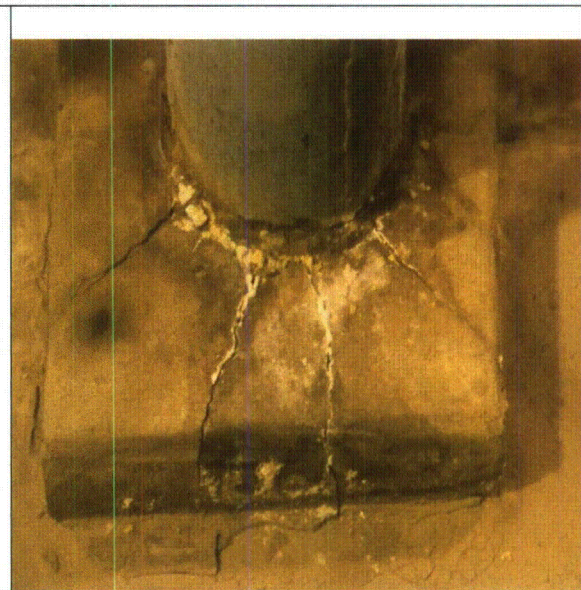
**Note:** Cracked grout penetration protection

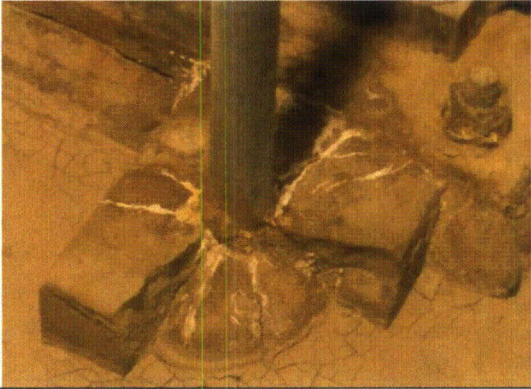
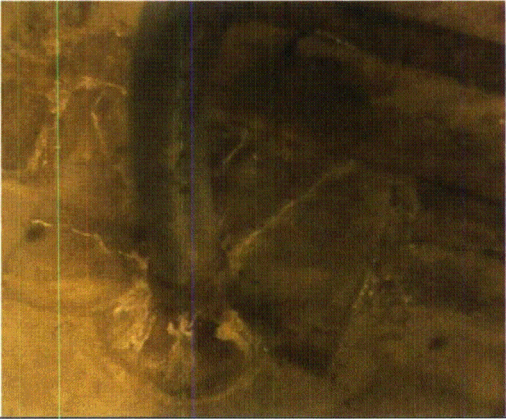
<p><b>Note:</b> Cracked and chipped grout penetration protection</p>	<p><b>Note:</b> Cracked and chipped grout penetration protection</p>

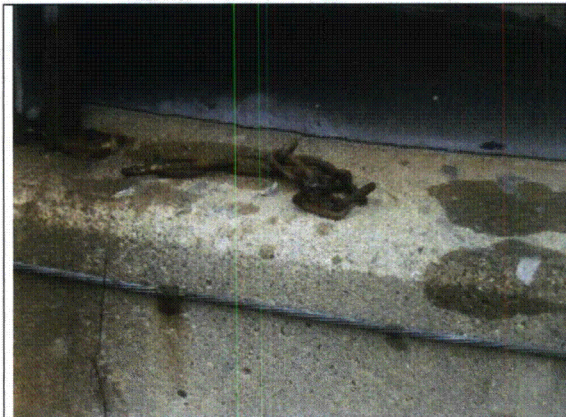
**Note:** Loose chain on top of RWST-31 foundation.

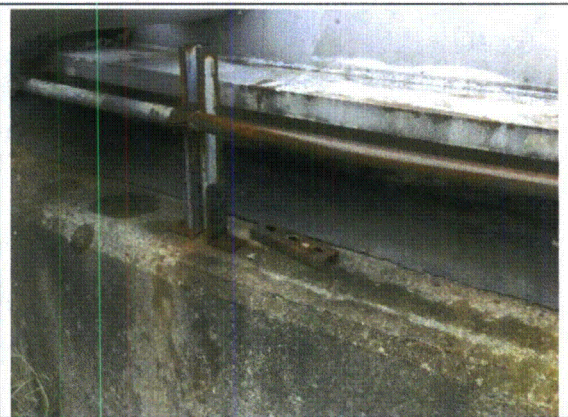
**Note:** Loose Unistrut on top of RWST-31 foundation.

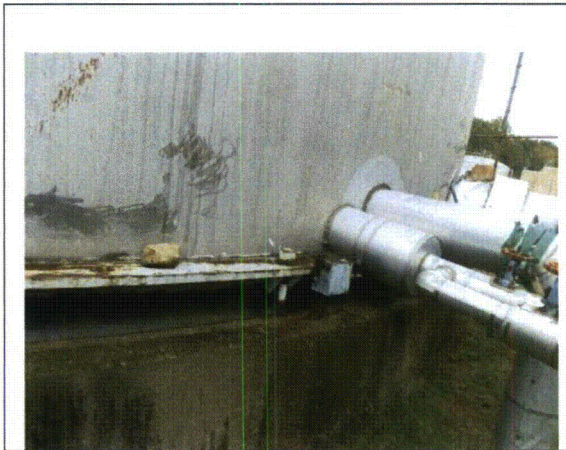
**Note:** Rock resting on the tank ring.

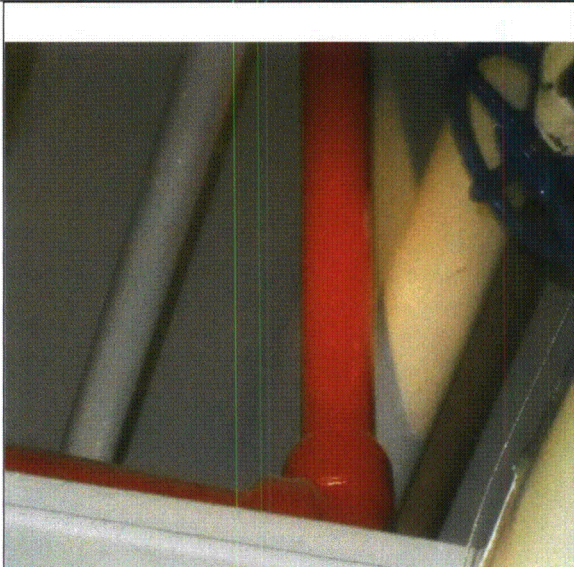
**Note:** Fire water line in close proximity to a conduit.

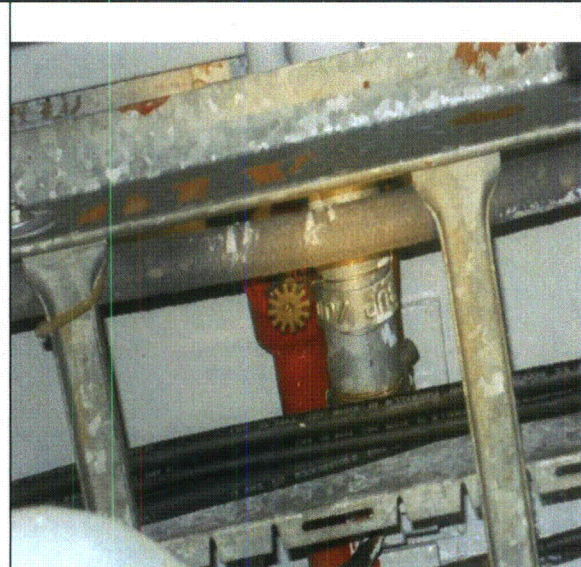
**Note:** Sprinkler head in close proximity to adjacent conduit.

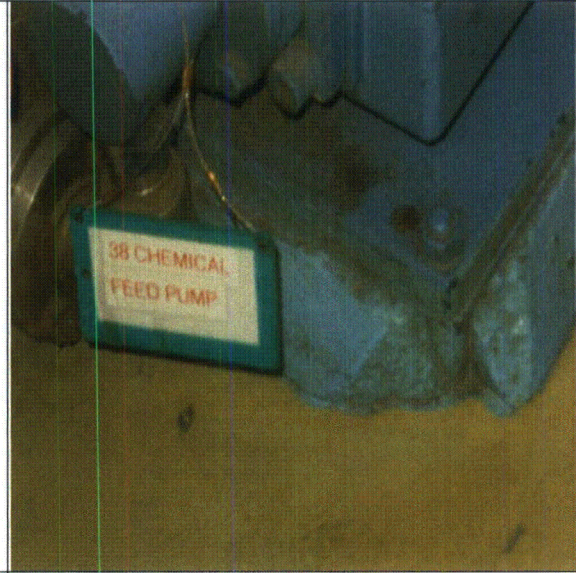
**Note:** Missing grout at anchor bolt at 38 Chemical Feed Pump

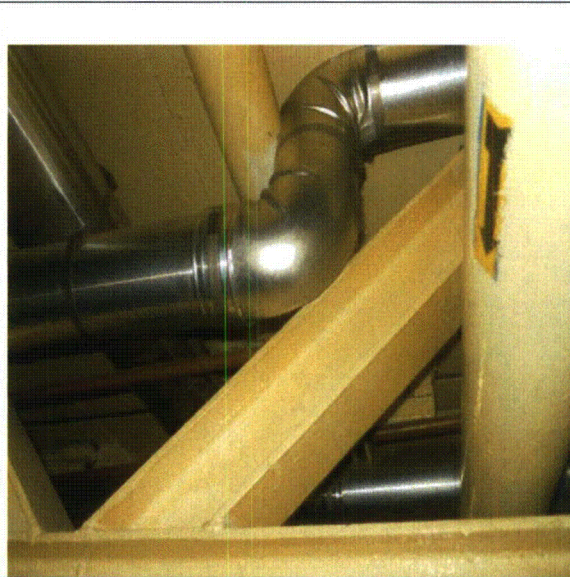
**Note:** Pipe insulation interference with structural steel.

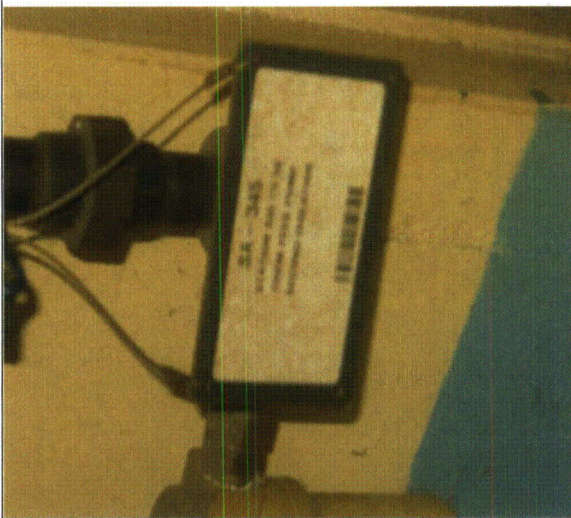
A photograph showing a close-up of a valve assembly. The valve handle is on the left, and a rectangular label is attached to the valve body. The label contains some text and a barcode. The valve is mounted on a wall, and there is a noticeable gap or missing insulation around the valve body.	
<p><b>Note:</b> <i>Missing insulation at valve.</i></p>	<p><b>Note:</b></p>

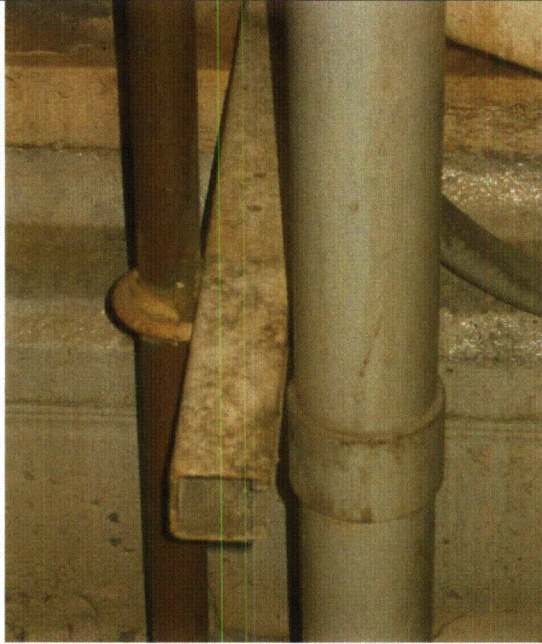
**Note:** The connection of the conduit riser next to column H8/19.5 is missing the U-bolt attachment to the Unistrut.

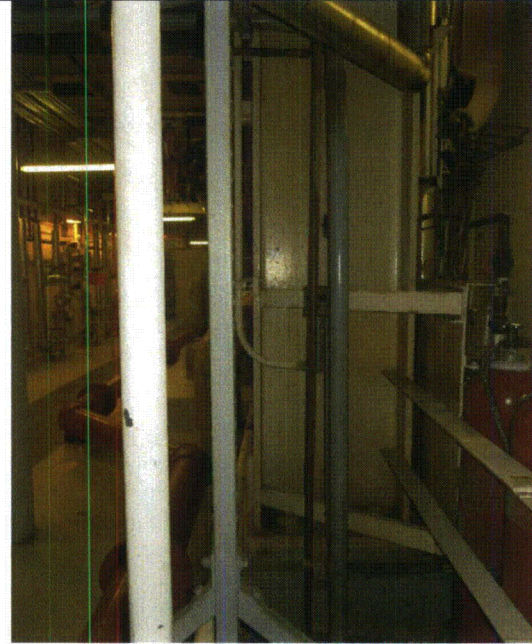
**Note:** View of the unsupported length of conduit shown in previous picture.

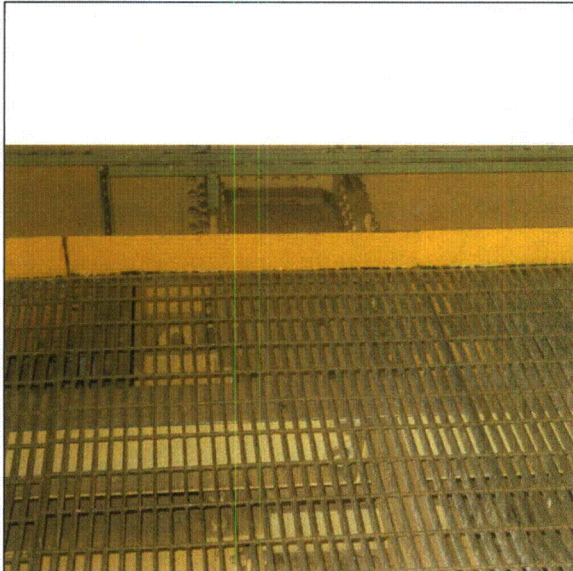
**Note:** *Some sections of grating are not attached to the steel beam below.*

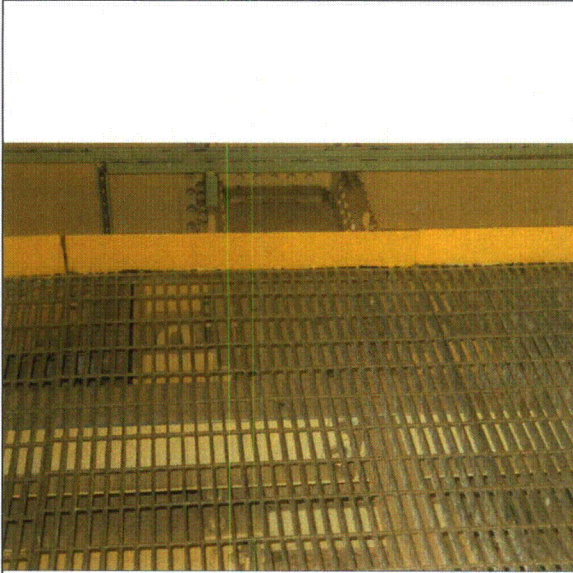
**Note:** Some sections of grating are not attached to the steel beam below.

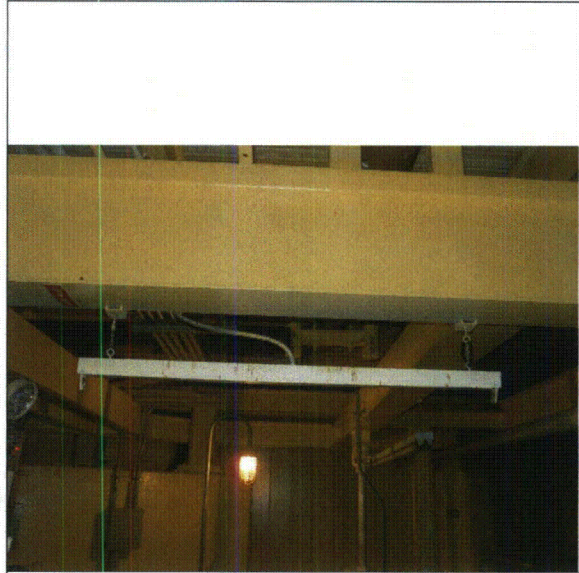
**Note:** Some fluorescent bulbs near south end of the platform are out and need to be replaced.

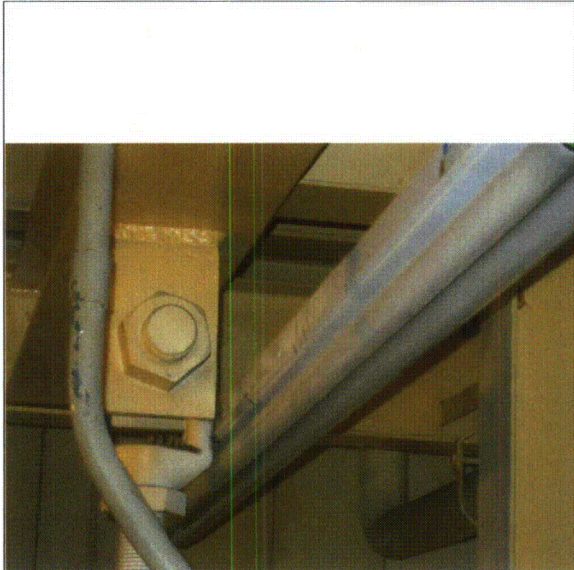
**Note:** One of the florescent fixtures is touching the steel hanger.

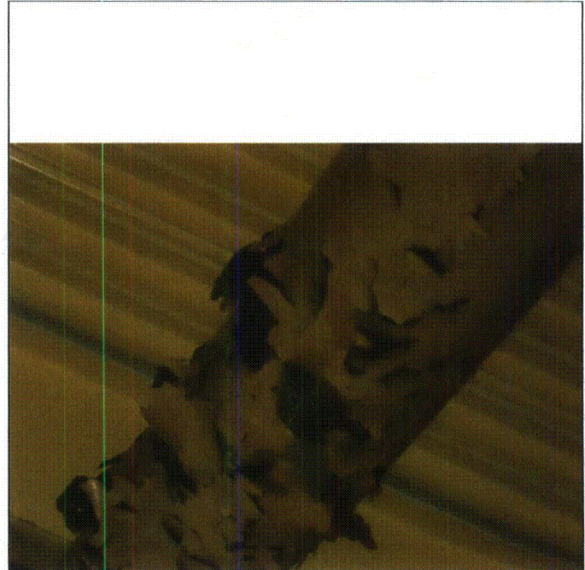
**Note:** The insulation cover of the overhead pipe is peeling off.

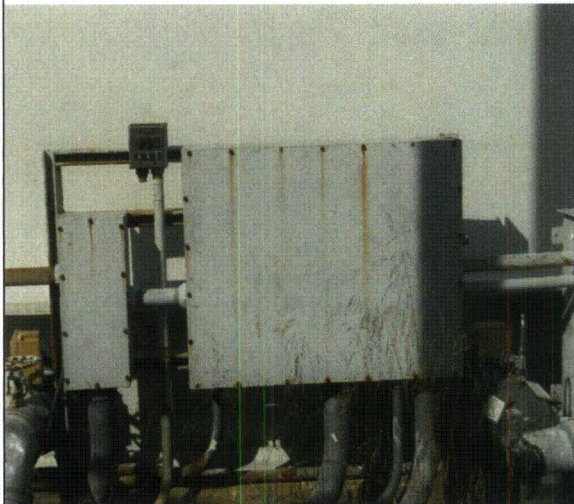
**Note:** Several screws are missing for the electric panels

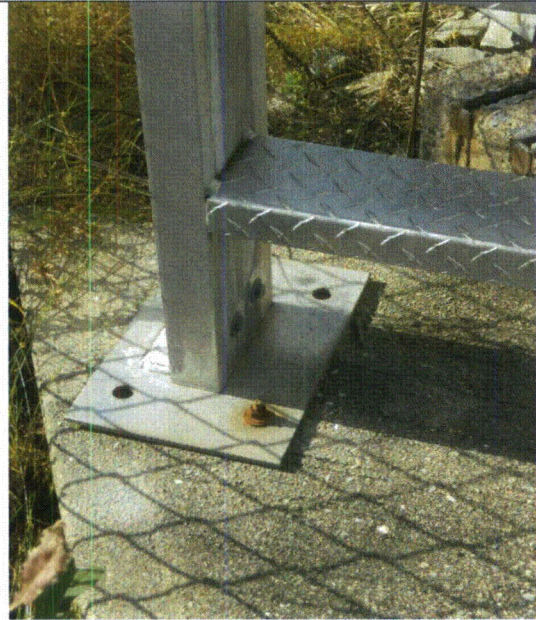
**Note:** The adjacent platform support base plate missing half number of anchor bolts.

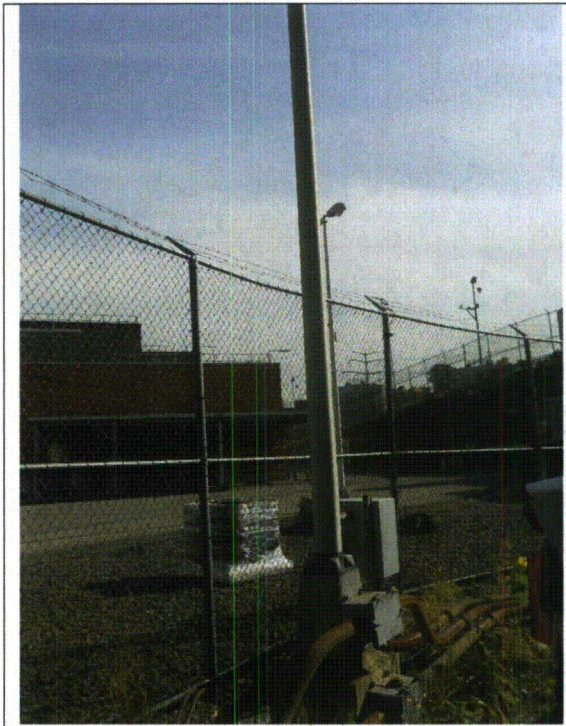
**Note:** *The lighting poles near the tank need to be verified for seismic adequacy.*

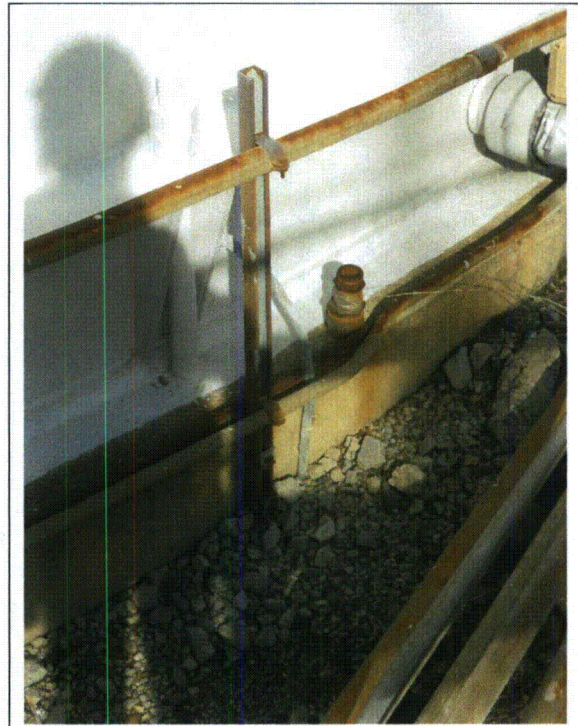
**Note:** *All the conduit and pipes show sign of various stages of corrosion.*
