**ATTACHMENT 9.7**

**AREA WALK-BY CHECKLIST**

IP3

**Area Walk-By Checklist (AWC)** AWC-020

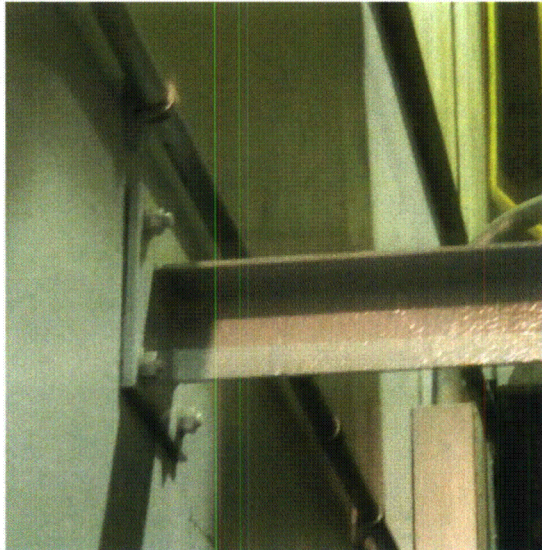
*Observed a wide flange across the room (spanning east-west) supporting B574 duct with a gap between the base plate and the east wall. The gap is observed to be approximately between 1/8" to 1/4" (see attached photo). This gap may result in bending of the anchor bolts. This is addressed in CR-IP3-2012-03361. LB-05 evaluates this condition.*

<p><b>Note:</b> wide flange across the room (spanning east-west) supporting B574 duct with a gap between the base plate and the east wall</p>	<p><b>Note:</b></p>

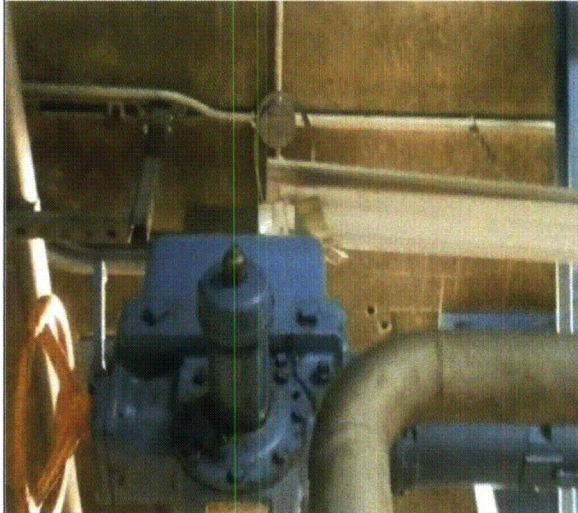
*Observed a broken fluorescent light fixture directly above CS Pump 32. The fixture is tied in the center (with rope or zip tie) but loose at the north end. During a seismic event the fixture may fall and strike the oil reservoir or any sensitive equipment (see attached photo). This is addressed in CR-IP3-2012-03481.*

<p><b>Note:</b> <i>broken fluorescent light fixture directly above CS Pump 32</i></p>	<p><b>Note:</b></p>

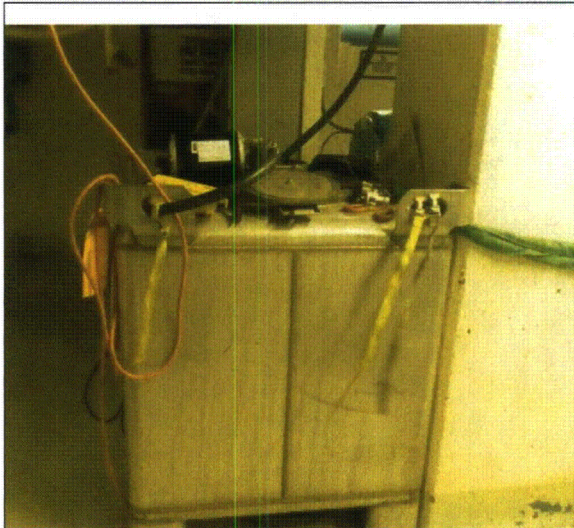
7. Does it appear that the area is free of potentially adverse seismic interactions associated with housekeeping practices, storage of portable equipment, and temporary installations (e.g., scaffolding, lead shielding)? Y  N  U  N/A   
*Observed tools, cables, parts resting on top of the CCW tank (see attached photos).*

**Note:** Tools on top of CCW tank

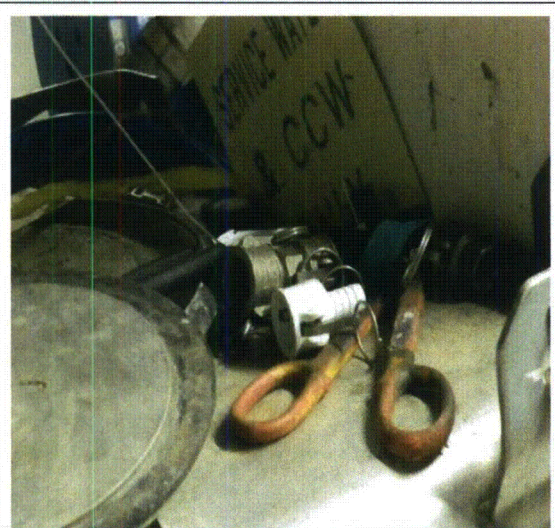
**Note:** Tools on top of CCW tank

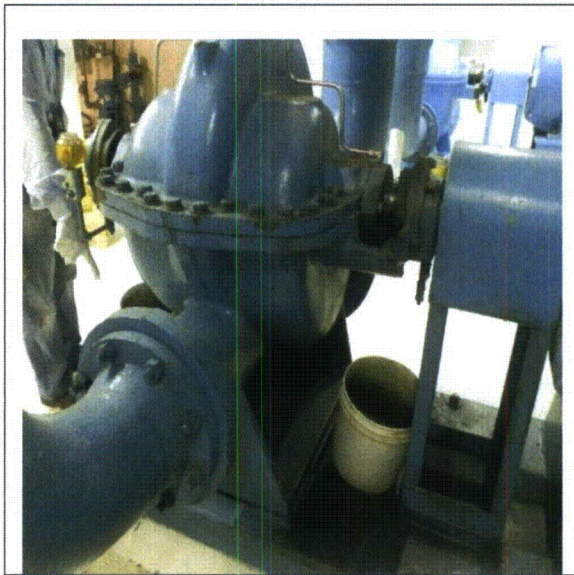
*Observed two buckets (collecting drips) at 32 CCW pump (see attached photos).*

**Note:** Bucket at 32 CCW pump

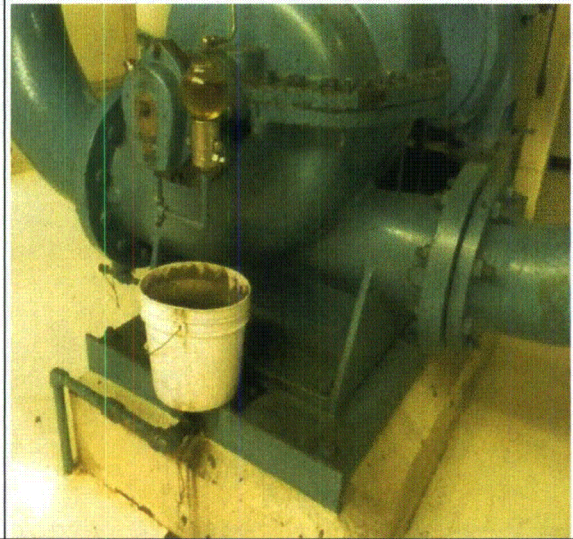
**Note:** Bucket at 32 CCW pump under the oil reservoir

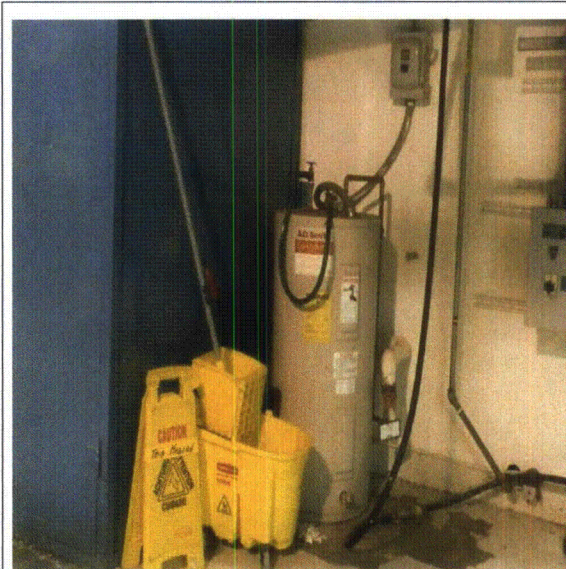
*Observed a bucket (with wheels) and mop stick near the hot water heater near Sump Pump 37 (see attached photo).*

**Note:** wheeled bucket and a mop stick

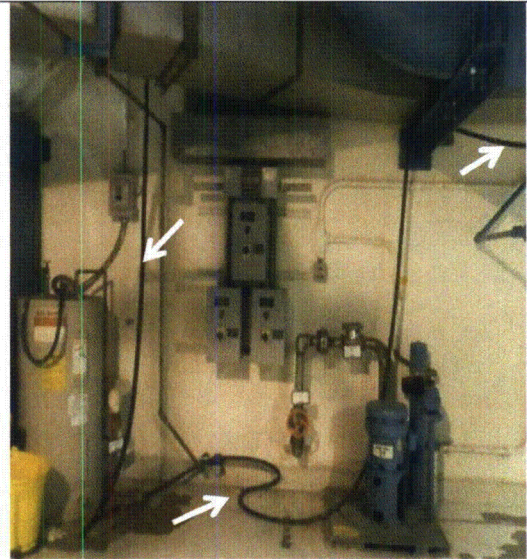
*Observed hoses coming out of CCW tank that are laid over piping, piping supports and ducts that are not tied down. The ends of two hoses seem to travel to an upper elevation connecting to another CCW tank. Another hose is resting on top of a pipe near SWN-32.*

**Note:** loose hose laying on floor going to an upper elevation.

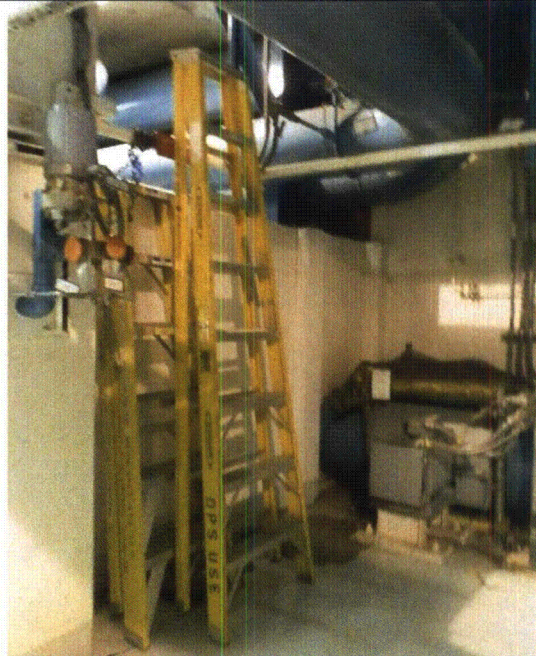
*Observed a ladder near the Appendix R safe shutdown ladder that is not restrained.*

**Note:** Unrestrained ladder by the Appendix R safe shutdown ladder.

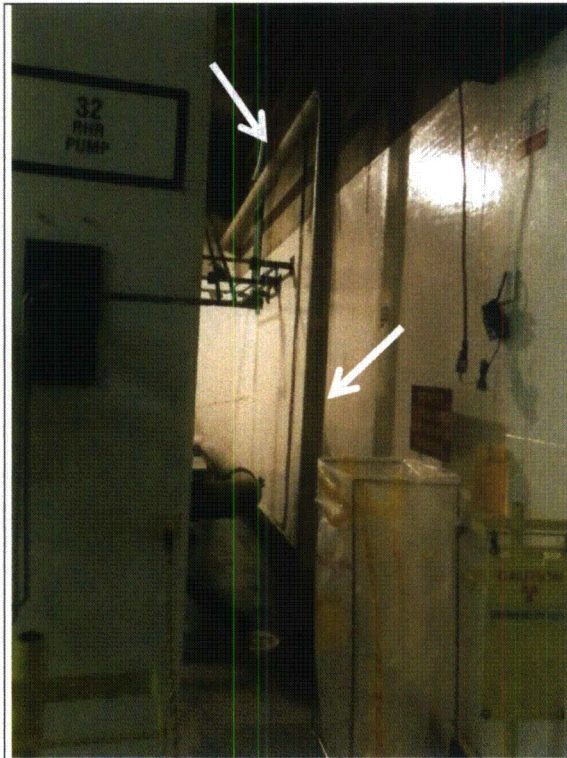
**Note:** piping with an unsupported length of approximately 25 to 30 ft.

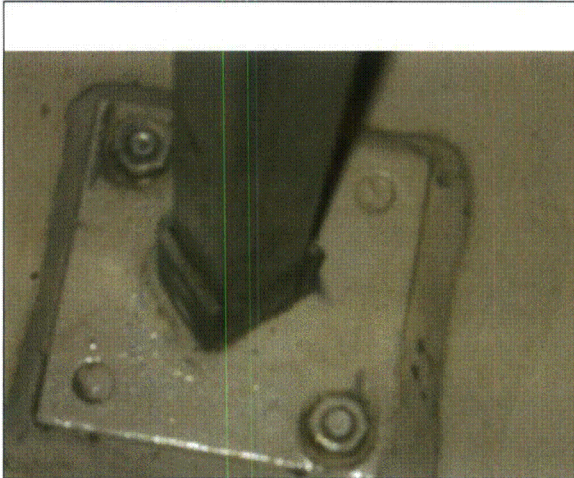
*TR-4004 support base plate is missing two out of four anchor bolts. This is typical of all four base plates and based on the size of the cabinet, it is judged that this configuration is adequate for applied seismic loading.*

**Note:** Base plate with two out of four anchor bolts in place.

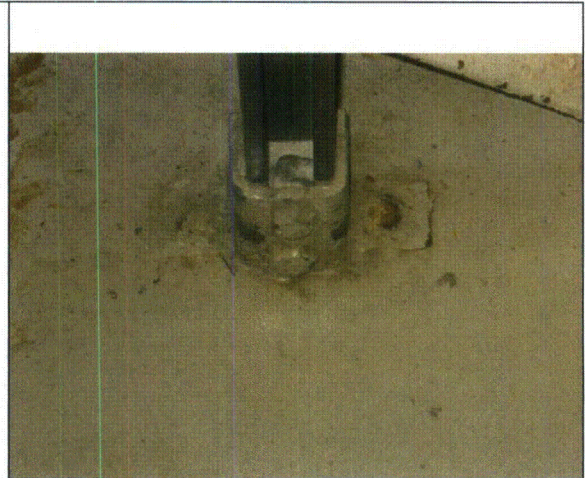
*Electric heat tracing cabinet support base plates and anchor bolts are severely corroded. The Unistrut support column has been welded to the stair stringer to provide additional support. CR-IP3-2012-03595 documents this condition. LB-19 has evaluated this condition.*

**Note:** Electric heat tracing cabinet base plate

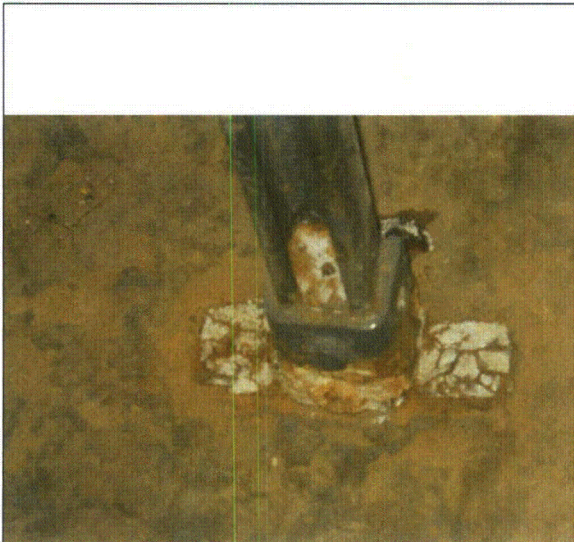
**Note:** Electric heat tracing cabinet base plate inside of curbed area.

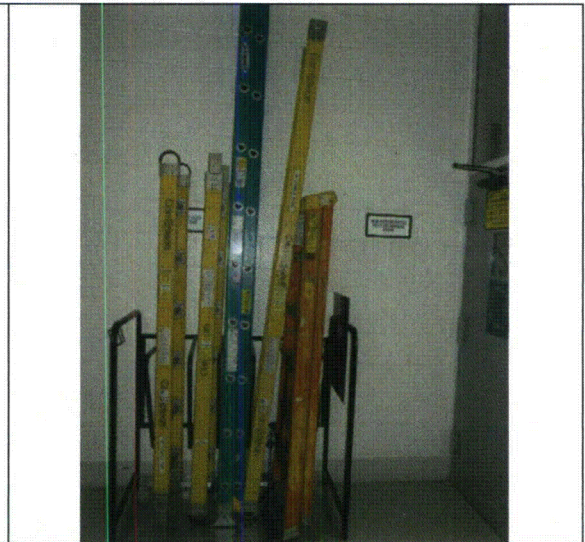
**Note:** Unsecured ladders at the Nonregenerative heat exchanger room

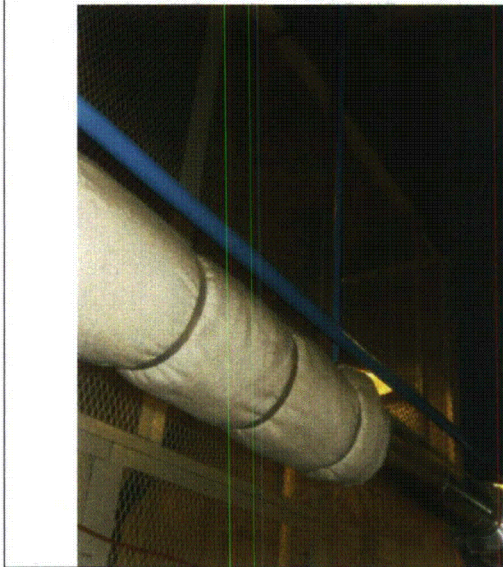
**Note:** Pipe hanger in close contact with horizontal pipe.

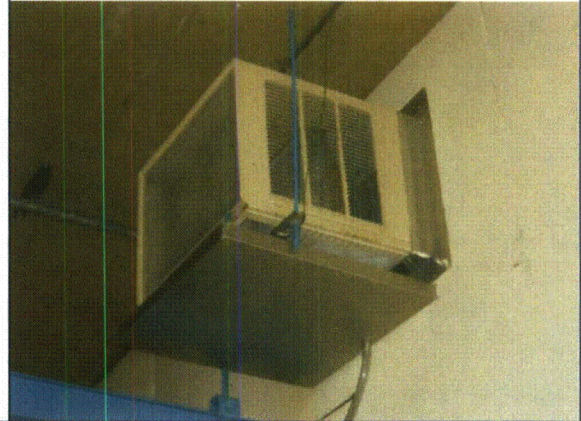
**Note:** Air conditioner with no apparent horizontal support.

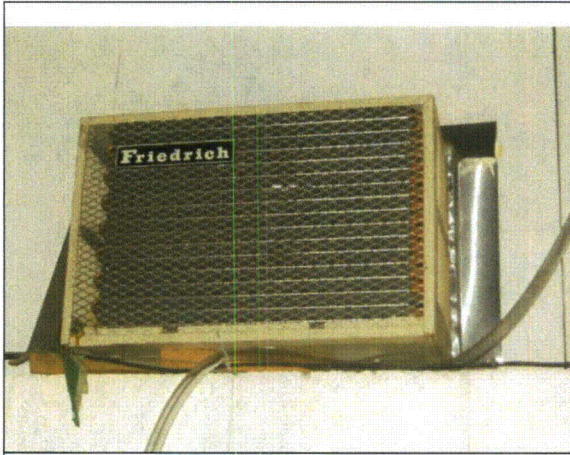
**Note:** Air conditioner with no apparent lateral support

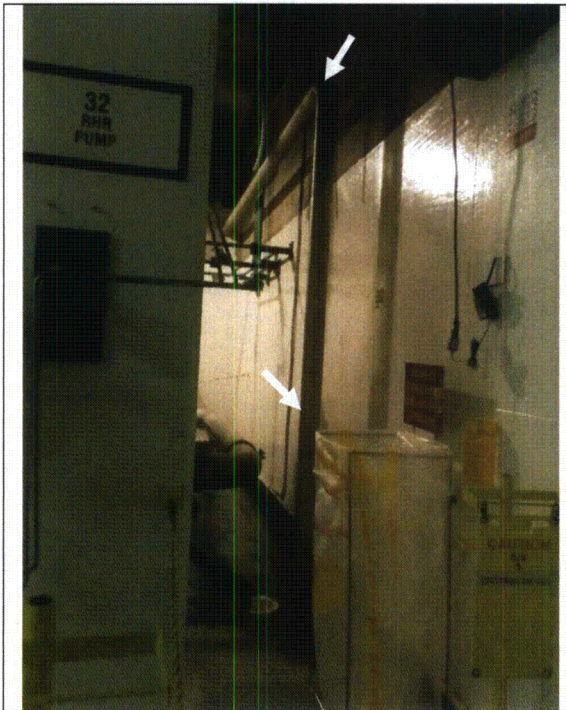
**Note:** piping with an unsupported length of approximately 25 ft to 30 ft

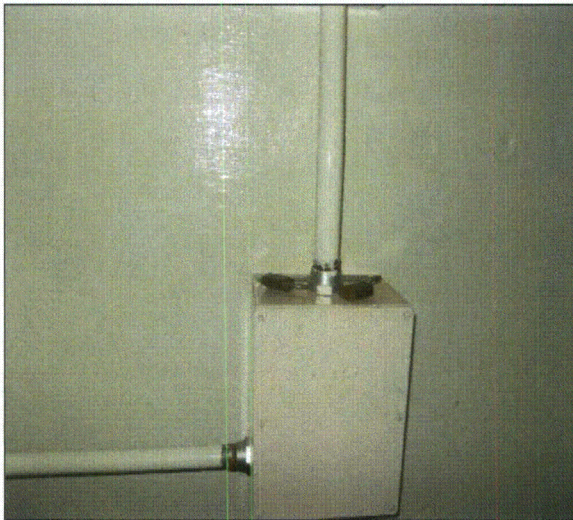
**Note:** Loose padlocks on top of cabinet

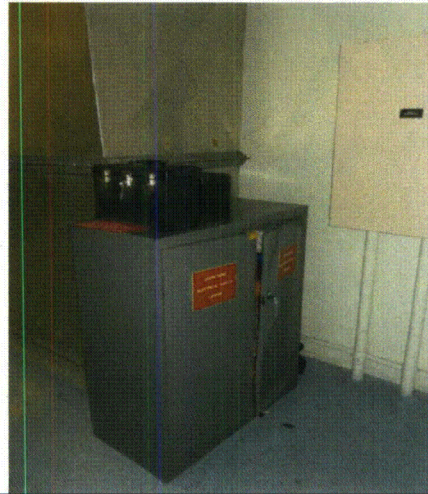
**Note:** Unsecured tool box on top of cabinet and cabinet door not closed.

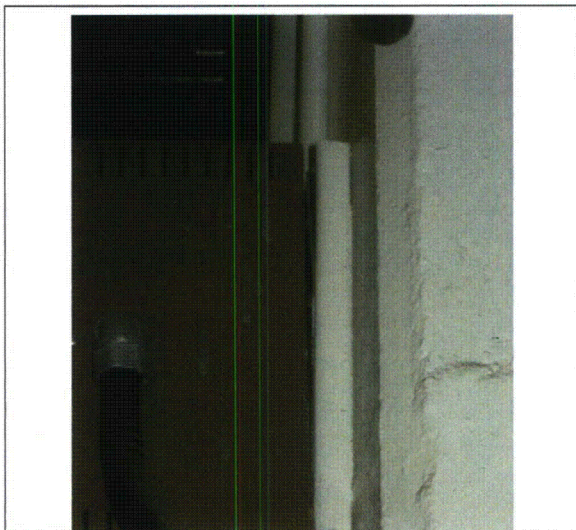
**Note:** Appendix R cabinet with gap at top behind back plate

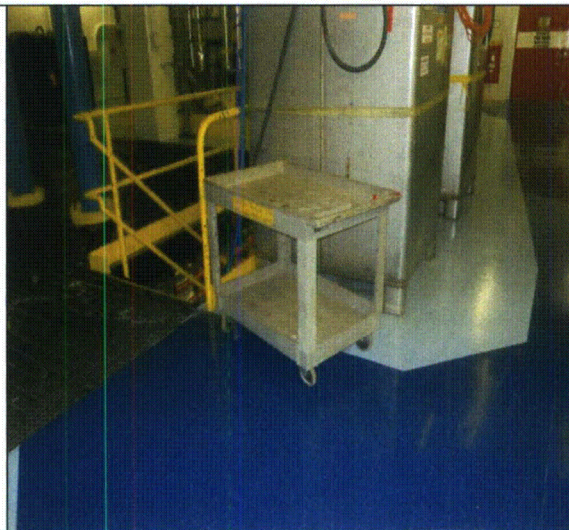
**Note:** Unsecured cart

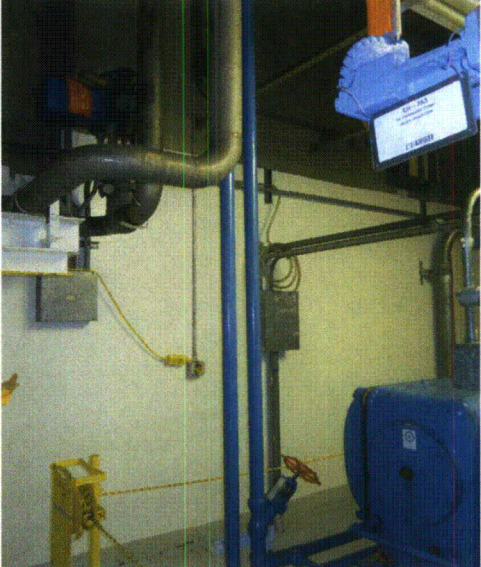
<p><b>Note:</b> Pipes connected to and near valve AC-757E have long unsupported length in the vertical direction and are in contact near the ceiling.</p>	<p><b>Note:</b></p>

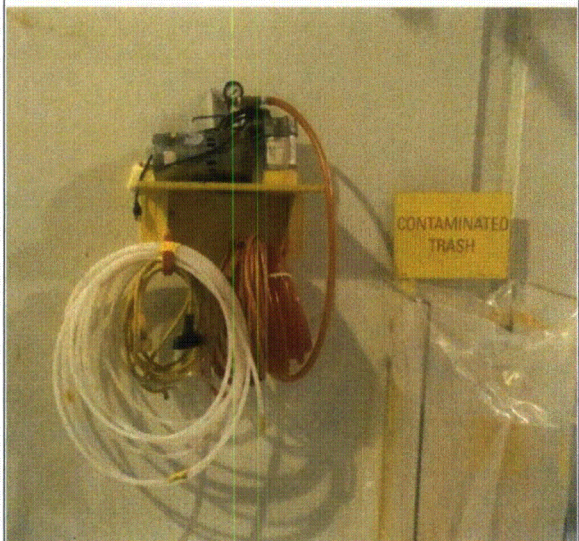
<p><b>Note:</b> unrestrained filter, brush and tape on wall shelf.</p>	<p><b>Note:</b></p>

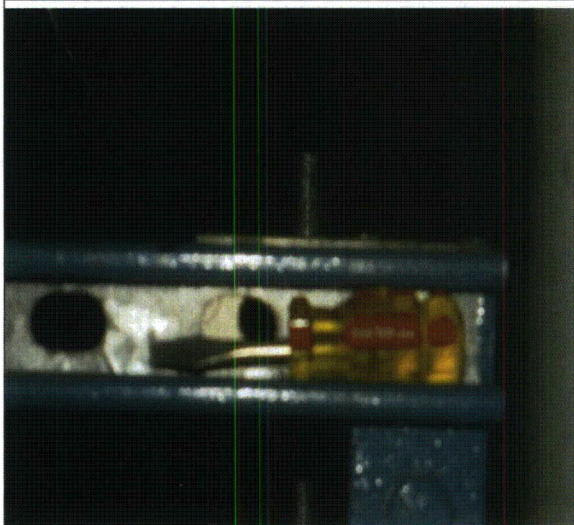
**Note:** Screw driver left on Unistrut

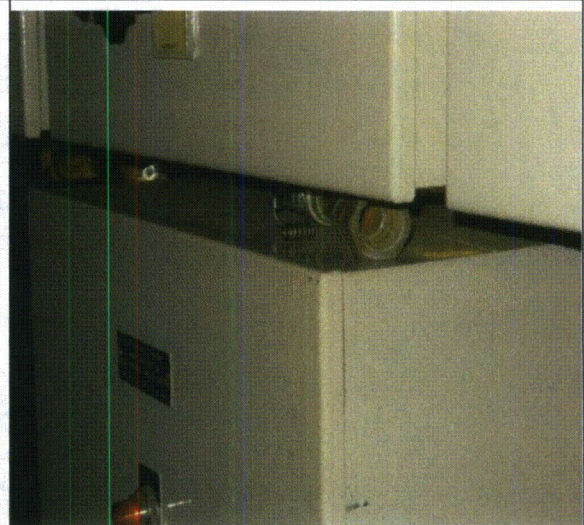
**Note:** Miscellaneous parts on top of panel

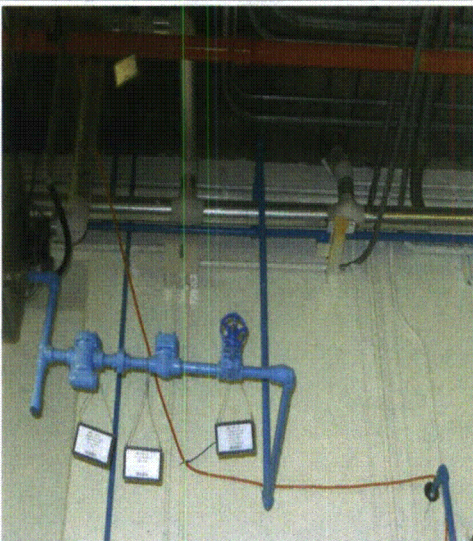
**Note:** Area heater UH334 piping not seismically supported

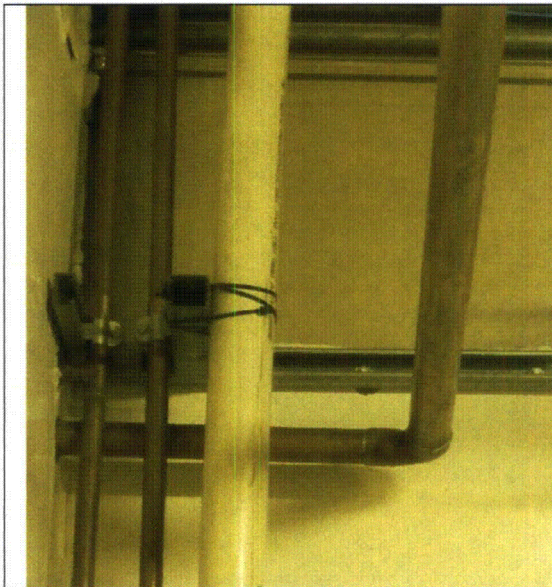
**Note:** PVC zip tied to unistrut

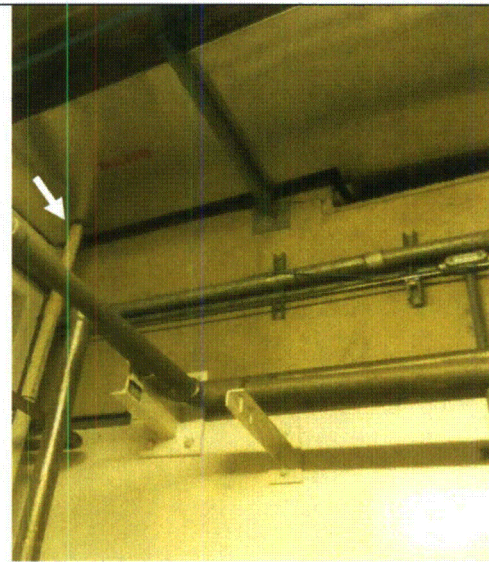
**Note:** PVC penetrates duct

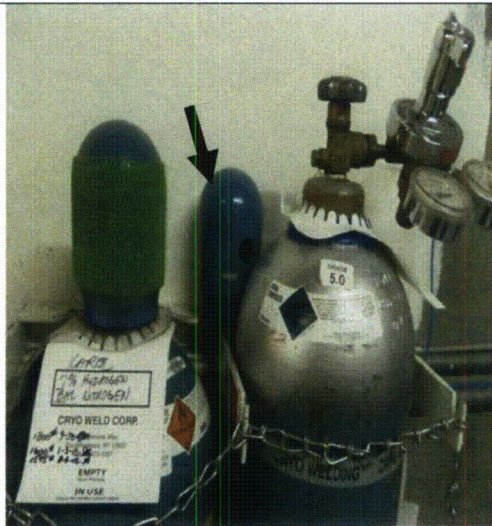
**Note:** Loose cap behind the compressed air bottles.

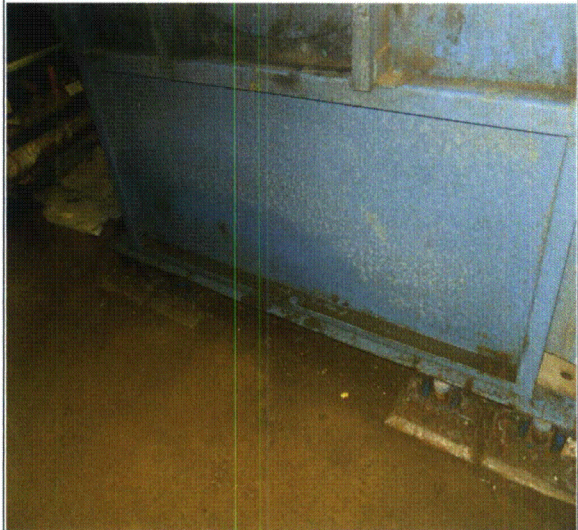
<p><b>Note:</b> <i>There is a considerable amount of water on the floor indicating potential leakage from piping in the area.</i></p>	<p><b>Note:</b></p>

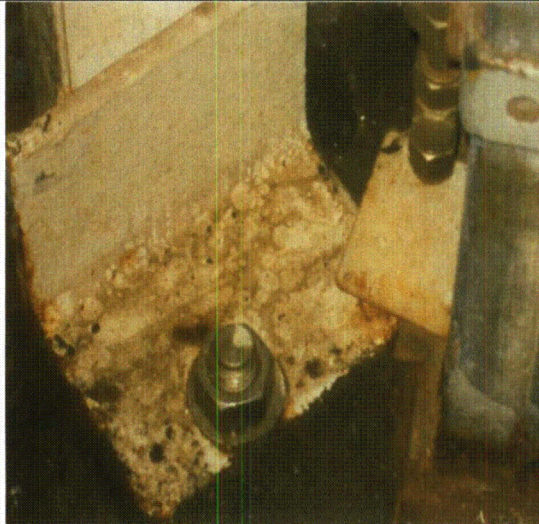
**Note:** Anchor bolt for strainer (stainless steel) with some corrosion of base angle.

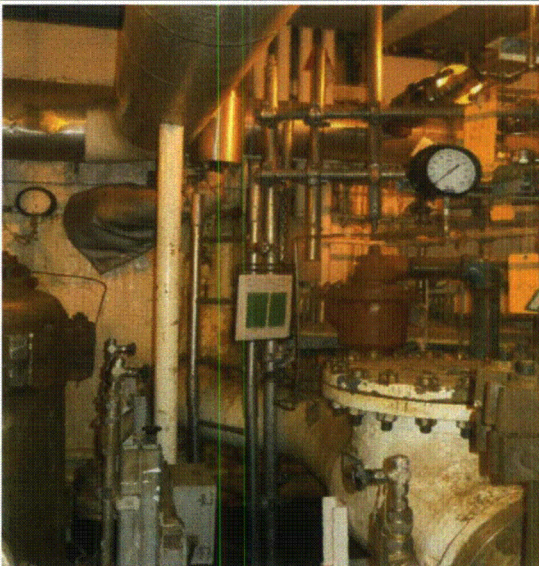
**Note:** Scaffolding adjacent to strainers with green tag.

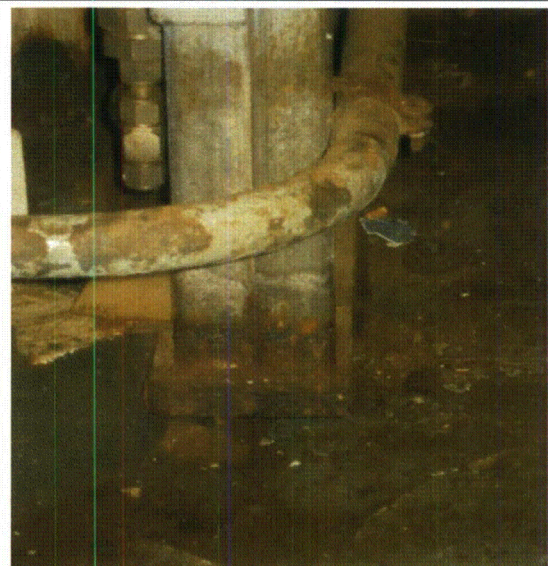
**Note:** Corrosion at the base of a Unistrut column

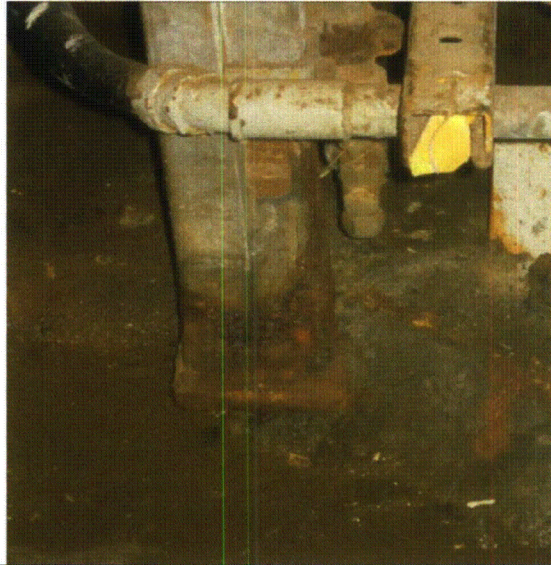
**Note:** Corrosion at the base of a Unistrut column

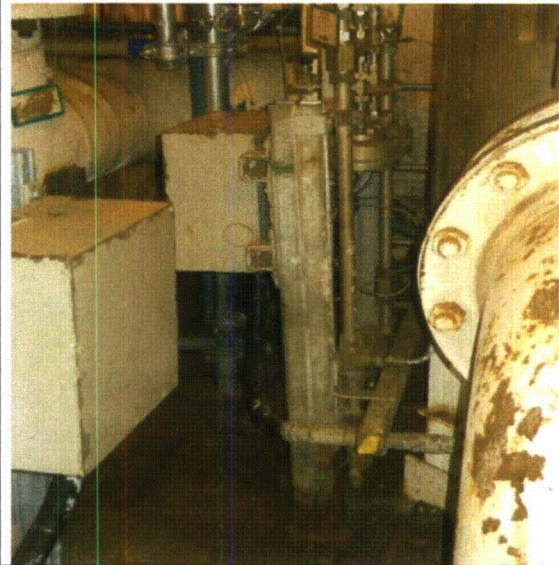
**Note:** Unistrut column which is beginning to tilt

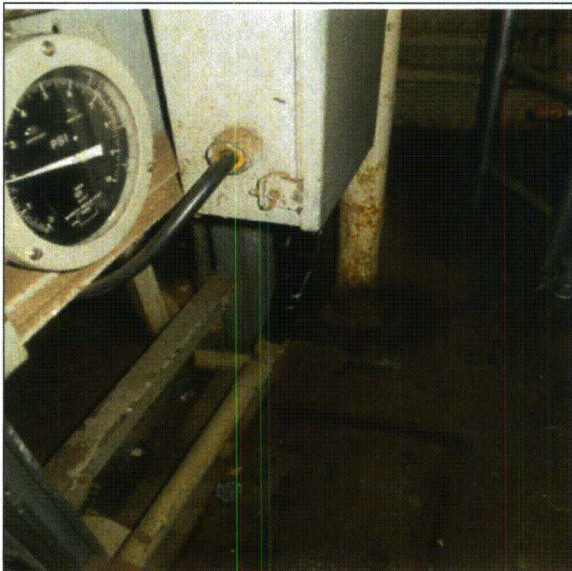
**Note:** Pipe support stanchion showing considerable corrosion

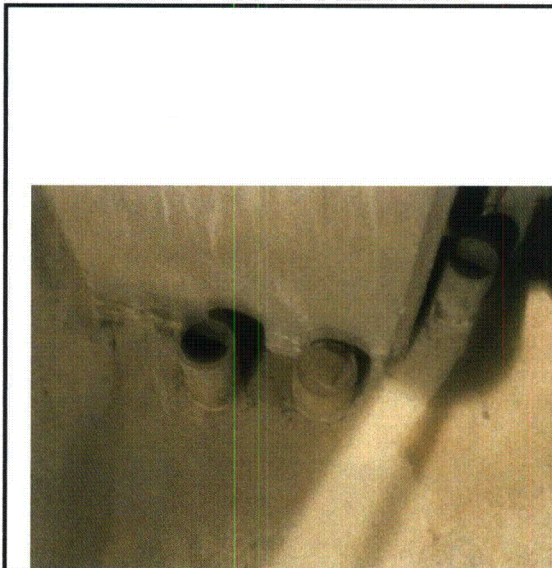
**Note:** Loose plug and unplugged piping.

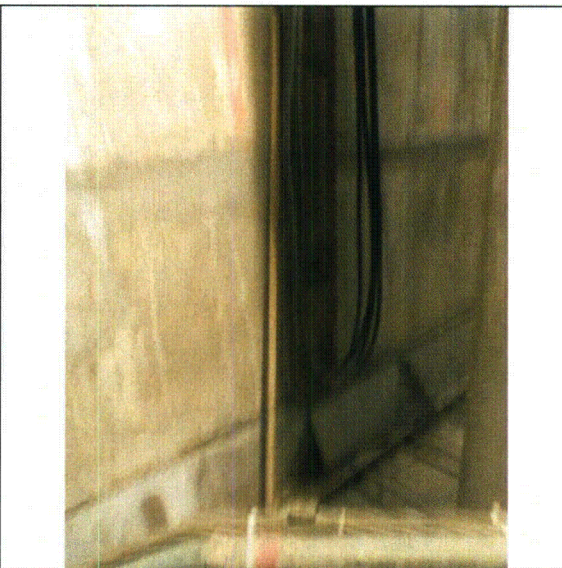
**Note:** unrestrained broom stick

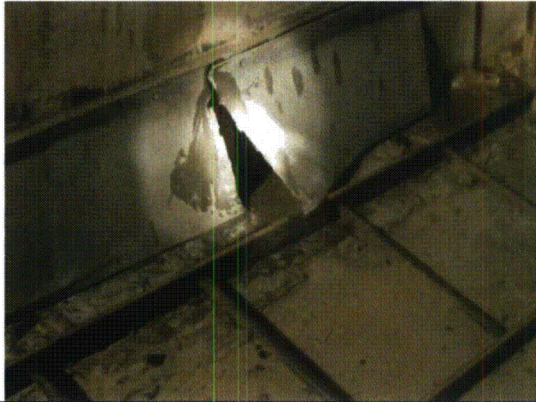
**Note:** Broken flashing

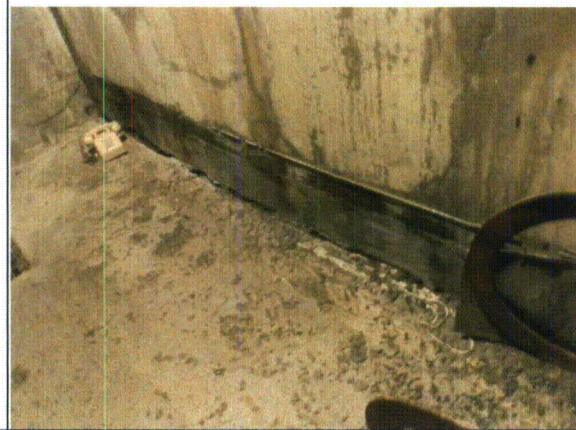
**Note:** Missing flashing along the wall

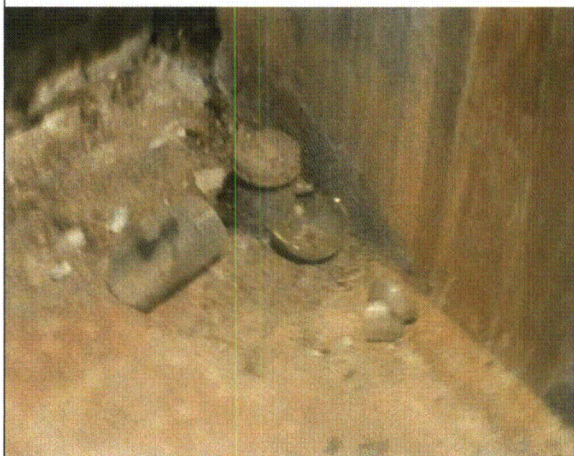
**Note:** Broken glass in the east corner of the room.

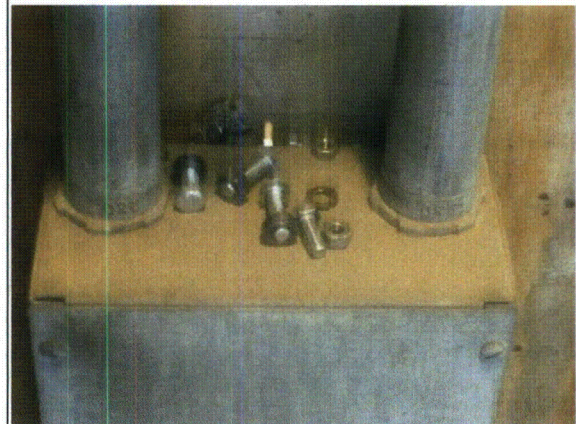
**Note:** Bolts and nuts on top of electrical box for GAI-Tronics.

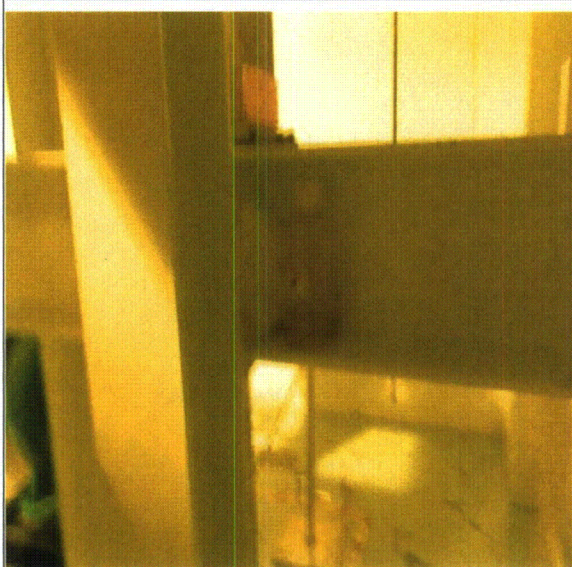
**Note:** bottle sitting on a beam

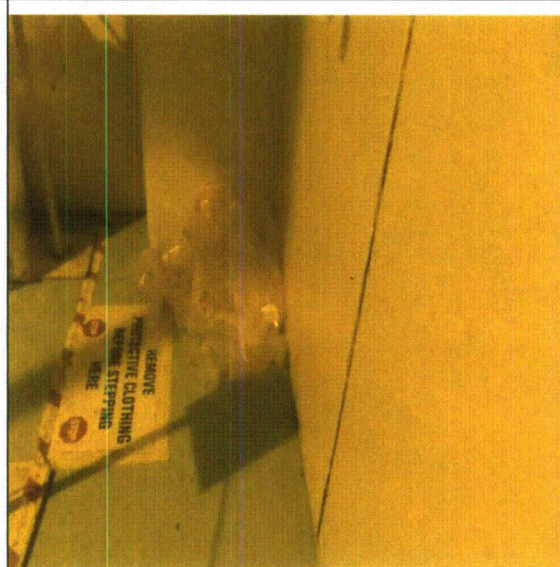
**Note:** waste bag on the floor

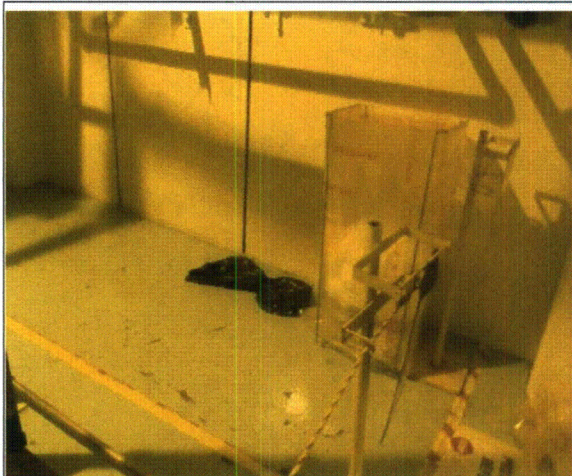
**Note:** waste bag on the floor

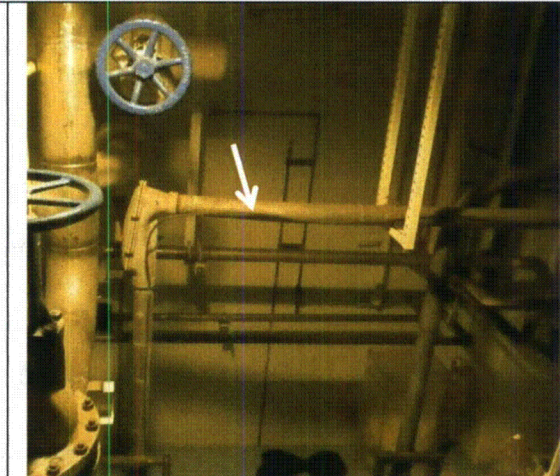
**Note:** bare wire attached to a conduit

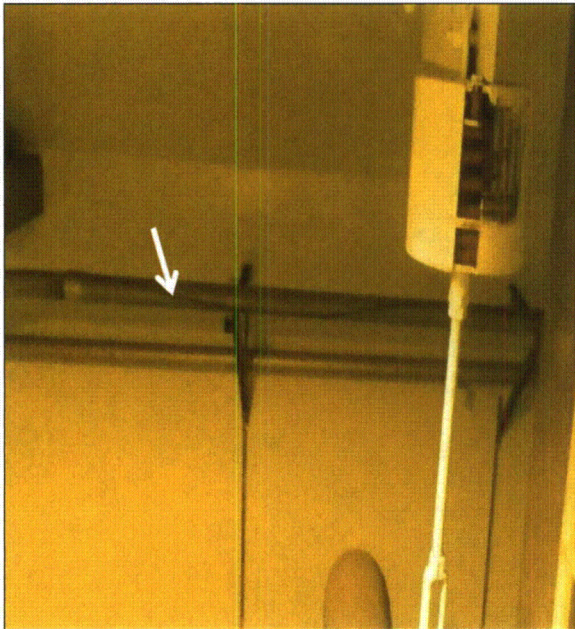
**Note:** bare wire attached to a conduit

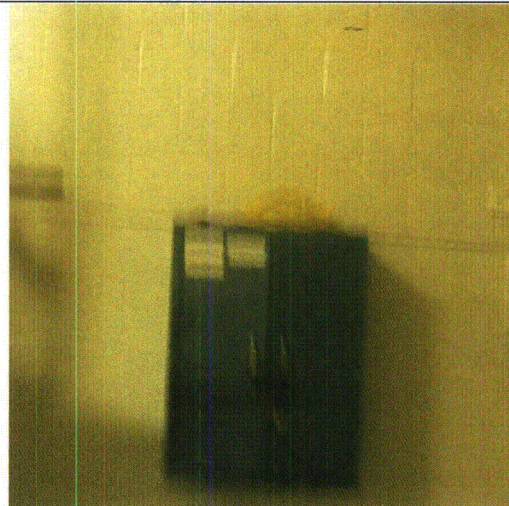
**Note:** Unrestrained cable and tools on top of the operations equipment cabinet

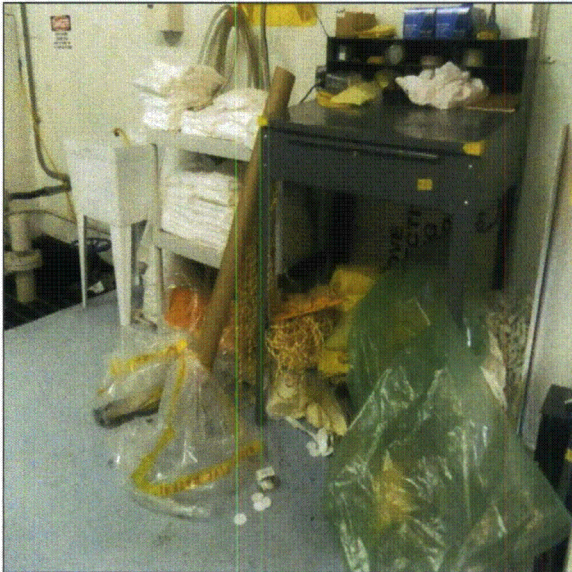
**Note:** waste bags on the floor

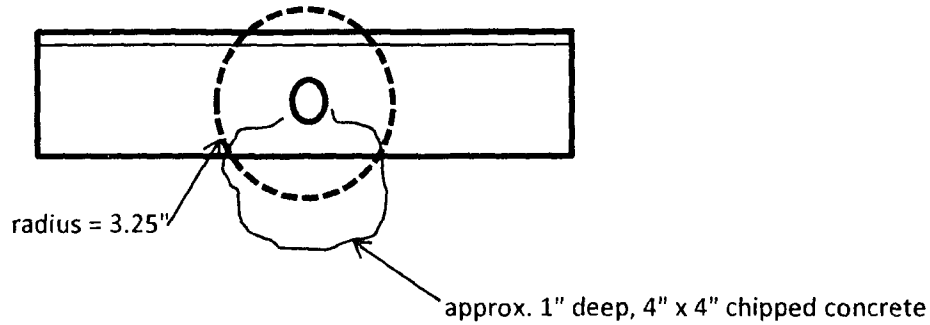
SWEL1-070

A 1" deep, 4"x4" chip concrete area adjacent to Hilti bolt

The 1" deep concrete chipped area is conservatively treated to cover 35% of the shear cone area for a 3.25" embedment expansion bolt. The 1" deep, chipped area still has capacity and can be considered as 35% of a shear cone area of a (3.25"-1") = 2.25" embedment anchor.
