Status: Y ☒ N ☐ U ☐**Seismic Walkdown Checklist (SWC)**Equipment ID No. 1P70-A002B Equip. Class¹ 0Equipment Description Emergency N2 BottleLocation: Bldg. REACTOR Floor El. 130 Room, Area RL-R9

Status: Y ☐ N ☒ U ☐**Seismic Walkdown Checklist (SWC)**Equipment ID No. 1Z41-F009B Equip. Class¹ 0,7Equipment Description AIR-ACTUATED DAMPER B003B INLocation: Bldg. CONTROL Floor El. 180 Room, Area _____

Status: Y ☒ N ☐ U ☐**Seismic Walkdown Checklist (SWC)**Equipment ID No. 1E21-C001A Equip. Class¹ 5Equipment Description Core Spray Pump 1ALocation: Bldg. REACTOR Floor El. 87 Room, Area SE Diagonal

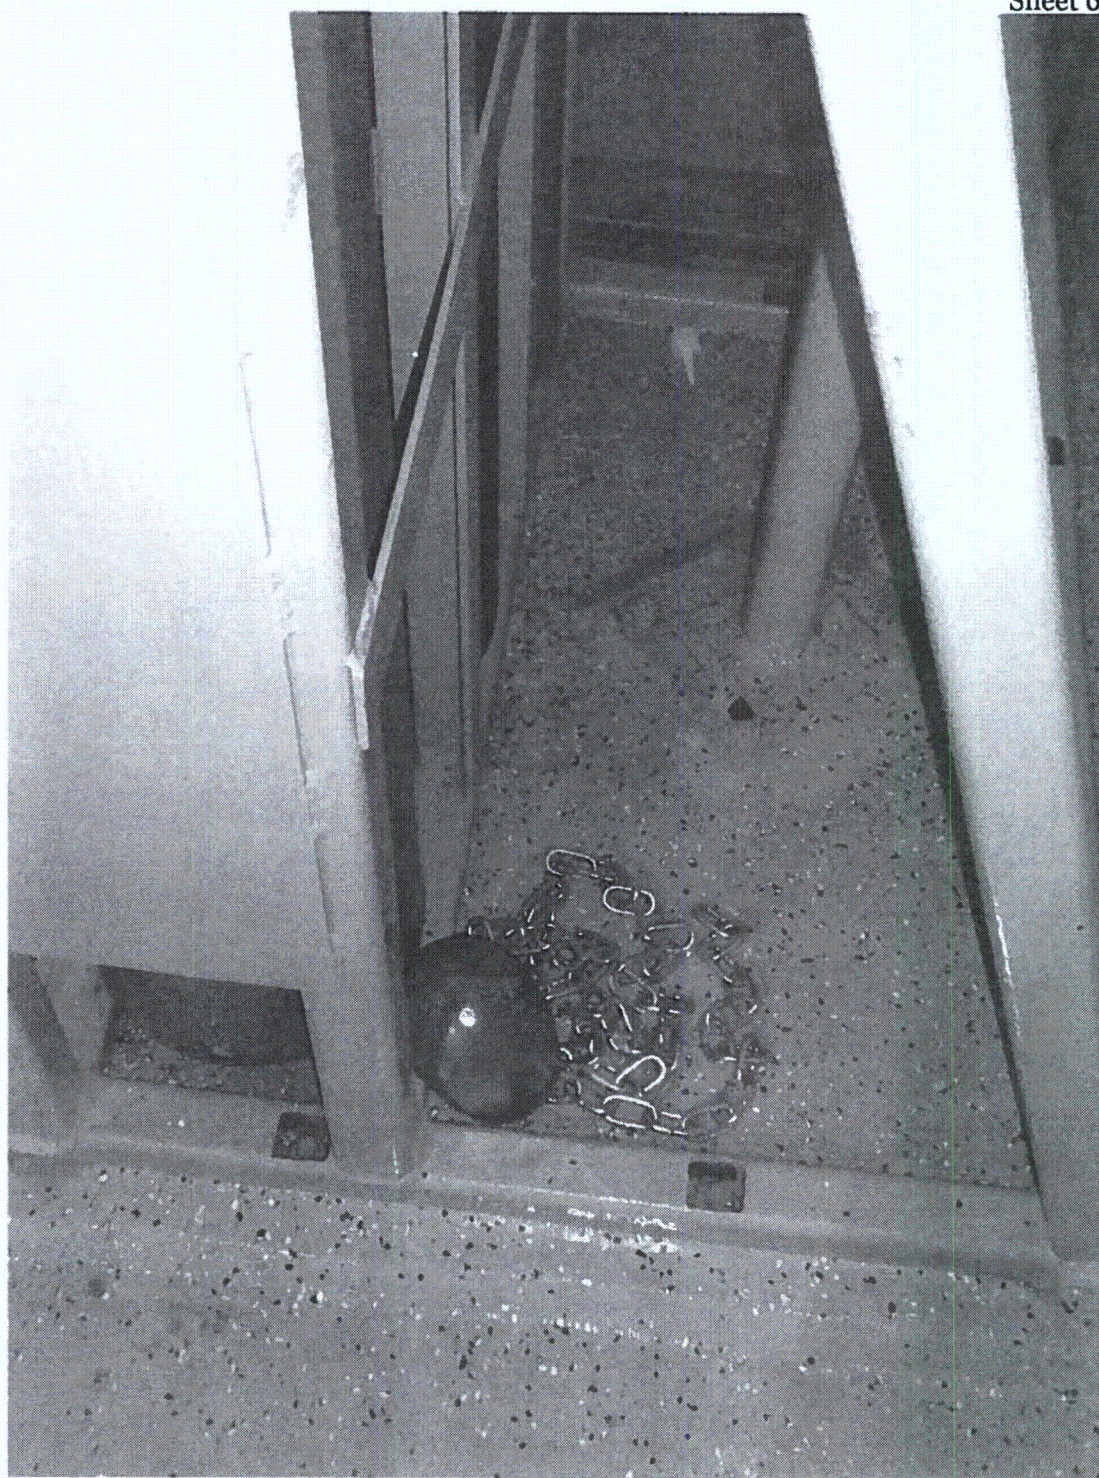
There are several housekeeping issues with Emergency N2 Bottle Rack 1P70-A002B. There does not appear to be an NPL tag affixed to the rack to aid in identifying the item (CR 516094); there is a rolled up sheet of paper with a metal tool of some sort (it appears to be a wrench) in the top left tube steel horizontal member; there is a bottle cap sitting between two of the bottles at the base of the rack; and there is a bottle cap sitting in the back of the rack near the diagonal support. In addition, there is a section of chain at the back of the rack at the same location as the bottle cap. All of these items are small and relatively light. During a seismic event, it is likely that the items will move from their existing locations, but do not have the potential to strike anything other than the bottle rack supports due to the location of the rack and its distance from any safety related SSCs. Therefore, it is judged to have no potentially adverse seismic condition.

Figure 3 – Tool and Paper in Top Tube Steel Horizontal (1P70-A002B)

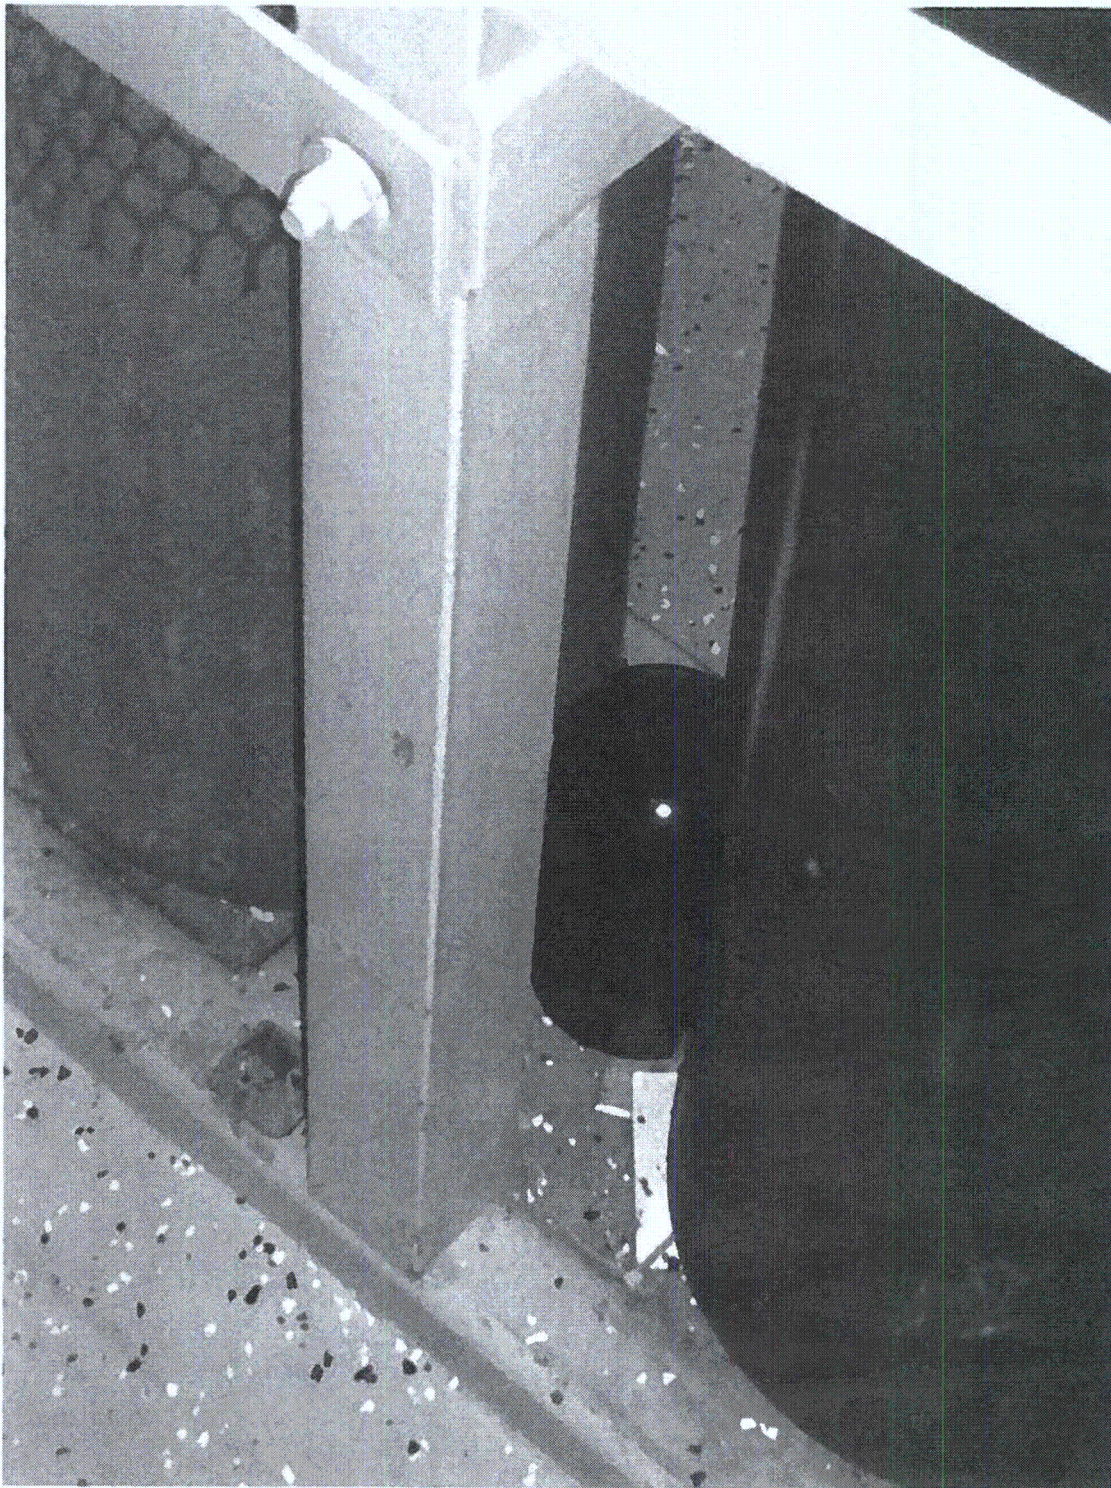
Figure 4 – Bottle Cap near Rack Base (1P70-A002B)

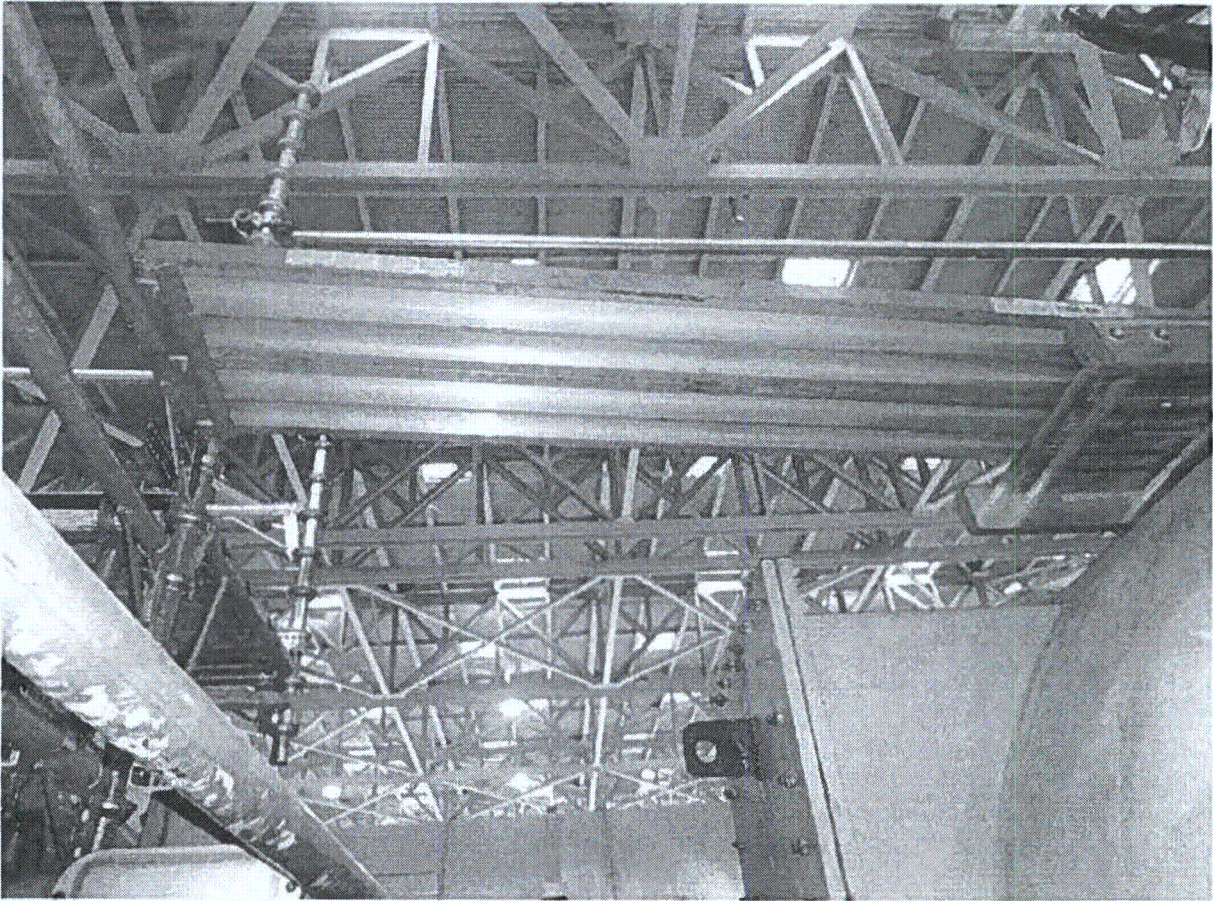
Figure 3 Scaffolding Above Component.

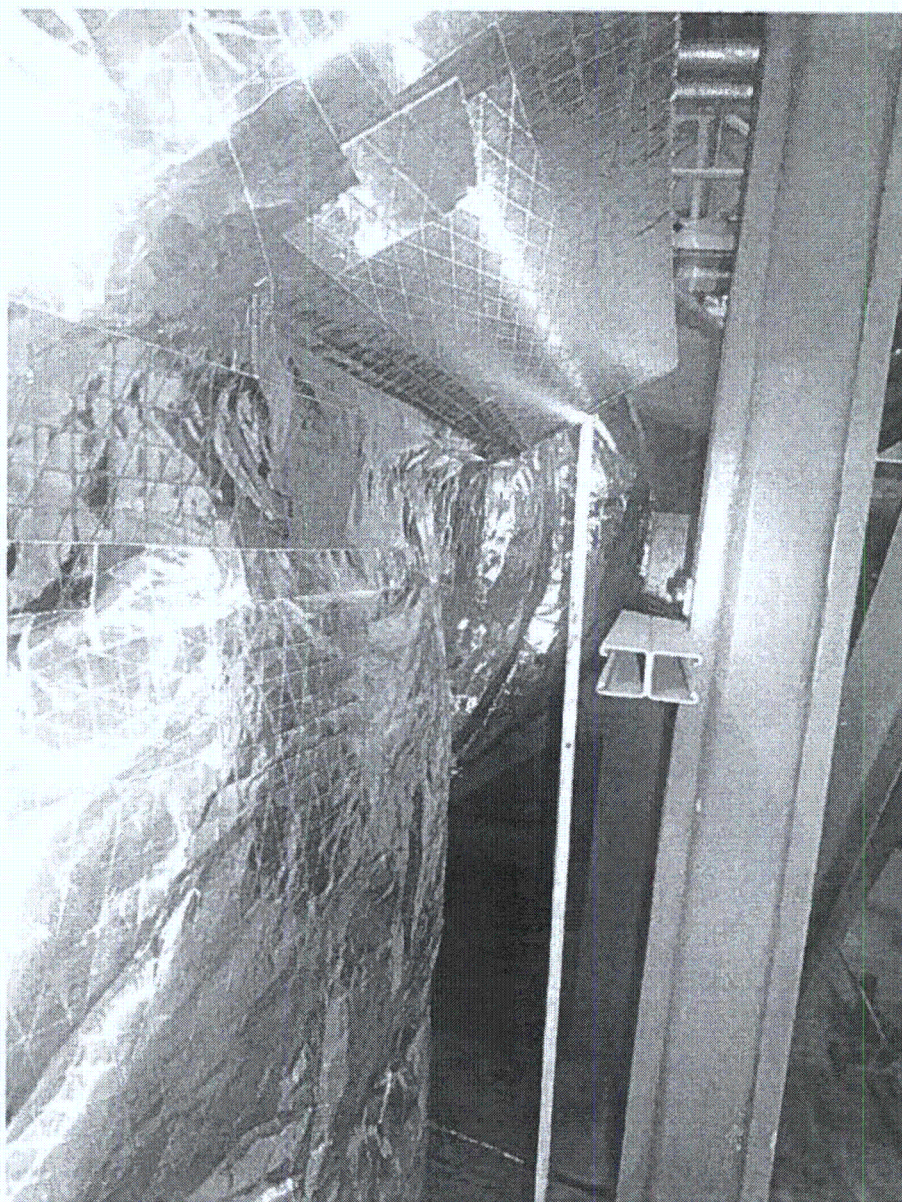
11. Have you looked for and found no other seismic conditions that could adversely affect the safety functions of the equipment? Y ☐ N ☒ U ☐
Because the duct is insulated at the damper flange connection the flange connection bolts could not be checked for broken, missing or loose hardware. All visible surfaces were inspected and no potential adverse conditions were found. Disassembly of the insulation would be required to inspect the flange connection bolts, which are not considered to be anchorage for the component.
In addition, The seismic support of the Air Line identified as an IPEEE vulnerability described in DCR 93-055 has apparently not been completed because the Air pipe is not adequately supported for seismic loads. The end of the hard pipe needs to be attached to an existing Unistrut with a P2558 or equivalent 2 bolt pipe clamp (See Figures 4, 5 and 6 for details). CR 525292 has been written to address this condition.

Figure 4 Missing Support on Air Line Hard Pipe to Valve 1Z41-F009B

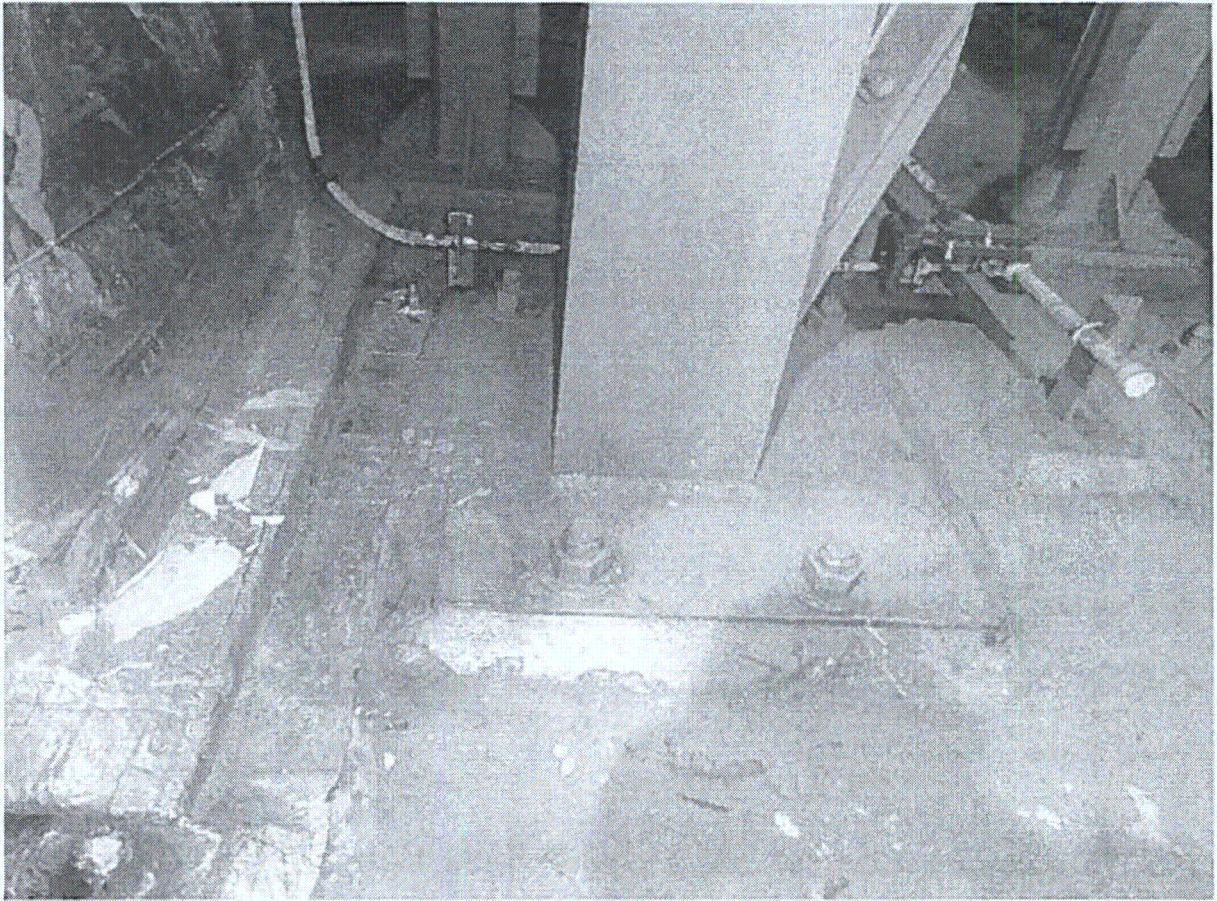
Figure 5 Air Line Pipe to Valve 1Z41-F009B at Floor Level showing Pipe Supports

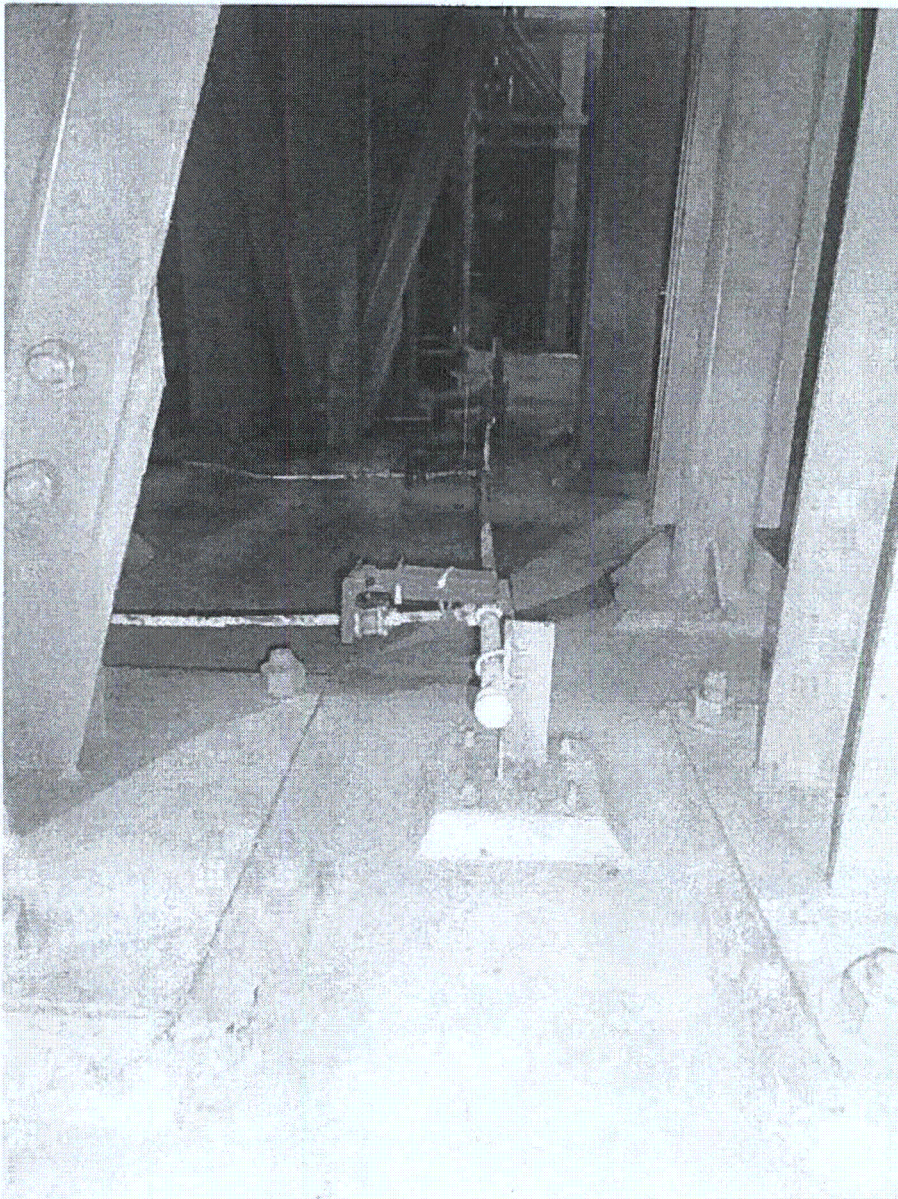
Figure 6 Air Line to Valve 1Z41-F009B at Floor Level showing additional Pipe Supports

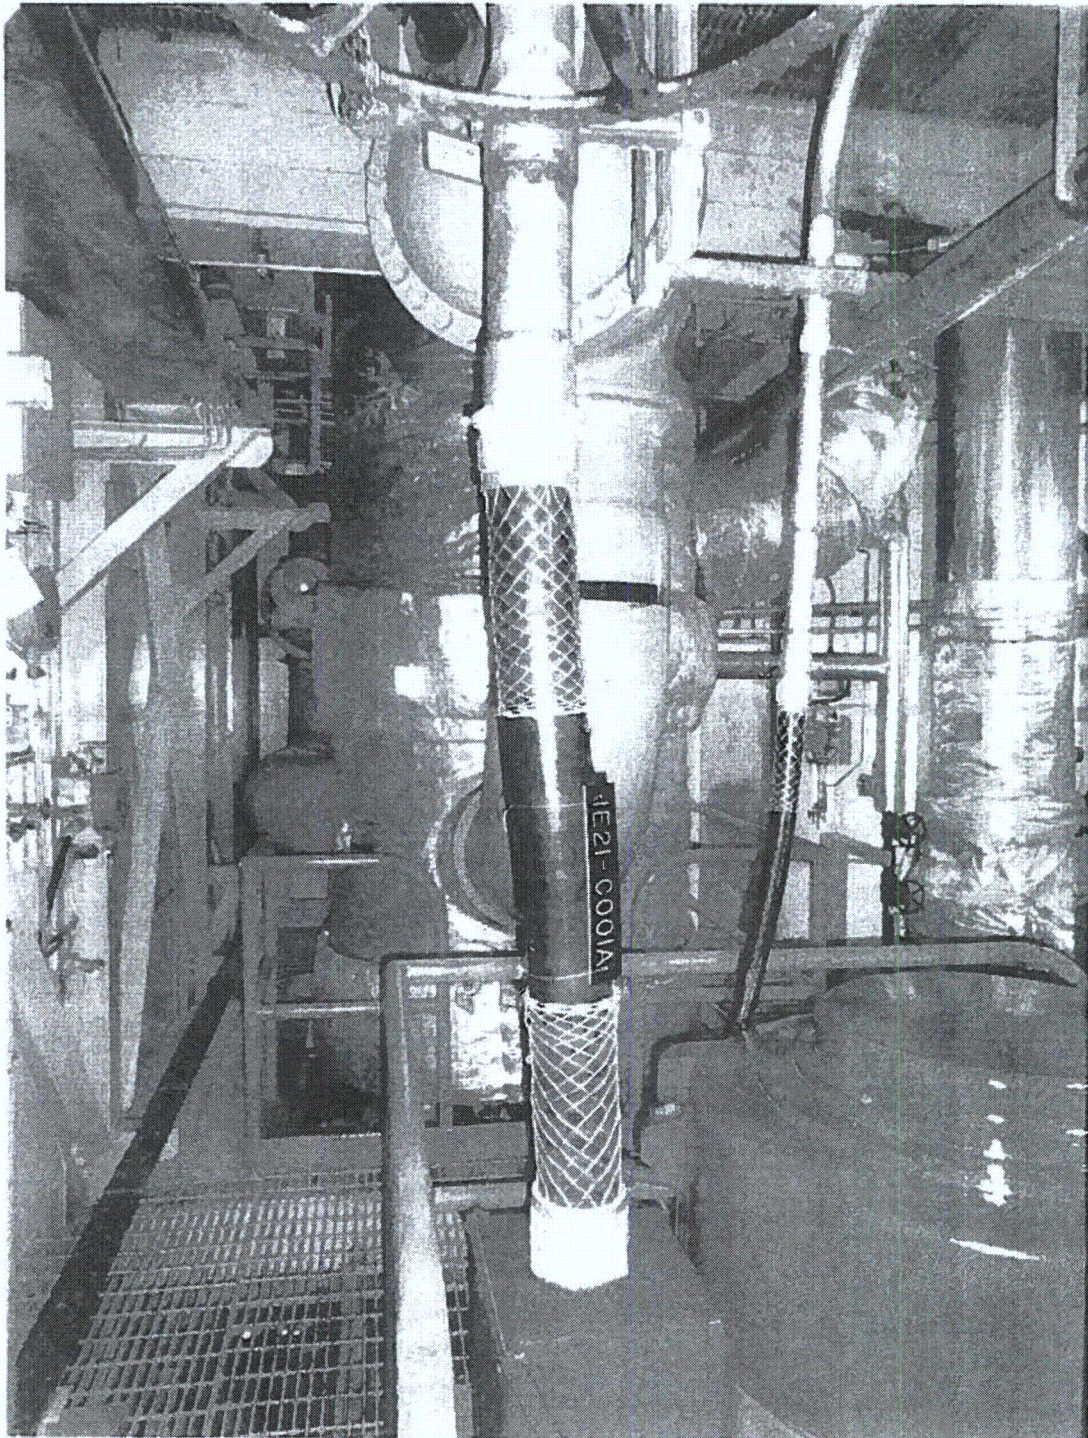
There is a flexible conduit section between the top of the pump and a rigid conduit section above the pump that is fairly tight. It is judged that the flex conduit can deflect 1" without putting significant stress on the conduit. SWE's judge that the pump will move less than 0.5" during a seismic event due to the elevation and rigidity of the equipment. Calculation SCNH-91-069 Rev. 0 for the adjacent RHR pump of the same type gives a maximum pump deflection of less than 0.2" at the top of the pump. Therefore, it is judged that the line has adequate flexibility for the pump seismic deflections.

Figure 3 – Attached Flex Conduit (1E21-C001A)

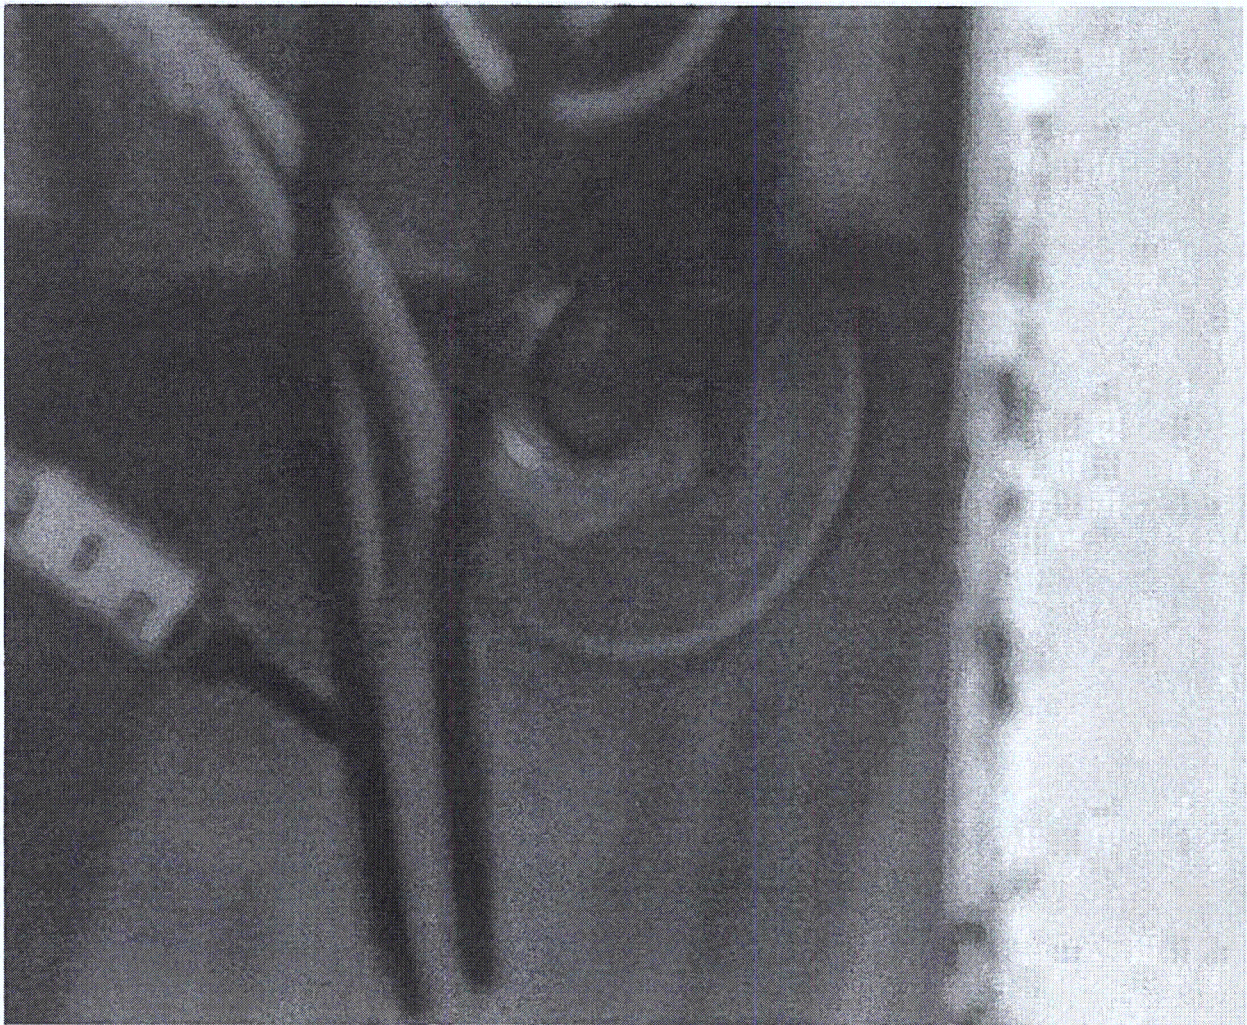
Both sides of Panel 1-H11-P652 are also attached to the adjacent panels at the lower front sides with two 5/8" diameter bolts. The loading of the sides of the panels are distributed due to the attached terminal strips, electrical components and wires. There are no significant concentrated loads at the rear edge of the panels. Therefore, considering the maximum capacity of the existing bolts (5/8" diameter), the loads associated with differential movement of the cabinets are judged to be adequately restrained. The rear vertical connection of Panel 1-H11-P652 to Panel 1-H11-P652 does not need to be enhanced and the bolt with less than optimal thread engagement does not need to be replaced.

3: Lack of Thread Engagement

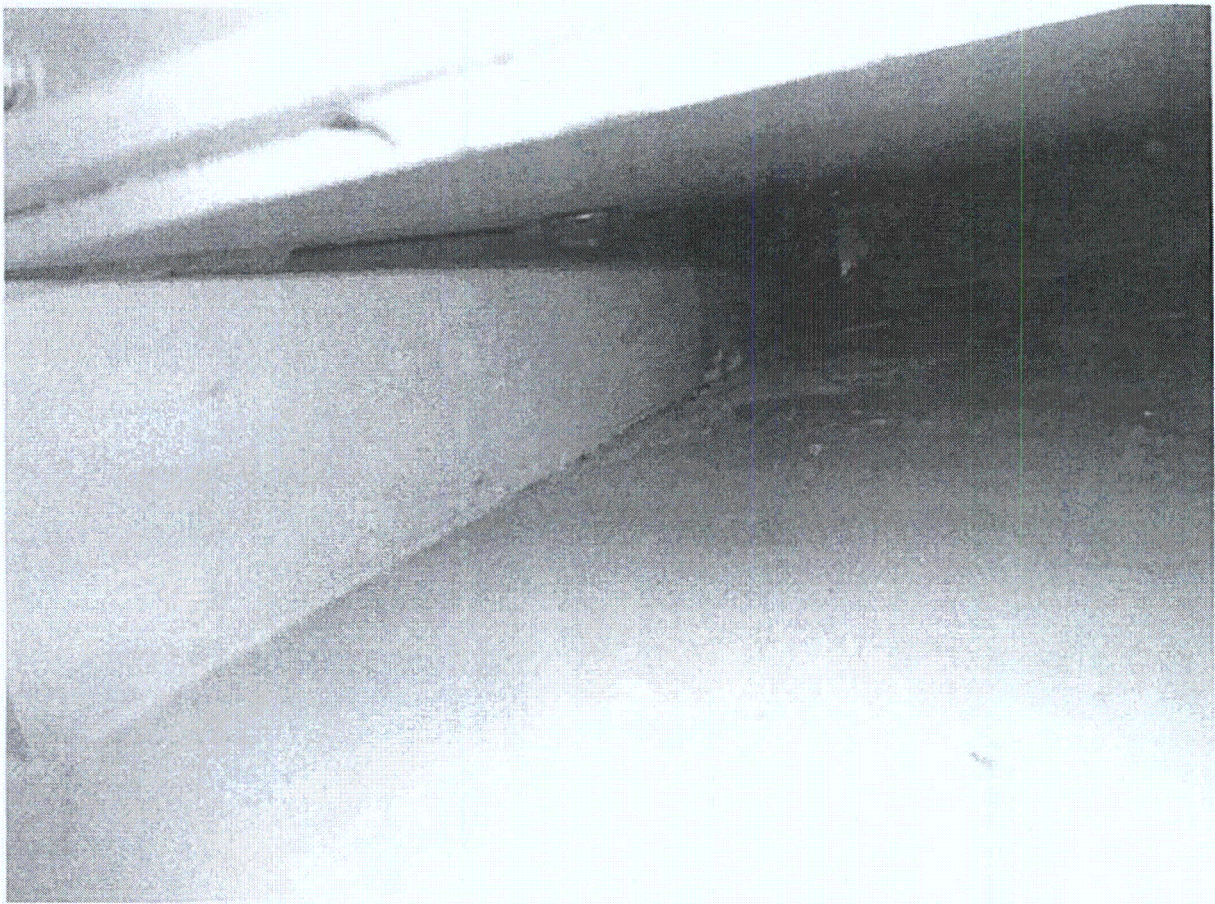
3. Is the anchorage free of corrosion that is more than mild surface oxidation? Y ☒ N ☐ U ☐ N/A ☐
4. Is the anchorage free of visible cracks in the concrete near the anchors?
Small amount of surface roughness on the concrete that has no effect on the anchor embedment. Therefore, the SWE's have determined that this has no effect on the seismic capacity of the anchorage. Y ☒ N ☐ U ☐ N/A ☐

Figure 3 Concrete Surface Roughness under Charger

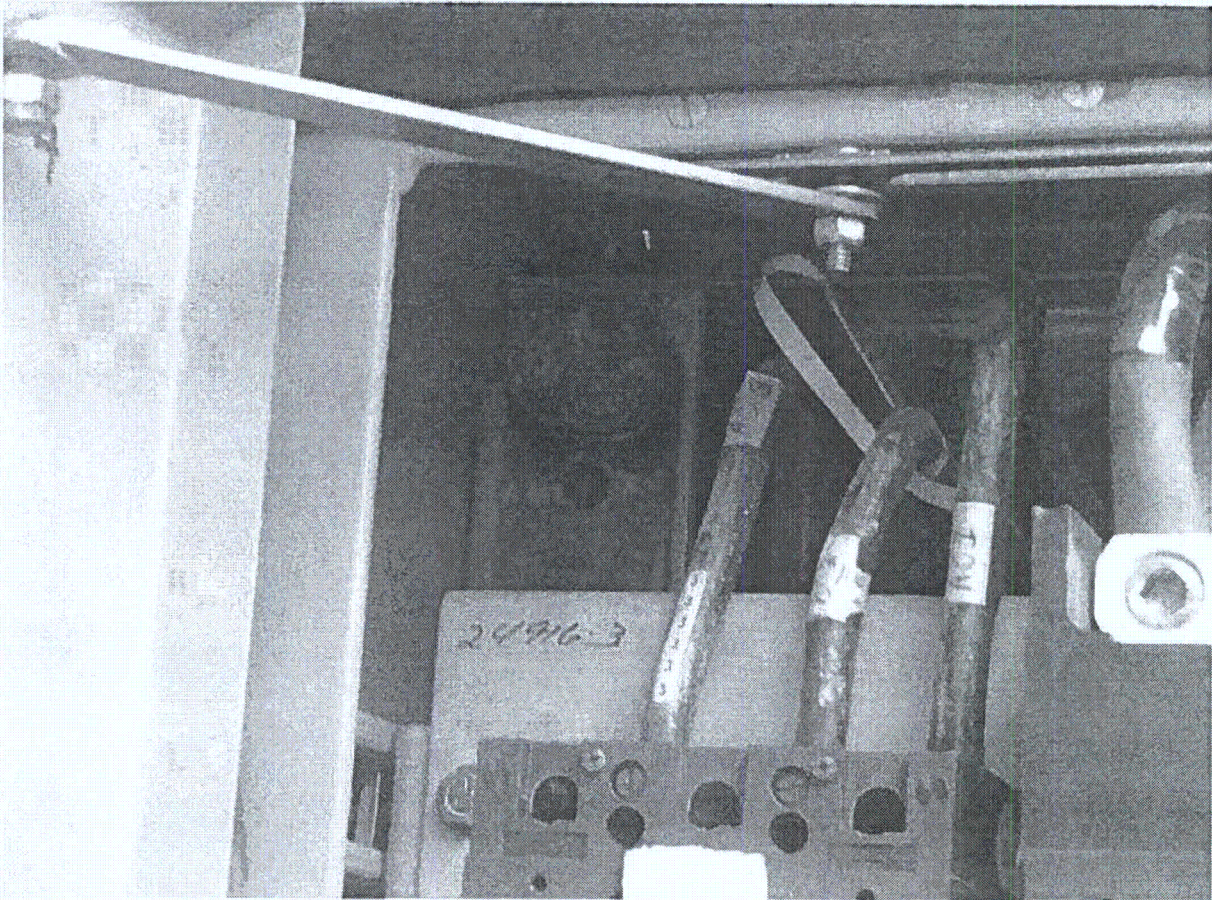
Components inside the battery charger were inspected visually in accordance with the direction provided in the FAQ related to opening panels per Work Order SNC436314. There is one empty hole at the top of the battery charger for an additional grounding line that is not being utilized, so no bolt is missing from the hole. Therefore, this is not a potentially adverse seismic condition, and no other potentially adverse seismic conditions were identified.

Figure 4 Empty Grounding Line Socket

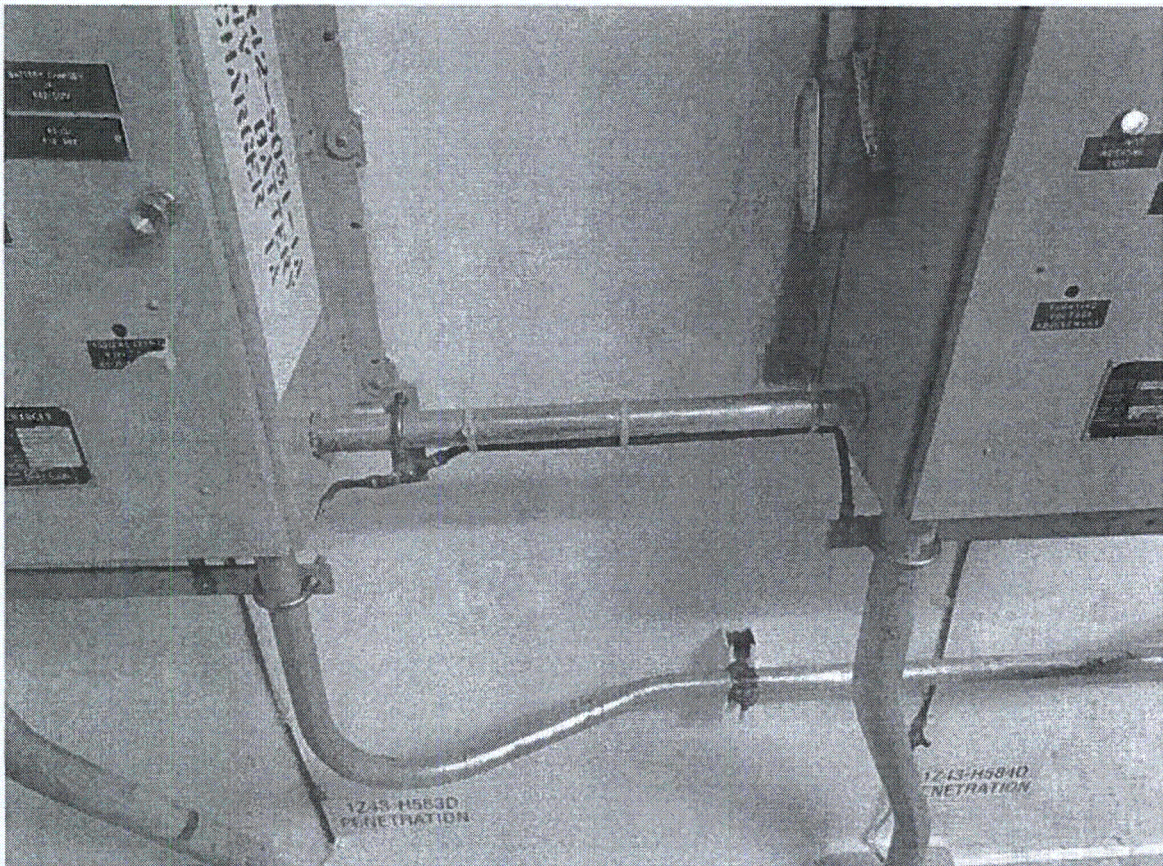
9. Do attached lines have adequate flexibility to avoid damage? Y ☒ N ☐ U ☐ N/A ☐
The conduit interconnecting the chargers shown in Figure 3 is not a seismic concern because the chargers are anchored to the same wall so there will be no seismic differential movements between the two Battery Chargers.

Figure 3 Conduit Tied between Battery Chargers on the same wall

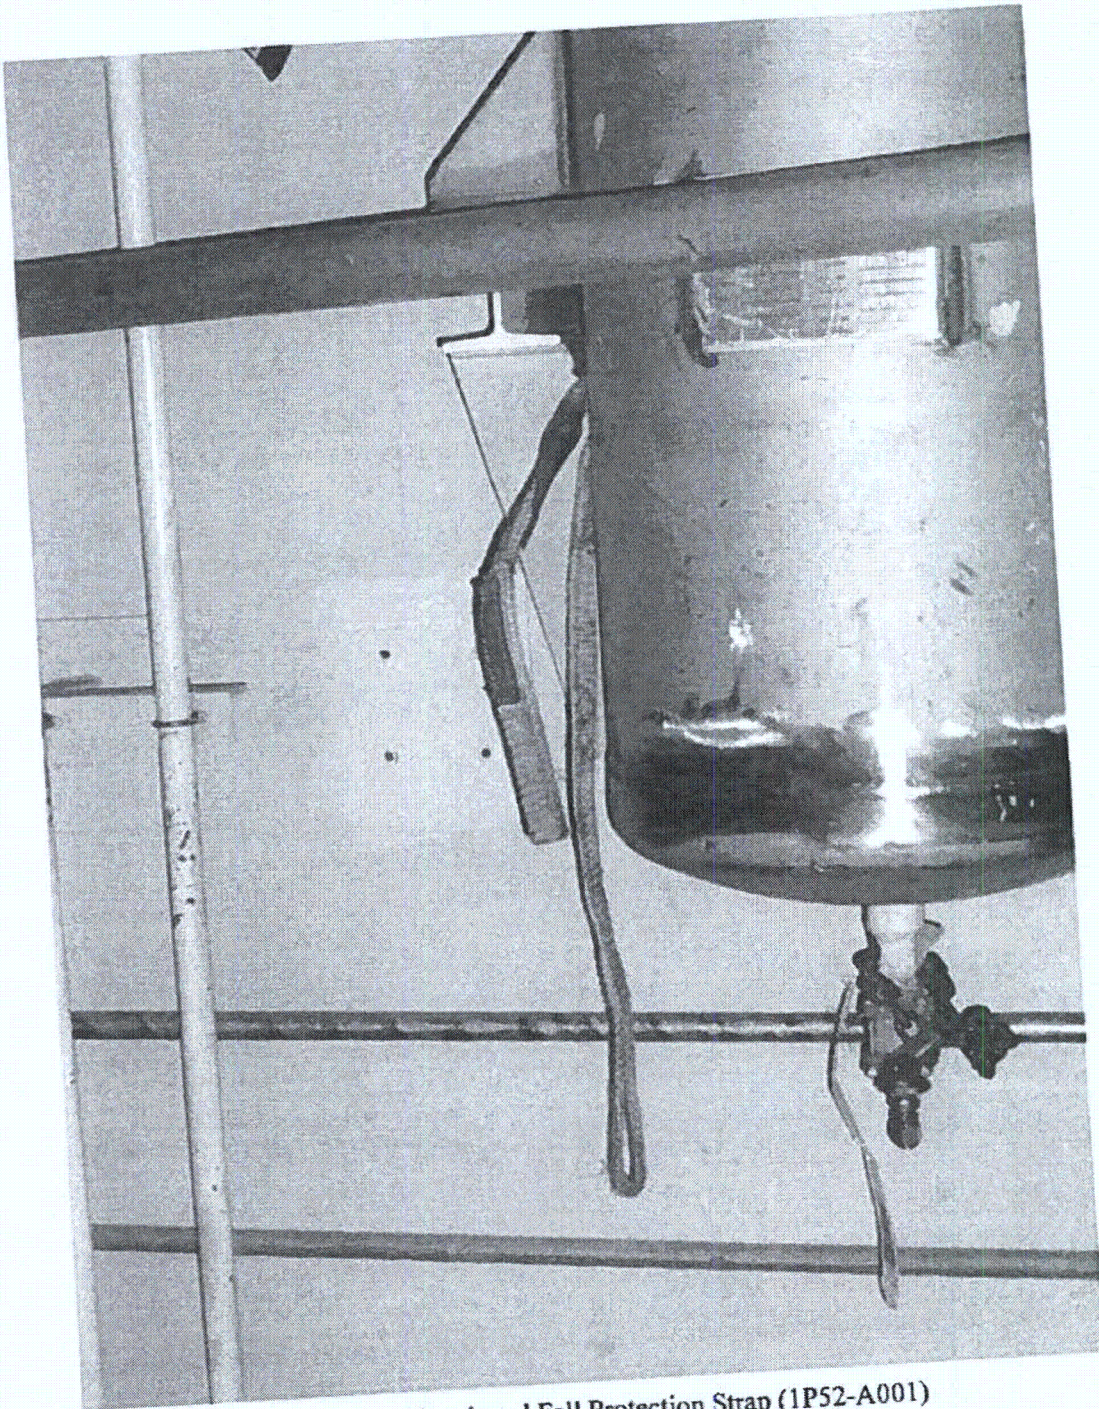
There is a fall protection strap left on the ESS Air ACC (CR 519465). The strap is wedged between the component and the support steel and is not attached to any other fall protection equipment. It appears that the strap could not be removed from the support and was abandoned. The strap is very light and is not near any sensitive parts of the component, so it is judged that the strap does not have the ability to create a potentially adverse seismic condition.

Figure 3 – Abandoned Fall Protection Strap (1P52-A001)
