Dresden Nuclear Power Station

Subject: Supplemental Licensee Event Report 237/2011-005-01, Standby Liquid Control
Explosive Valve Failure

4. TITLE
Standby Liquid Control Explosive Valve Failure

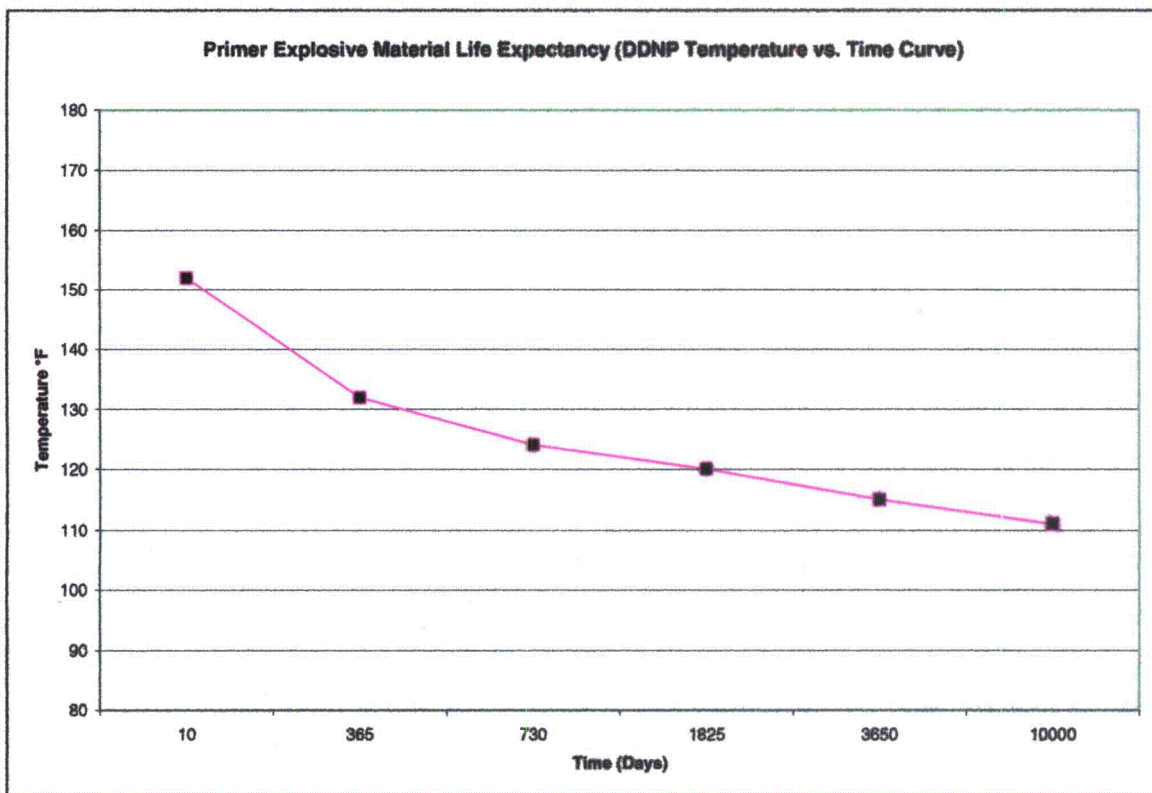
The explosive material, Diazondinitrophenol (DDNP), contained in the installed SLC system explosive valve trigger assemblies is rated for five years with exposure of temperatures up to 120°F. A DDNP Primer explosive temperature vs. time curve is shown in Figure 1 below. This curve was used to estimate the primer life at various temperature environments. Temperature data was collected once a week for three consecutive weeks. According to the data collected the "A" trigger assembly was subjected to higher than expected temperatures. The average temperature of "A" trigger assembly was 124°F with the highest temperature being 132°F. The "B" trigger assembly average temperature was 102°F with the highest temperature being 103°F.

Figure 1: Primer Explosive Material Life Expectancy (DDNP Temperature vs. Time Curve)

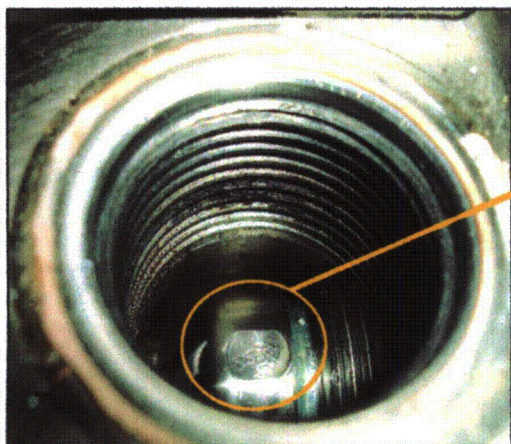
Subsequent troubleshooting by plant personnel verified the "A" explosive firing circuitry functioned as designed. The failure mode of flow blockage due to foreign material was also eliminated by inspections and the successful functional test following explosive valve replacement. The inlet fitting did have an indentation indicating contact with the explosive valve actuation shaft (ram). The contact was insufficient to shear the inlet fitting.

Failed Valve Indentation created by Ram.

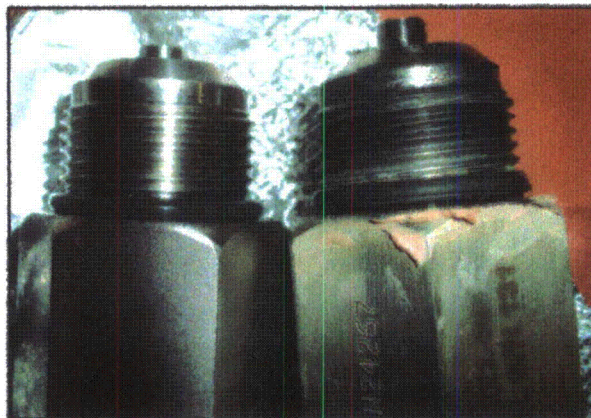
Troubleshooting by plant personnel revealed that the failure of the "A" explosive valve was related to the trigger assembly. The failed components were sent to the vendor for a failure analysis. The vendor analysis concluded the cause of the "A" explosive valve failure is thermal degradation of the primer's explosive material.

New unfired explosive (left) and the failed explosive (right)

"As found" condition of the inlet fitting after removing failed explosive

The failed assembly was replaced and the functional testing was subsequently completed satisfactorily. Following successful testing of the 2A system, a new explosive valve was installed. A work order was completed to rearrange the heat trace for the Unit 2 SLC system so that it is installed in accordance with the modification instruction.

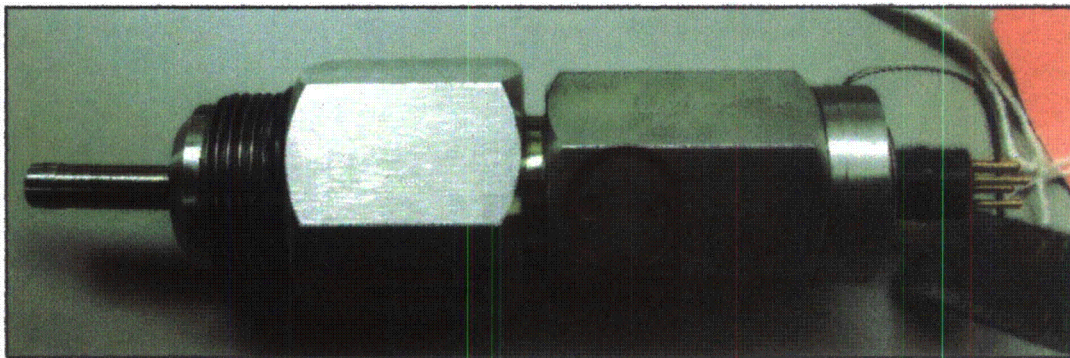
Successfully fired explosive
