Seismic Walkdown Checklist (SWC)

Equipment ID No. Q2R16B006-A, Pkg F2-110 Equip. Class¹ 2

Equipment Description 600V LOAD CENTER 2D

UNIT 2 – AREA WALK-BY CHECKLISTS (AWCs)

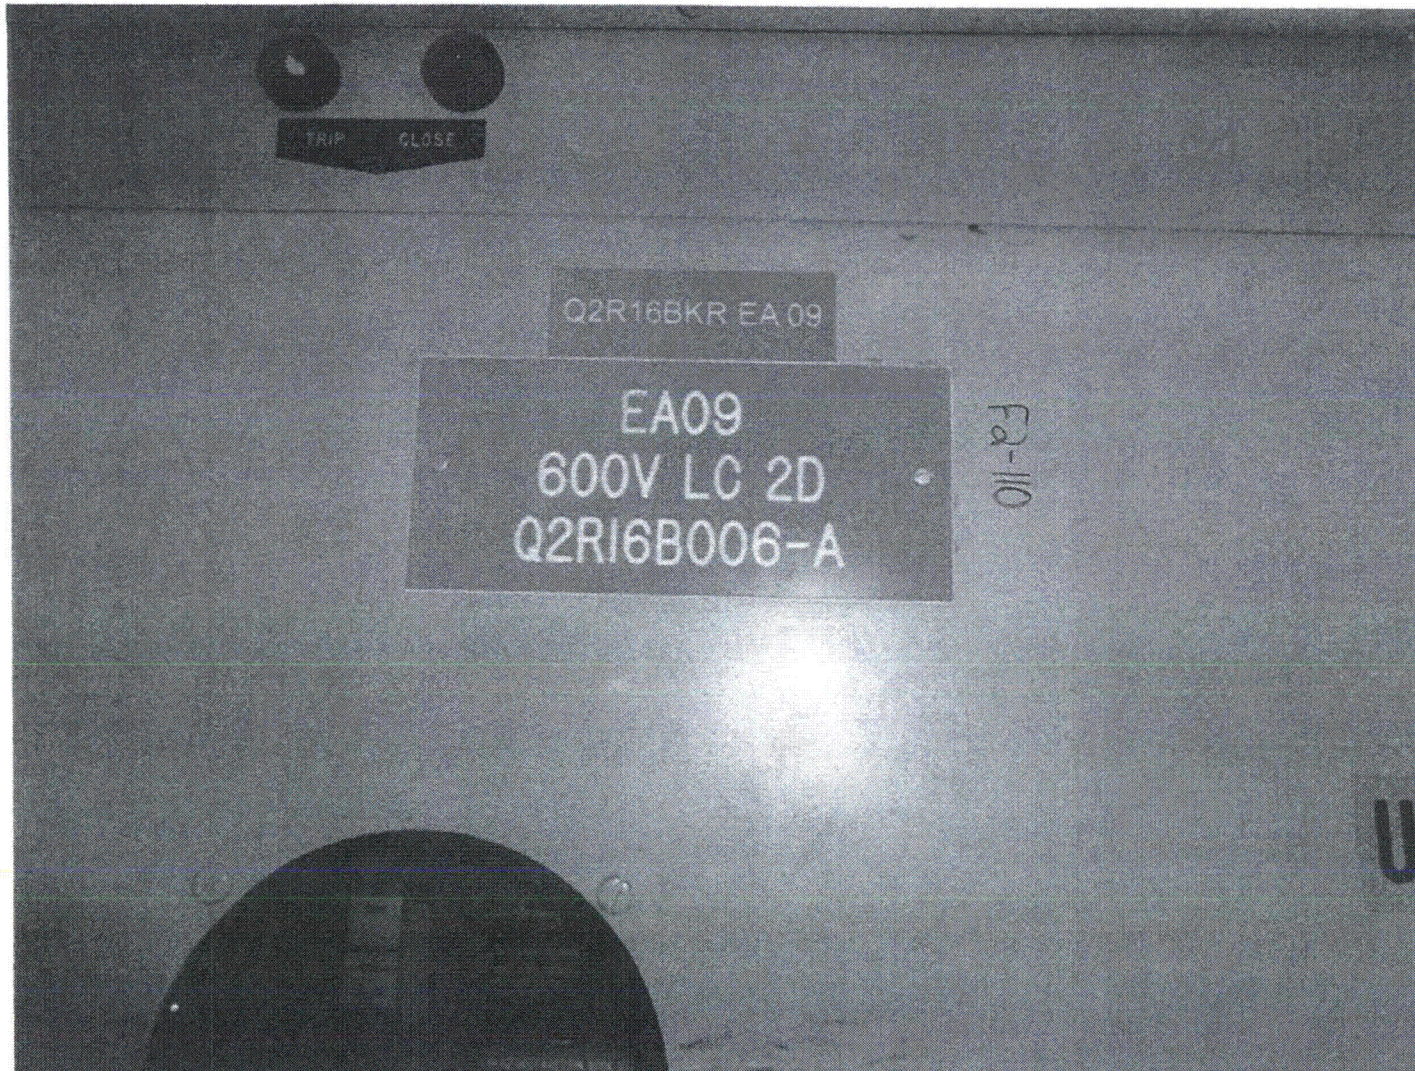
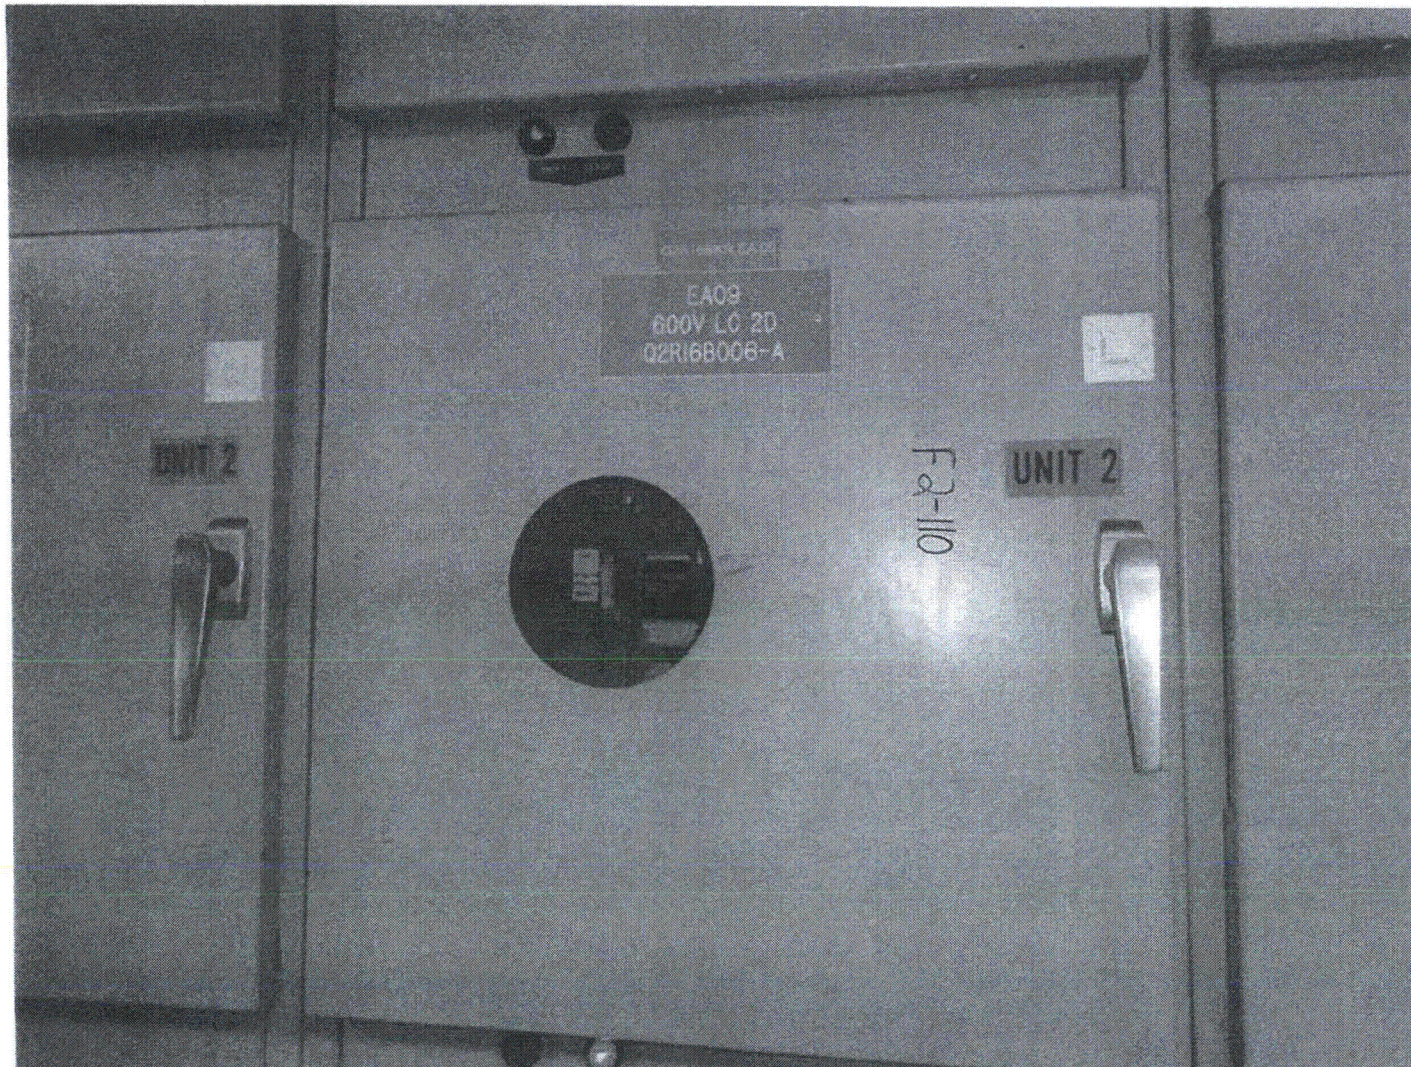
F-2-110

3. Is the anchorage free of corrosion that is more than mild surface oxidation? Y N U N/A
Cannot open cabinet, anchorage is inside cabinet

6. Based on the above anchorage evaluations, is the anchorage free of potentially adverse seismic conditions? Y N U
Cannot open cabinet, anchorage is inside cabinet

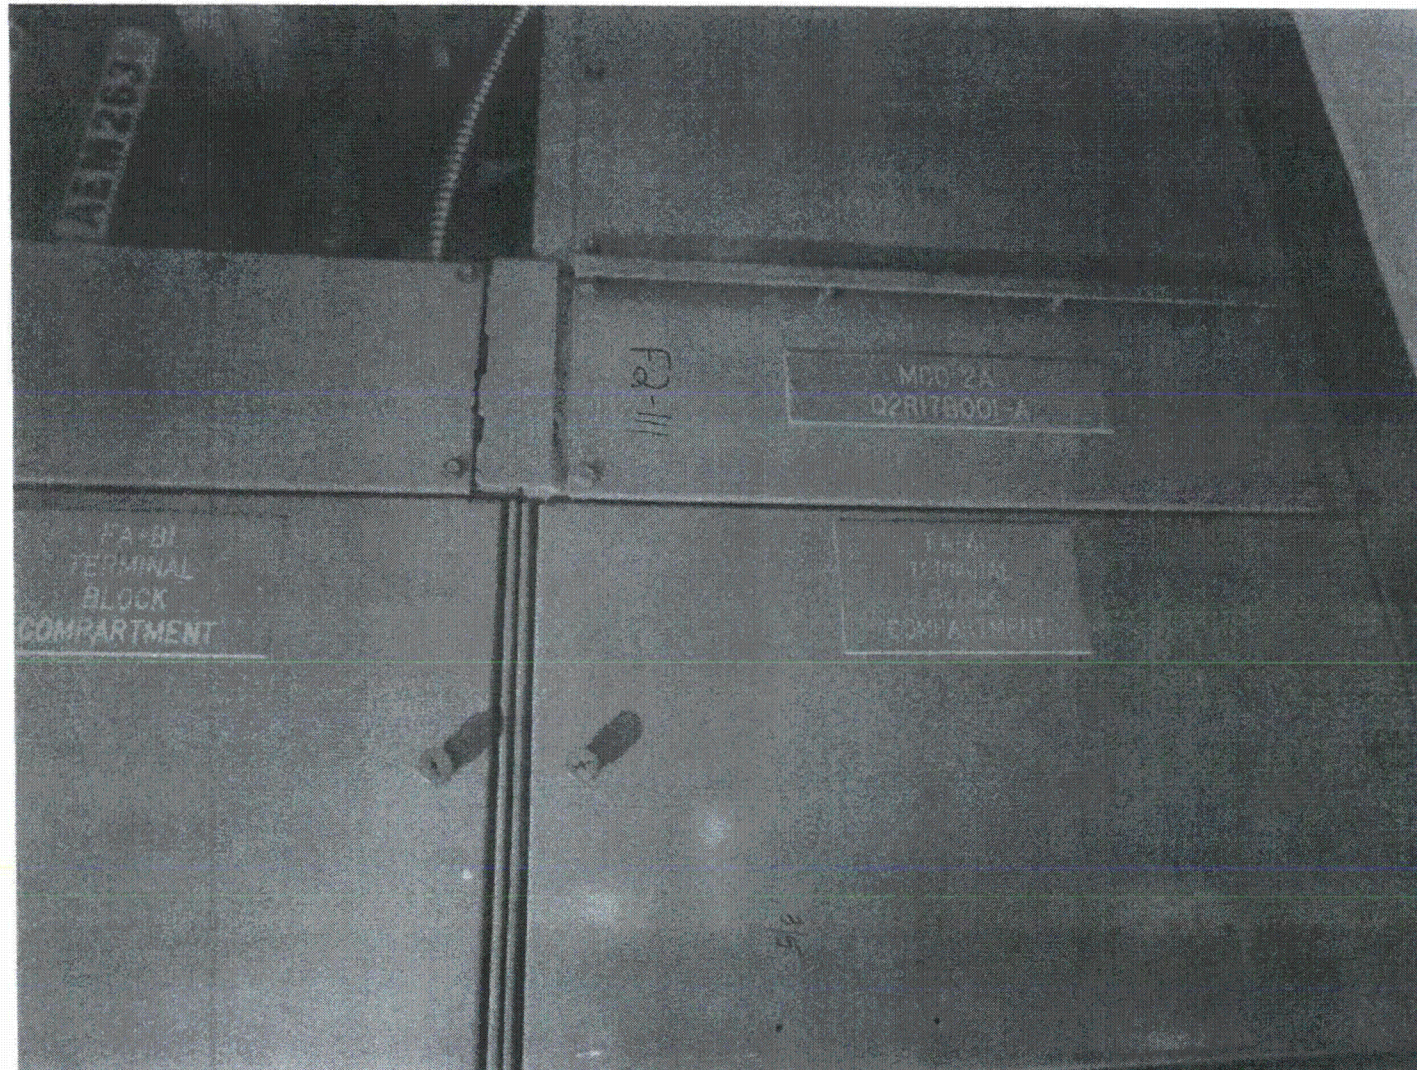
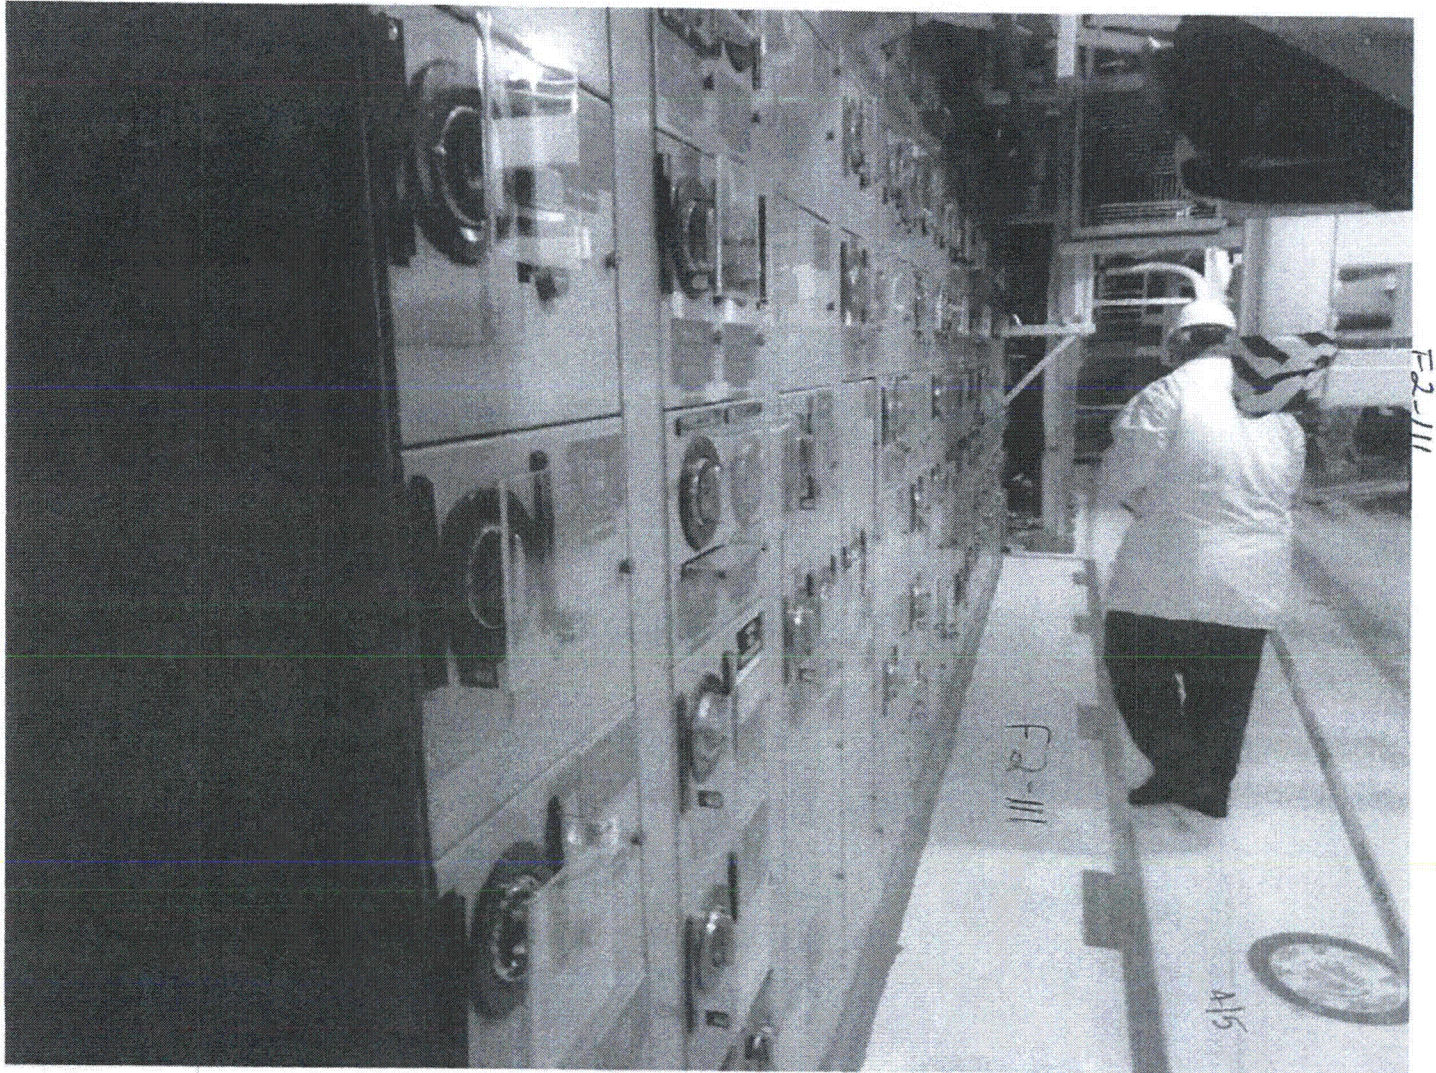
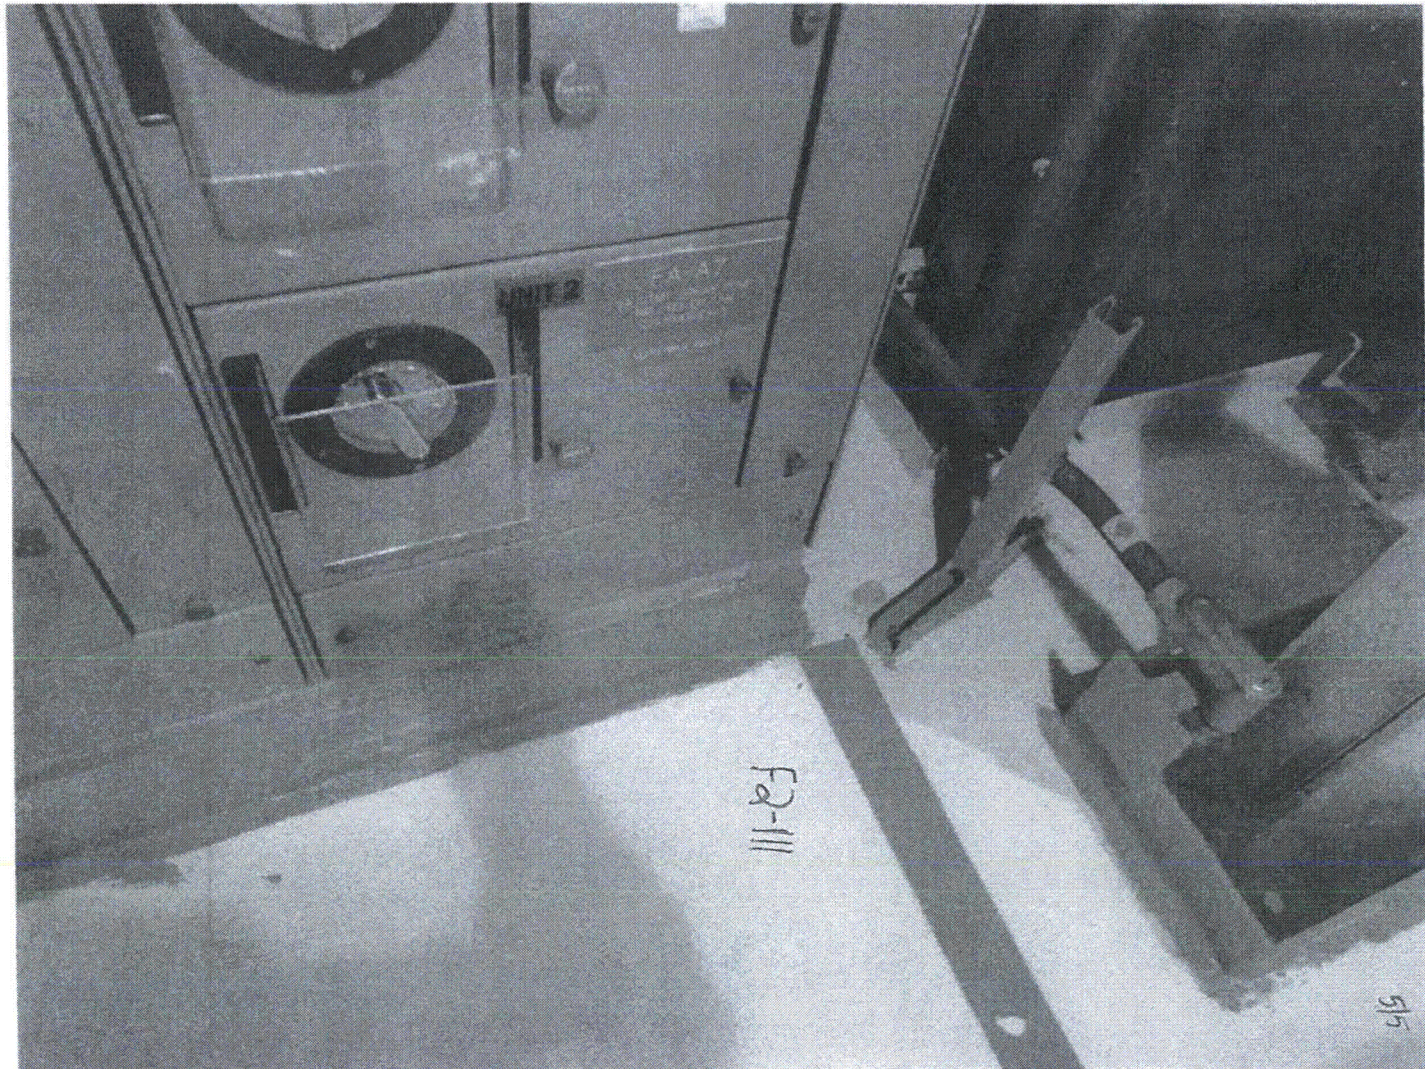
P2-112

2. Is the anchorage free of bent, broken, missing or loose hardware? Y N U N/A
WELDED TO FLOOR

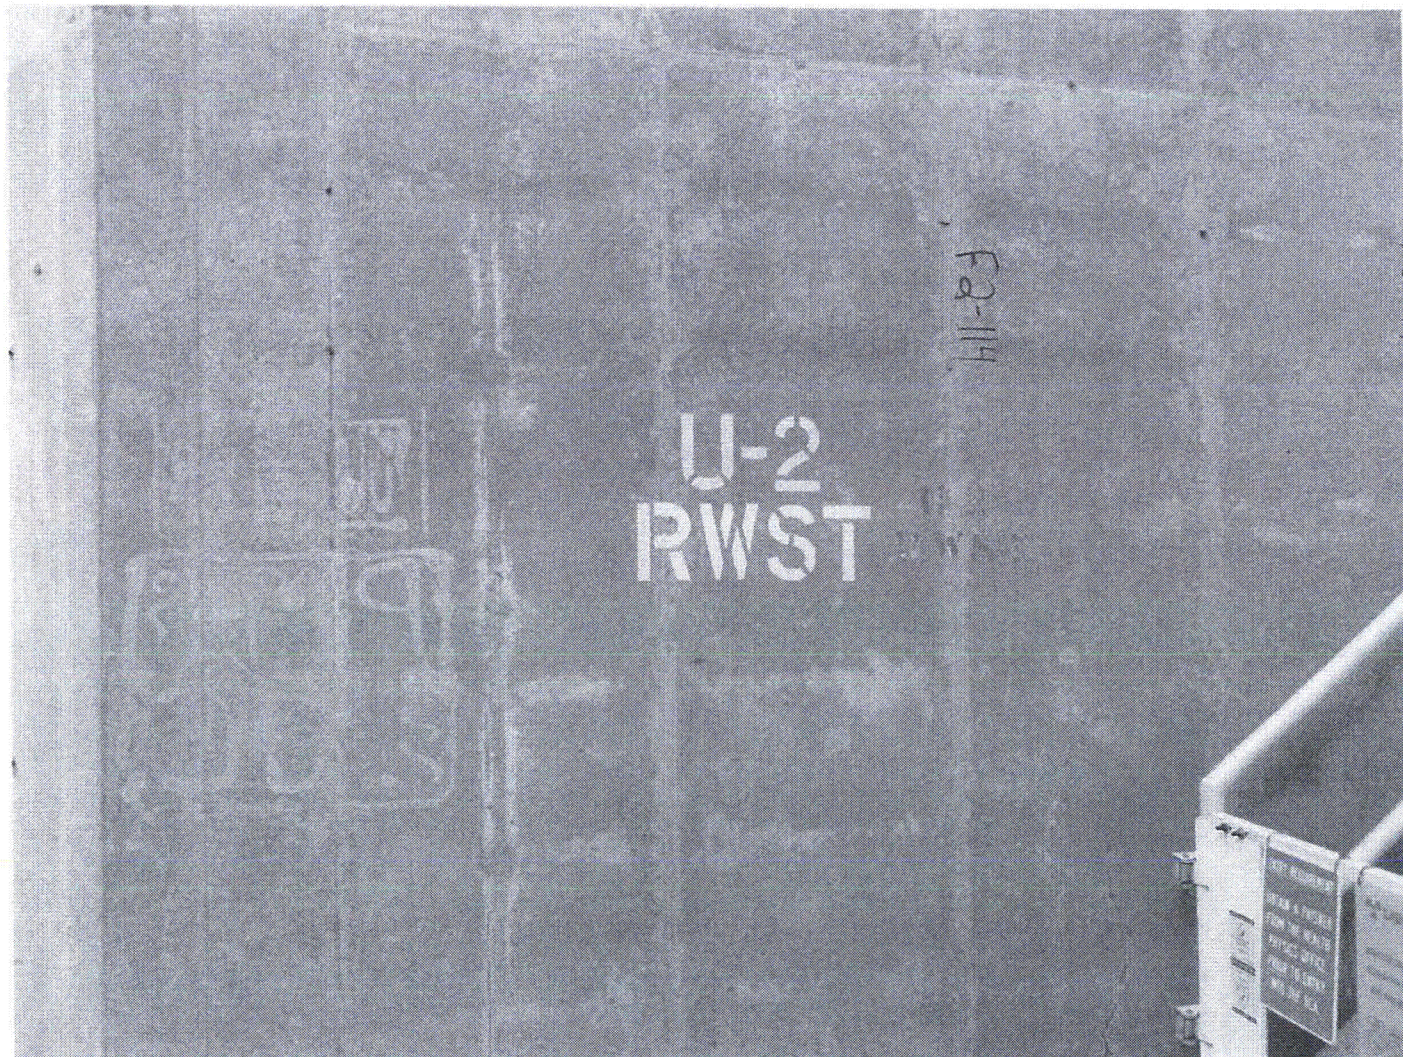
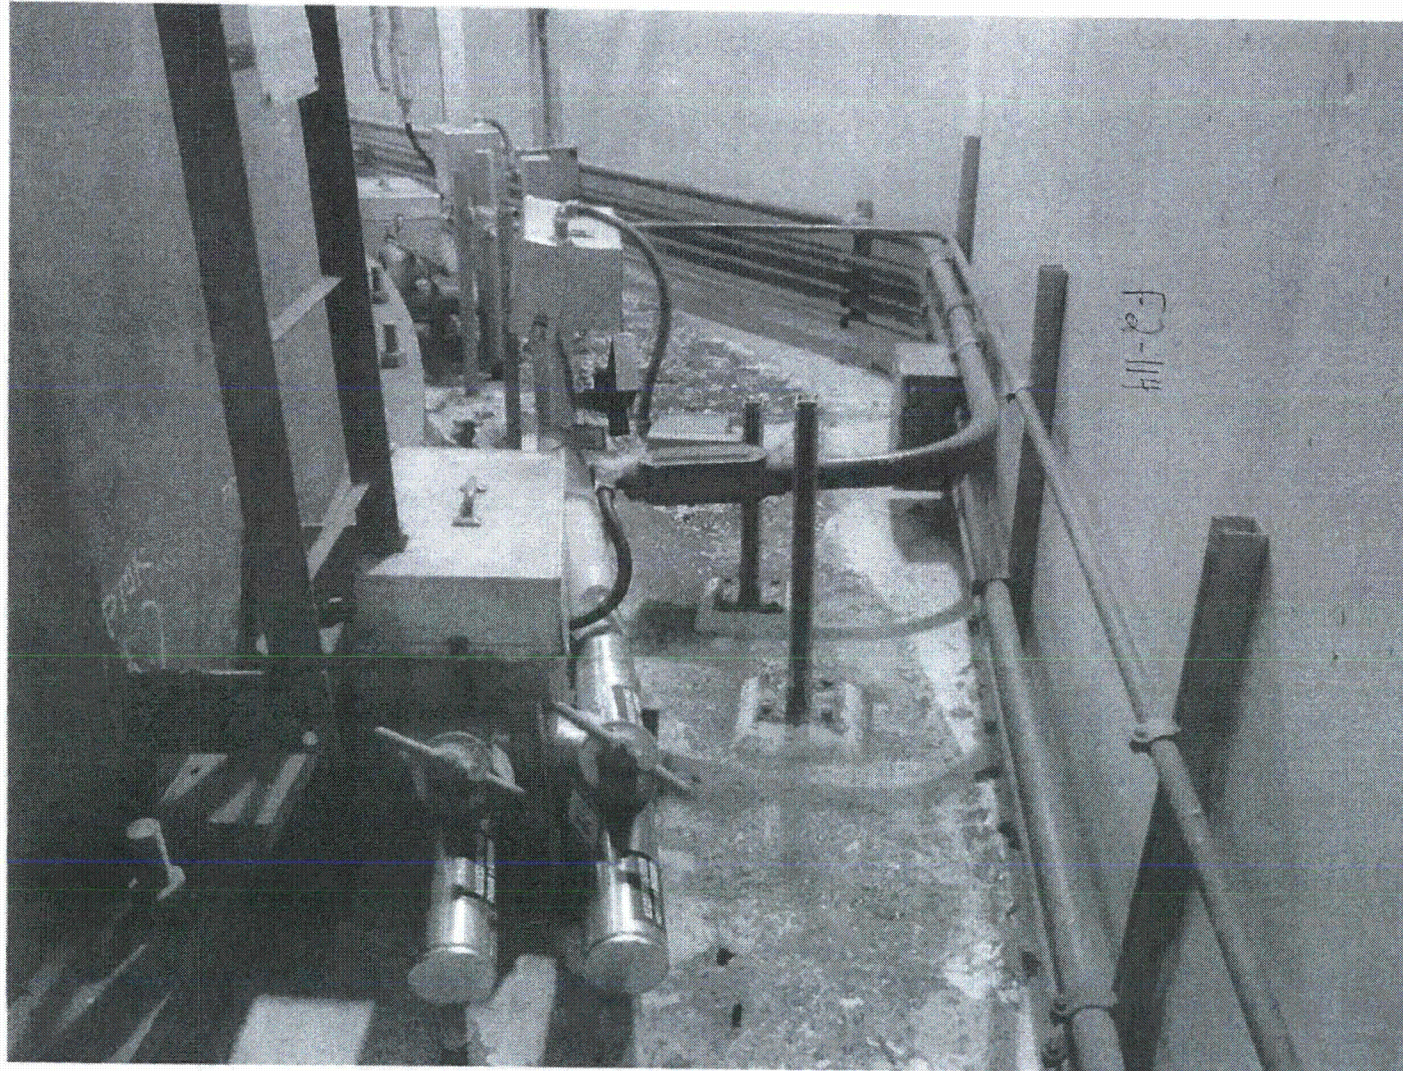
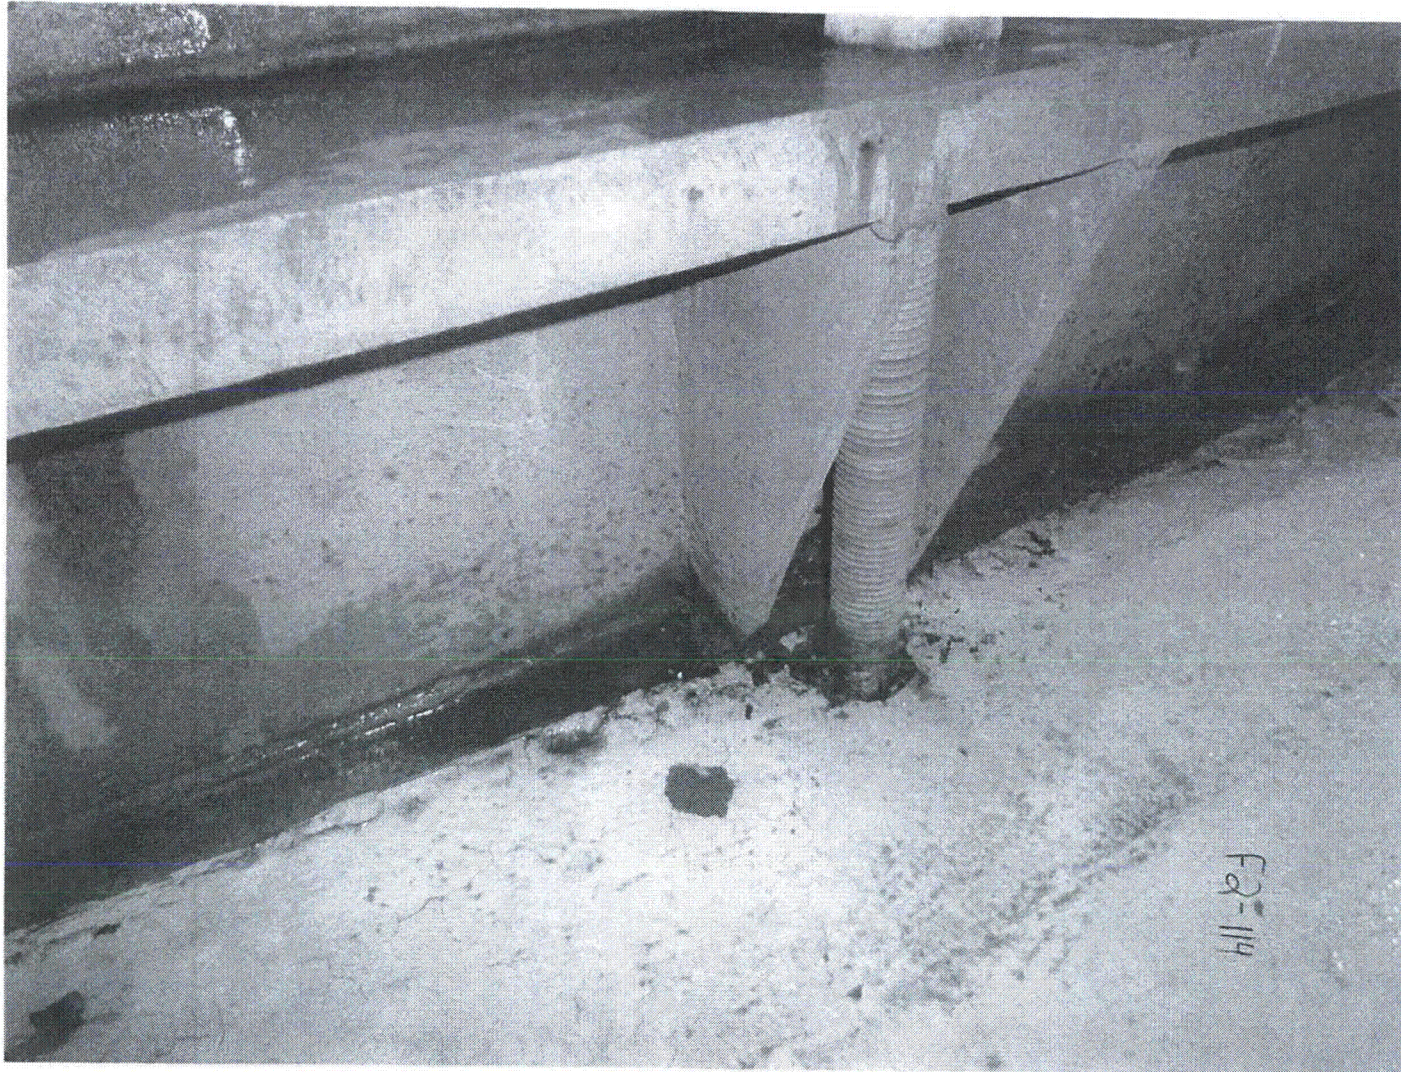
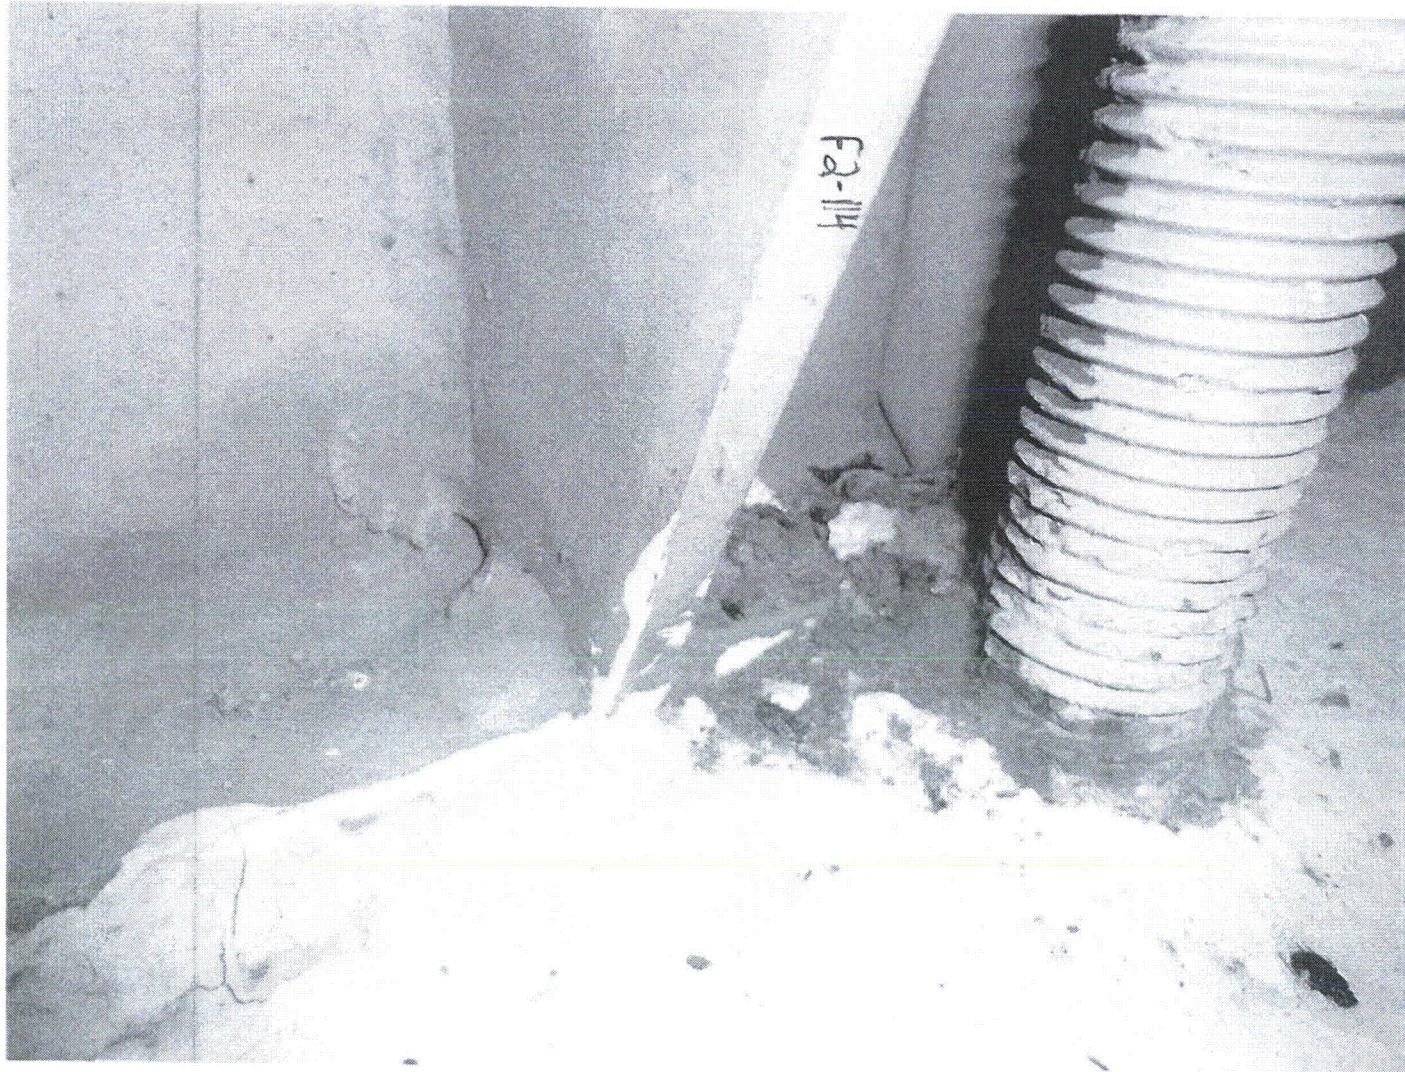
F2SW 2-2

2. Is the anchorage free of bent, broken, missing or loose hardware? Y N U N/A
Component welded to channel welded to embedded plate. Welds inspected for cracks, corrosion and other potentially adverse seismic conditions.

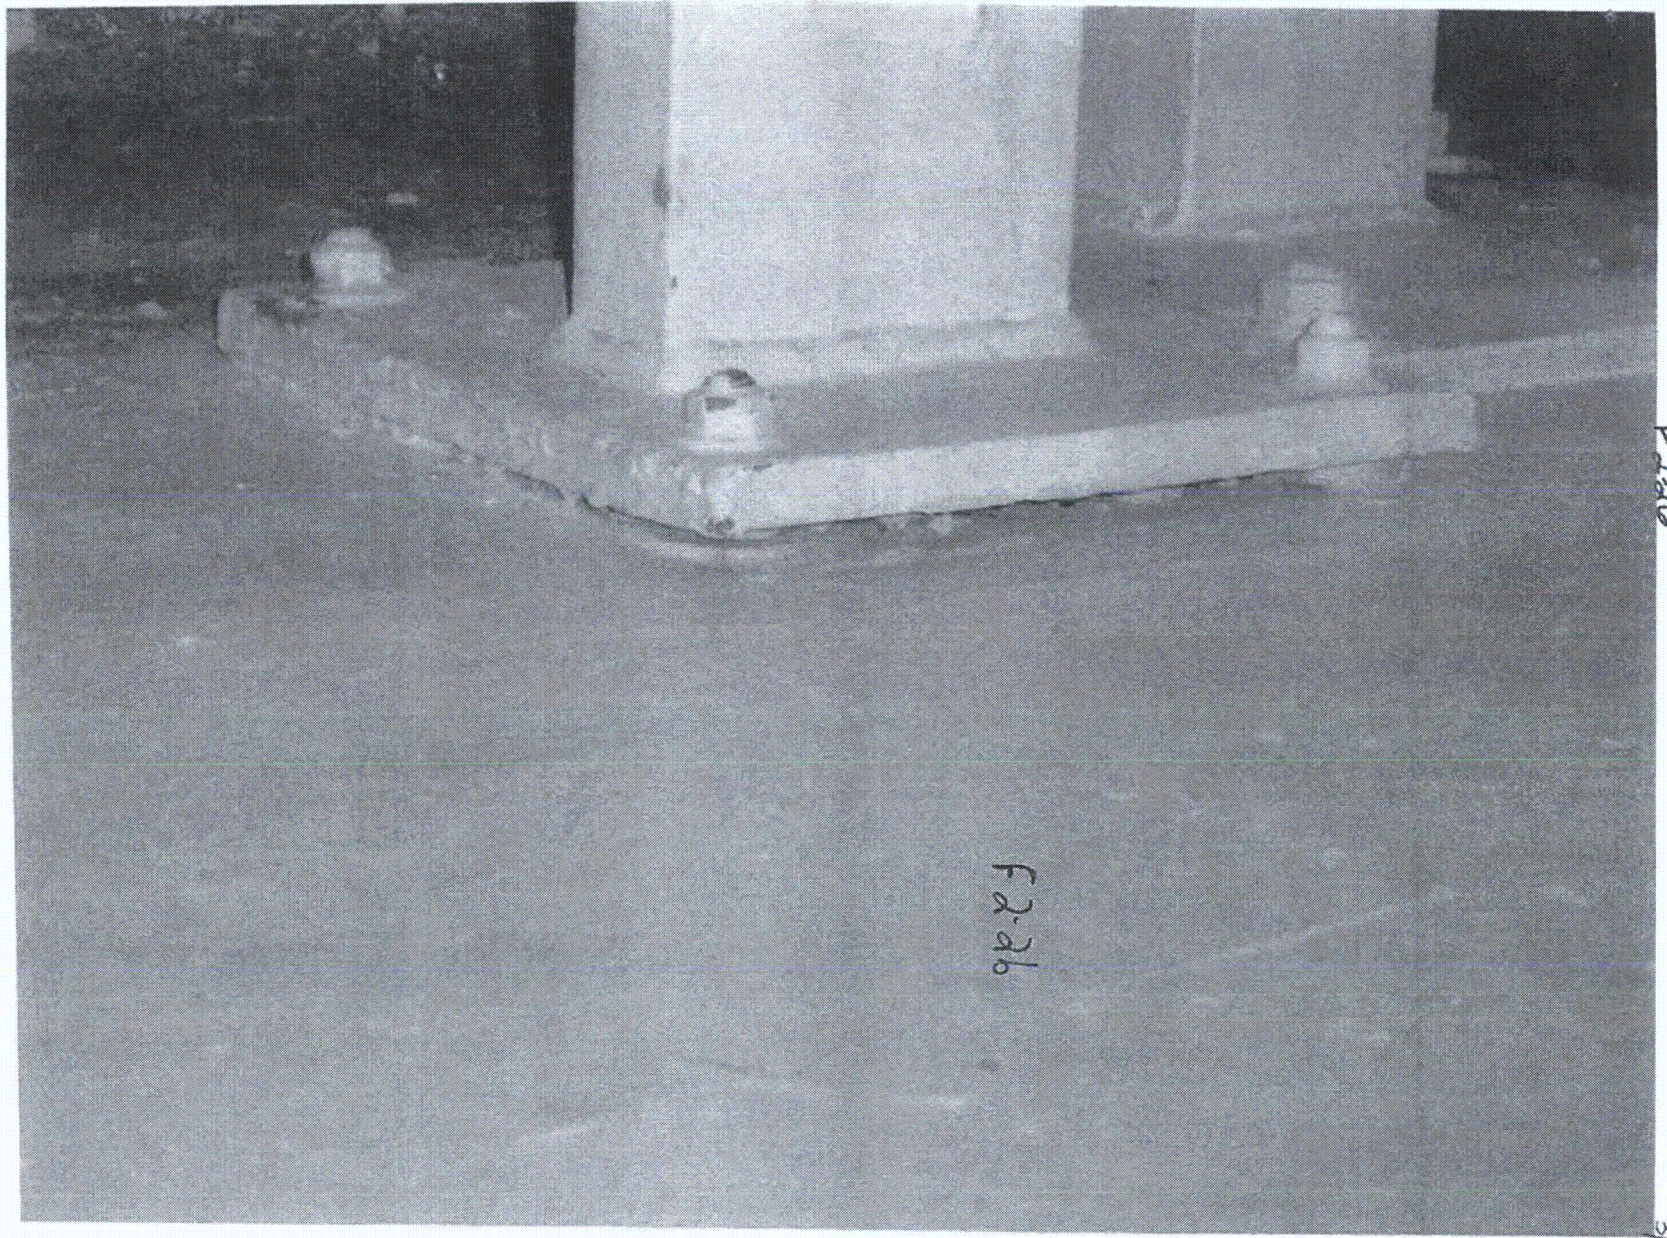
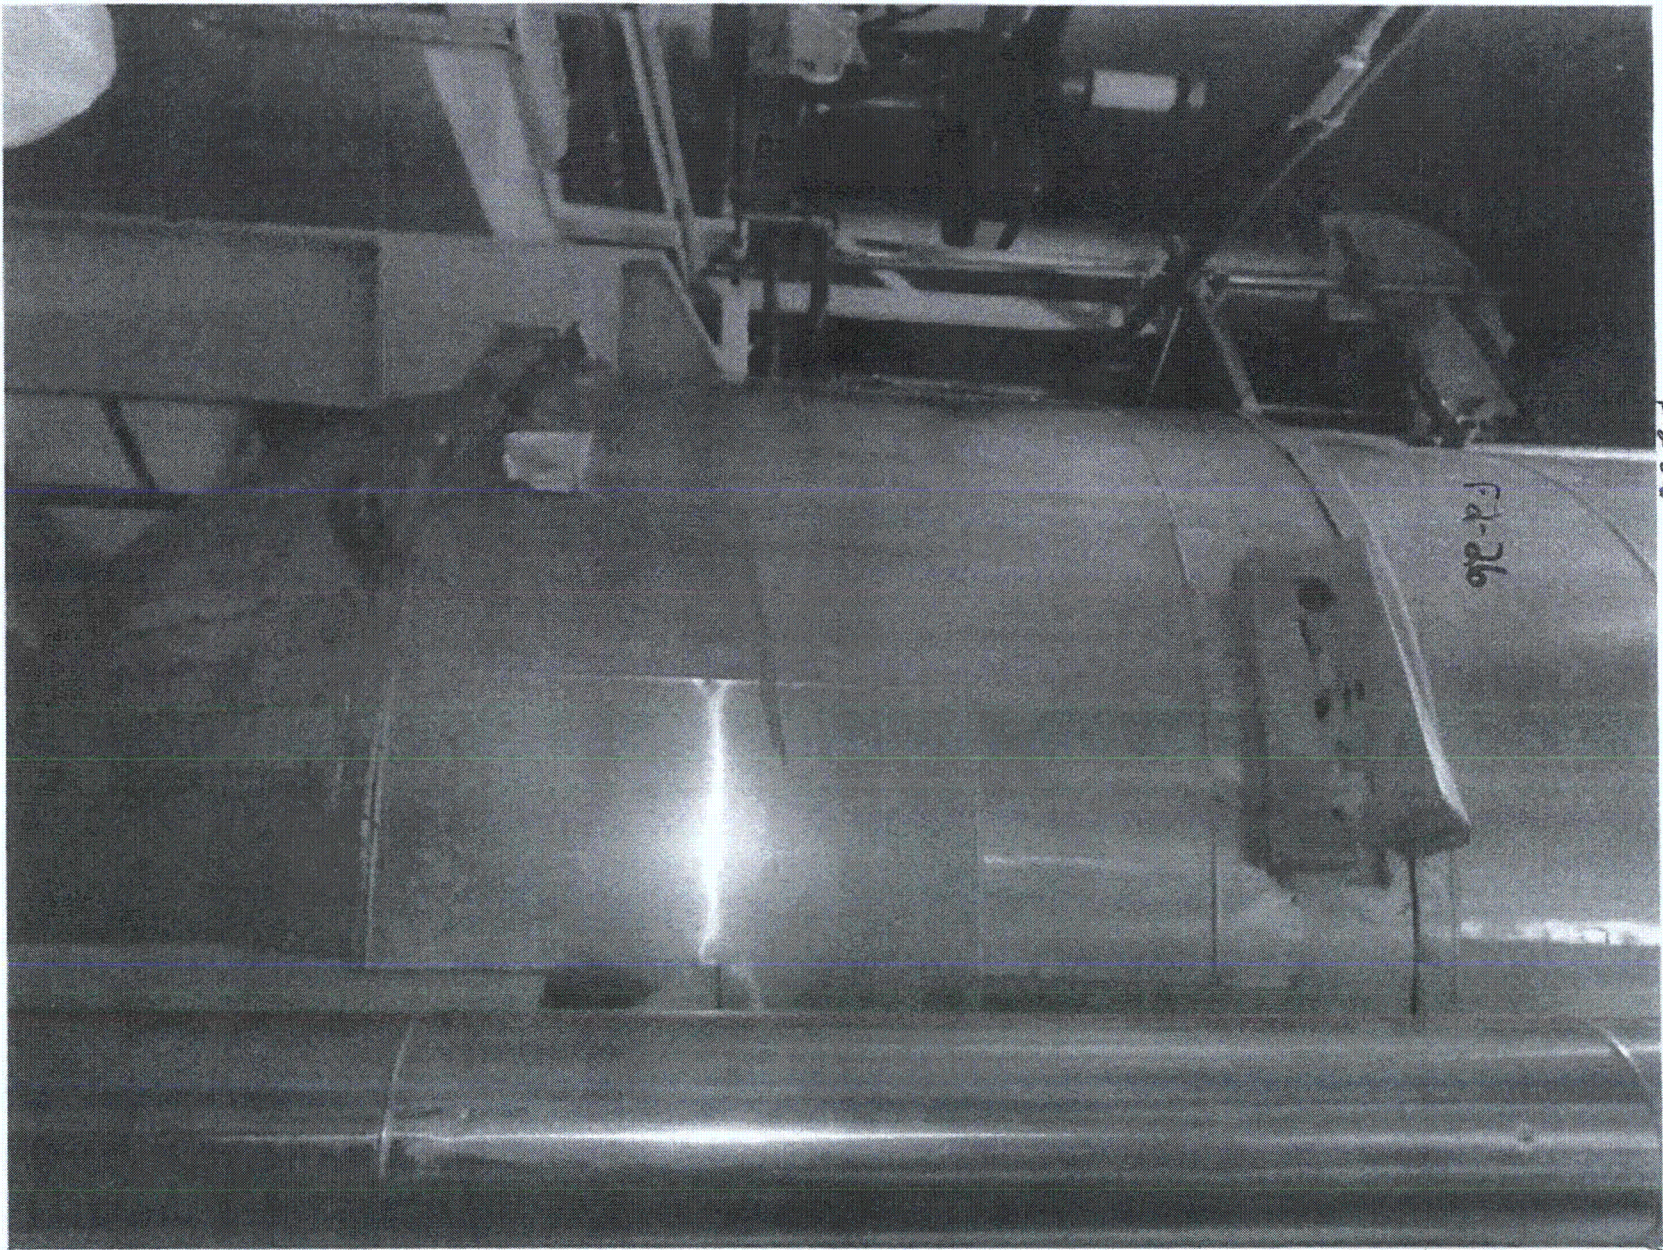
F2-26

Conduit support in contaminated ledge has gap 7/16" under base plate. Determined to be adequate by engineering judgment as there are (3) 3" conduits spanning approx. 8" between adjacent supports. ~~and~~ In addition, the gravity loads are not eccentric and therefore should not cause additional lift on the b.p.

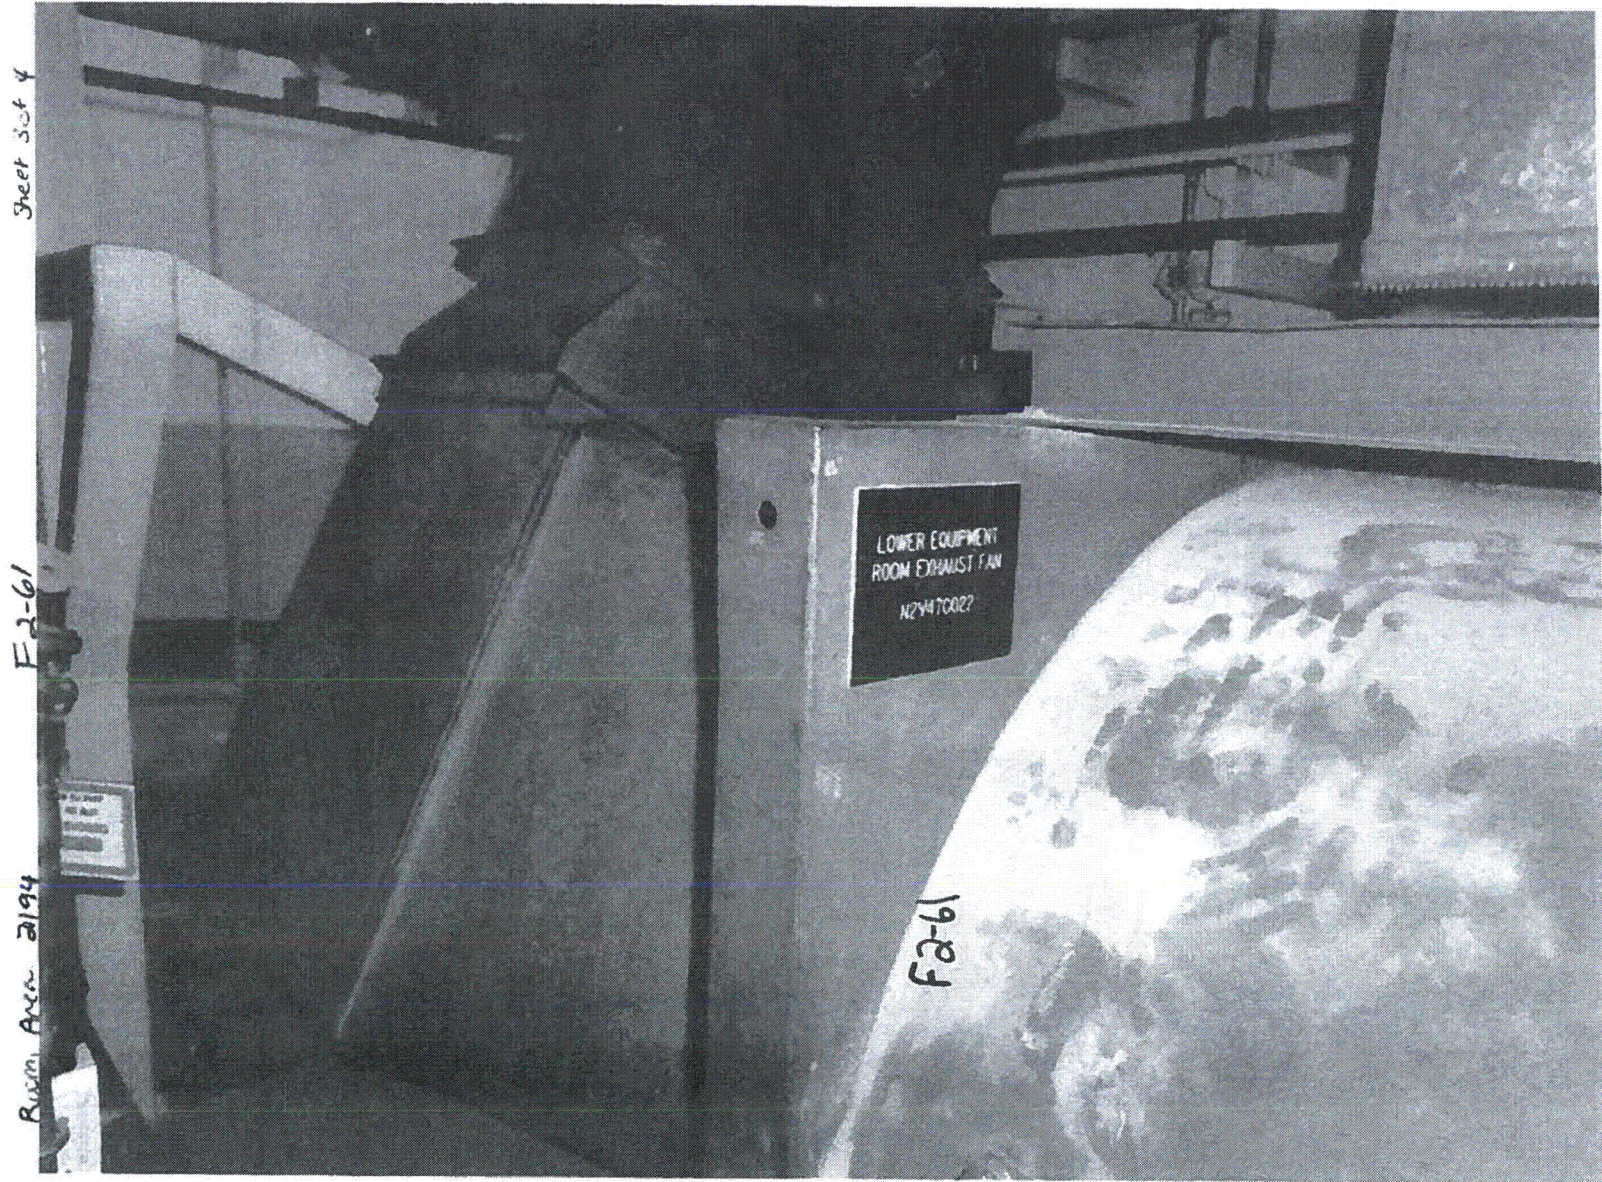
F2-61

Minor rust on bolts for Exhaust Fan, N2V475022,
Judged to be acceptable. photo
