APPENDIX B SEISMIC WALKDOWN CHECKLISTS (SWCs)

Seismic Walkdown Checklist (SWC)

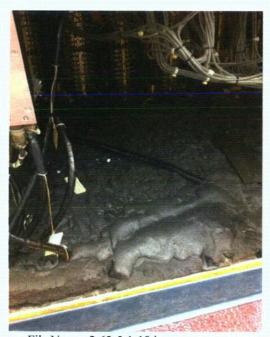
File Name: 2-61-5-1-18.jpeg

Description: General view of component
