APPENDIX C
AREA WALK-BY CHECKLISTS (AWCs)

Area Walk-By Checklist (AWC)

Room 105 Floor El. 545 Bldg. AUXB

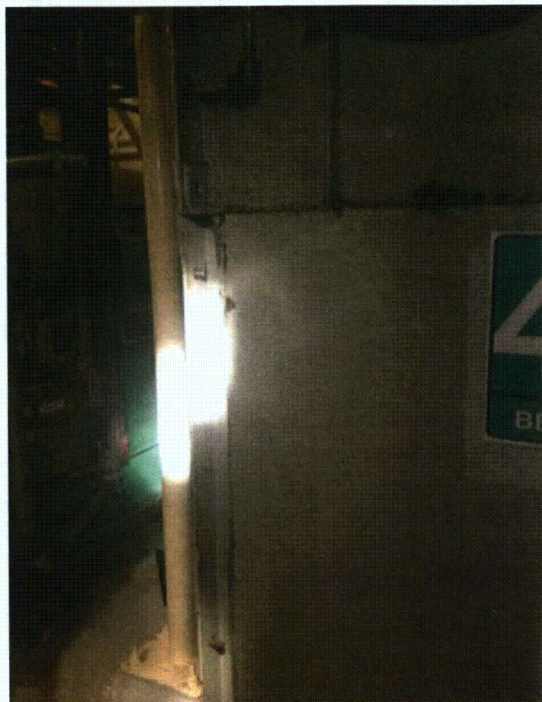
Anchorage for cover plate of E31-4 does not have nuts, see Photo 2. Concern has been judged not to represent an adverse condition regarding the component's seismic performance.

Photo 2
Missing Nuts on Cover of E31-4

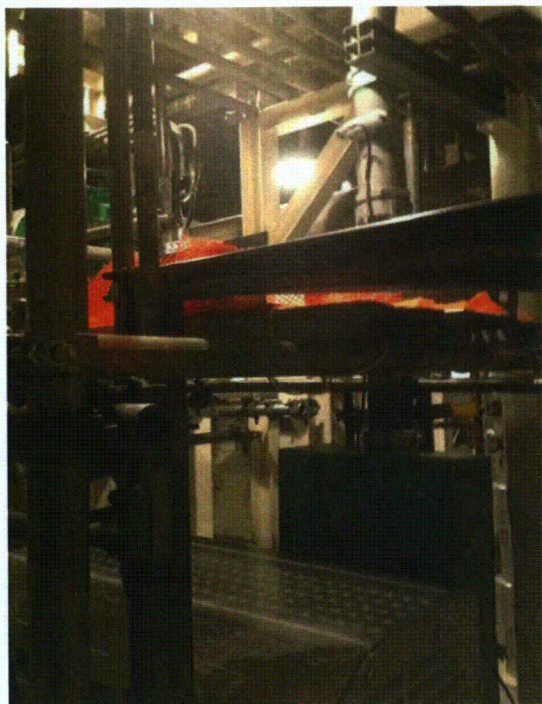
Temporary scaffolding in area appears to be adequately restrained. See Photo 3.

Photo 3
Temporary Scaffolding Restrained

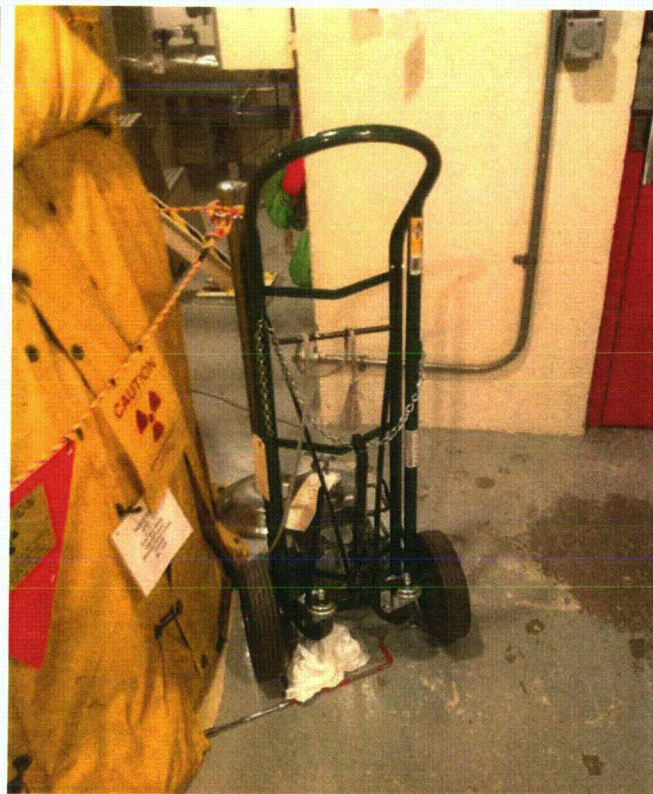
A dolly was found unrestrained in the area. Since the dolly had restraining chains on it, it was judged that it is temporarily located at the position found in the room and will be returned to its storage location and tied when work is done. Also, no sensitive equipment found in the vicinity of this dolly.

Photo 2
Unrestrained Dolly in Area

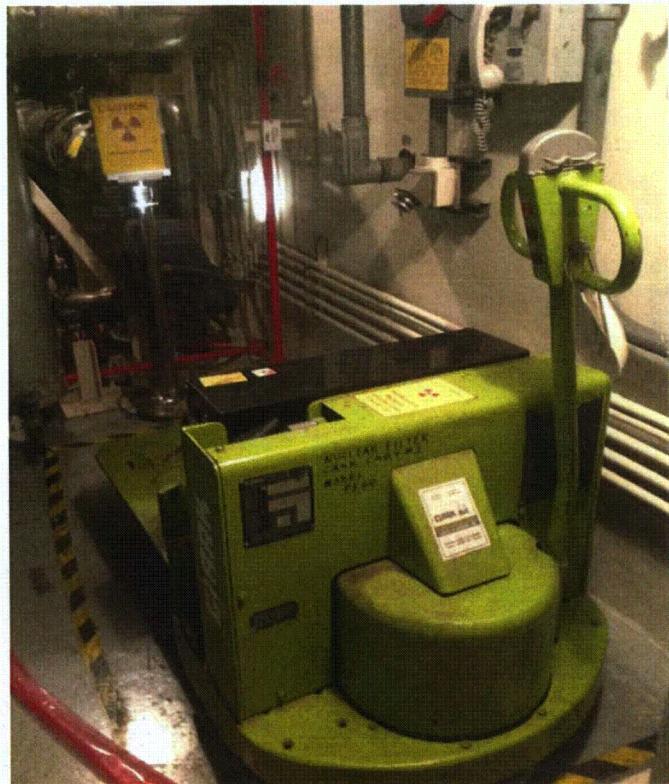
*Nuclear filter cask cart unrestrained adjacent to components.
There are no sensitive equipment in the zone of influence of this cart and it is judged OK. It is also noted that this cart appear to be temporarily in the area.*

Photo 2
Nuclear Filter Cask Cart Not Restrained

In a subsequent visit to his area on the next day, it was observed that this cart was properly restrained.

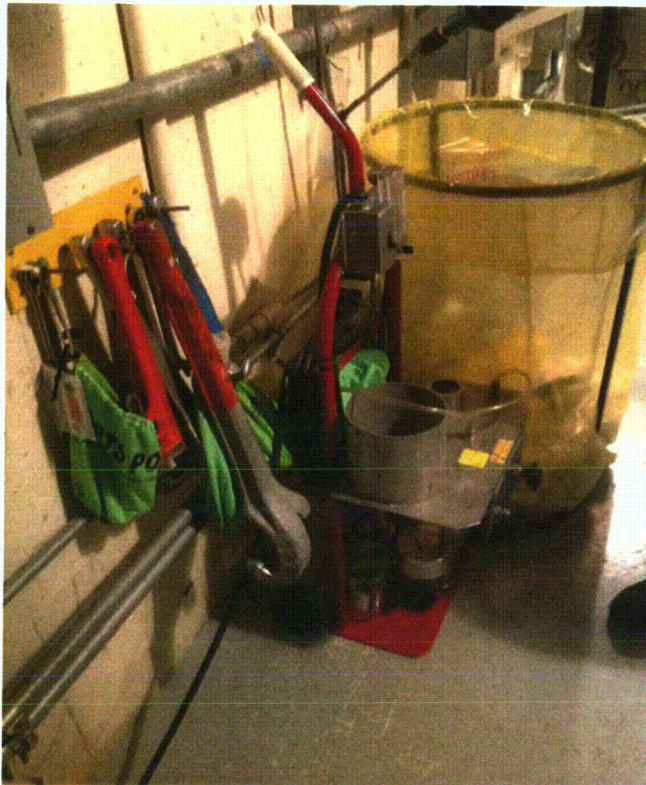
Photo 1
Dolly Not Restrained

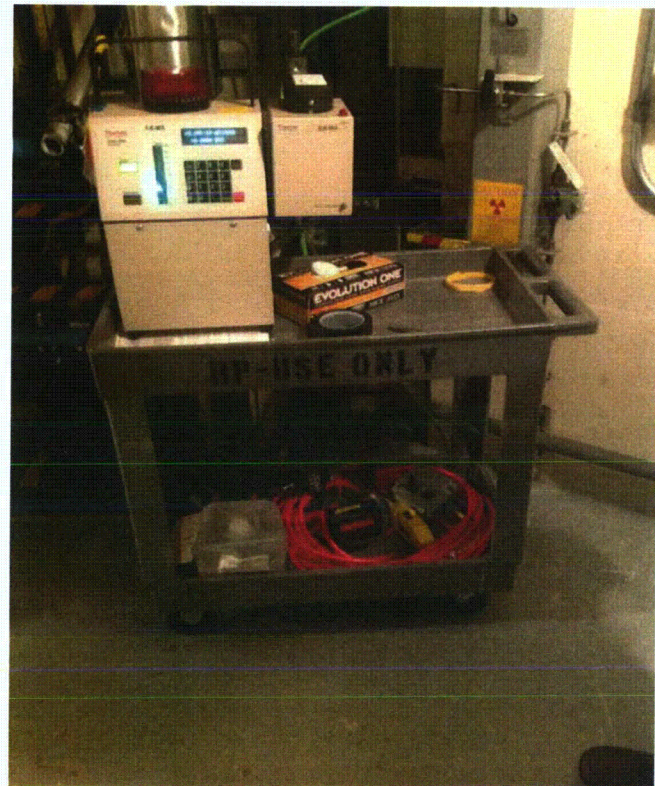
Photo 2
RP Cart Not Restrained

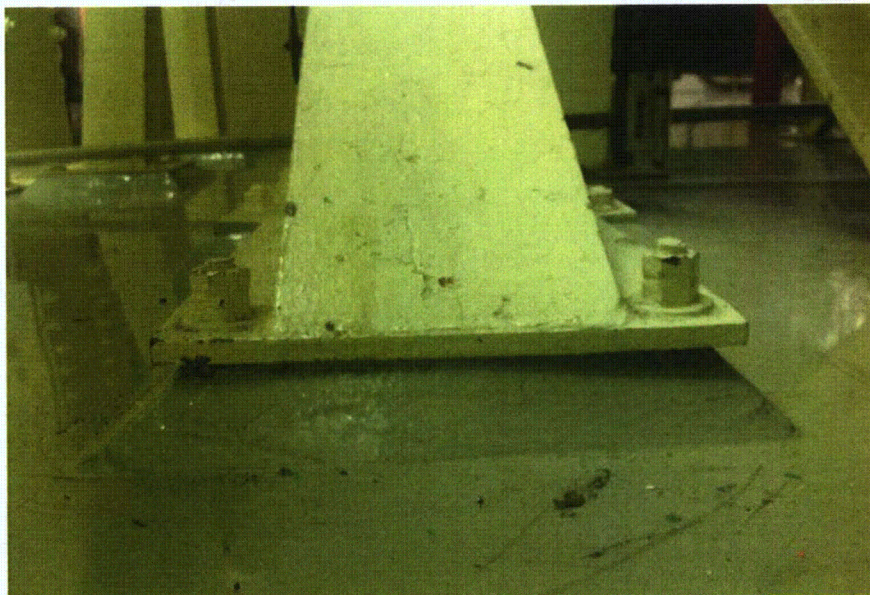
Photo 2
Gap Between Grout and Anchor Plate

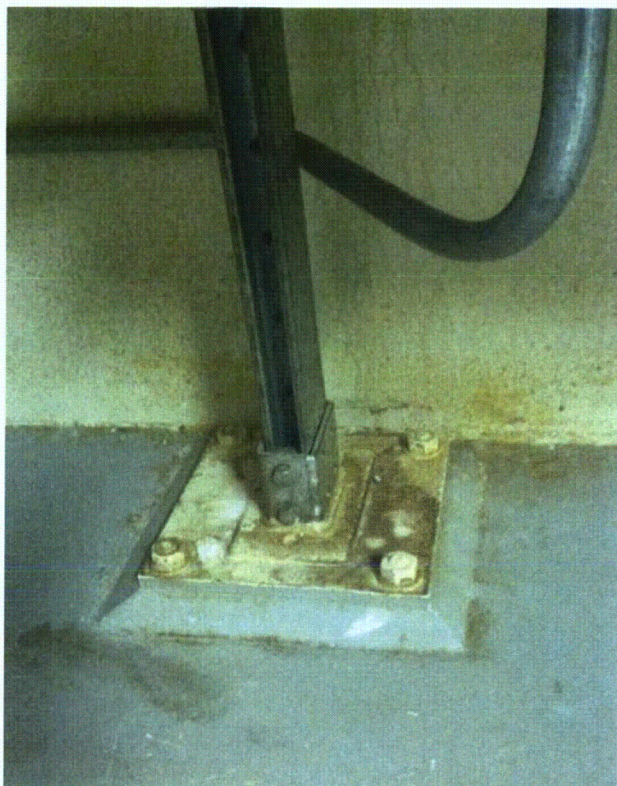
Minor corrosion noted in anchorage supporting sensor panel, see Photo 3. Deemed not a significant degraded condition.

Photo 3
Minor Corrosion on
Anchor Plate

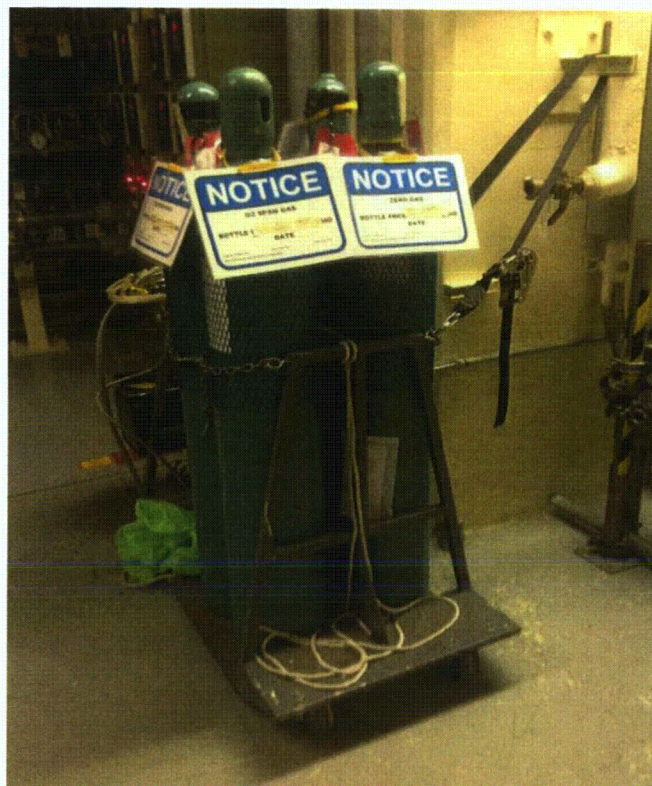
*Cart with gas cannisters loosely restrained to wall, see Photo 4.
Judged not a concern since straps and chains will keep
cannisters in place thus no direct contact with nearby equipment is expected.*

Photo 4
Cart Containing Gas Canisters
Loosely Restrained

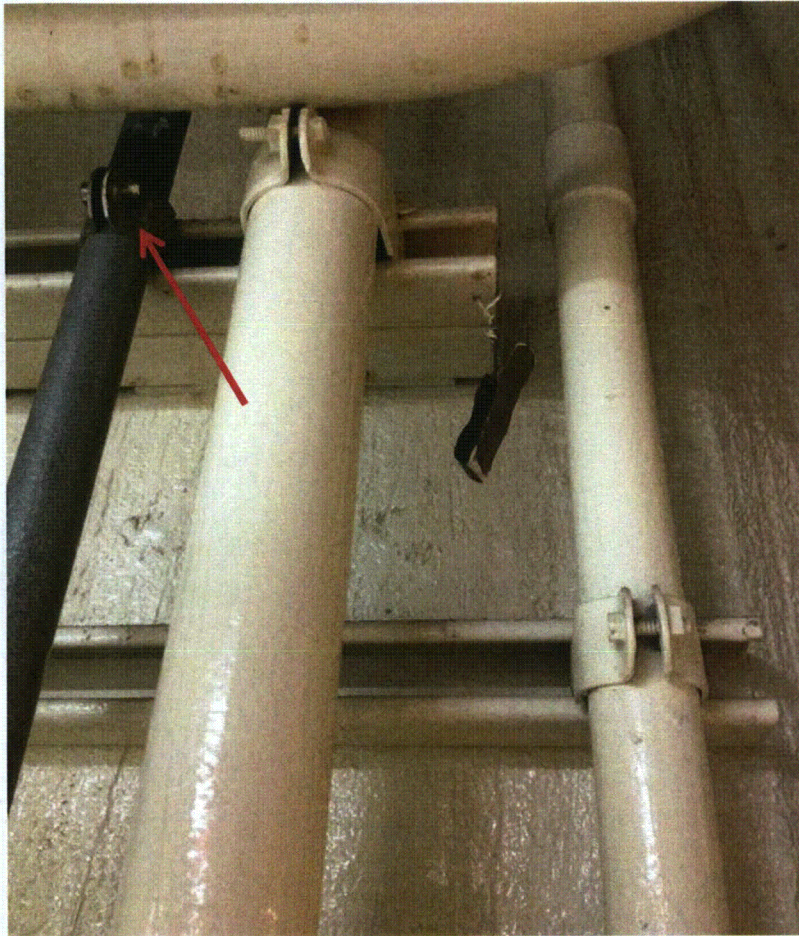
Nut missing on conduit, see Photo 1.

Photo 1
Nut Missing on Conduit

Condition report issued : CR-2012-10920

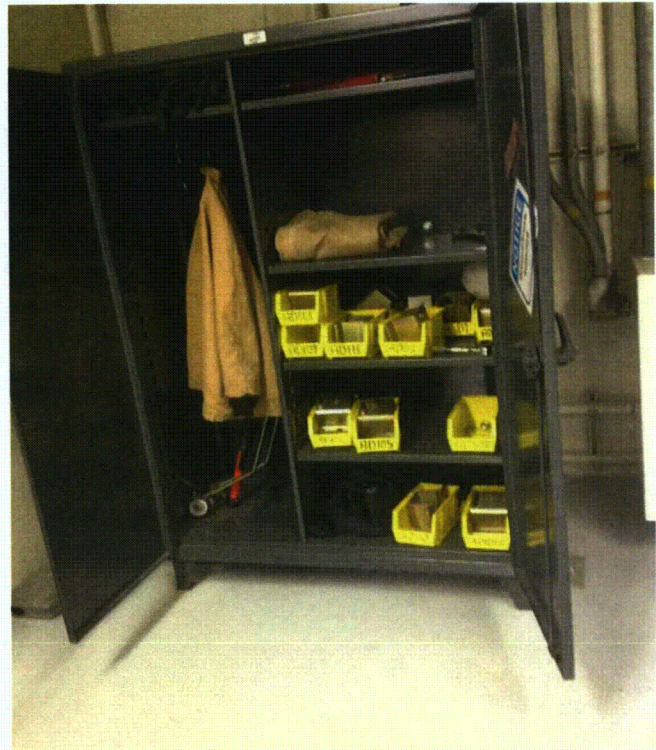
Photo 2
Supply Cabinet Left Open

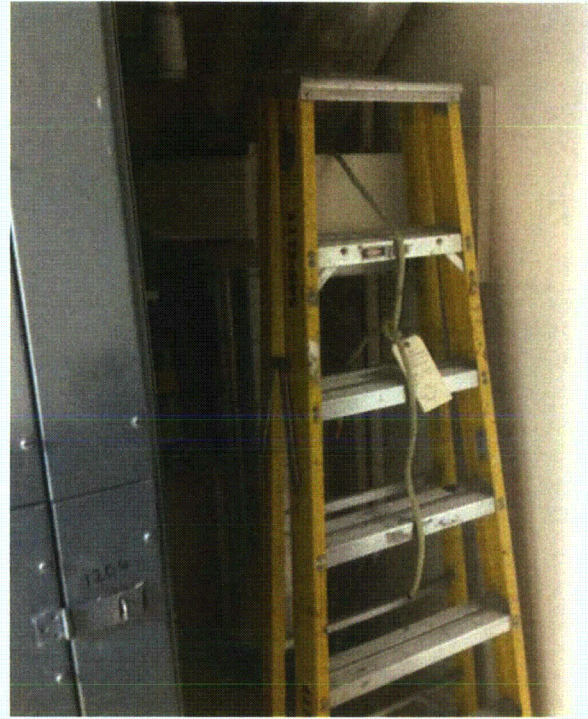
Photo 2
Ladder Loosely Tied Adjacent to MCC F11A

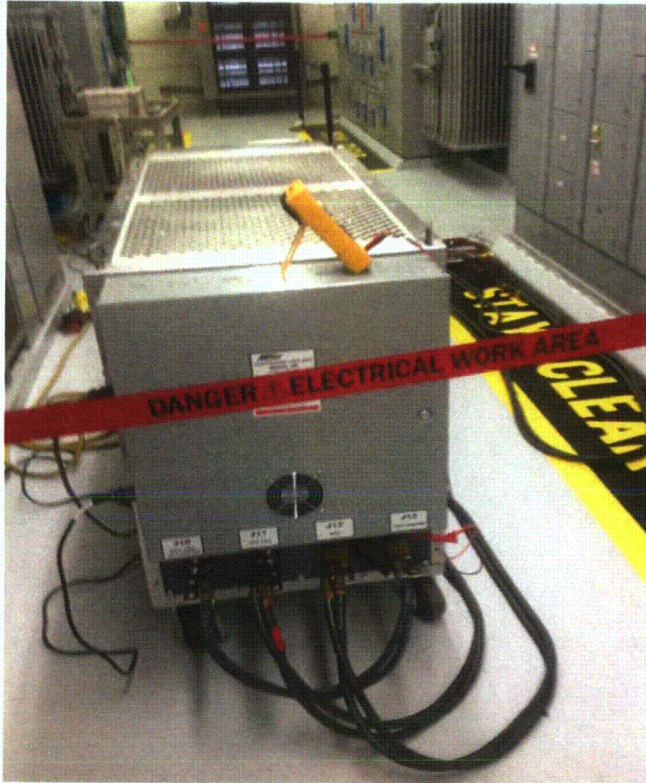
Photo 3
Unrestrained Work Cart

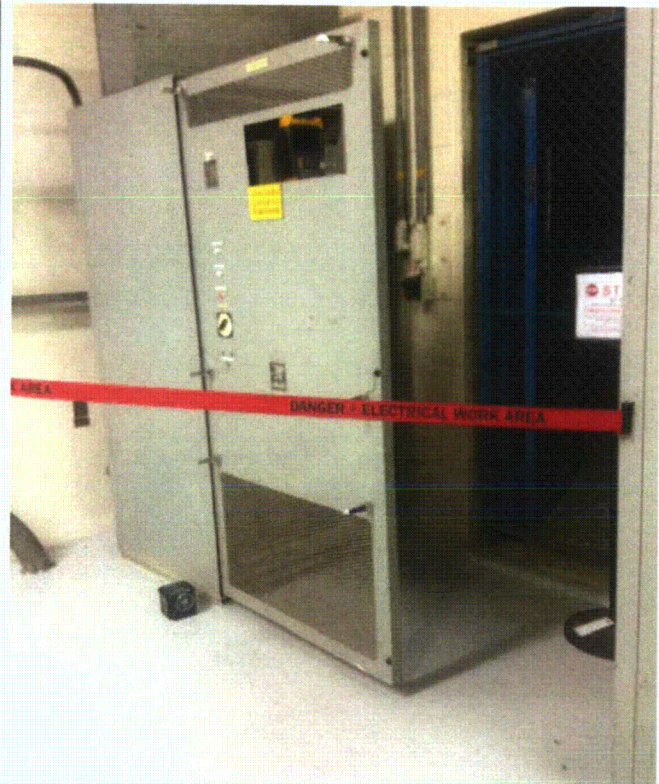
Photo 4
Cabinet DCB-2P Door Left Open
