Area Walk-By Checklist (AWC)

Area 1AB-1g Floor El. 574 Bldg. AX

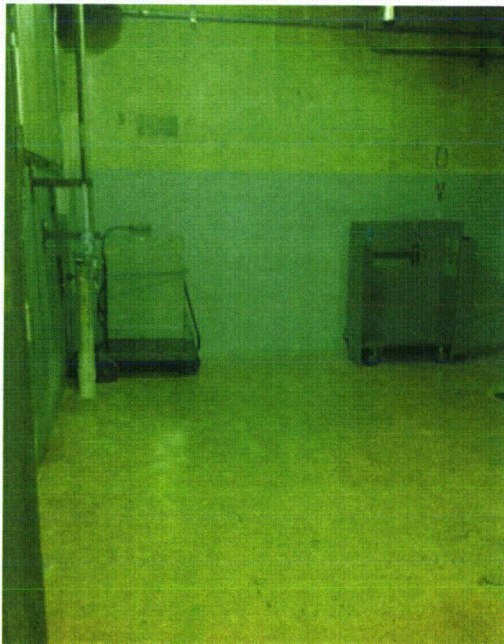
Barrier and welding machine adequately restrained. Temporary scaffolding in area judged to be adequately restrained

File Name: 1-65-3-1-18.jpeg
Description: View of temporary equipment restrained

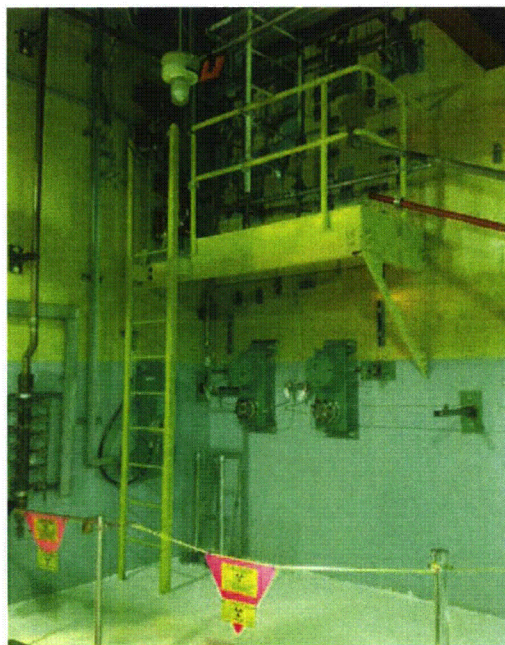
Anchorage of components in a high radiation contaminated area was examined visually from a distance of ~10 ft and no adverse conditions were identified.

File Name: 1-67-3-1-18.jpeg
Description: Inaccessible high radiation contaminated area where anchorage was checked from ~10 ft

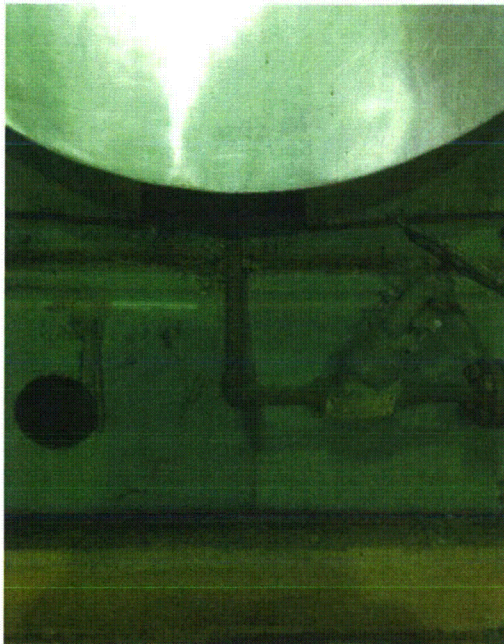
TB Chillers 1P46-B001A and 1P46-B001B are very large double stack chillers anchored with only four 3/4" anchor bolts on a ~16" wide x ~6" high pedestal. These chillers are not category I and anchorage may not be adequate for seismic loading. Judged acceptable because the chillers have a limited water supply and would not impact or flood any CAT-1 components if they should fail.

Anchorage for TB chillers identified with significant corrosion. This is judged to be acceptable, as described in comments for Question 1.

File Name: 1-70-3-1-20.jpeg
Description: View of corroded pipe in IP46B001A

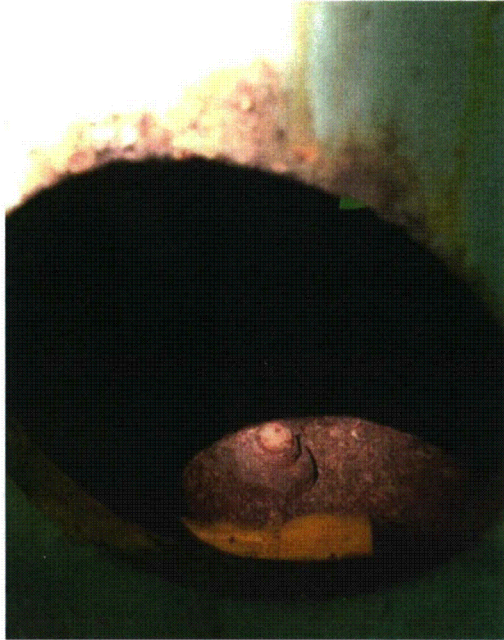
Description: View of corroded bolt located north east end of 1P46B001B

Anchorage for two CAT-2 chillers in area were identified with significant corrosion. This is judged to be acceptable because the chillers have a limited water supply and would not impact or flood any CAT-1 components if they should fail.

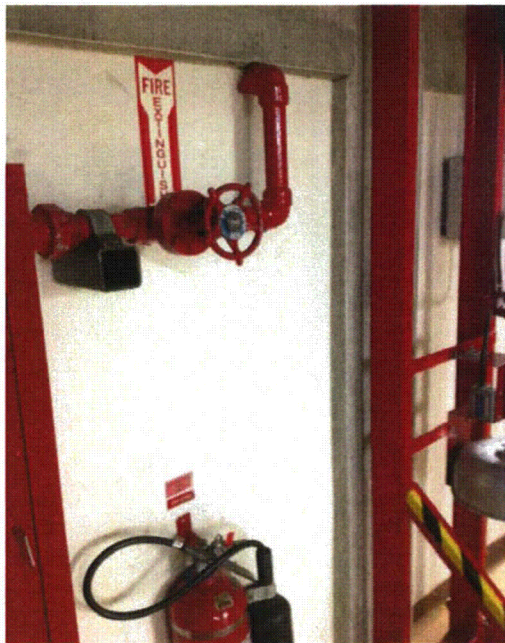
A fire protection valve near components was observed to be adequately supported. Fire protection piping throughout room is CO2. No concerns identified regarding flood sources.

File Name: 1-65-1-1-06.jpeg
Description: Fire protection valve well supported

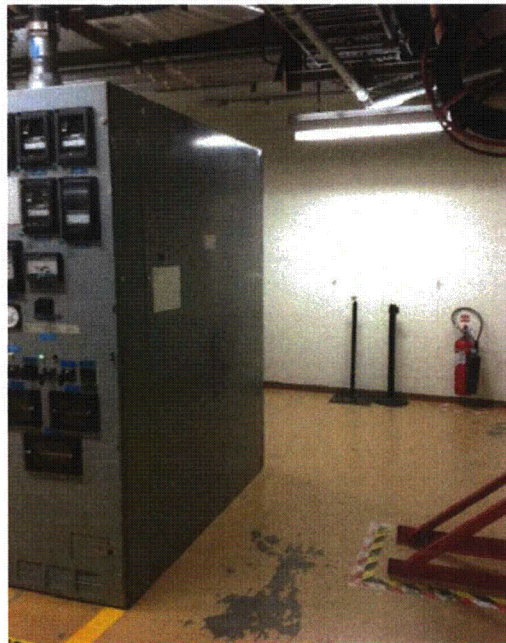
An unrestrained tool storage locker was found near components. CR 2012-12222 generated to document this situation, and the cabinet was subsequently moved. Most fluorescent lights have compression fittings. A row of twist-in style lights was observed, but it was judged to be unlikely to impact any components. Trolleys on top of switchgear were observed to be unrestrained. These trolleys were positioned in the center of the switchgear, consistent with IPEEE resolution of the issue.

File Name: 1-72-1-1-06.jpeg
Description: View of area where tool locker was located

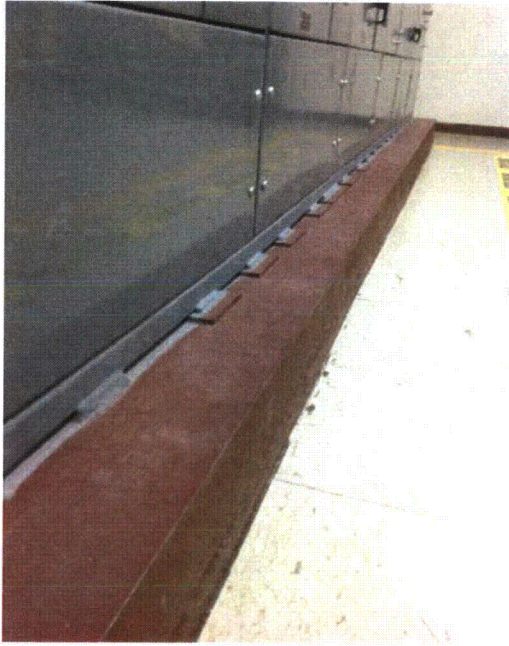
File Name: 1-65-2-1-06.jpeg
Description: View of 1R24-S0029 welded shims

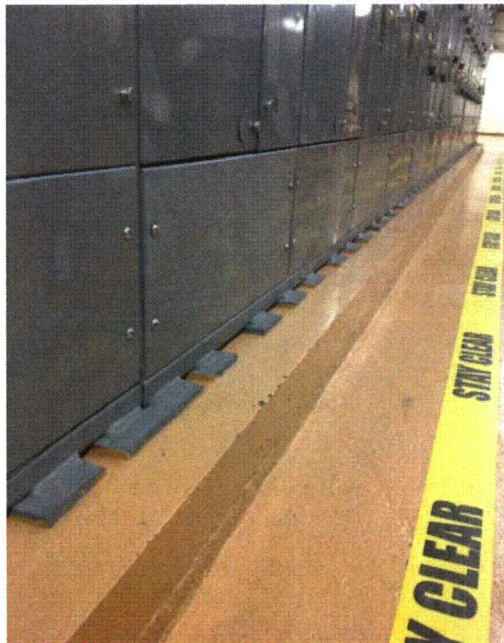
File Name: 1-60-3-1-06.jpeg
Description: View of 1R24-S0021 welded to shims

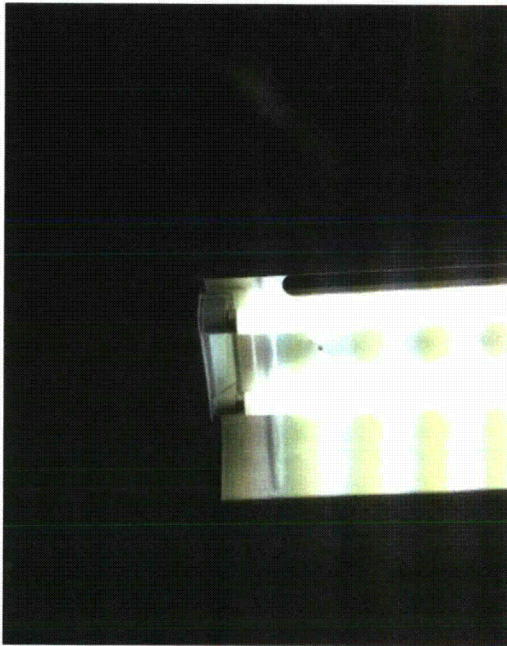
Fluorescent lights appear to have compression fittings, thus judged acceptable for seismic motion. A single row of flourescent lights was observed with twist-in fittings, but this row was judged not to have any credible impact targets as it was more than ~4' from components. Trolleys on top of switchgear were observed to be unrestrained. These trolleys were positioned in the center of the switchgear, consistent with IPEEE resolution of the issue.

File Name: 1-65-1-1-02.jpeg
Description: View of compression fitting on fluorescent light

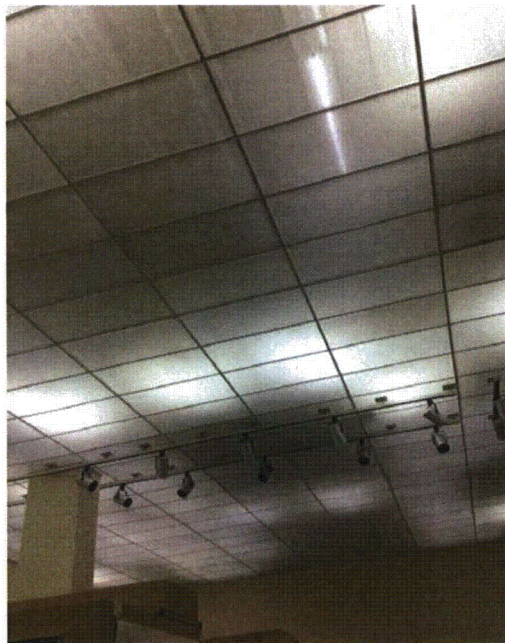
File Name: 1-60-1-1-03.jpeg
Description: Ceiling tiles not anchored

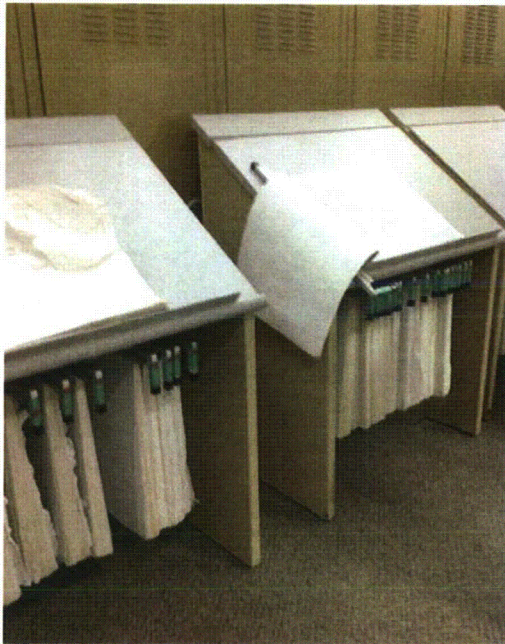
File Name: 1-65-1-1-03.jpeg
Description: Desks adjacent to reactivity control cabinets

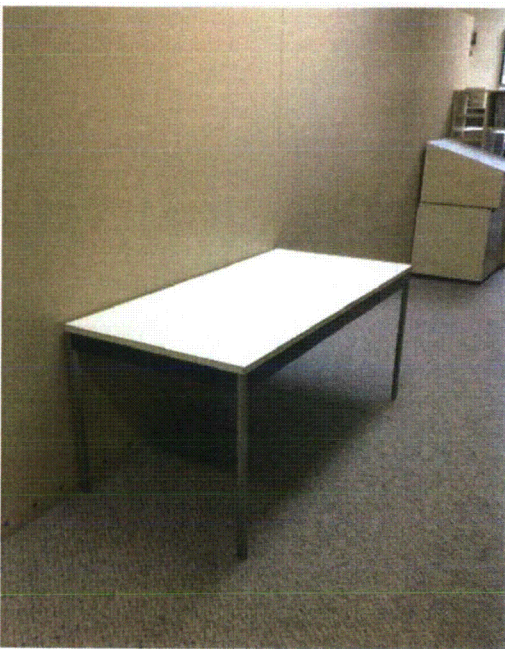
File Name: 1-68-1-1-03.jpeg
Description: Table not restrained

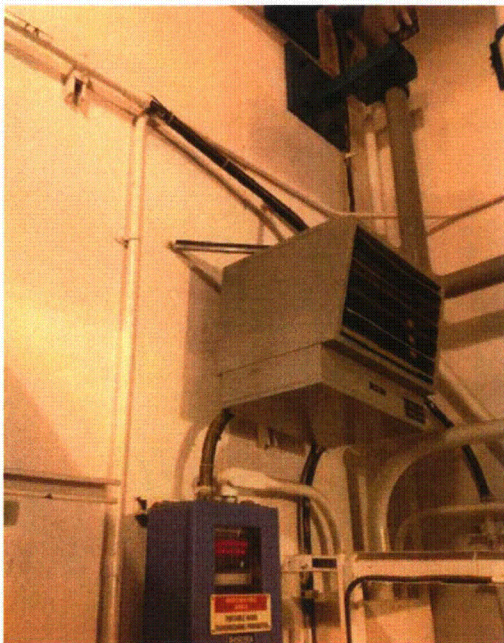
File Name: 1-66-1-1-08.jpeg
Description: View of heater anchorage

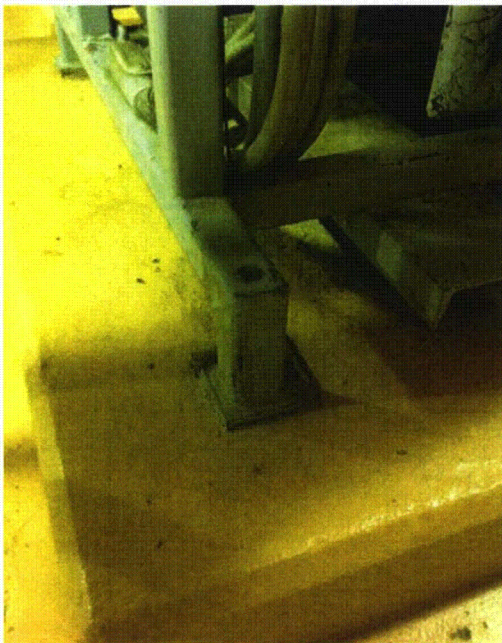
File Name: 1-74-1-1-01.jpeg
Description: Air dryer rack (1P52-D003B) missing anchorage (similar issue 1P52-D003A)

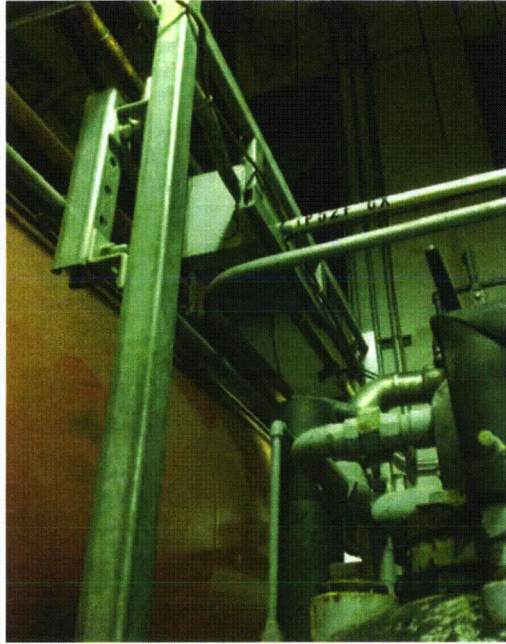
File Name: 1-75-1-1-01.jpeg
Description: Anchorage for air dryer racks (at top)

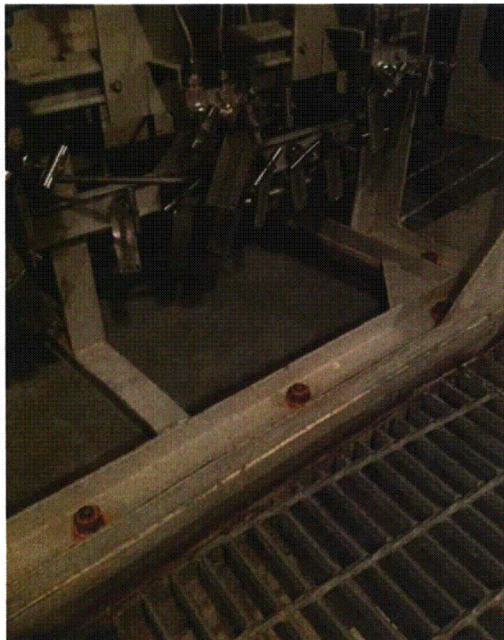
File Name: 1-65-1-1-13.jpeg
Description: Corrosion in instrument rack anchorage

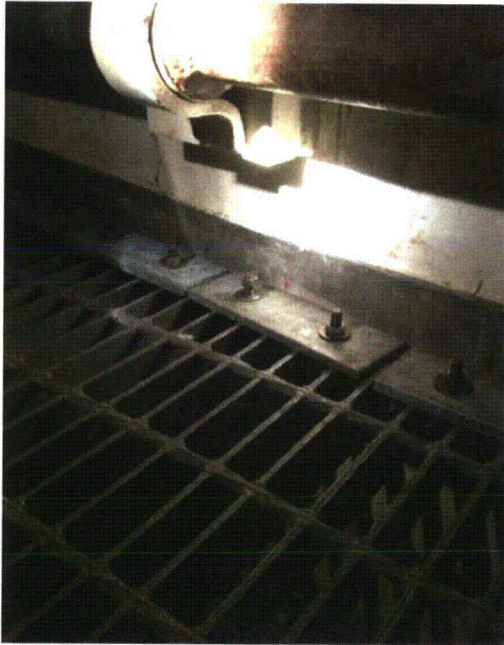
File Name: 1-66-1-1-13.jpeg
Description: Loose nut for securing grating.

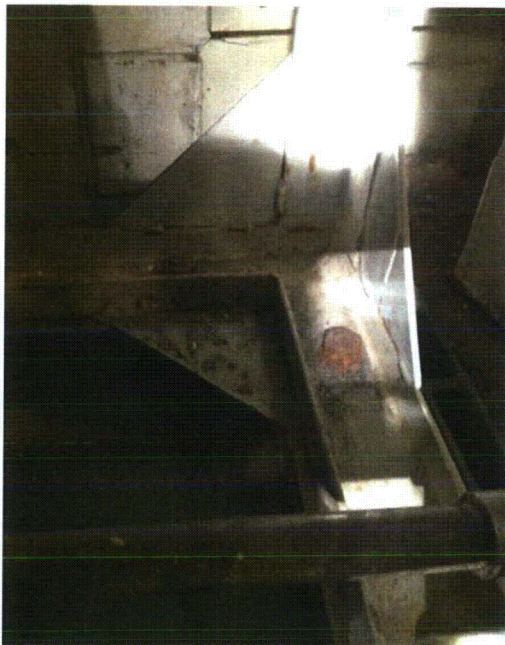
File Name: 1-71-1-1-13.jpeg
Description: Mild corrosion identified in anchorage

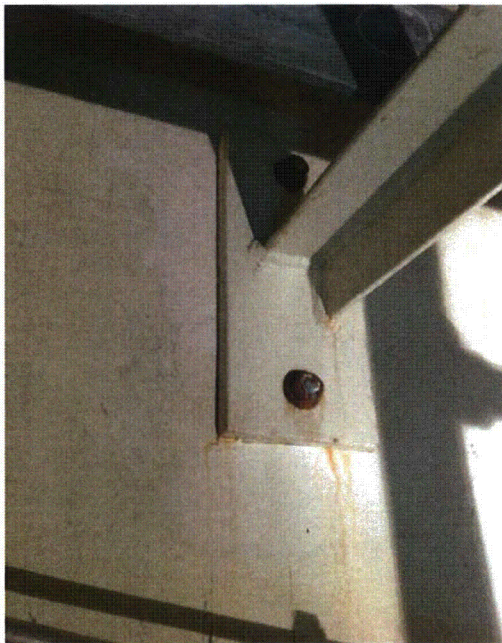
File Name: 1-60-1-1-12.jpeg
Description: Surface corrosion identified

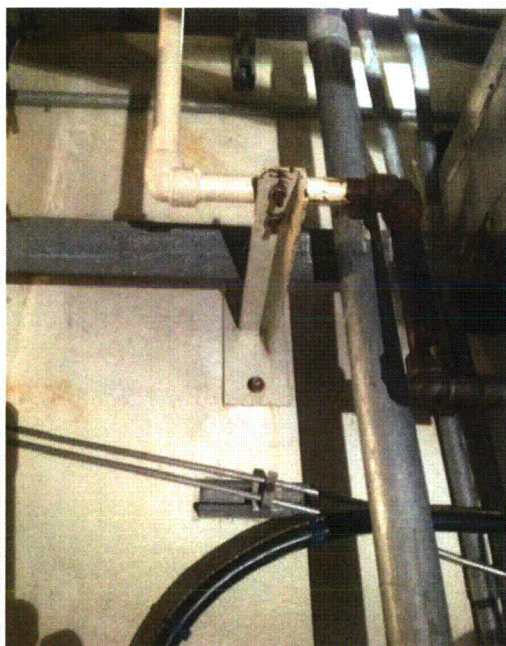
File Name: 1-65-1-1-12.jpeg
Description: Surface corrosion identified

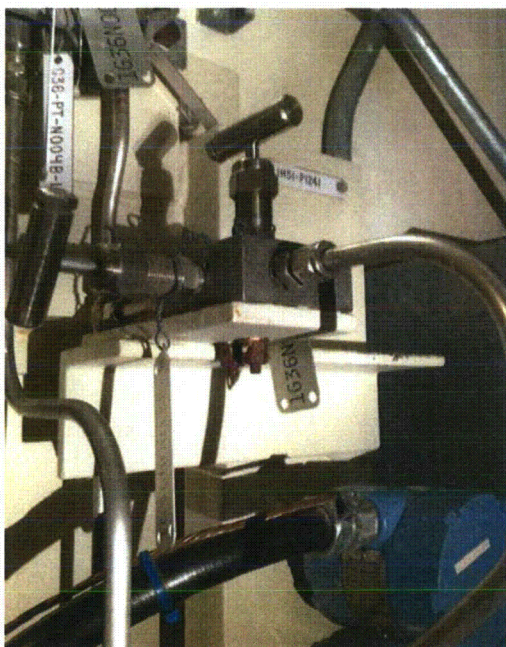
File Name: 1-67-1-1-12.jpeg
Description: Surface corrosion identified

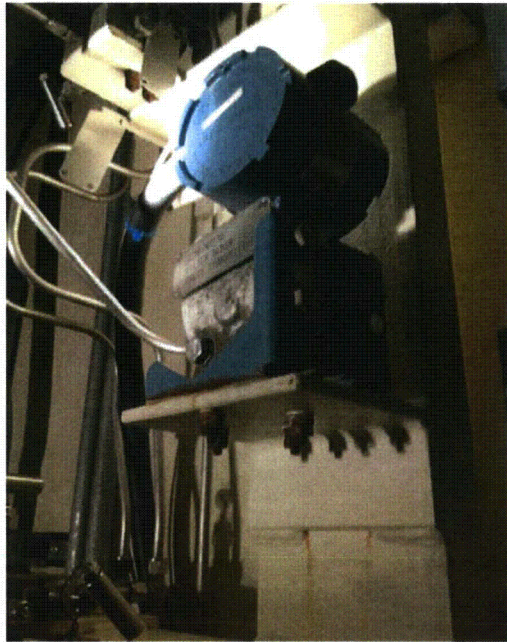
File Name: 1-68-1-1-12.jpeg
Description: Surface corrosion identified

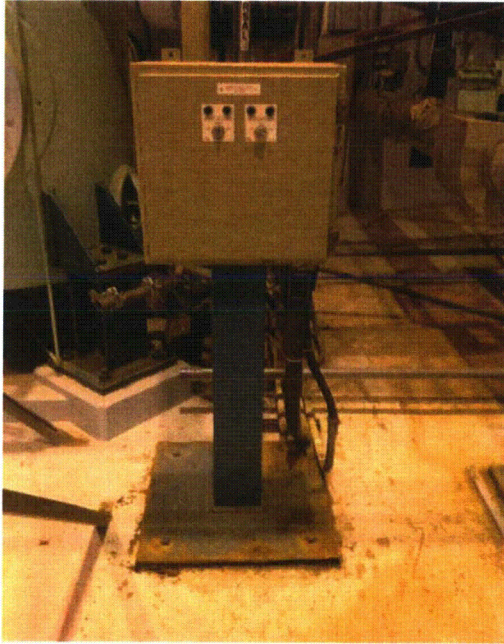
File Name: 1-65-1-1-05.jpeg
Description: View of 2H51-P753B anchorage condition

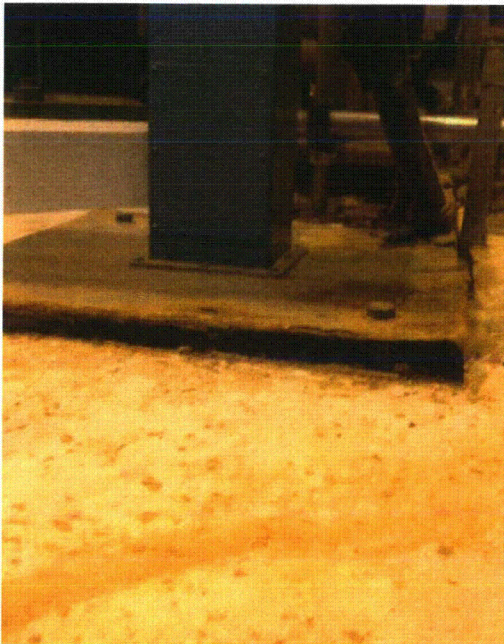
File Name: 1-66-1-1-05.jpeg
Description: Close up of anchorage condition

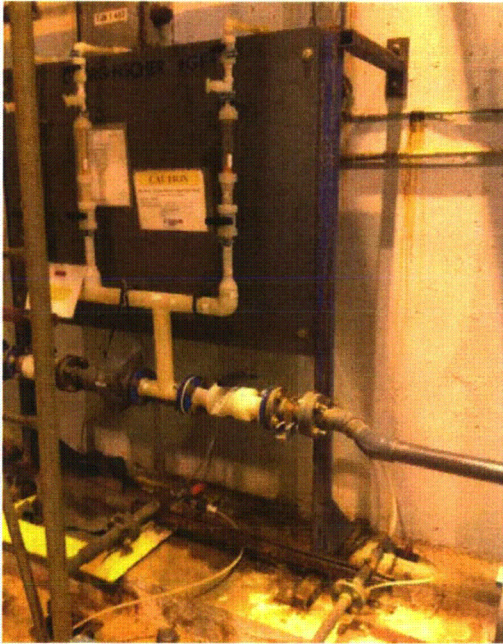
File Name: 1-70-1-1-05.jpeg
Description: Surface corrosion identified

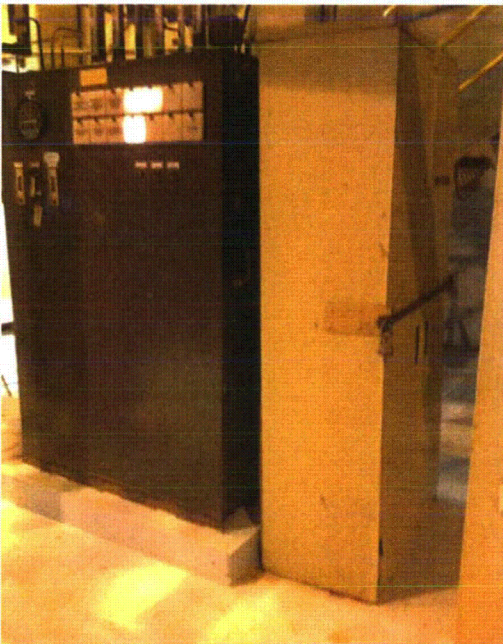
File Name: 1-71-1-1-05.jpeg
Description: Storage container identified next to H51-P010A

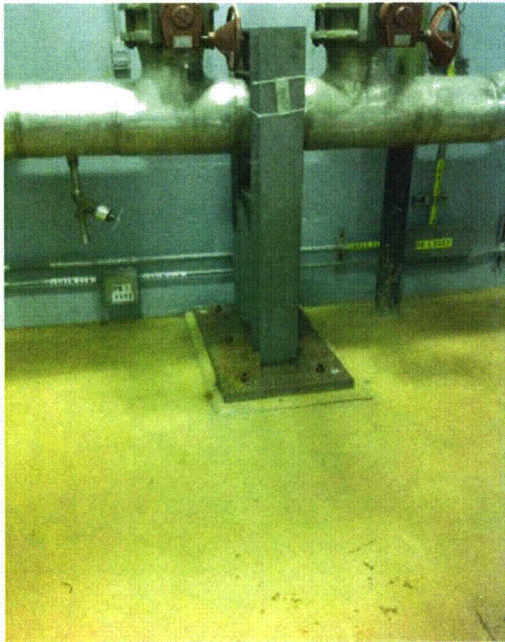
File Name: 1-60-2-1-22.jpeg
Description: Mild surface corrosion identified

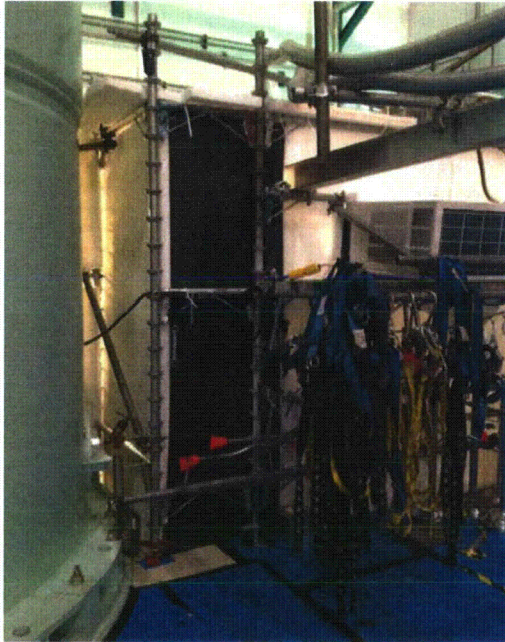
File Name: 1-67-2-1-17.jpeg
Description: Scaffolding clamped to tank

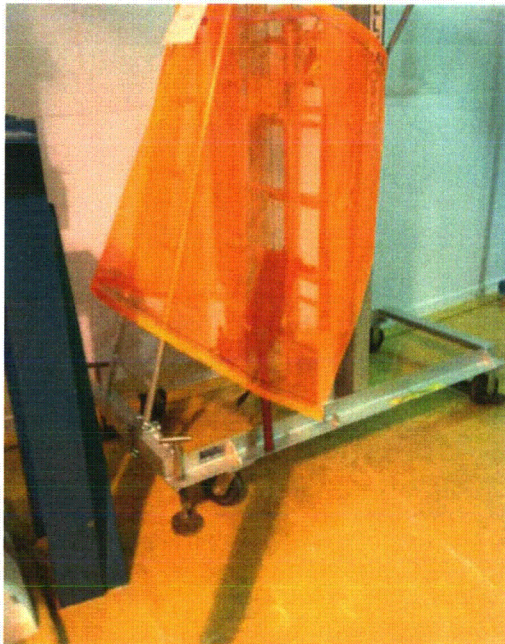
File Name: 1-60-2-1-14.jpeg
Description: Maintenance equipment identified in the area
