## PART 21 REPORT INVOLVING TYPE 546NS TRANSDUCERS

"Fisher Information Notice: FIN 2013-01; 9 January 2013

"Subject: Type 546NS Transducers

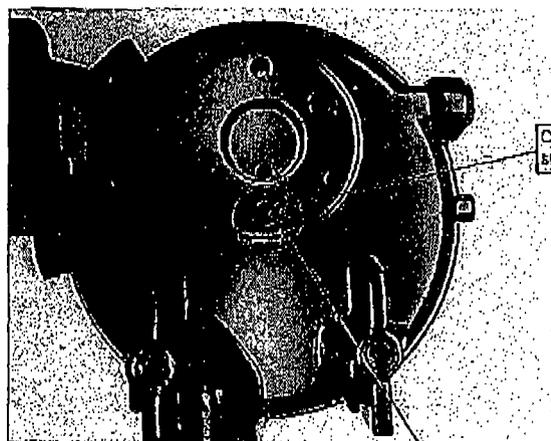
Figure 1

This procedure is to be used to inspect the 546 transducer vent passage between the 546 case and 82 relay for a possible obstruction due to aluminum flash in the vent passage. If the vent passage is found to be obstructed by aluminum flash, the flash may be removed with a punch or other hard pointed object by breaking and removing the flash. The 546 transducer will operate normally once the flash is removed and the relay is re-installed.

Clear passage with flame suppressor visible

1. To remove the type 82 relay, perform step 1. of the Relay Removal and Replacement instructions on page 15 of the instruction manual.
2. Inspect the case vent passage (see figures 1 - 3). The passage should be open and the interior surface of the flash suppressor should be visible through the hole (see figures 1 and 2). If the passage is obstructed with aluminum flash, the passage will appear to be a blind hole (see figure 3).
3. If the passage is obstructed with aluminum flash, use a punch or other hard sharp instrument to break the flash and remove it from the vent passage.
4. Once the aluminum flash is removed, or if no aluminum flash is present, re-install the type 82 relay by performing step 3 of the Relay Removal and Replacement procedure on page 15 of the instruction manual.
5. The 546 transducer is now ready to be placed into service.
