Part 21 (PAR)

PART 21 REPORT INVOLVING TYPE 546NS TRANSDUCERS

Fisher Information Notice: FIN 2013-01
9 January 2013

Subject: Type 546NS Transducers

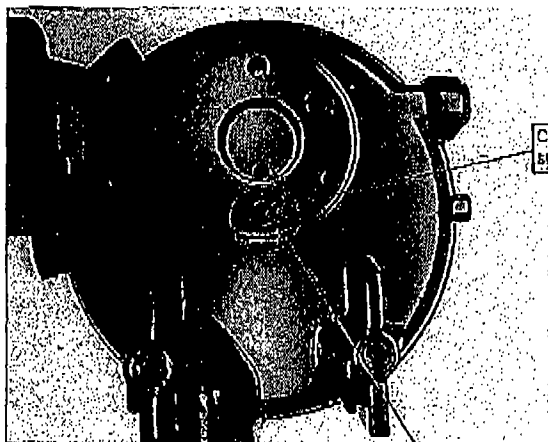
Figure 1

This procedure is to be used to inspect the 546 transducer vent passage between the 546 case and 82 relay for a possible obstruction due to aluminum flash in the vent passage. If the vent passage is found to be obstructed by aluminum flash, the flash may be removed with a punch or other hard pointed object by breaking and removing the flash. The 546 transducer will operate normally once the flash is removed and the relay is re-installed.

1. To remove the type 82 relay, perform step 1. of the Relay Removal and Replacement instructions on page 15 of the instruction manual.
2. Inspect the case vent passage (see figures 1 - 3). The passage should be open and the interior surface of the flash suppressor should be visible through the hole (see figures 1 and 2). If the passage is obstructed with aluminum flash, the passage will appear to be a blind hole (see figure 3).
3. If the passage is obstructed with aluminum flash, use a punch or other hard sharp instrument to break the flash and remove it from the vent passage.
4. Once the aluminum flash is removed, or if no aluminum flash is present, re-install the type 82 relay by performing step 3 of the Relay Removal and Replacement procedure on page 15 of the instruction manual.
5. The 546 transducer is now ready to be placed into service.
