12.0 Annual Inspection of the Mexican Hat, Utah, UMTRCA Title I Disposal Site

13.0 Annual Inspection of the Naturita, Colorado, UMTRCA Title I Disposal Site

14.0 Annual Inspection for the Rifle, Colorado, UMTRCA Title I Disposal Site

15.0 Annual Inspection of the Salt Lake City, Utah, UMTRCA Title I Disposal Site

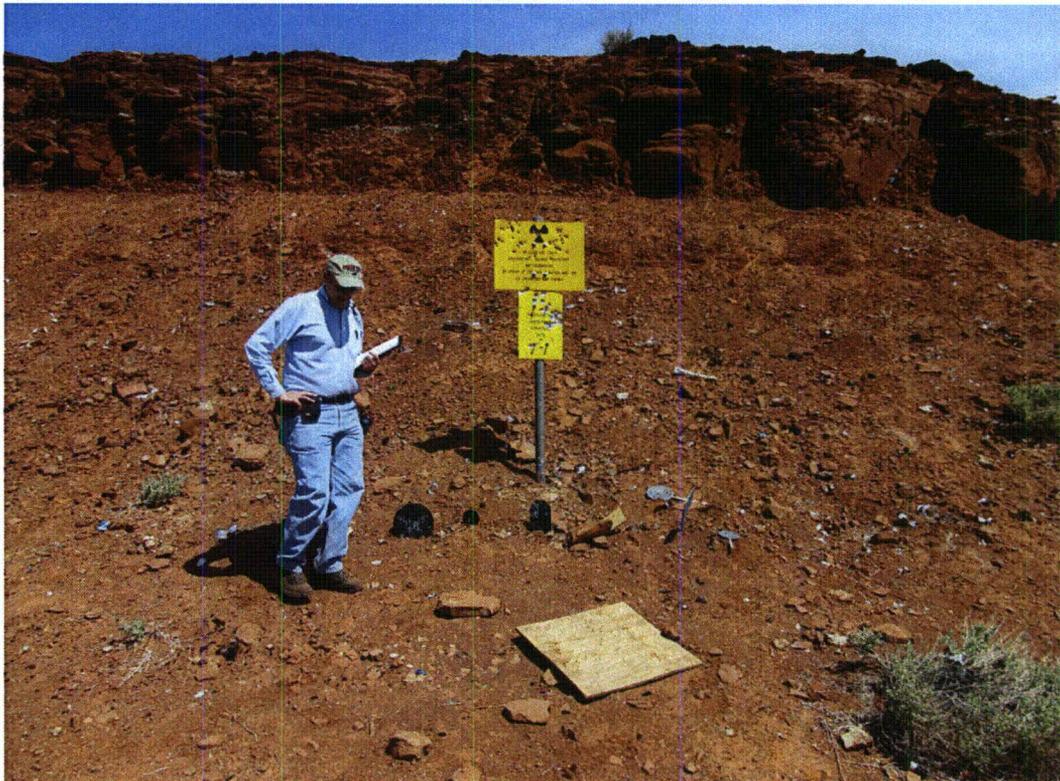
HAT 4/2012. PL-1. Photo of perimeter sign P20 with bullet damage.

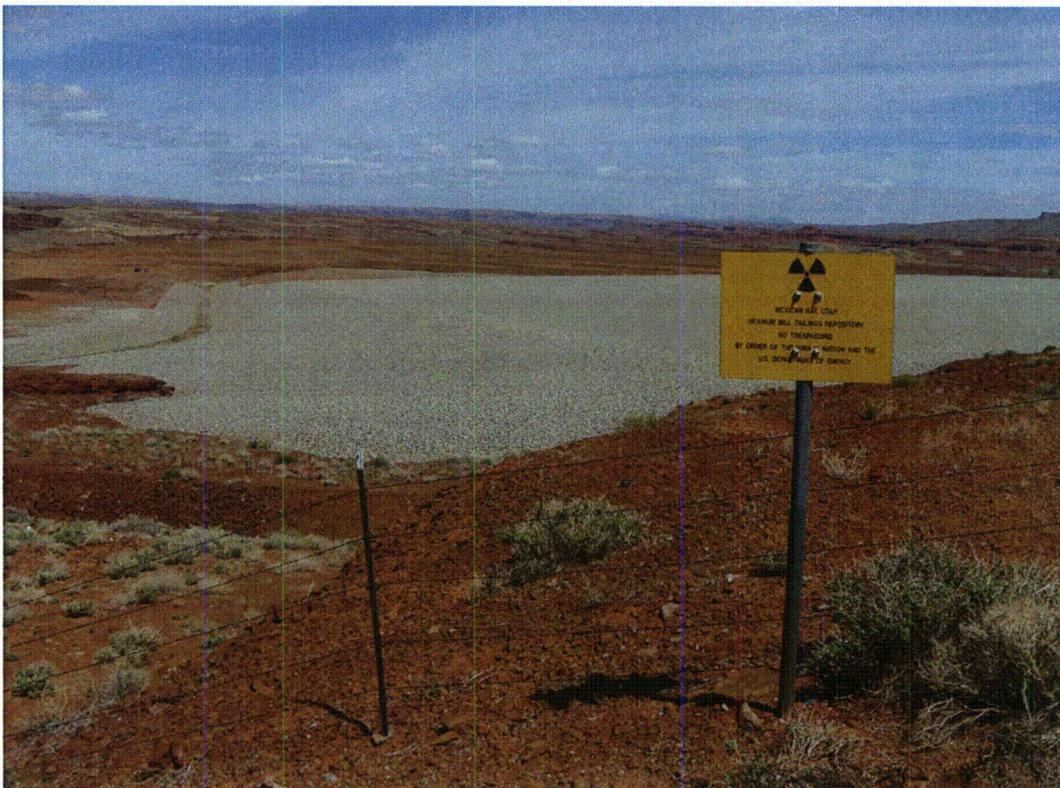
HAT 4/2012. PL-2. Missing radiation warning sign at perimeter sign P31.

- 12A A missing radiological warning sign (P31) and some minor fence repair near perimeter sign P22 will be required in the future. A warning sign should also be placed at seep 0254.

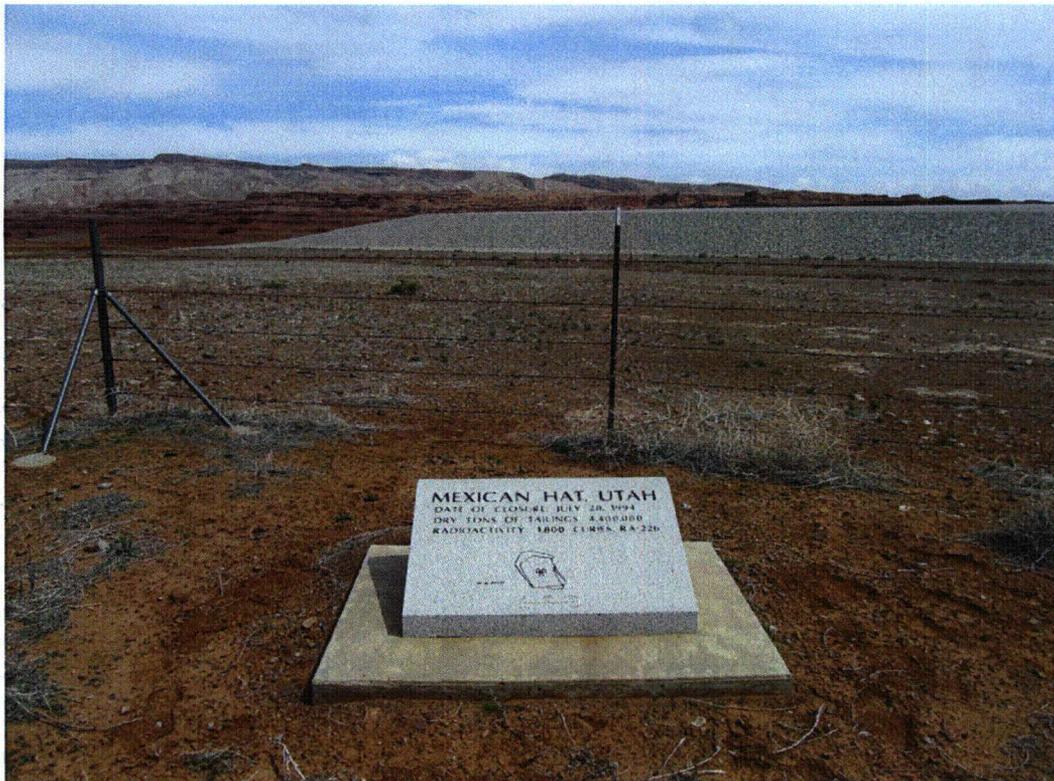
Two granite site markers are on the site. Site marker SMK-1 is on the ground inside the southwest security fence line. Its concrete base has several minor cracks, but there is no need for repairs at this time; overall the site marker was in good condition (PL-3). Site marker SMK-2, located at crest of the disposal cell, was in excellent condition (PL-4).

HAT 4/2012. PL-3. Site Marker 1 (SMK-1).

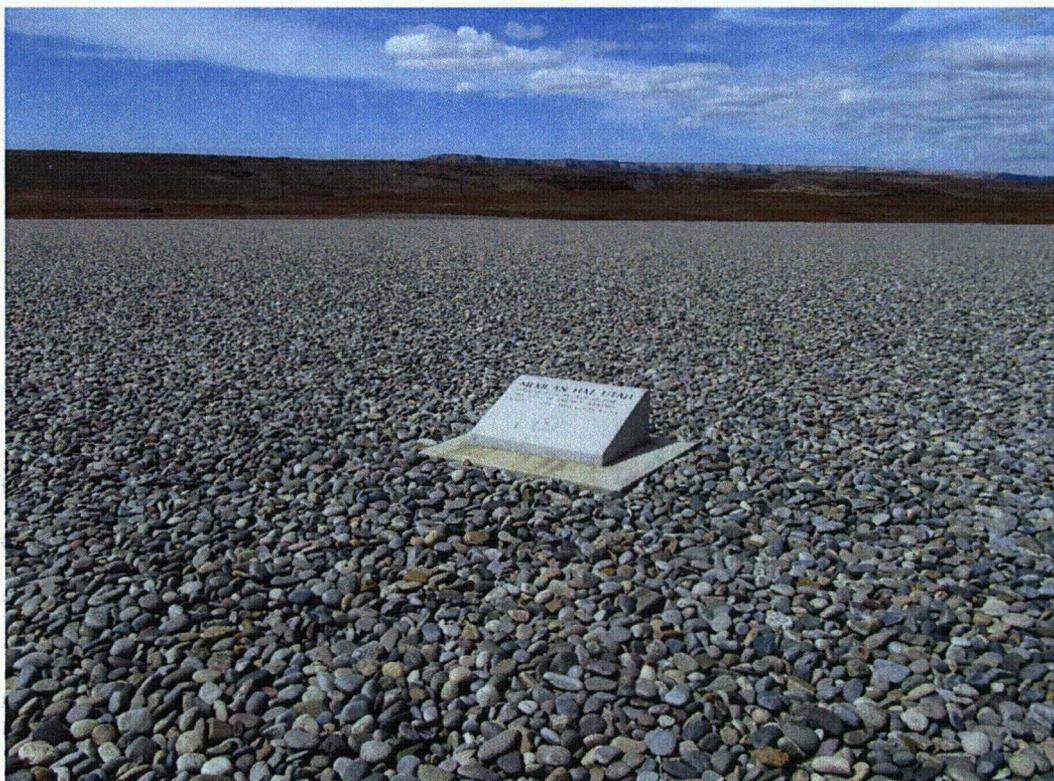
HAT 4/2012. PL-4. Site Marker 2 (SMK-2).

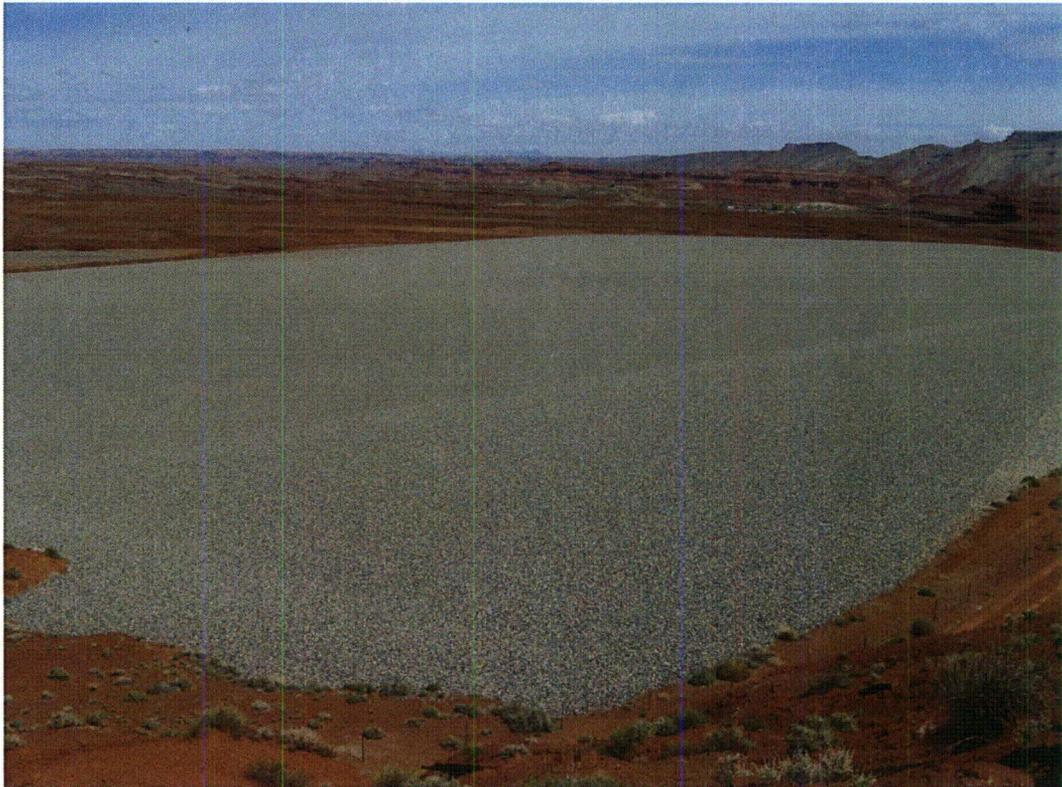
The top of the disposal cell is in excellent condition (PL-5, PL-6, and PL-7). There was no evidence of differential settling, cracking, erosion, or burrowing. All visible components of the disposal cell and cover were functioning as designed. No vegetation was observed to be growing on top of the disposal cell.

HAT 4/2012. PL-5. Central portion of the disposal cell.

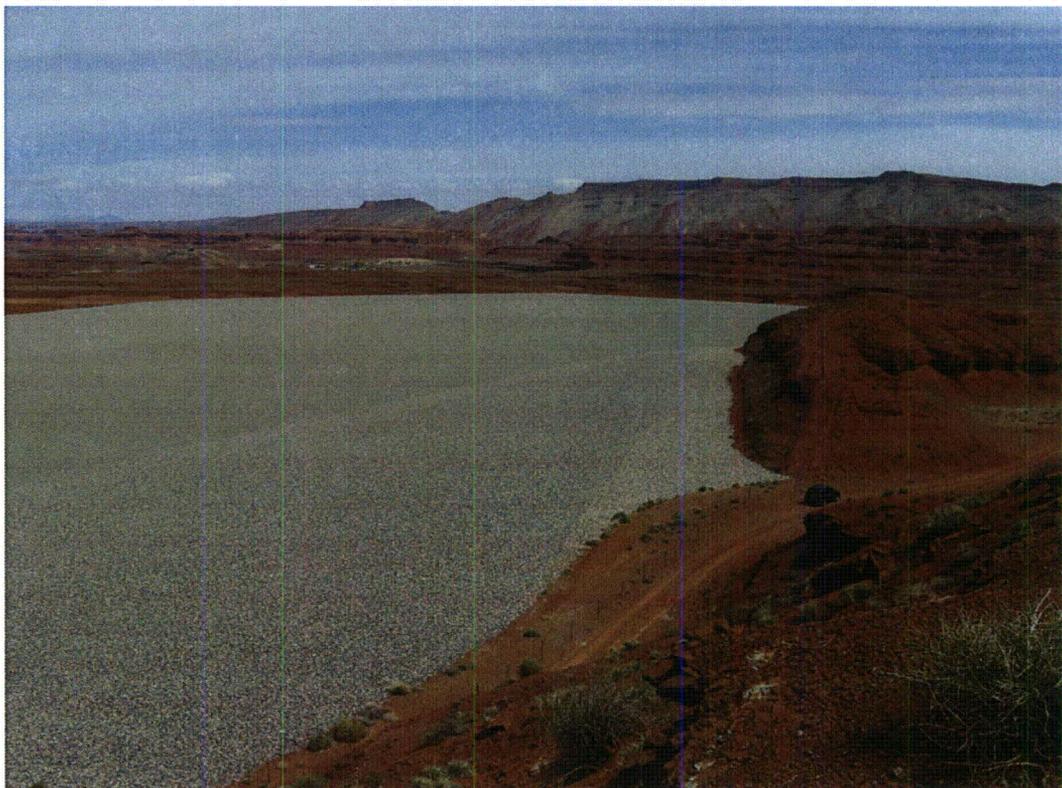
HAT 4/2012. PL-6. Southeast portion of the disposal cell.

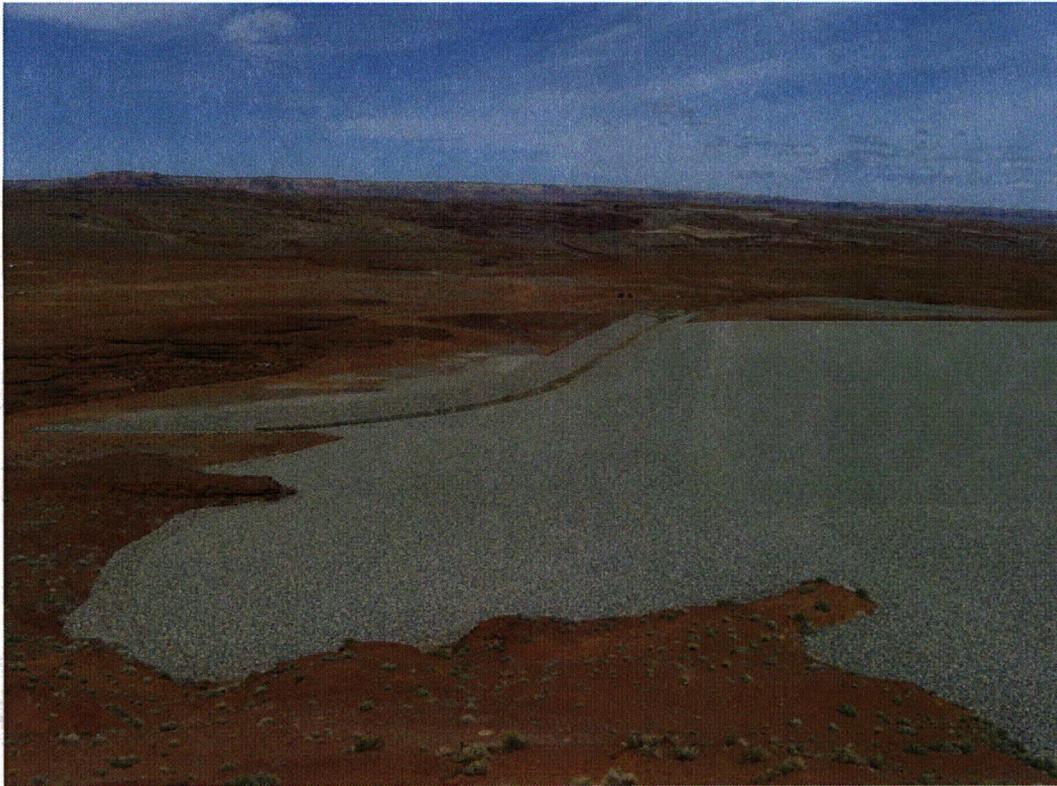
HAT 4/2012. PL-7. West portion of the disposal cell and the west diversion channel.

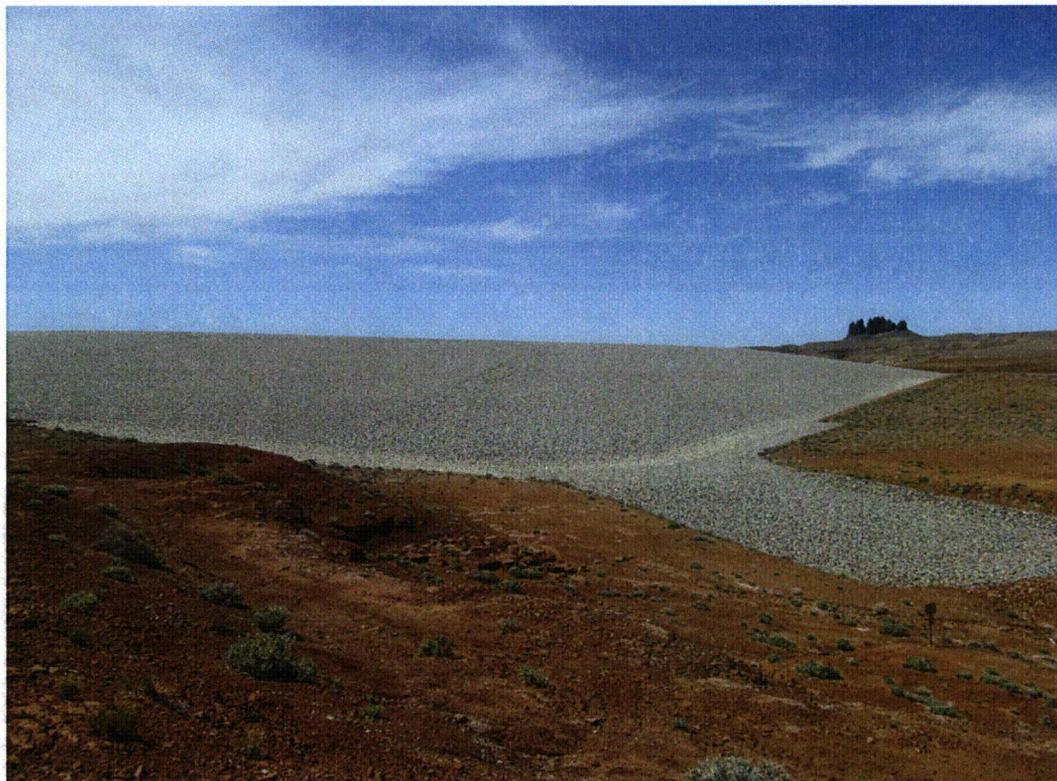
The disposal cell side slopes, toe drains, aprons, and diversion channels were in excellent condition and functioning as designed (PL-8).

HAT 4/2012. PL-8. West view of northeast and east slope.

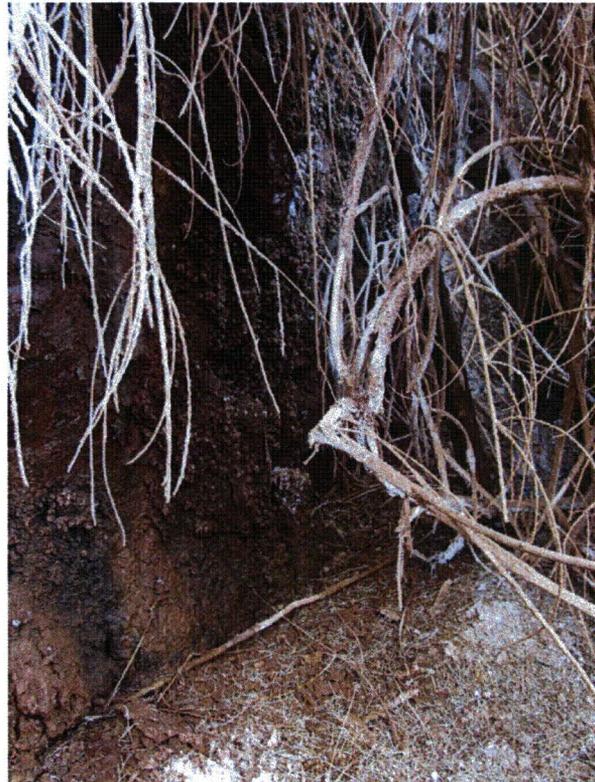
HAT 4/2012. PL-11. Seep 0248 close up of bank (no pooling).

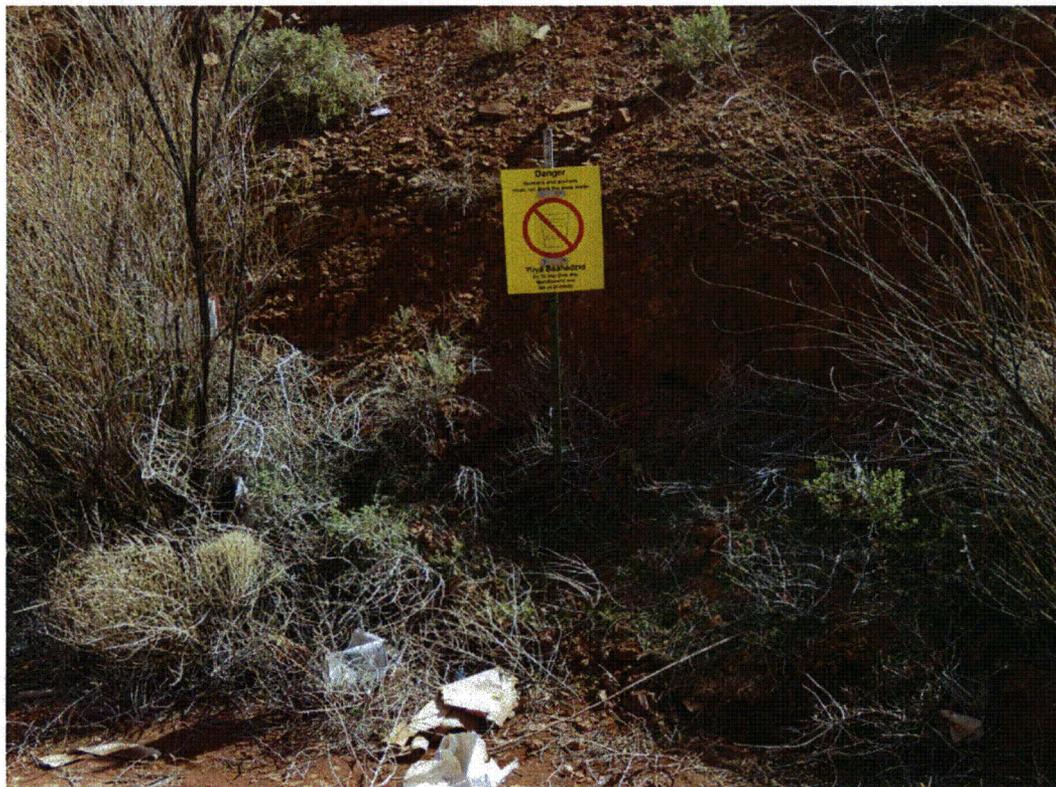
HAT 4/2012. PL-12. Seep 0251 in the North Arroyo (dry).

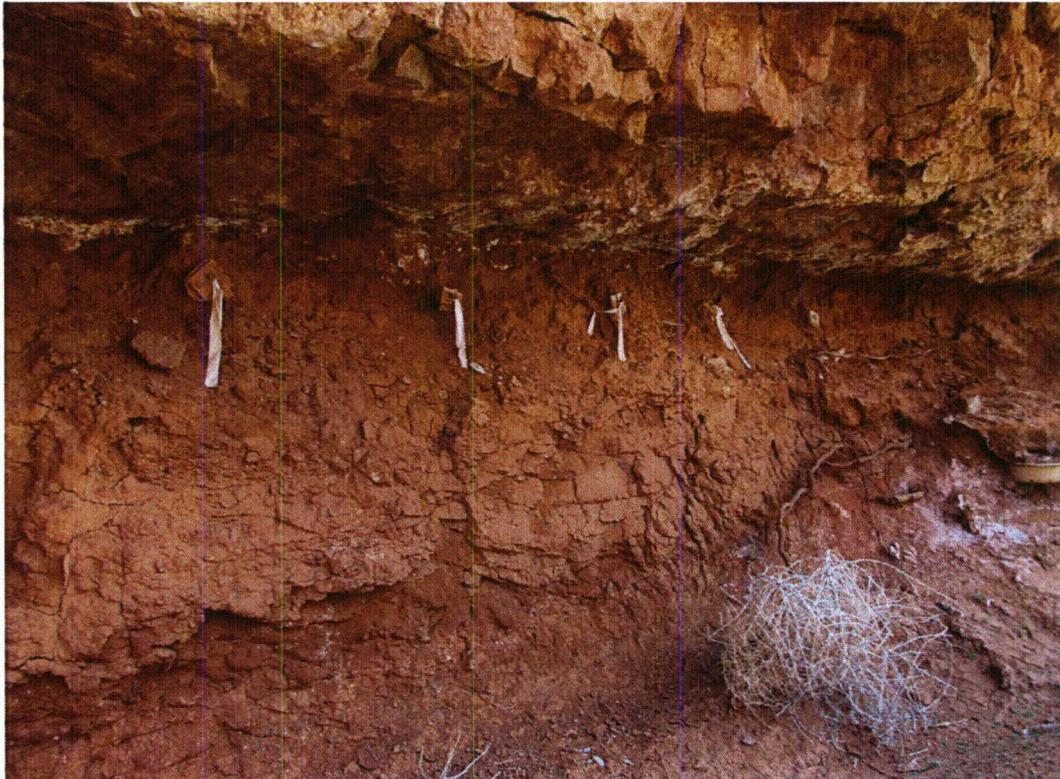
HAT 4/2012. PL-13. Seep 0254.

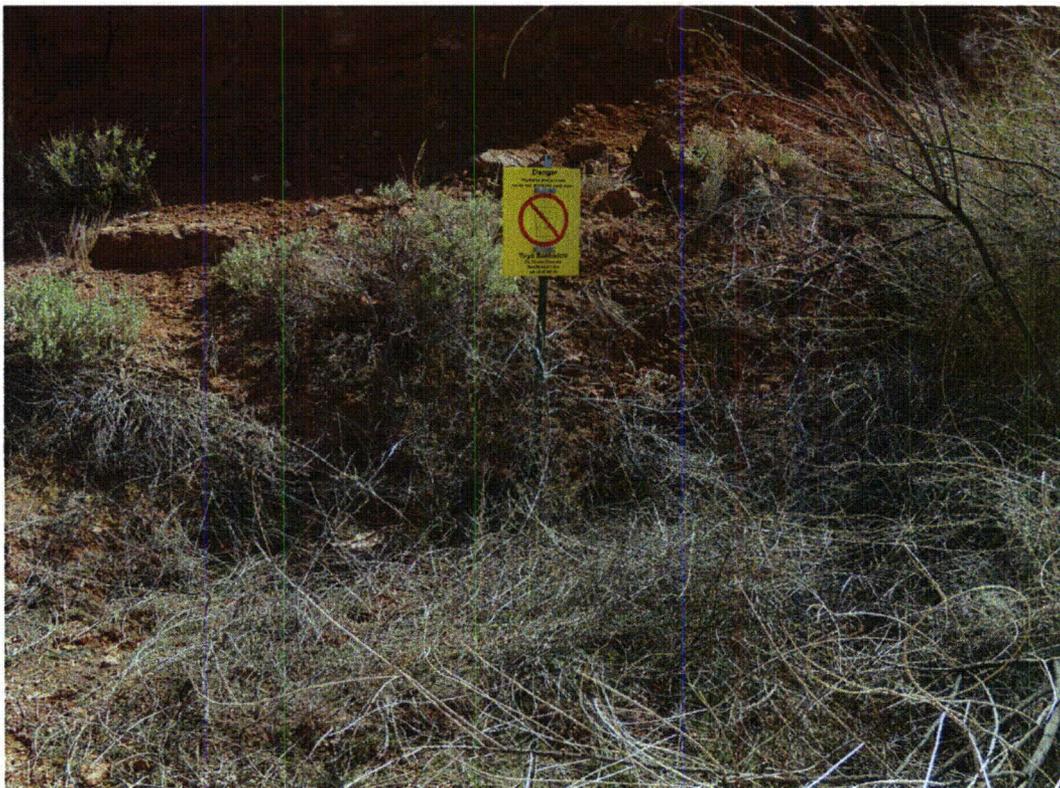
HAT 4/2012. PL-14. Seep 0264 in the North Arroyo (dry).

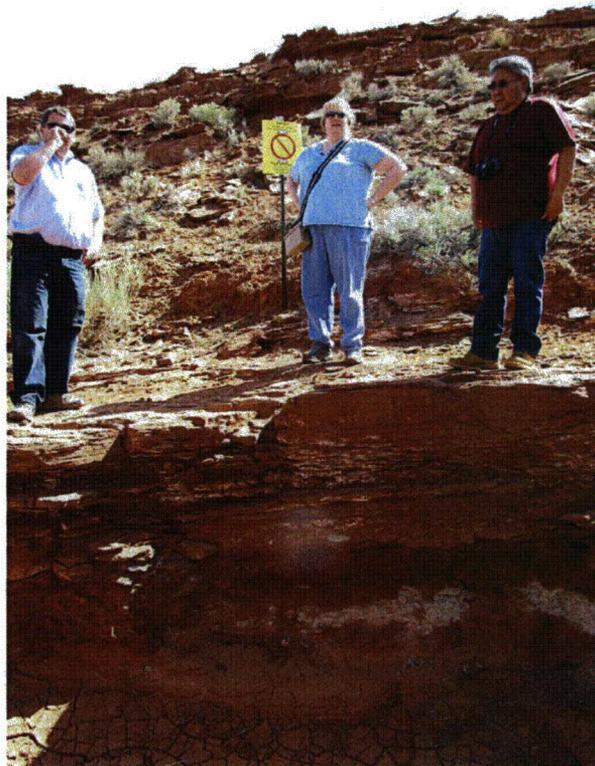
HAT 4/2012. PL-15. Seep 0922.

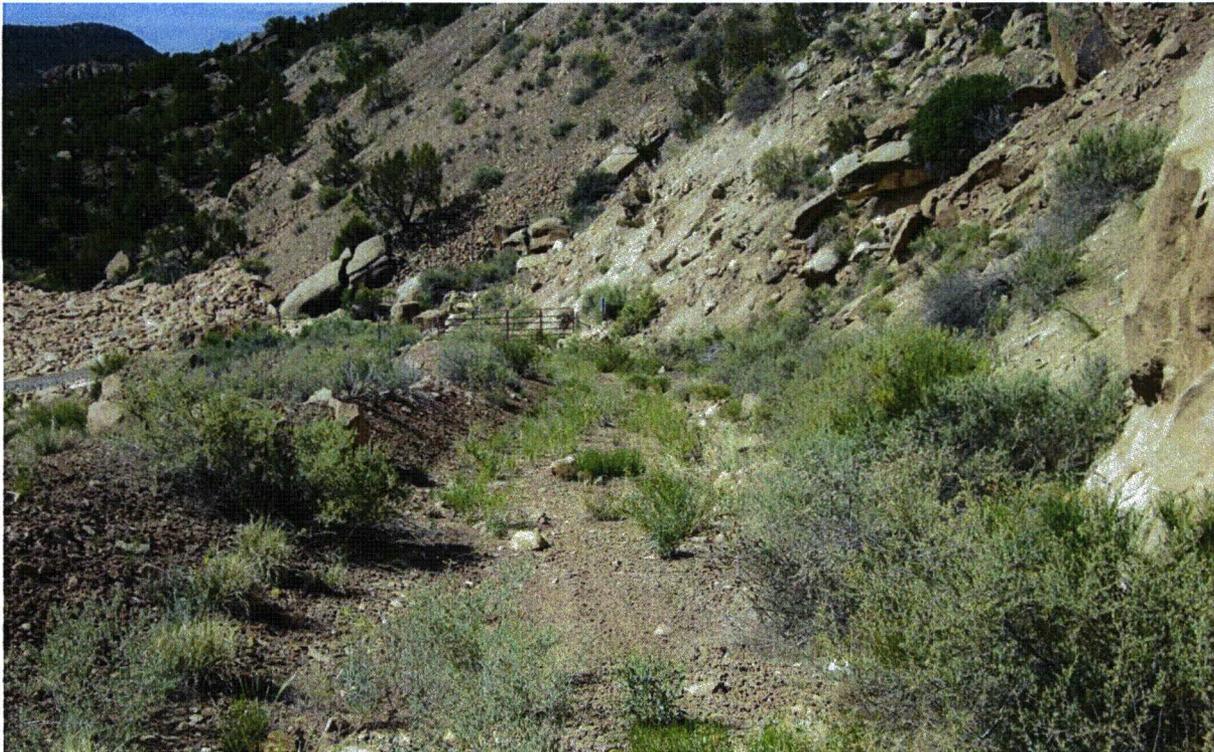
The entrance gate consists of a locked pair of tubular metal gates that hang on galvanized steel gateposts. Two other metal gates allow access to monitoring wells adjacent to the west side of the cell. The gates are in good condition. The disposal cell access road along the northwest side of the site descends through the shale and sandstone units of the Salt Wash Member, Morrison Formation (PL-1).

NAD 5/2012. PL-1. Access road west of cell.

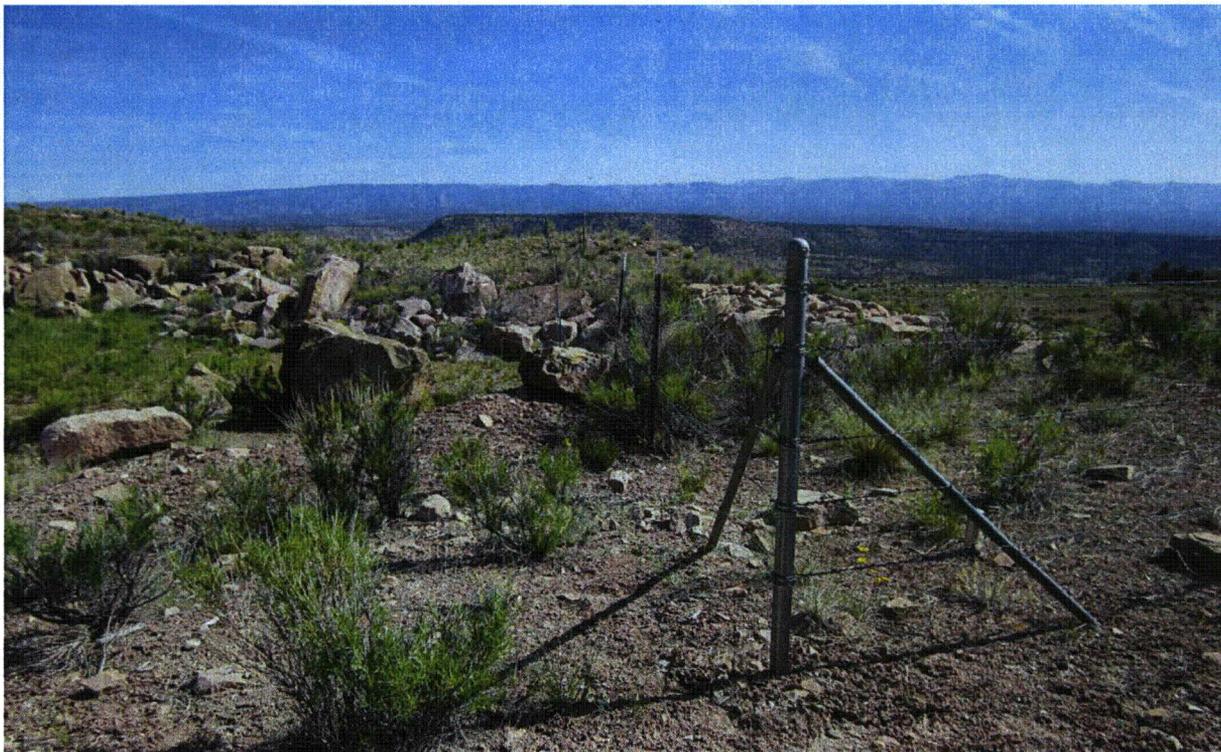
A barbed-wire stock fence encloses the site. The fence is in good condition except for sections with broken and loose strands north of perimeter sign P1 and broken strands near sign P21 (PL-2). Fence wire strands will be repaired or tightened before the next annual inspection. Cattle grazing should be of little concern because forage within the site or in the immediate area is minimal.

NAD 5/2012. PL-2. Broken fence strands near perimeter sign P21.

- 13A Fence strands are broken and loose near perimeter signs P1 and P21. Personnel will repair the strands when they are next in the area.

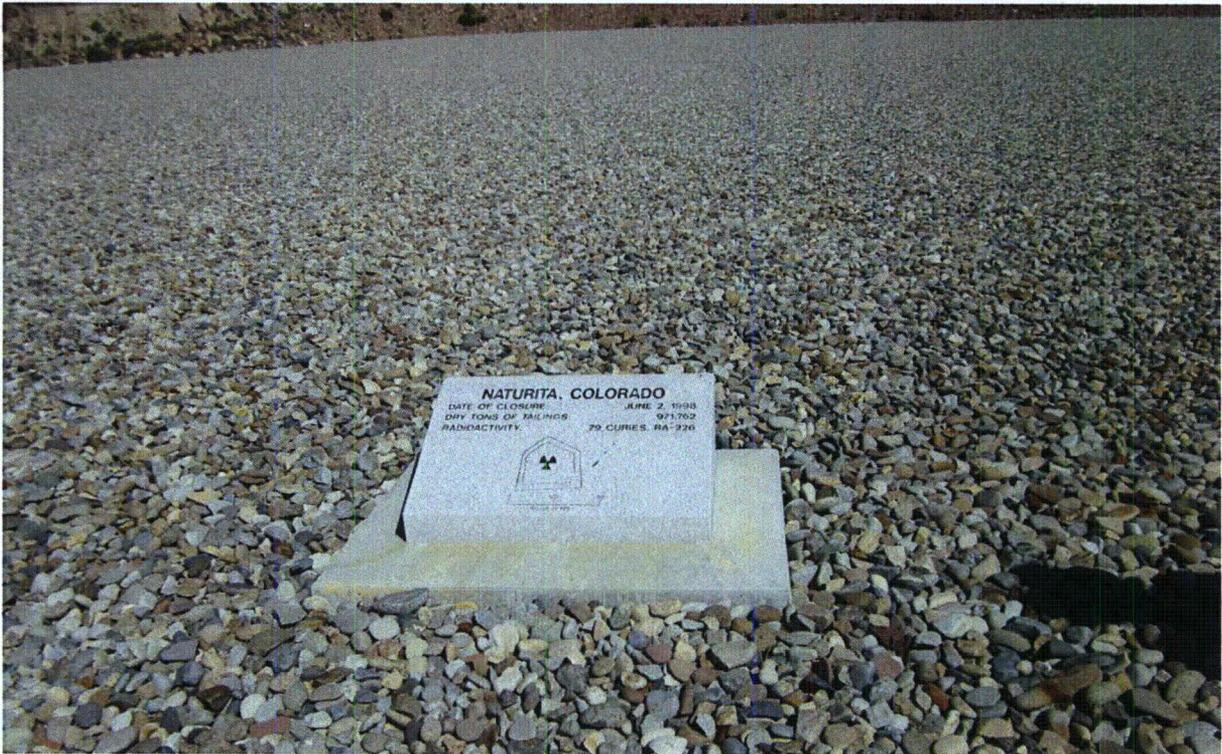
Two granite site markers identify the site. Site marker SMK-1 is set just inside and left of the entrance gate; site marker SMK-2 (PL-3) is located on the disposal cell in the south-central portion of the top slope. Both markers were undisturbed and in good condition; however, SMK-1 has a minor chip off the northeast corner of the concrete pad on which it is placed.

NAD 5/2012. PL-3. Monument on top of cell.

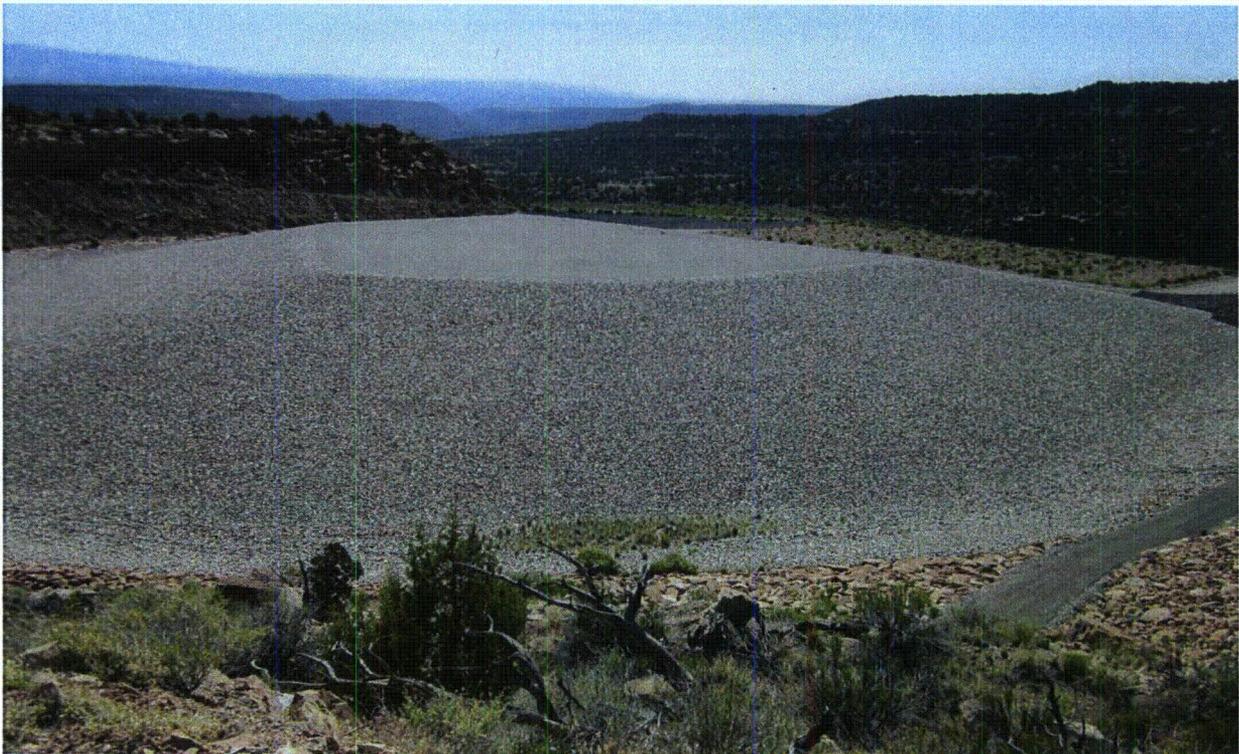
Rock covers the 2-acre top of the disposal cell and the approximate 8 acres of side slopes. The rock is rounded, with larger rock on the side slopes than on the top. The rock-covered surfaces are in excellent condition (PL-4) and show no signs of disturbance except on the southwest side of the top surface. This is an area that had a standpipe removed several years ago, and the slightly irregular surface is the result of this activity. No other degradation or vegetation was evident on the cell.

NAD 5/2012. PL-4. Top of cell from west.

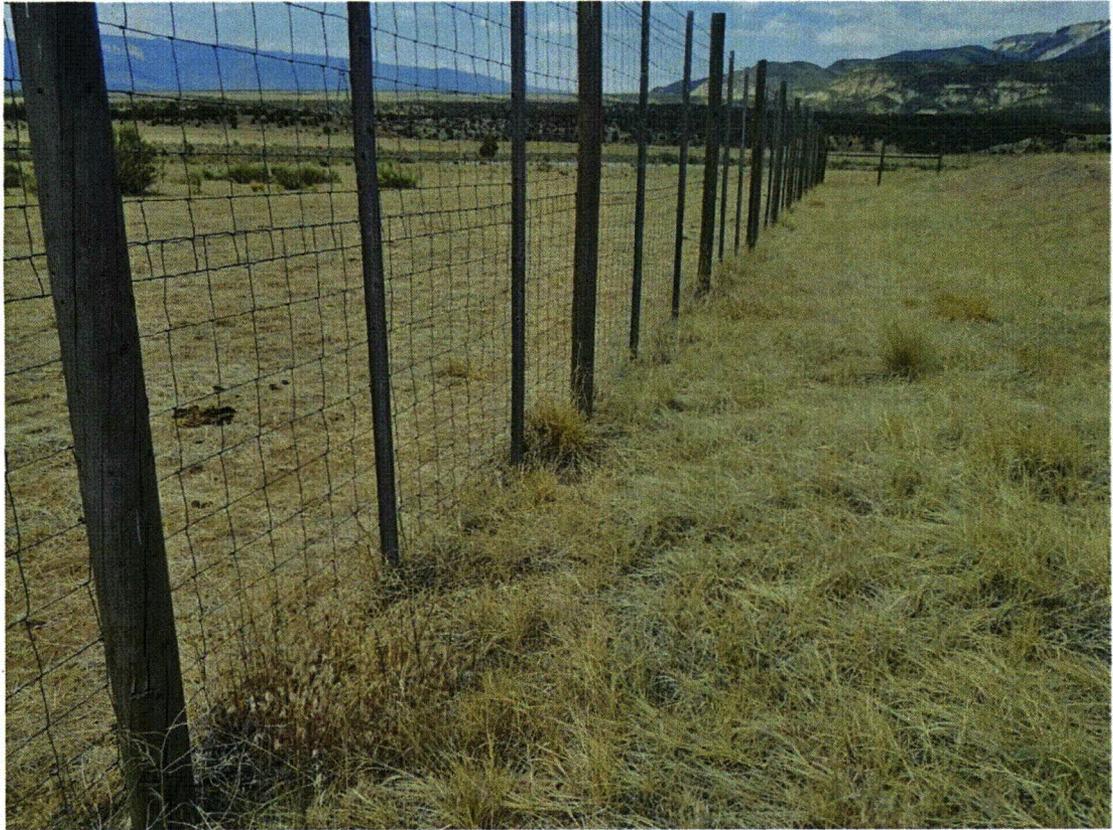
RFL 6/2012. PL-1. Contrast of cattle grazing inside and outside evaporation pond fence.

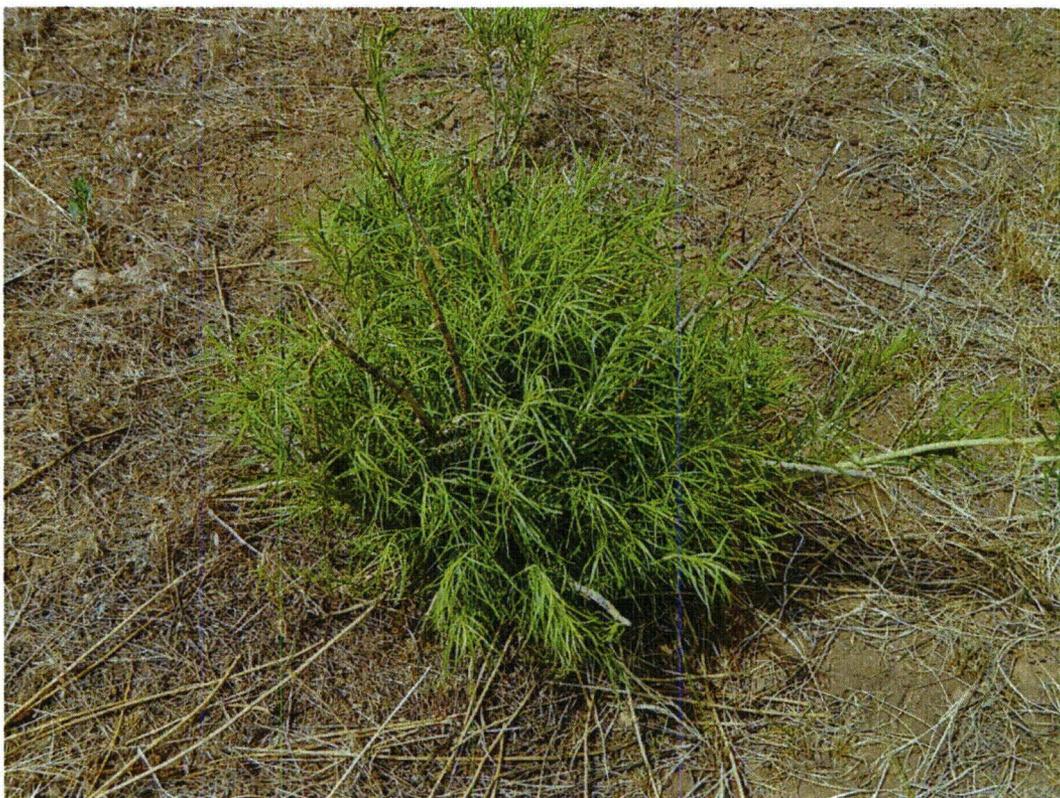
RFL 6/2012. PL-7. Rabbitbrush browsed by cattle.

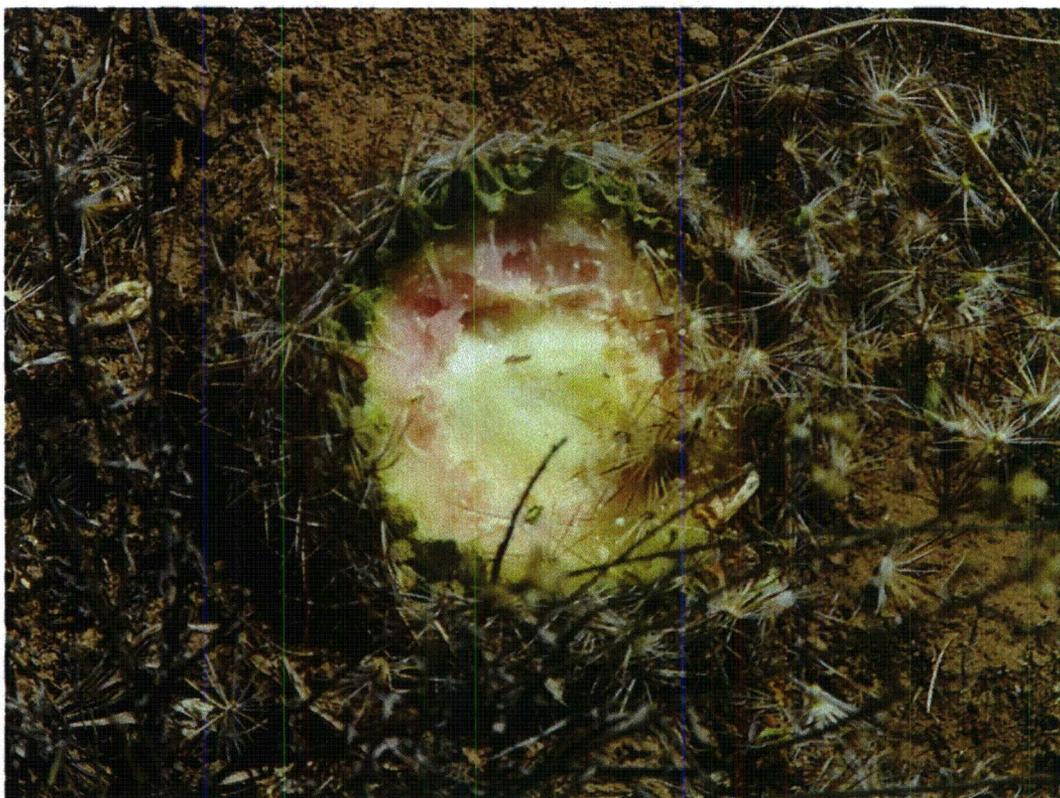
RFL 6/2012. PL-8. Small spiny star cactus browsed by cattle.

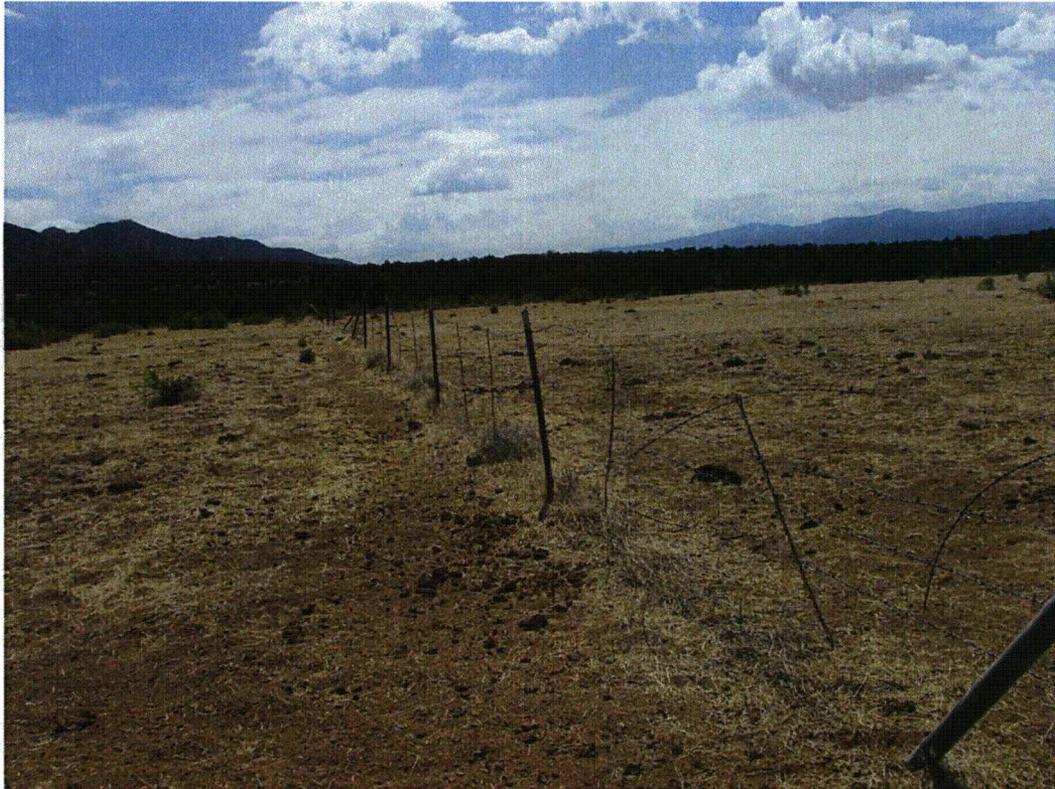
The barbed-wire perimeter fence that limits access to the site was damaged at the time of the inspection. The fence extends to the edge of steep-sided arroyos that bound the site on the east and west and act as a deterrent for easy access to the site. The barbed-wire personnel gate at the southeast corner of the site was open, a section of perimeter fence had been cut and folded back between perimeter signs P0 and P1, and some bent fence posts and broken or loose wires were found in many places along the fence. Cattle had heavily grazed inside the site boundary and around the perimeter of the cell. A comparison between vegetation inside the fence enclosing the evaporation pond (where no grazing had been done) and outside the fence shows the extent of grazing (PL–1). Other signs of deer and elk grazing in the revegetated areas adjacent to and inside the disposal cell site boundary were identified. Such grazing has occurred historically.

RFL 6/2012. PL-9. Section of damaged perimeter fence near perimeter sign P10.

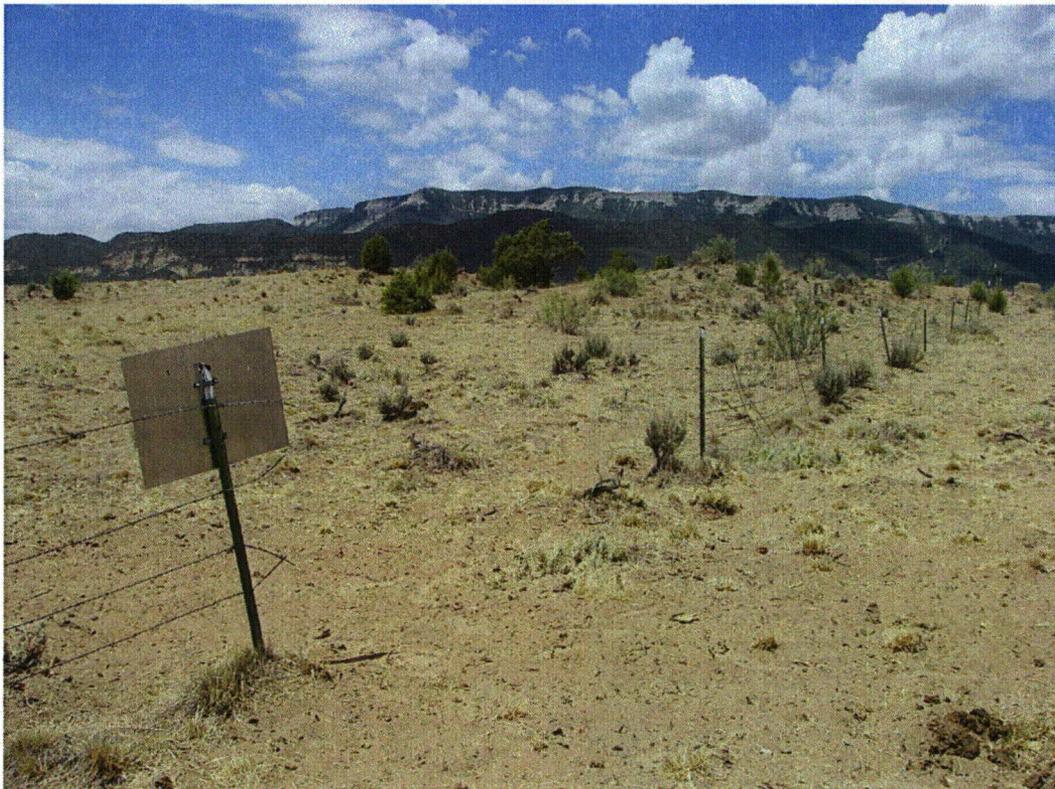
RFL 6/2012. PL-10. Fence cut and folded back near perimeter sign P1.

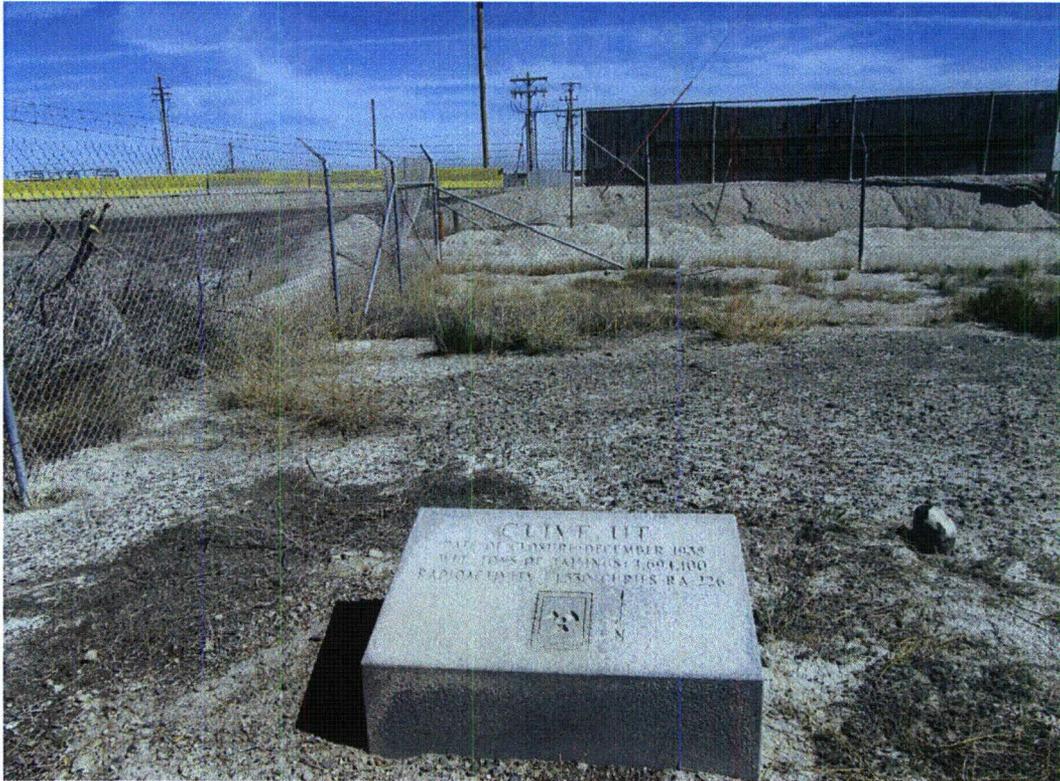
SLD 5/2012. PL-1. Site marker SMK-1's pitted surface.

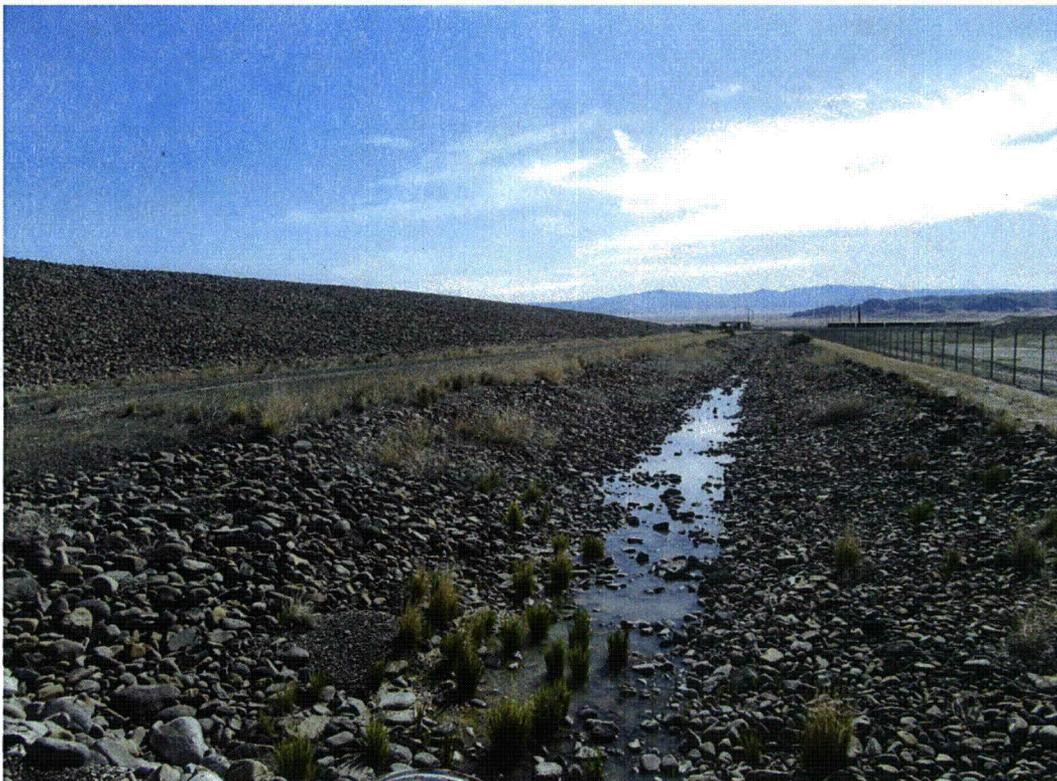
SLD 5/2012. PL-16. Standing water in drain south side of perimeter road.
