16.0 Annual Inspection of the Shiprock, New Mexico, UMTRCA Title I Disposal Site

17.0 Annual Inspection of the Slick Rock, Colorado, UMTRCA Title I Disposal Site

18.0 Annual Inspection of the Spook, Wyoming, UMTRCA Title I Disposal Site

19.0 Annual Inspection of the Tuba City, Arizona, UMTRCA Title I Disposal Site

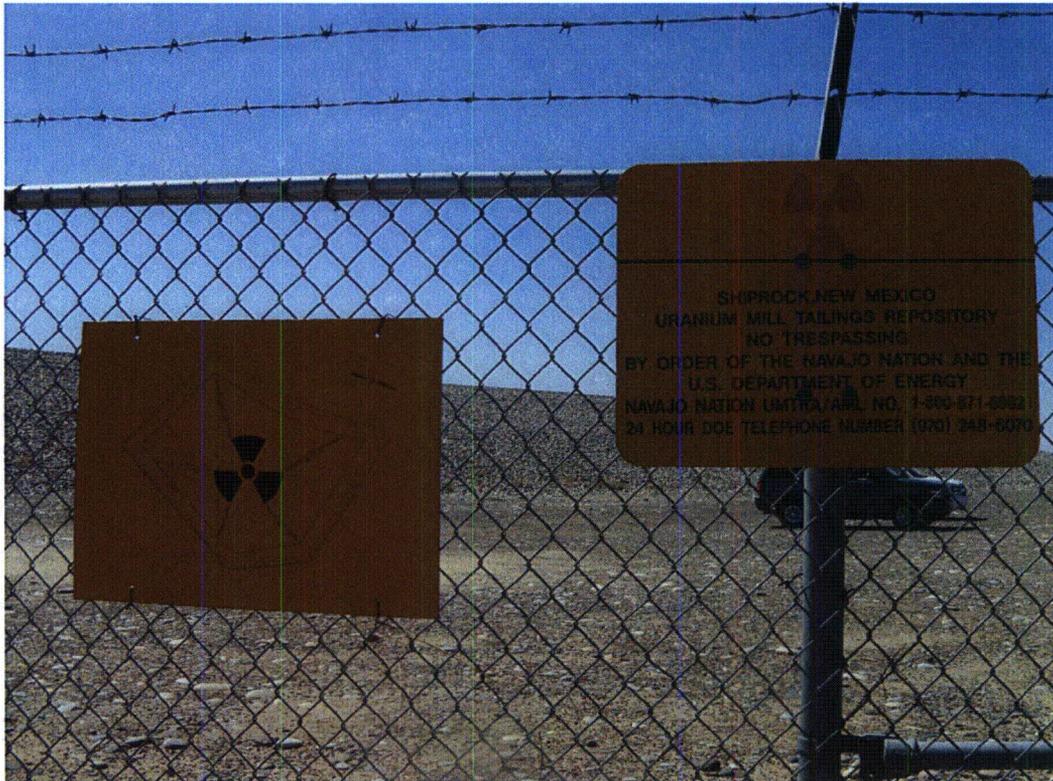
SHP 5/2012. PL-1. New entrance sign at east gate.

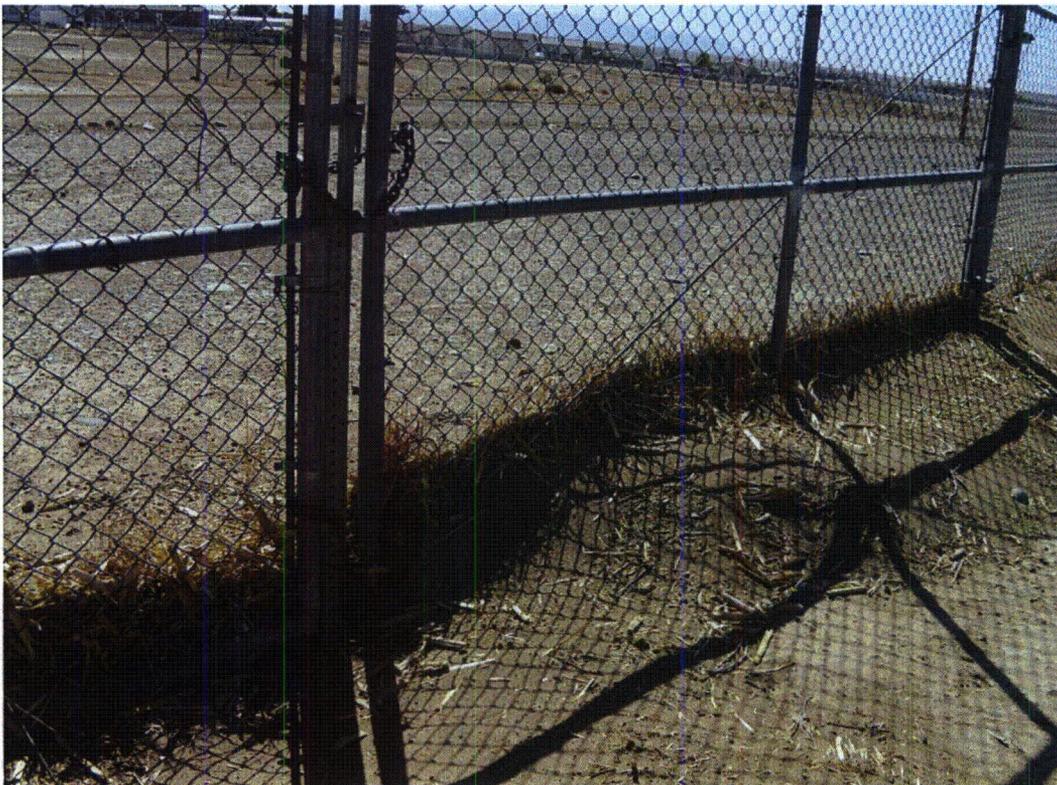
All three of the site's entrance gates remained intact. All perimeter signs were present, legible, and in good condition. One pictorial entrance sign was missing from the northwest gate. Sediment had accumulated under the southwest gate. The perimeter fence, although damaged in places, was intact and functional. Inspectors placed rocks in all significant gaps that formed under the perimeter fence. Boundary monuments BM-2 through BM-6 were not found during the annual inspection; a survey team found and reestablished the missing boundary monuments after the inspection. One erosion control marker was previously damaged by a vehicle but remained functional.

SHP 5/2011. PL-2. Sediment buildup along southwest gate.

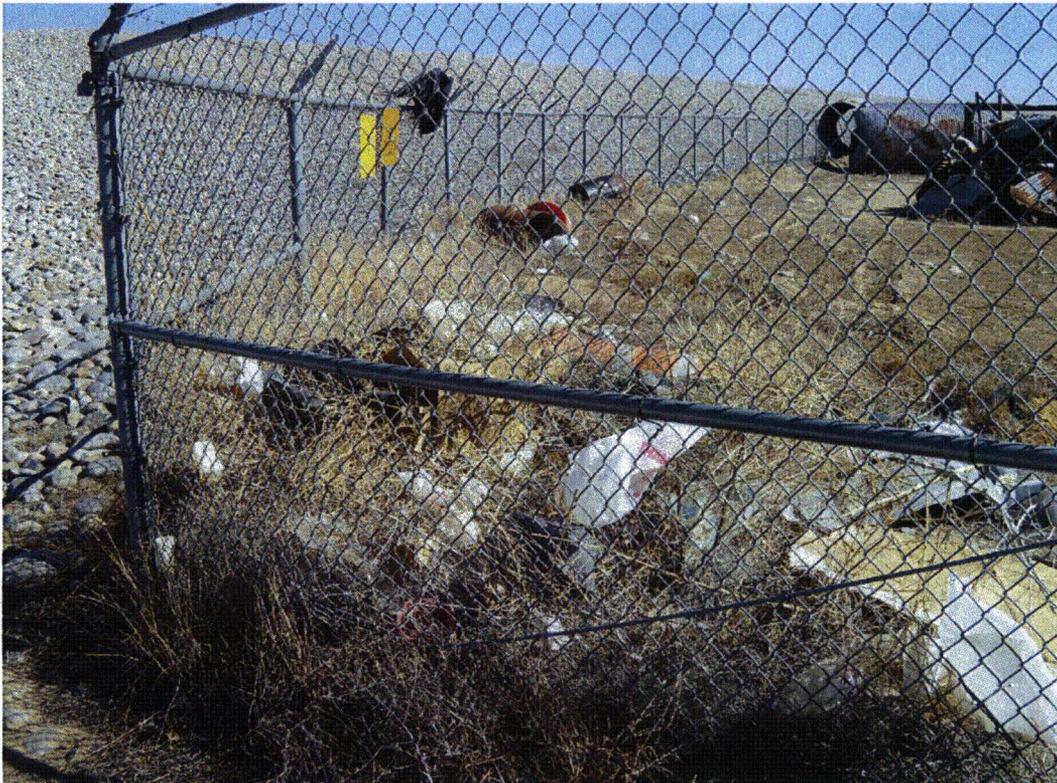
Trash and tumbleweeds have accumulated in many places along the perimeter fence (PL-3 and PL-4), including a section of fence across the outflow channel. These accumulations potentially represent a fire hazard and increase the possibility of damage to the fence, particularly during high winds. To improve the safety and appearance of the site the tumble weeds and trash have been removed.

SHP 5/2012. PL-3. Trash and tumbleweed buildup in fence corner by perimeter sign P14.

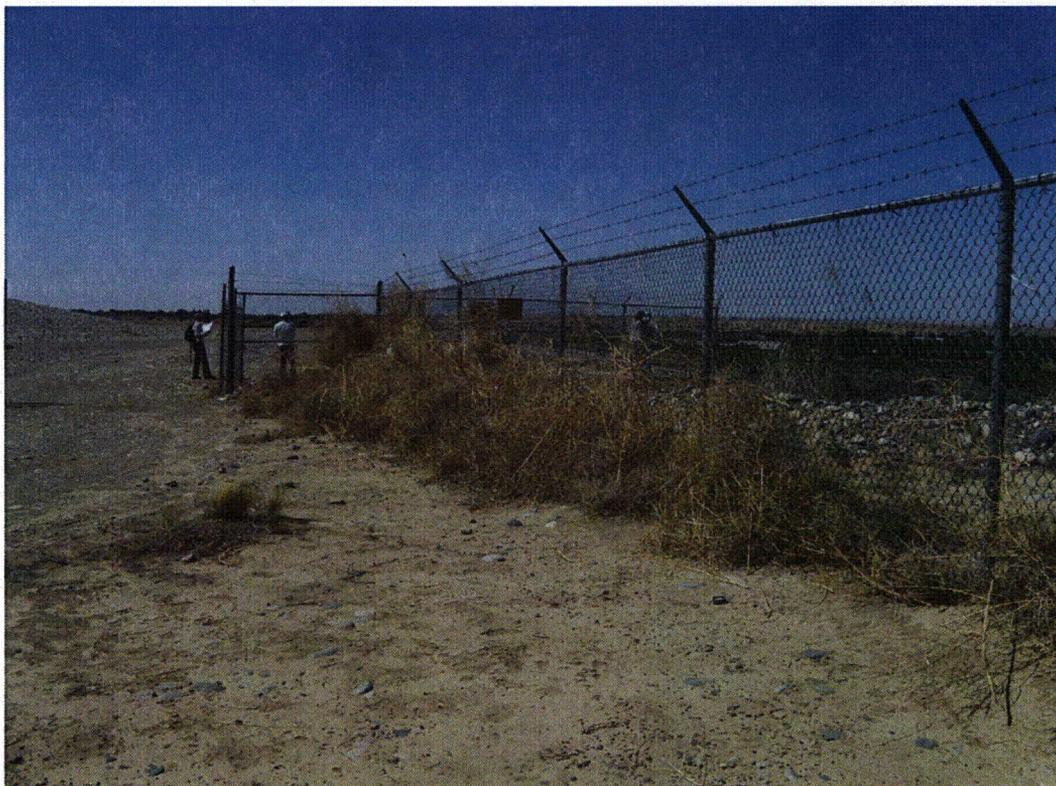
SHP 5/2012. PL-4. Tumbleweed buildup near the east gate.

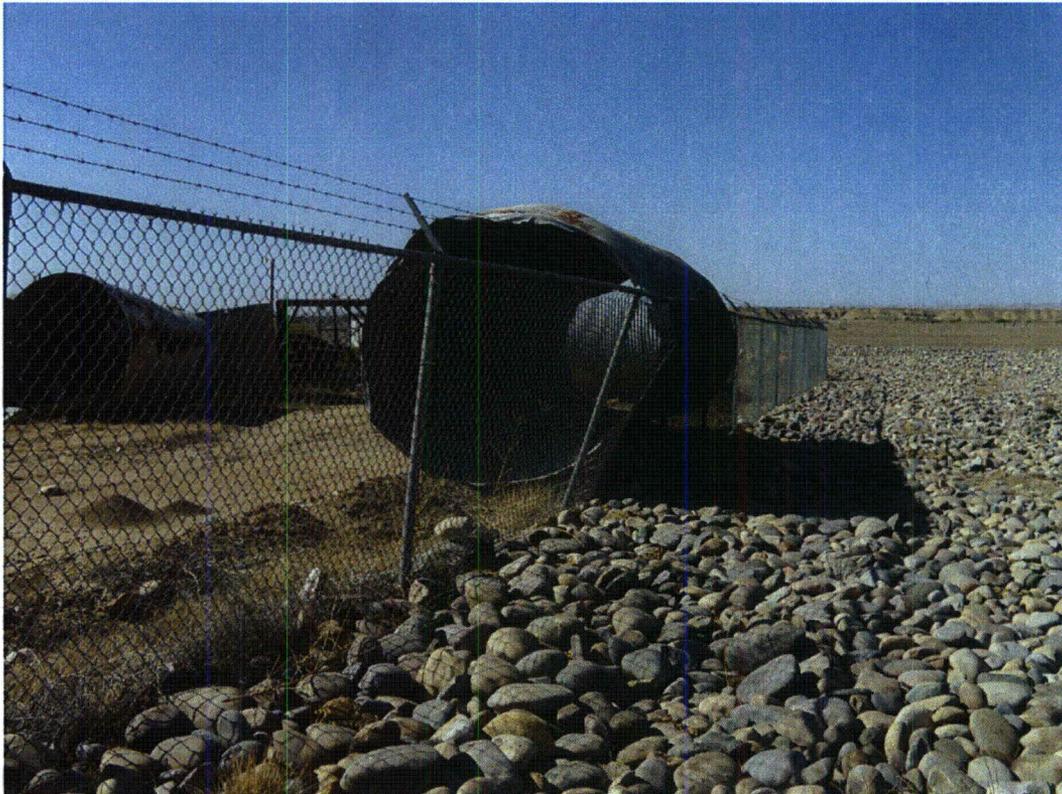
As observed in previous years, the perimeter fence was intact and functional but damaged in a number of areas. Damaged fence sections reported in previous years include bent posts and bent fence fabric between perimeter signs P11 and P12, dirt mounded against the fence near P13, bent posts near P14, a broken fence riser near P15, and fence risers separated from posts between P15 and P16. New damage consists of a section of bent fence near P13; damage resulted from a large culvert placed in the adjoining NECA yard (PL-5). Damaged areas will continue to be monitored.

SHP 5/2012. PL-5. Bent fence (still intact) from large culvert in NECA yard near perimeter sign P13.

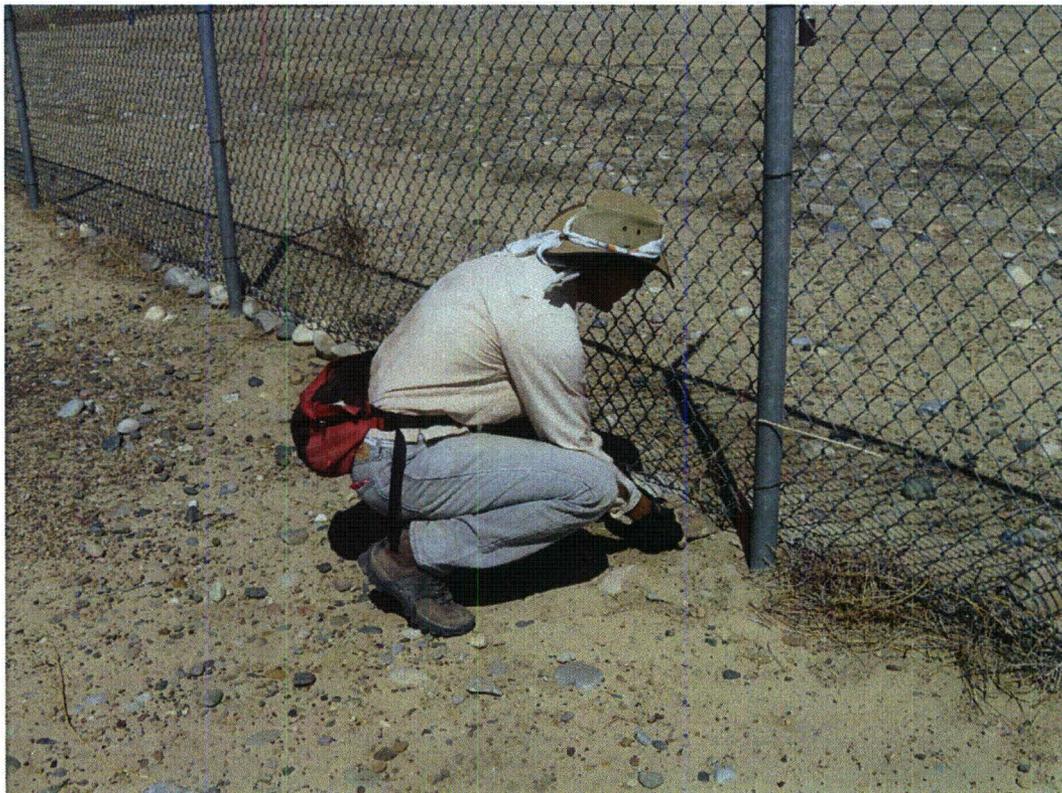
SHP 5/2012. PL-6. Placing rocks in hole under perimeter fence.

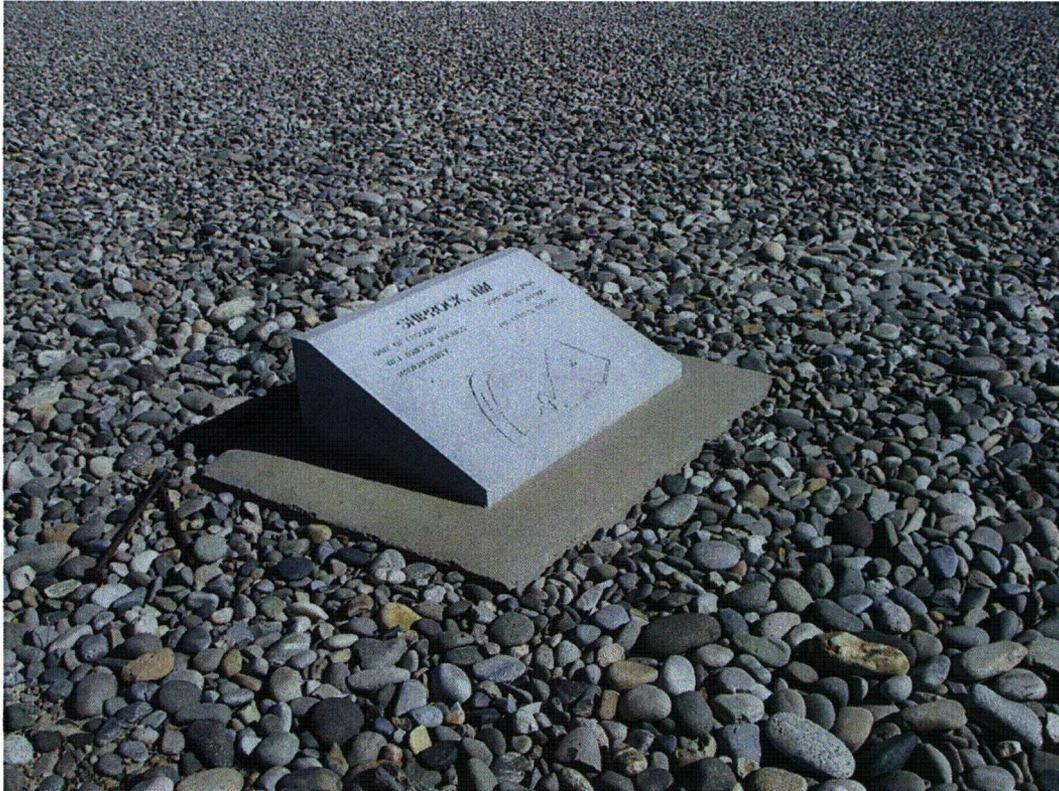
Site marker SMK-1, located just inside the southwest gate, and site marker SMK-2, located on top of the disposal cell (PL-7), were both in good condition. Minor cracks in the concrete base of SMK-1 were sealed in May 2003 and have not changed.

SHP 5/2012. PL-7. Site marker SMK-2.

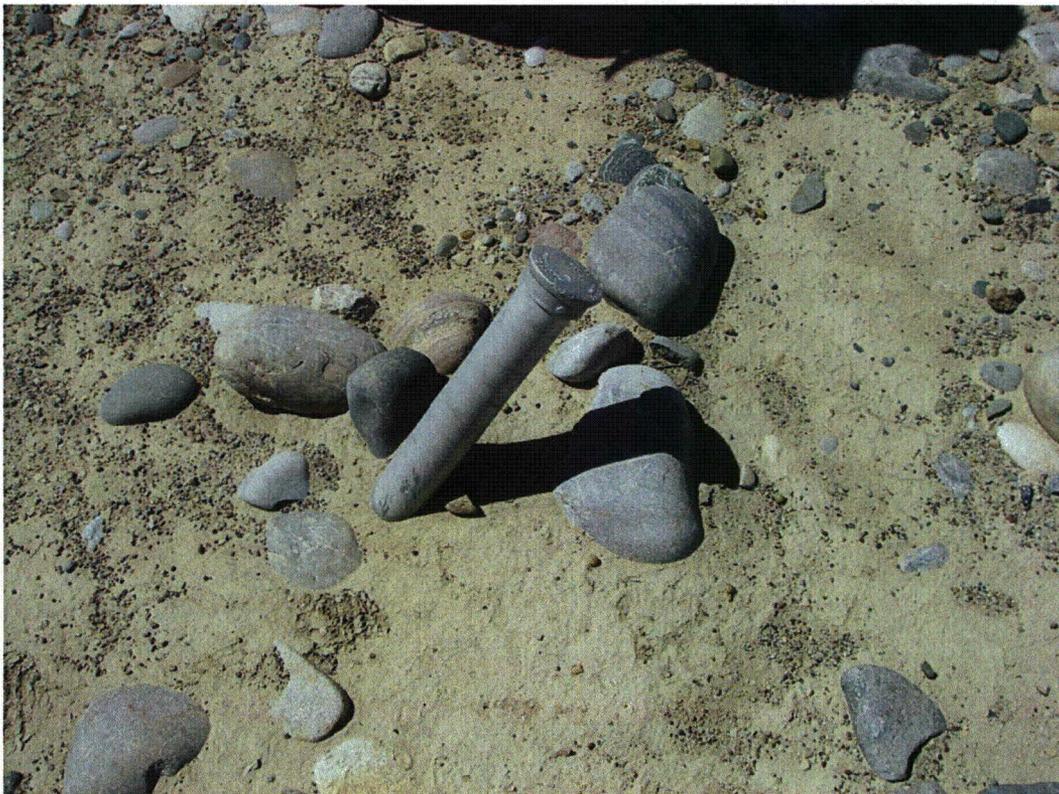
The four pairs of erosion control markers along the edge of the terrace escarpment were in good condition except for the marker near the east entrance gate. This marker was previously damaged by a vehicle (PL-8), but it is still functional and does not require repair at this time.

SHP 5/2012. PL-8. Erosion control marker damaged but functional.

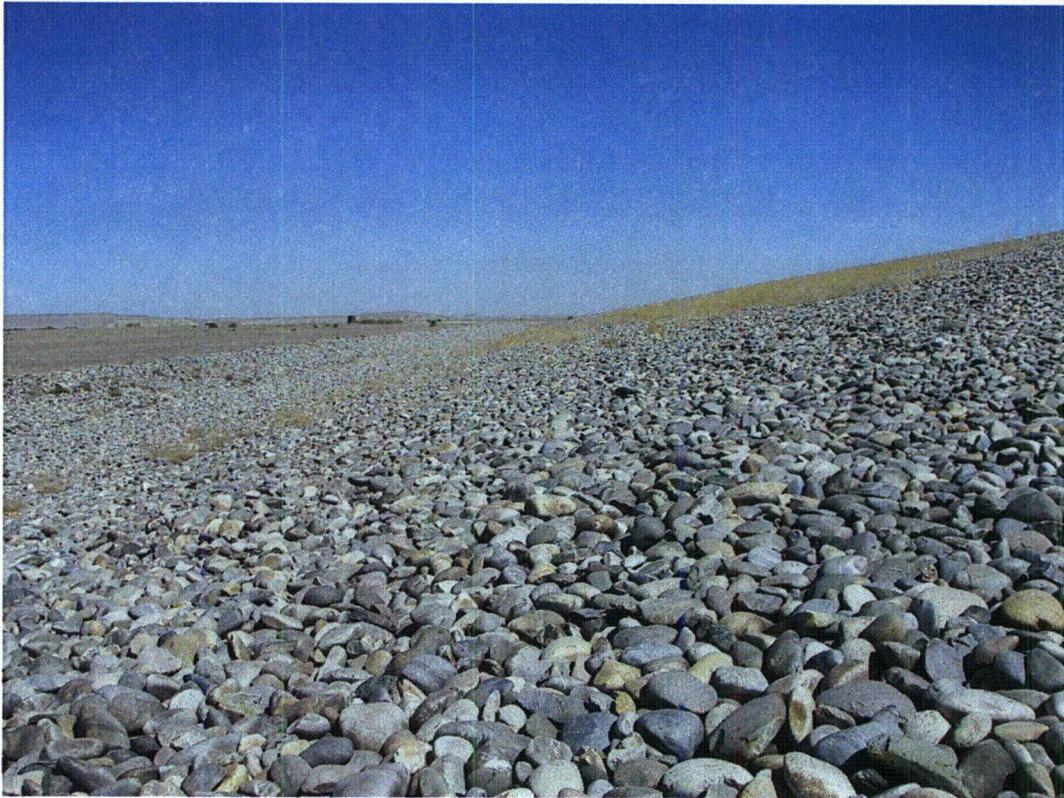
The riprap-covered top and side slopes of the cell were in good condition. No evidence of settling, slumping, erosion, animal intrusion, riprap deterioration, or other disturbance was found (PL-9). Five open research pits, described in previous annual inspection reports, were present on the cell top (PL-10). These research pits, installed in 2005 were filled in after the 2012 inspection. In 2002, Piezocones installed on the cell cover were removed and the associated pits filled in. Since that time, several of these pits have subsided slightly, forming conical depressions in the cover (PL-11). The surface of the cell was also covered with vehicle ruts (PL-12), many of which were formed in 2008 during herbicide treatment. The condition of the depressions and vehicle ruts is monitored annually and had not changed significantly since the 2011 inspection.

SHP 5/2012. PL-9. Side slope of disposal cell, view east.

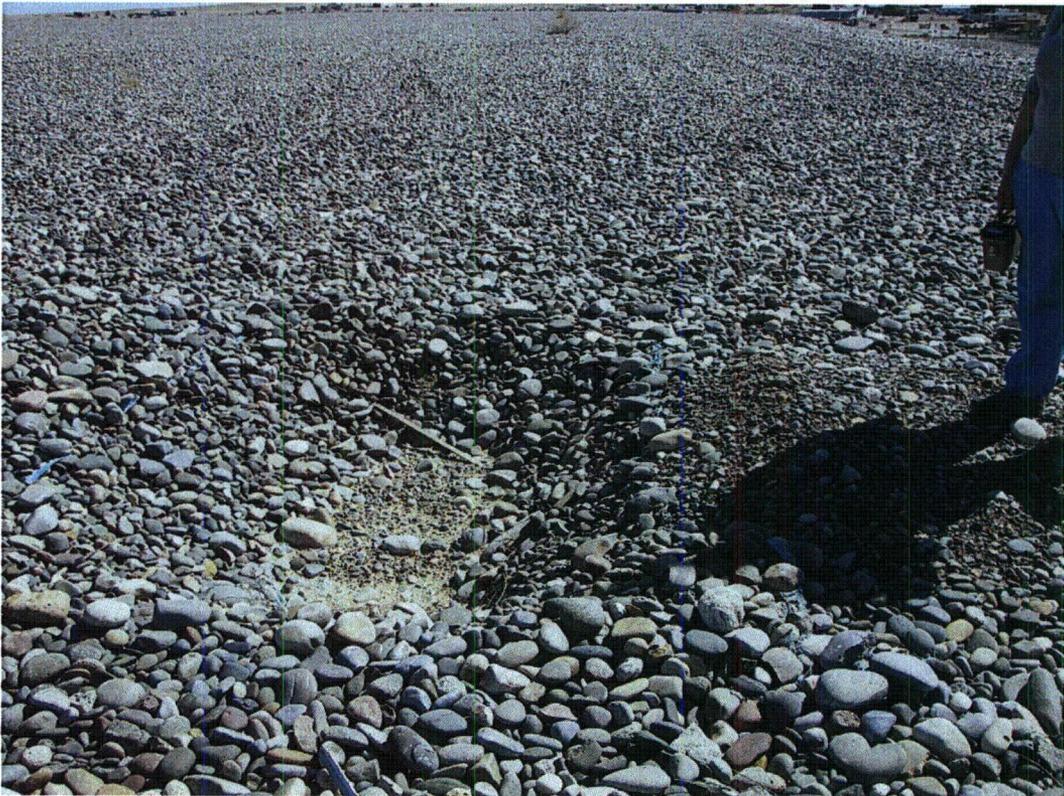
SHP 5/2012. PL-10. Open test pit on western portion of cell.

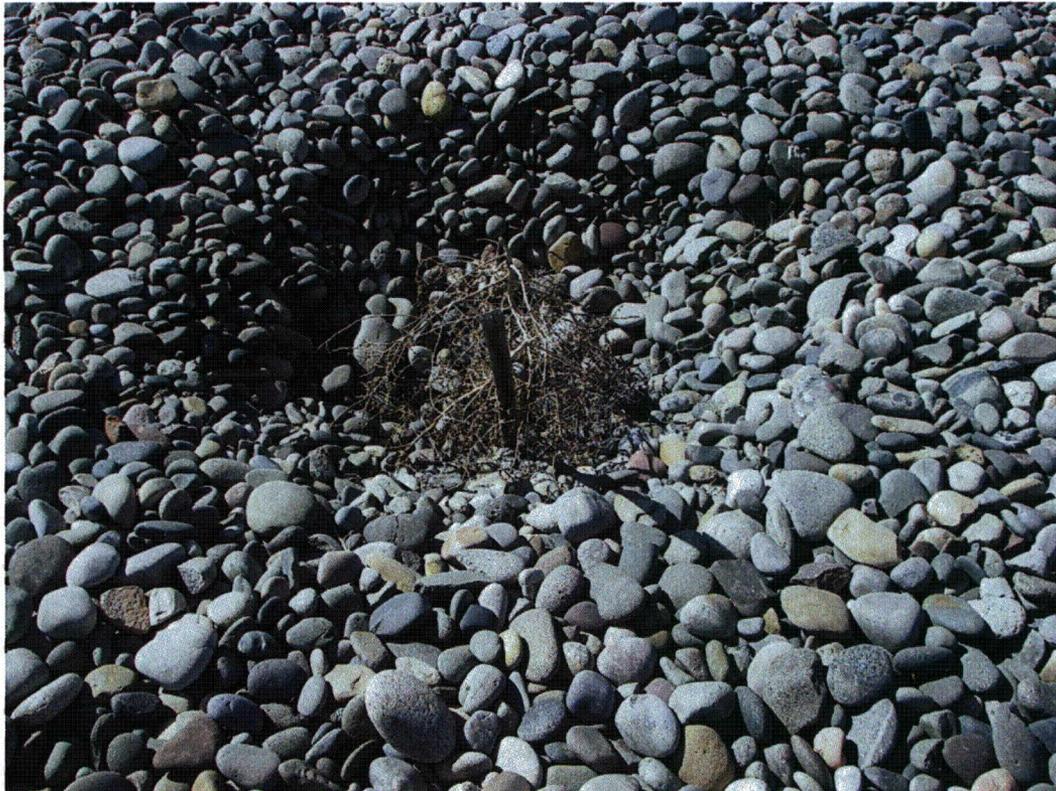
SHP 5/2012. PL-11. Historical test pit on eastern edge of cell.

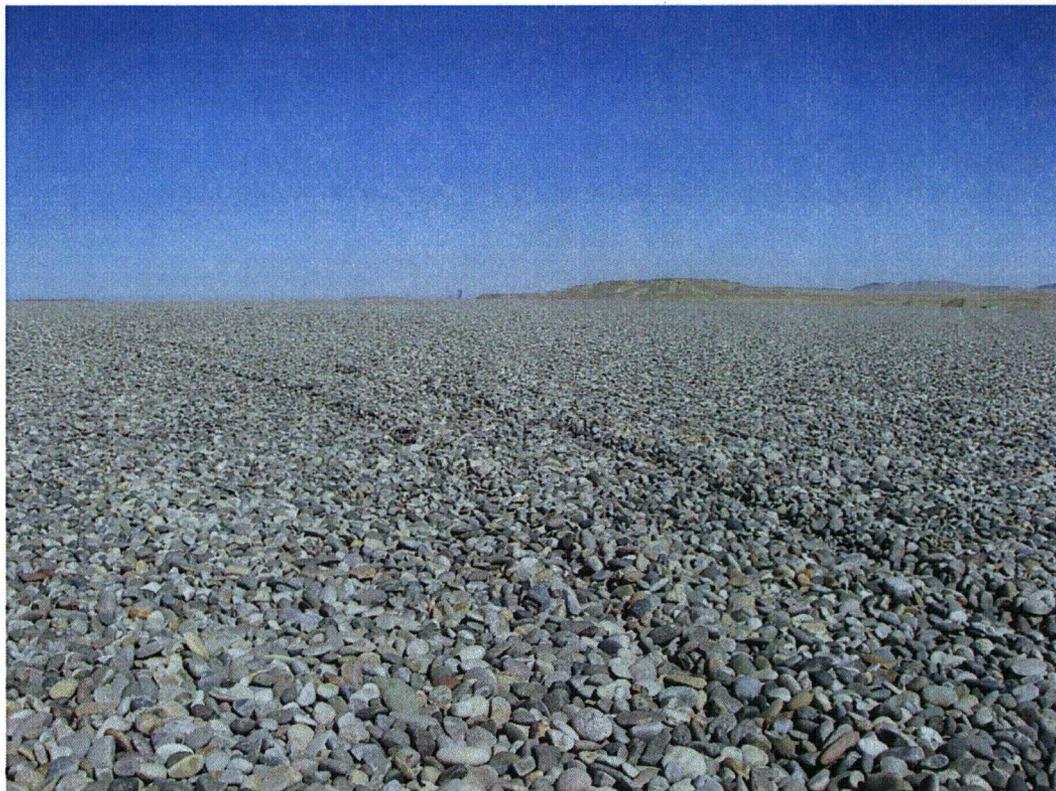
SHP 5/2012. PL-12. Vehicle tracks visible on disposal cell cover, southwest portion of cell.

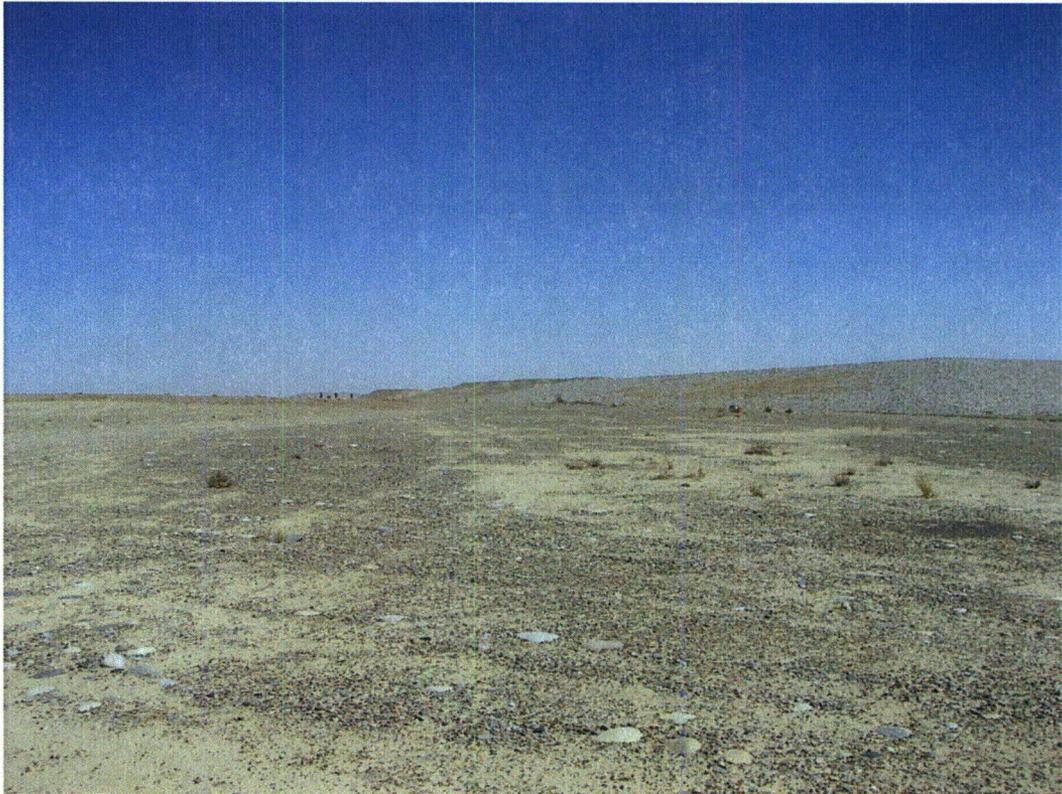
The terrace area is located north and northeast of the disposal cell along the top of a steep escarpment. Very little vegetation grows on the terrace (PL-13). The escarpment, approximately 300 feet from the eastern edge of the disposal cell, is prone to slumping. Fractures and incipient slumps can occur in the Mancos Shale bedrock along the escarpment northwest of erosion control marker 1A. No new erosion was evident in 2012 (PL-14).

SHP 5/2012. PL-13. View of terrace from the northern phytoremediation test plot.

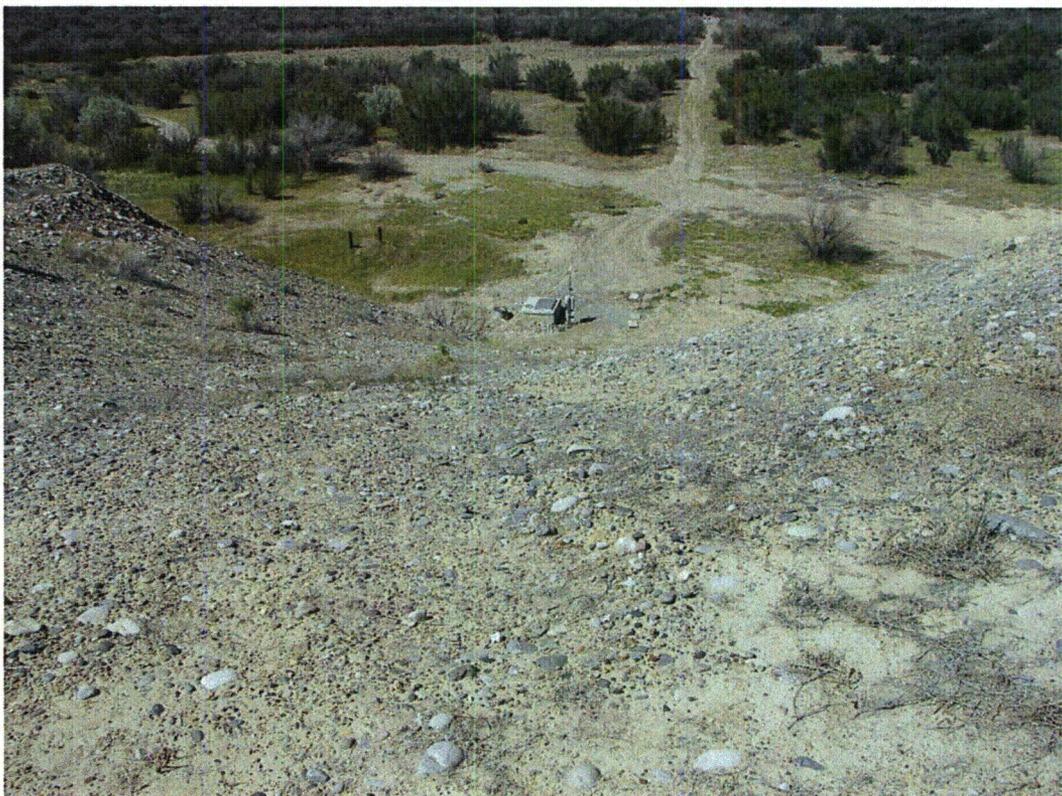
SHP 5/2012. PL-14. Section of escarpment near survey monument SM-1.

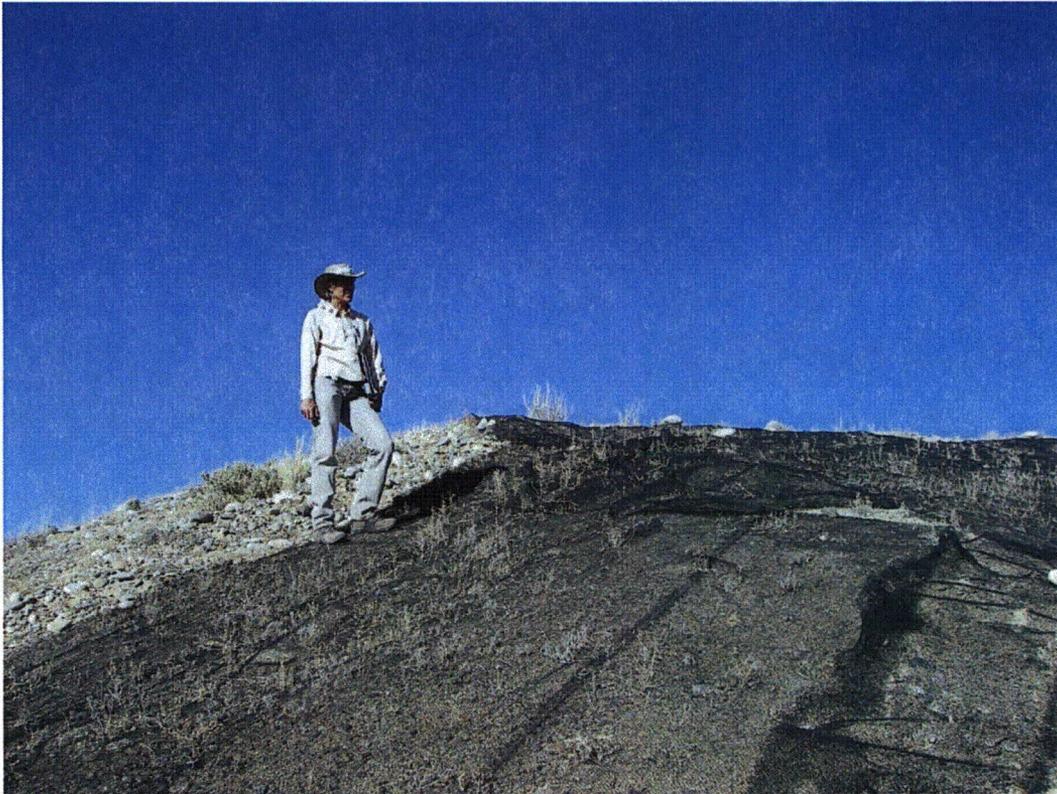
The offsite portion of the outflow channel was functional and in good condition (PL-15).

SHP 5/2012. PL-15. Erosion control fabric along outflow channel.

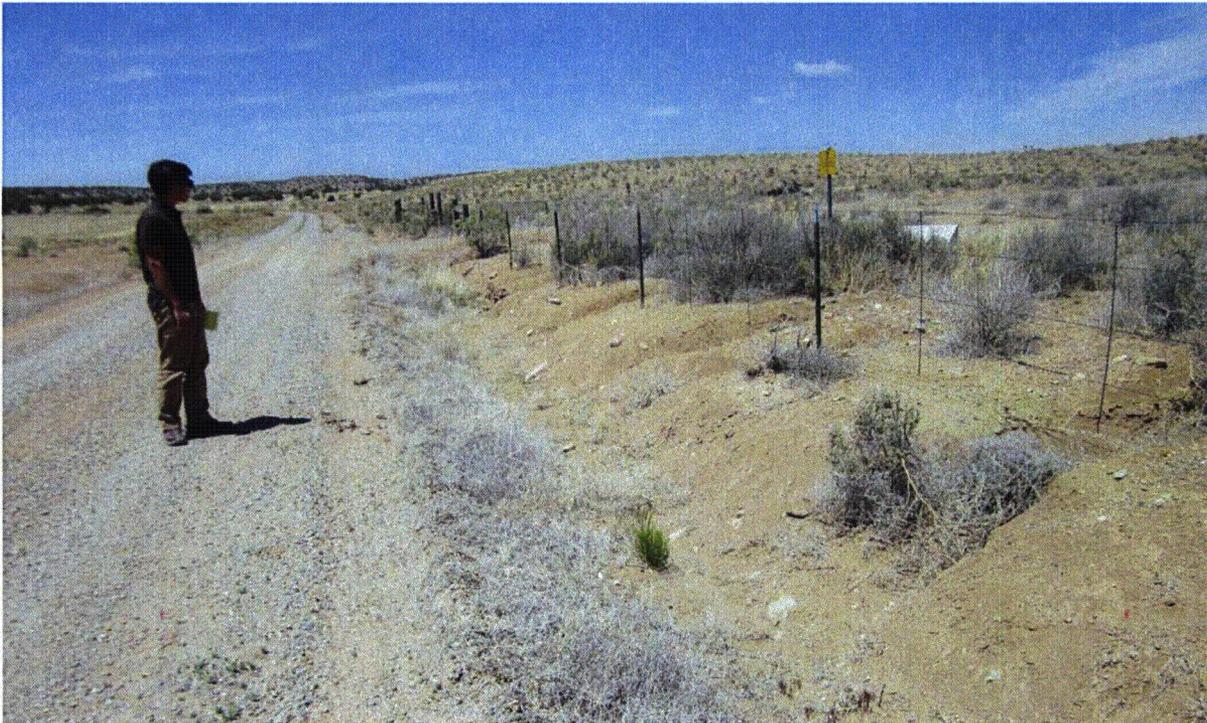
Site access is by an improved gravel and dirt road maintained by San Miguel County. The road is in good condition. Soil erosion under the fence along the county road continues to be monitored (PL-1).

SRK 5/2012. PL-1. View toward northwest along county road; fence line erosion.

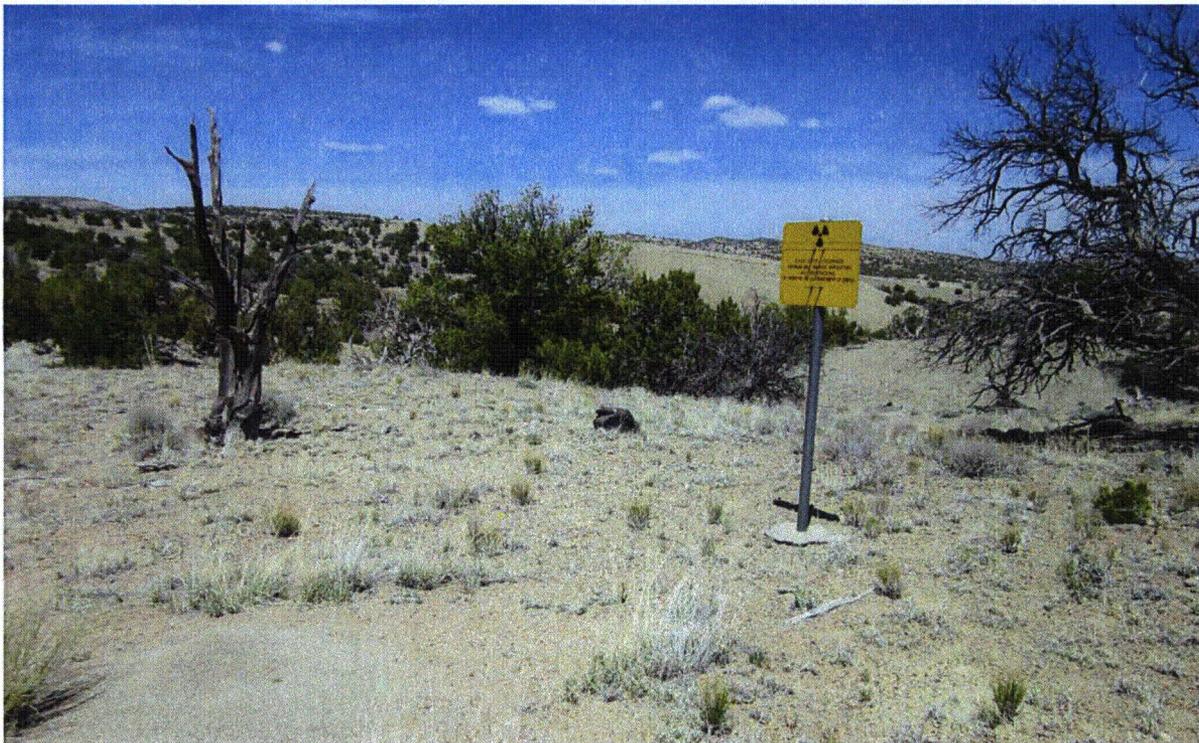
Thirty-two perimeter signs, designated P1 through P32, are spaced at approximately 200-foot intervals around the site (PL-2). The signs, attached to steel posts set in concrete, are 5 feet inside the site boundary. Perimeter sign P30 was missing in July 2011 and was replaced in October 2011 using theft-resistant fasteners. All other signs are in good condition.

SRK 5/2012. PL-2. Typical perimeter sign along west boundary of site.

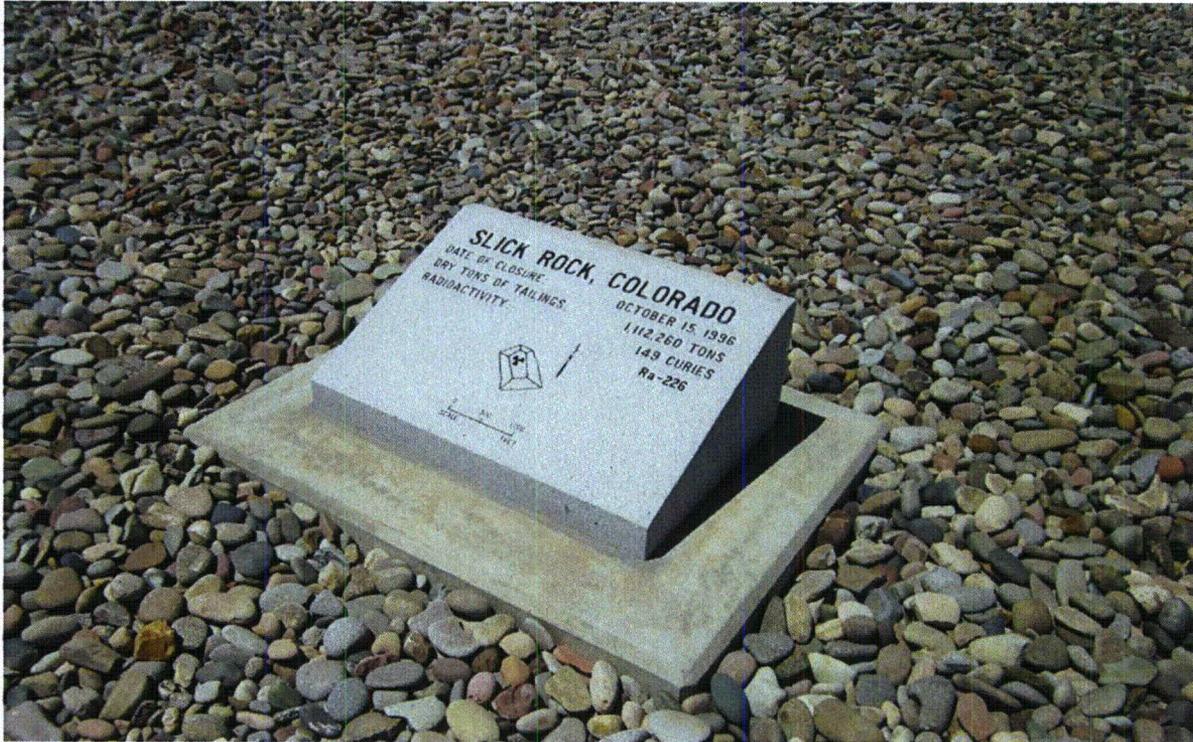
The two granite site markers, SMK-1 near the entrance gate and SMK-2 (PL-3) on the north-central part of the disposal cell, are in excellent condition. Erosion near SMK-1 is being monitored and may require remedial work if heavy rainfalls occur and erosion of the surrounding soil continues.

SRK 5/2012. PL-3. Site marker 2 on top of disposal cell.

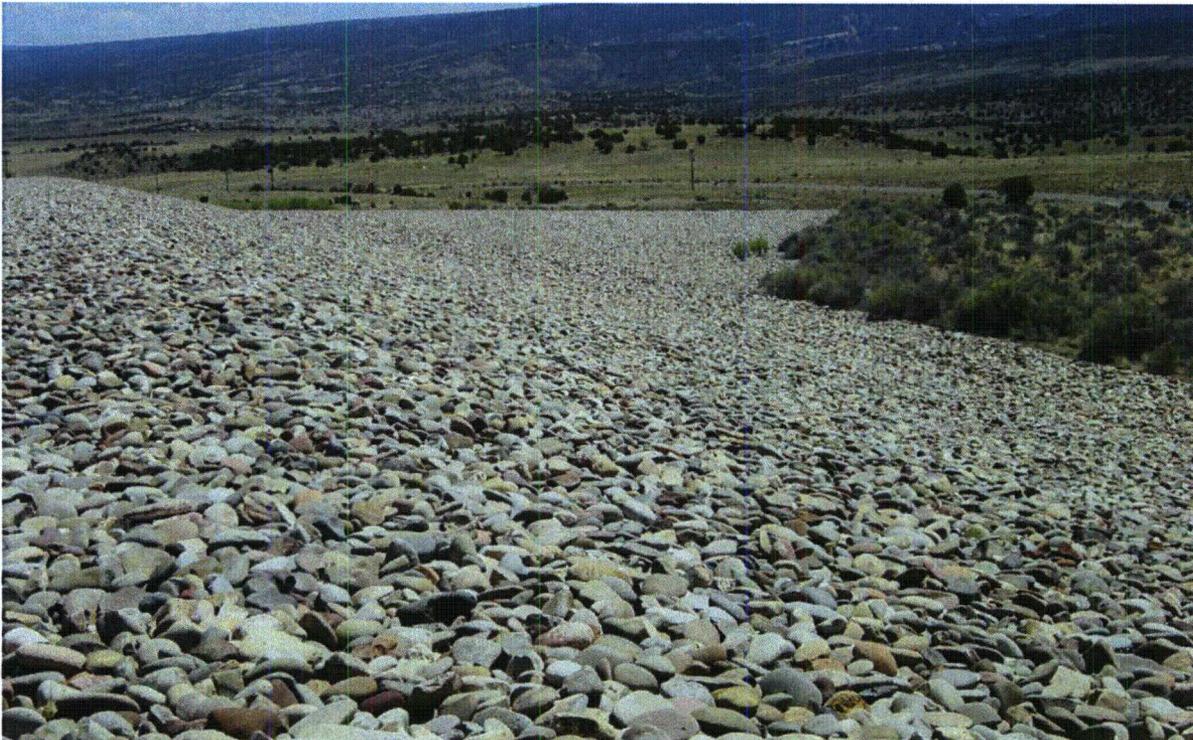
Rock covering the disposal cell, key trench, and apron is rounded cobble- and pebble-sized material. The rock is in excellent condition (PL-4 and PL-5). No evidence of settling, slumping, or erosion was seen on any of the rock-covered surfaces of the disposal cell. No phreatophytes or other deep-rooted plant species were observed on the surface of the cell.

SRK 5/2012. PL-4. Southeast face of cell, across apron.

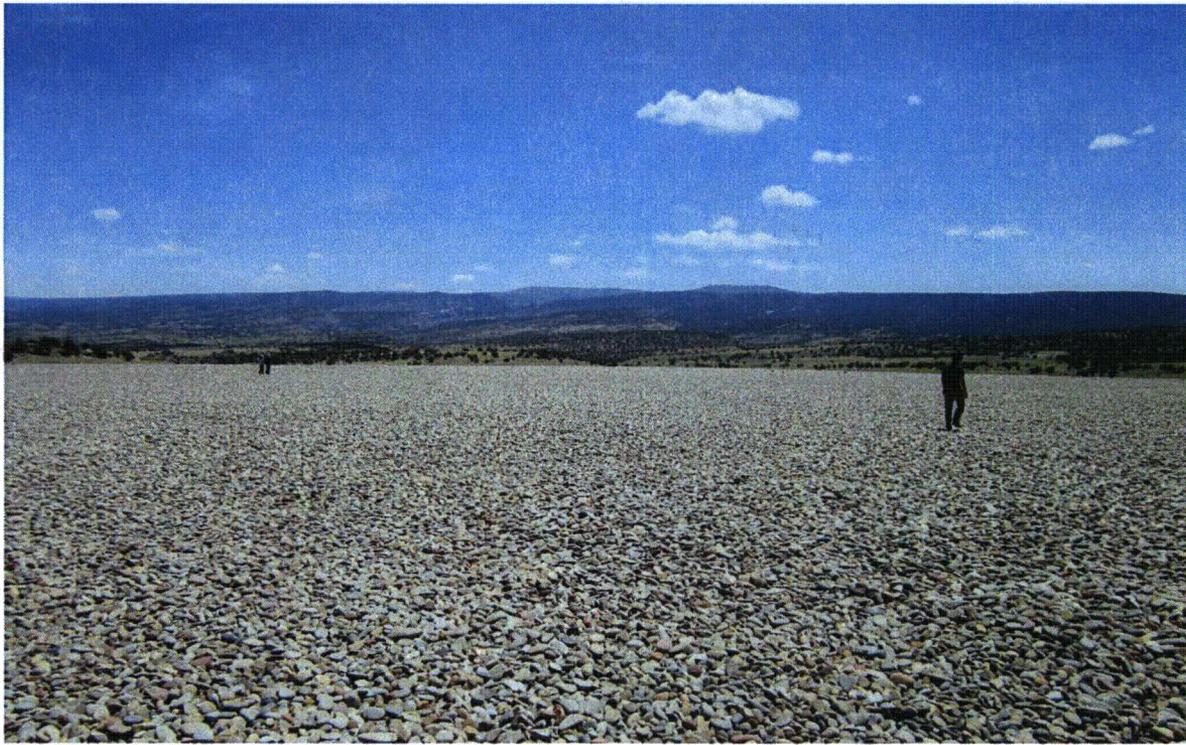
SRK 5/2012. PL-5. Top of cell from northwest to southeast.

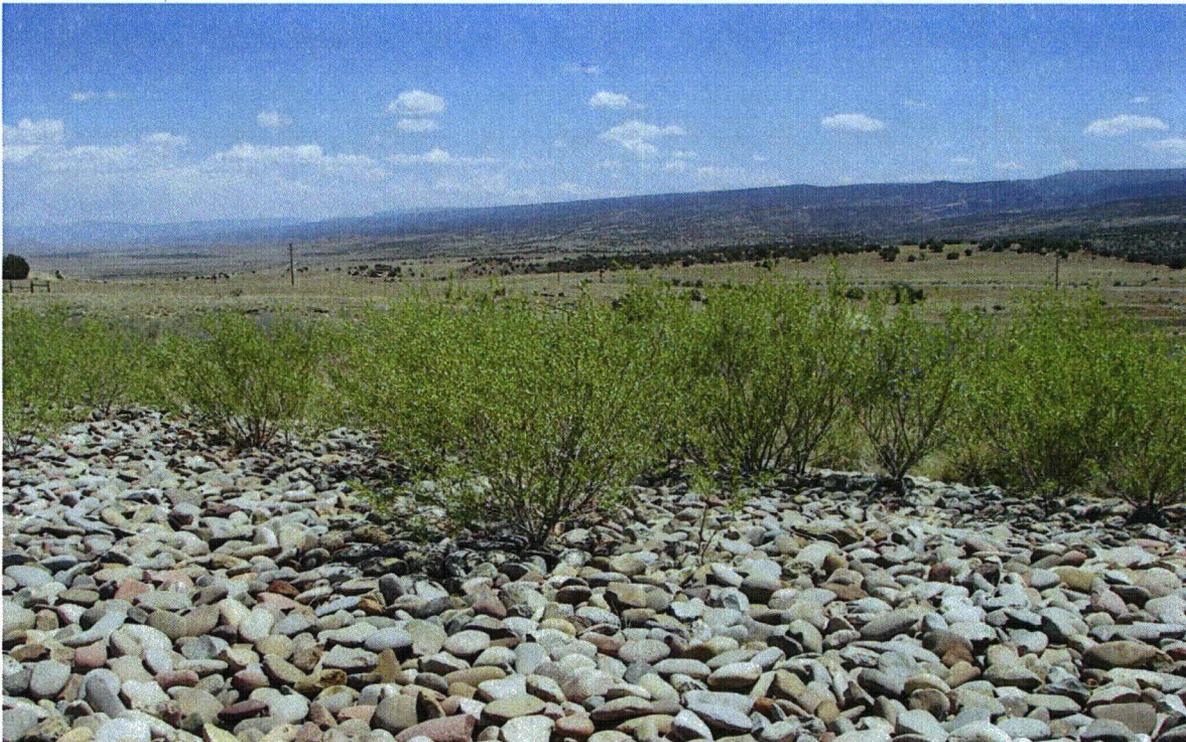
The top of the disposal cell is roughly pentagonal. Five side slopes descend from the disposal cell top at a maximum grade of 25 percent and are covered with riprap. At the base of the side slopes is a key trench that encircles the disposal cell. The key trench is as much as 5 feet deep and 20 feet wide and filled with riprap. South and downslope of the disposal cell, an apron of riprap extends for 50 to 200 feet beyond the key trench (PL-6). All side slopes, the key trench, and the apron are in excellent condition.

SRK 5/2012. PL-6. Willows growing at base of apron.

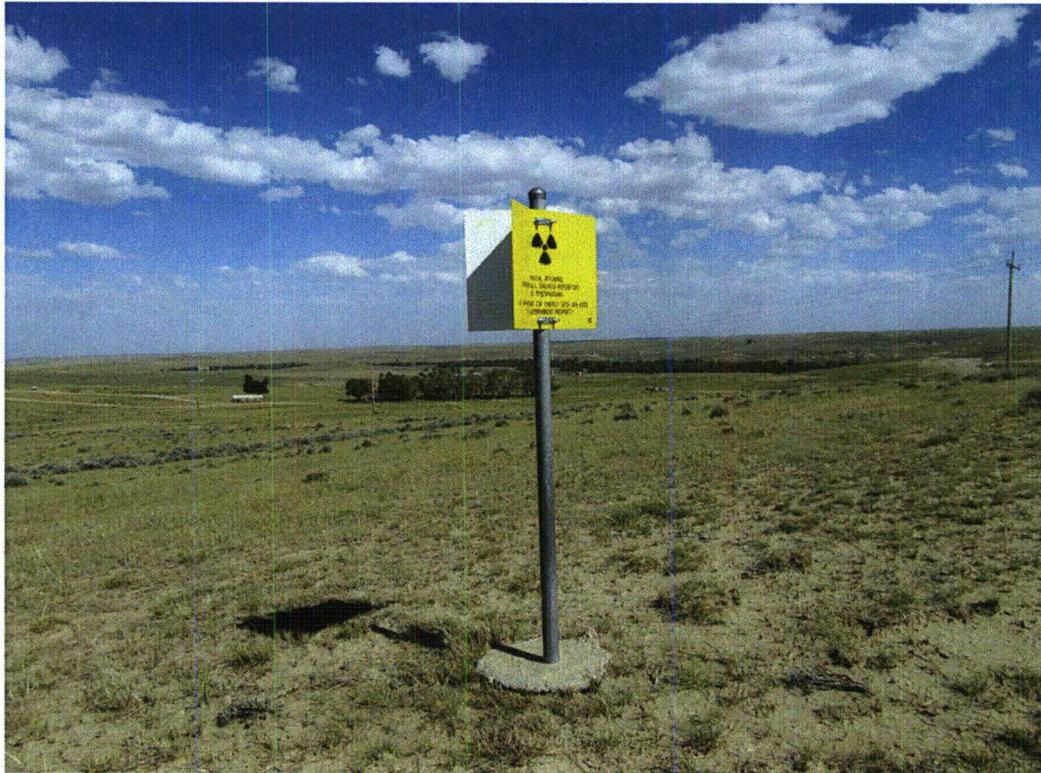
The site is unfenced and defined by 10 perimeter signs. Perimeter sign P10 is damaged from wind. The signs were made in two layers, and the top layer has peeled away from the base. The sign is still legible (PL-1).

SPK 6/2012. PL-1. Perimeter sign P10 damaged by wind.

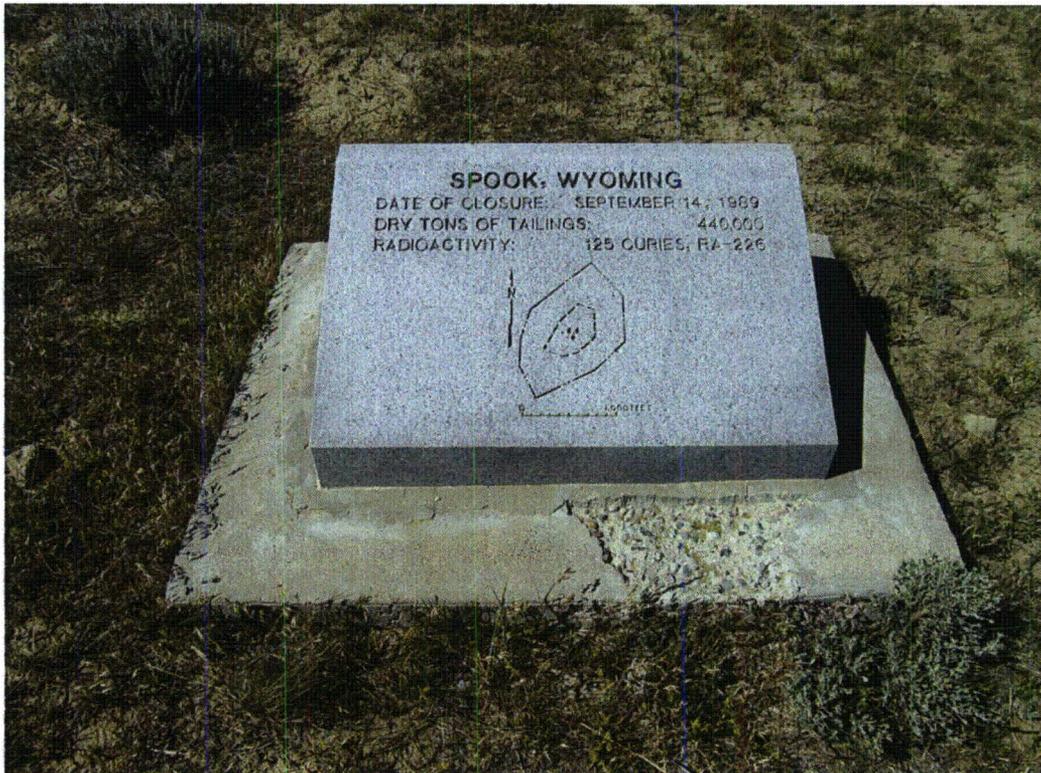
Site marker SMK-2 was in excellent condition. The concrete base of site marker SMK-1 is damaged due to spalling but is stable; no changes were observed from the previous year (PL-2).

SPK 6/2012. PL-2. Site marker SMK-1.

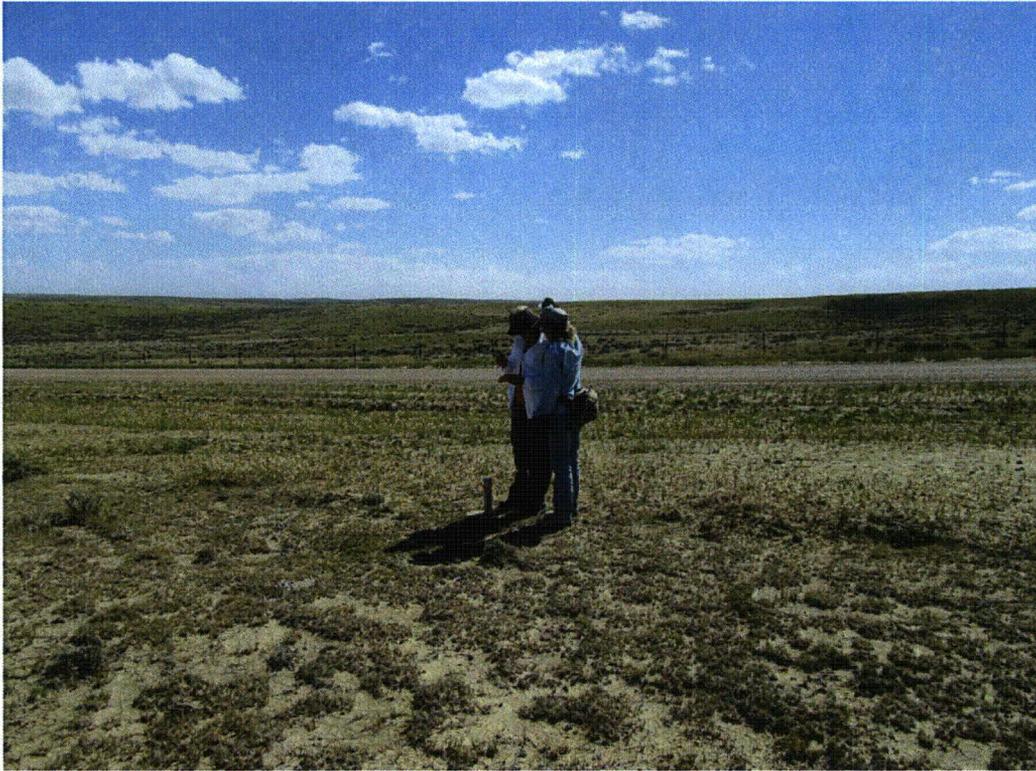
The eight boundary monuments and three survey monuments are in excellent condition. The locations of the boundary monuments were confirmed by GPS (PL-3).

SPK 6/2012. PL-3. Collecting GPS coordinates at boundary monument BM-5.
