16.0 Annual Inspection of the Shiprock, New Mexico, UMTRCA Title I Disposal Site

17.0 Annual Inspection of the Slick Rock, Colorado, UMTRCA Title I Disposal Site

18.0 Annual Inspection of the Spook, Wyoming, UMTRCA Title I Disposal Site

19.0 Annual Inspection of the Tuba City, Arizona, UMTRCA Title I Disposal Site

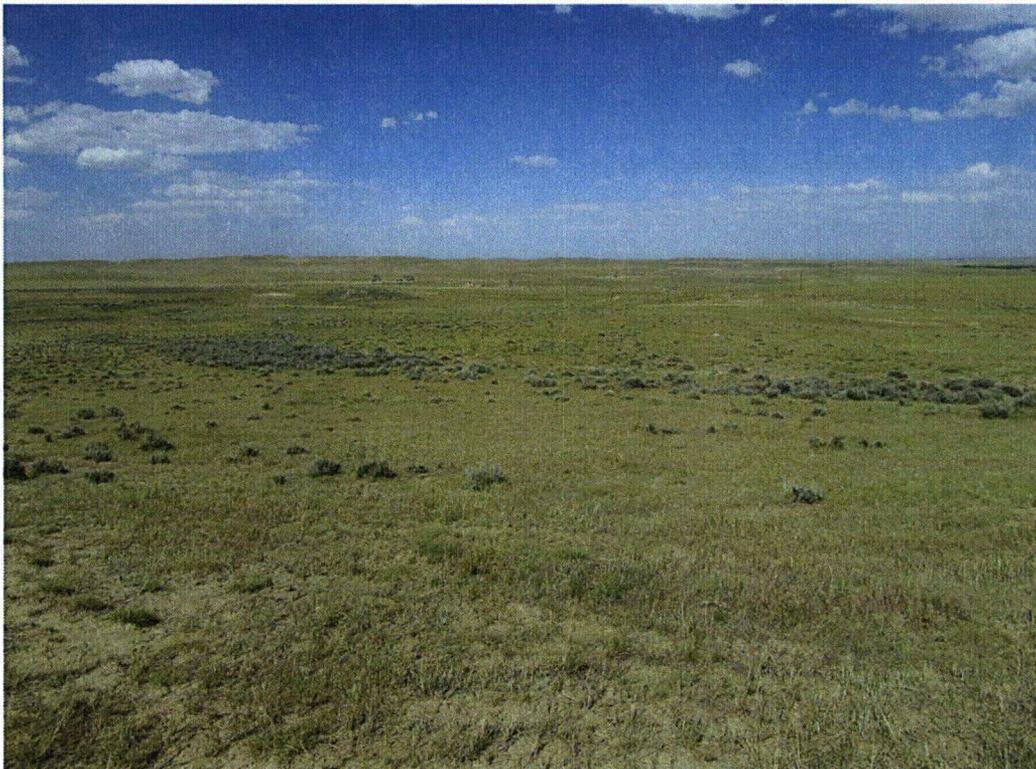
The site is unique among Title I sites in that tailings were encapsulated in the bottom of an open pit mine and covered with 40 to 60 feet of clean fill and topsoil. As such, many of the observations and concerns routinely associated with above-grade disposal cells—such as the quality of the riprap, the stability of side slopes, or the presence of deep-rooted plants (biointrusion) above the radon barrier—do not apply to this site. The surface of the 5-acre disposal cell, completed in 1989, was in excellent condition. No evidence of settling was observed over the former mine pit. Vegetation across the cell, consisting of grasses and forbs, appears healthy and is indistinguishable from that which grows on the surrounding hills and valleys. The same species are present, and the overall health and density of vegetation are similar (PL-4).

SPK 6/2012. PL-4. Northeast view across the disposal cell.

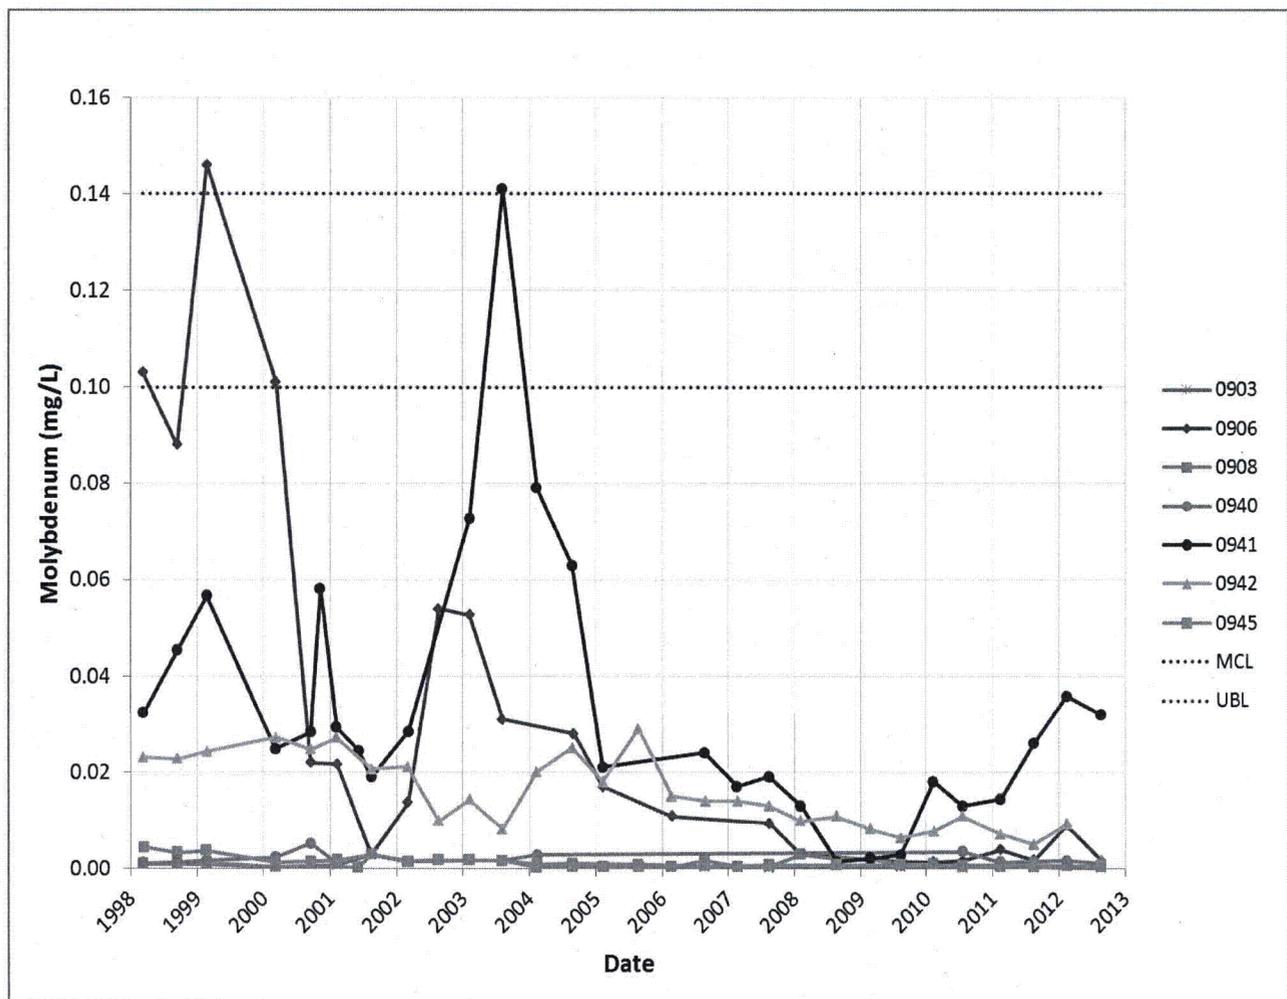
Figure 19–2. Time-Concentration Plots of Molybdenum in Groundwater at the Tuba City Disposal Site

As has been the case since 2004, molybdenum concentrations in groundwater were below both the MCL of 0.1 milligram per liter (mg/L) and the UBL of 0.14 mg/L in all wells (Figure 19–2). With respect to background well 0945, molybdenum has been elevated only in wells 0906, 0941, and 0942. Concentrations of molybdenum in wells 0908 and 0940, and in offsite well 0903, have been comparable to background. Molybdenum concentrations in wells 0906 and 0941 were highly variable between 1998 and 2005 (occasionally exceeding the UBL), but they have since stabilized (less than 0.04 mg/L).

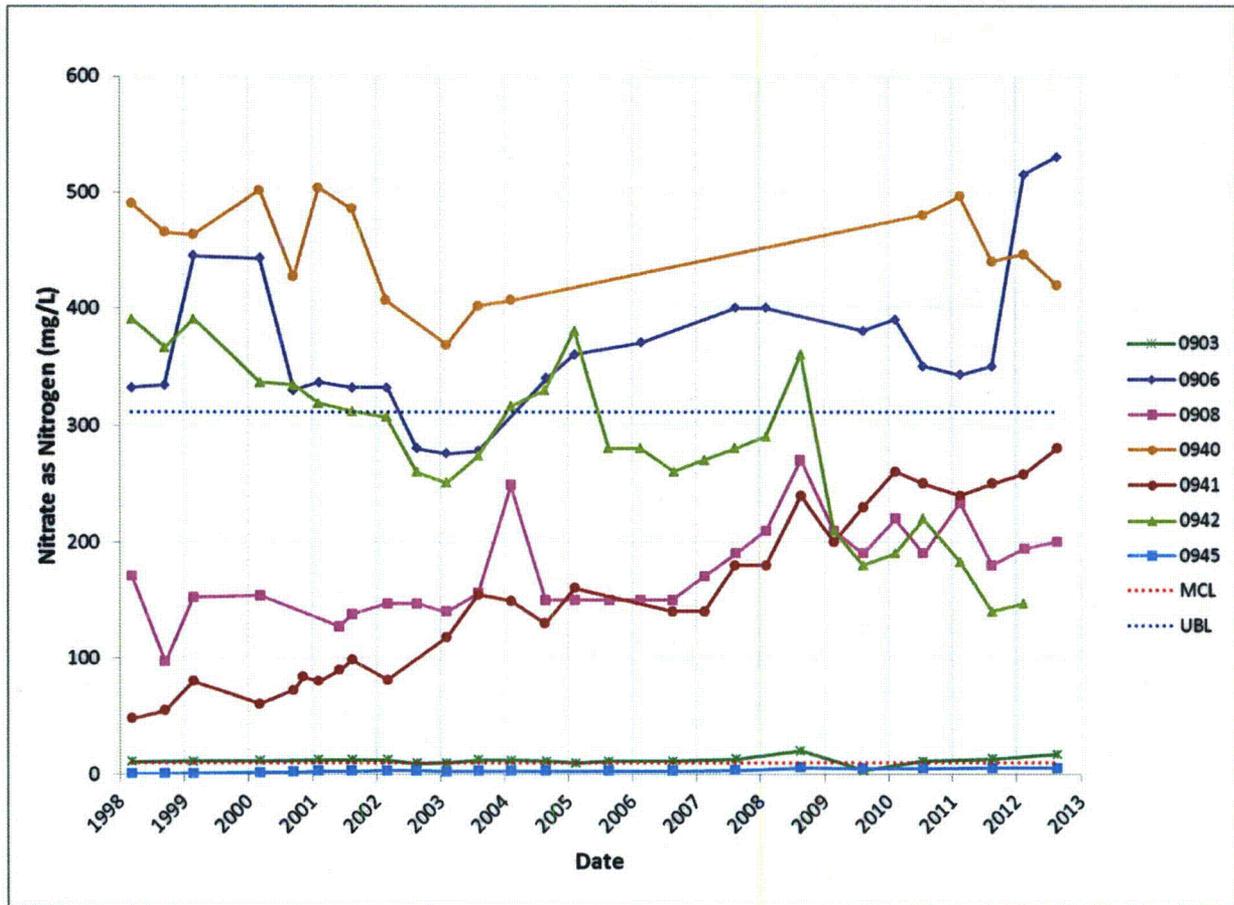
Figure 19–3. Time-Concentration Plots of Nitrate in Groundwater at the Tuba City Disposal Site

Since 1998, nitrate concentrations in all onsite downgradient wells—0906, 0908, 0941, and 0942—have exceeded the 10 mg/L MCL, most by an order of magnitude or more (Figure 19–3). Nitrate concentrations exceeding the 311 mg/L UBL have only been measured in 0906 (currently 530 mg/L), 0942 (last exceedance in August 2008), and 0940 (currently 420 mg/L). Wells 0908 and 0941 are the only wells that indicate any notable trending (with gradual increases evident since 1998–2000), but nitrate concentrations have stabilized somewhat in the last few years. Nitrate concentrations measured in the offsite downgradient well 0903, although above background and occasionally exceeding the MCL, are still well below the UBL. Concentrations in the upgradient background well 0945 remain below the MCL.

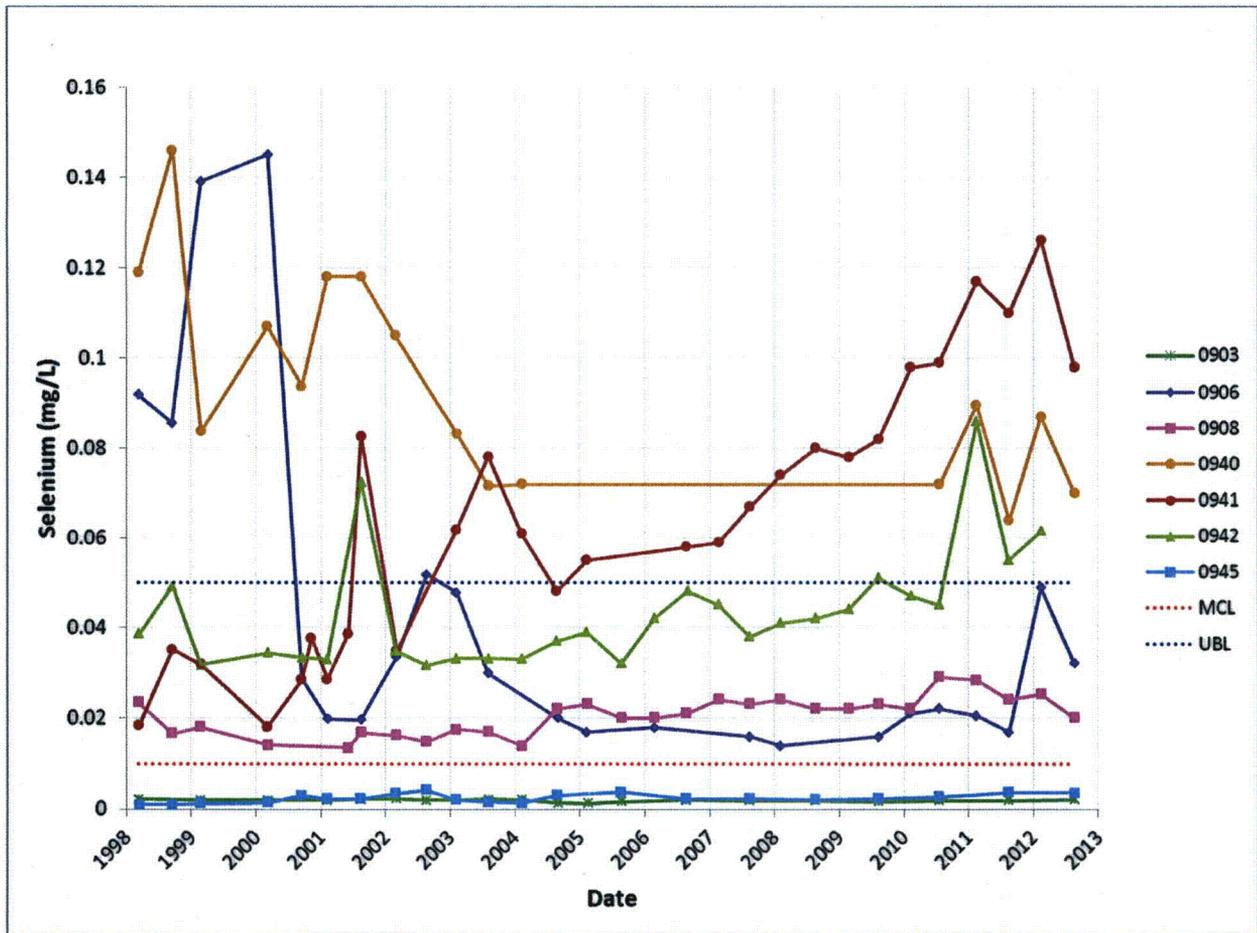
Figure 19-4. Time-Concentration Plots of Selenium in Groundwater at the Tuba City Disposal Site

As shown in Figure 19-4, selenium concentrations measured in groundwater in 2012 exceeded the 0.01 mg/L MCL in all wells except for the offsite downgradient well 0903 and background well 0945. Selenium concentrations exceed the 0.05 mg/L UBL in wells 0940, 0941, and 0942. Selenium concentrations in 0903 have consistently been below both the UBL and the MCL.

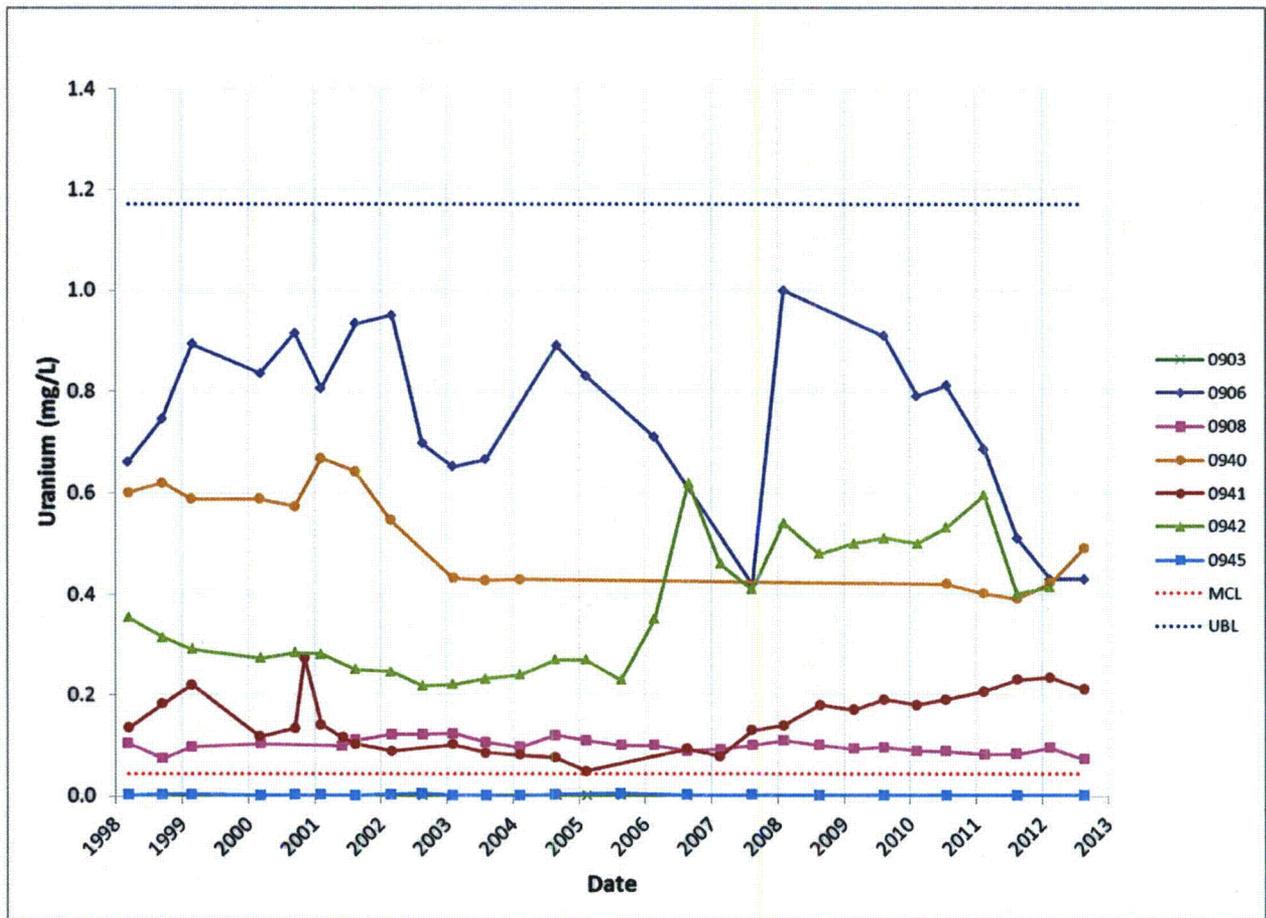
Figure 19-5. Time-Concentration Plots of Uranium in Groundwater at the Tuba City Disposal Site

In 2012, uranium concentrations in groundwater exceeded the 0.044 mg/L MCL but remained below the 1.17 mg/L UBL in all onsite downgradient wells. This has been the case historically, as shown in Figure 19-5. Concentrations in the upgradient well 0945 and the offsite downgradient well 0903 remain below the MCL. Uranium concentrations in most wells have been quite stable. Exceptions are found in wells 0906 and 0942, where uranium has varied erratically at times.

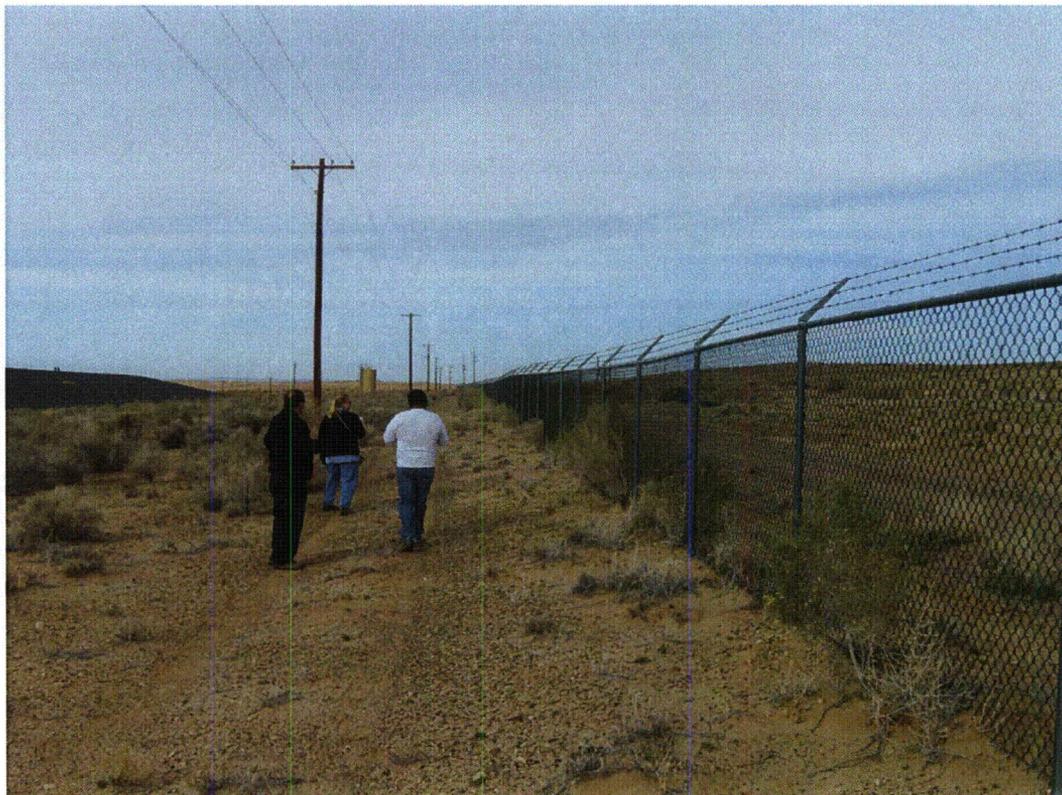
The security fence around the site perimeter was in good condition (PL-2).

TUB 4/2012. PL-2. Northwest security fence line.

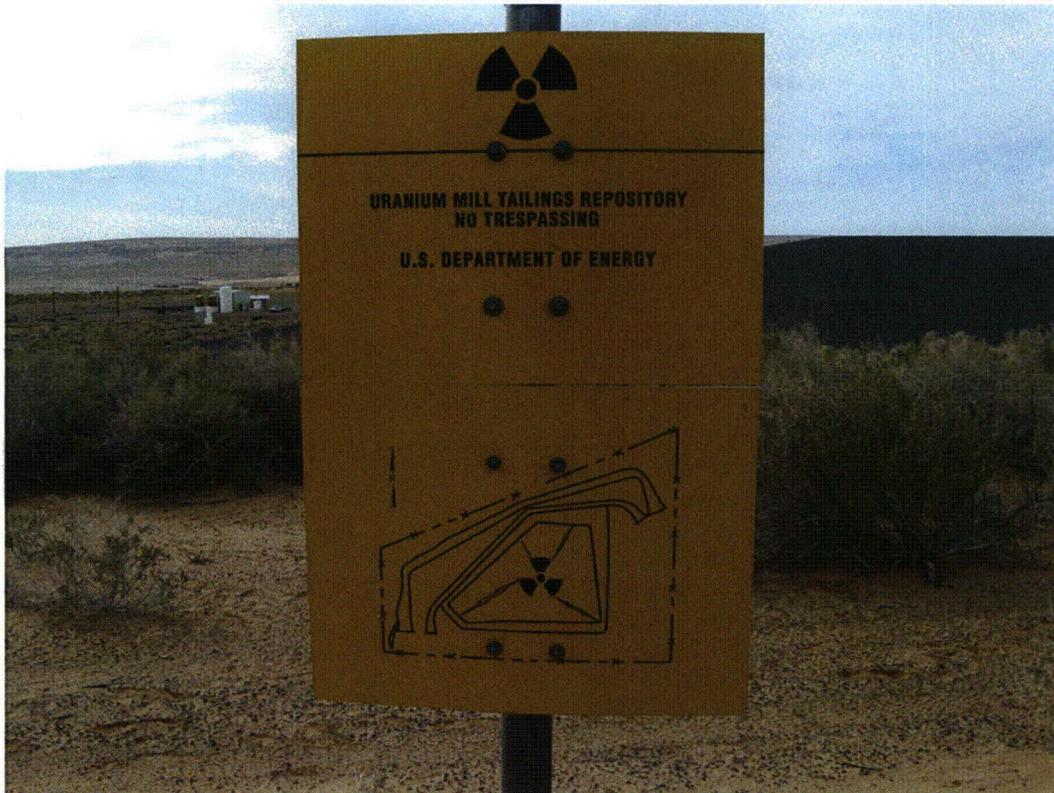
Perimeter signs are posted in pairs at regular intervals around the site perimeter. Each sign pair, secured to a metal post, consists of a “No Trespassing” sign with a radioactive materials trefoil symbol and a schematic sign with a diagram of the disposal cell (also identified by the radioactive materials trefoil symbol) and the site boundary (PL-3). All of the signs were in good condition.

TUB 4/2012. PL-3. Perimeter sign P30 near the entrance gate.

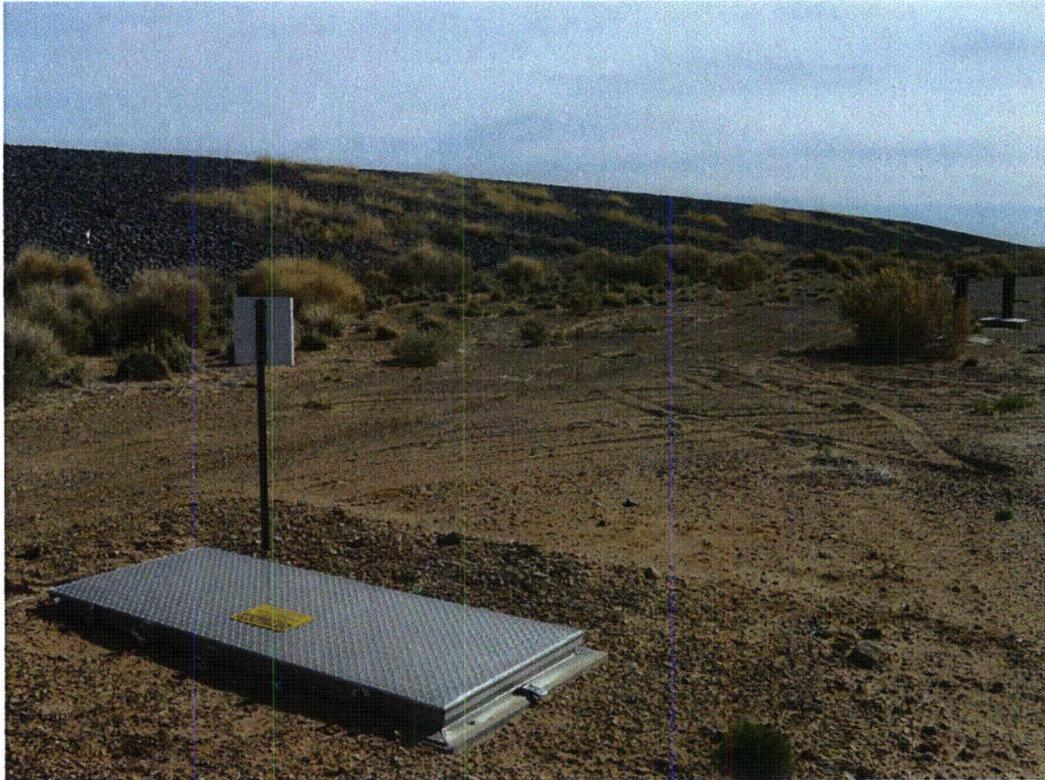
TUB 4/2012. PL-9. Vegetation encroachment on the south side slope of the disposal cell. Repeat photograph taken from extraction well 1107.

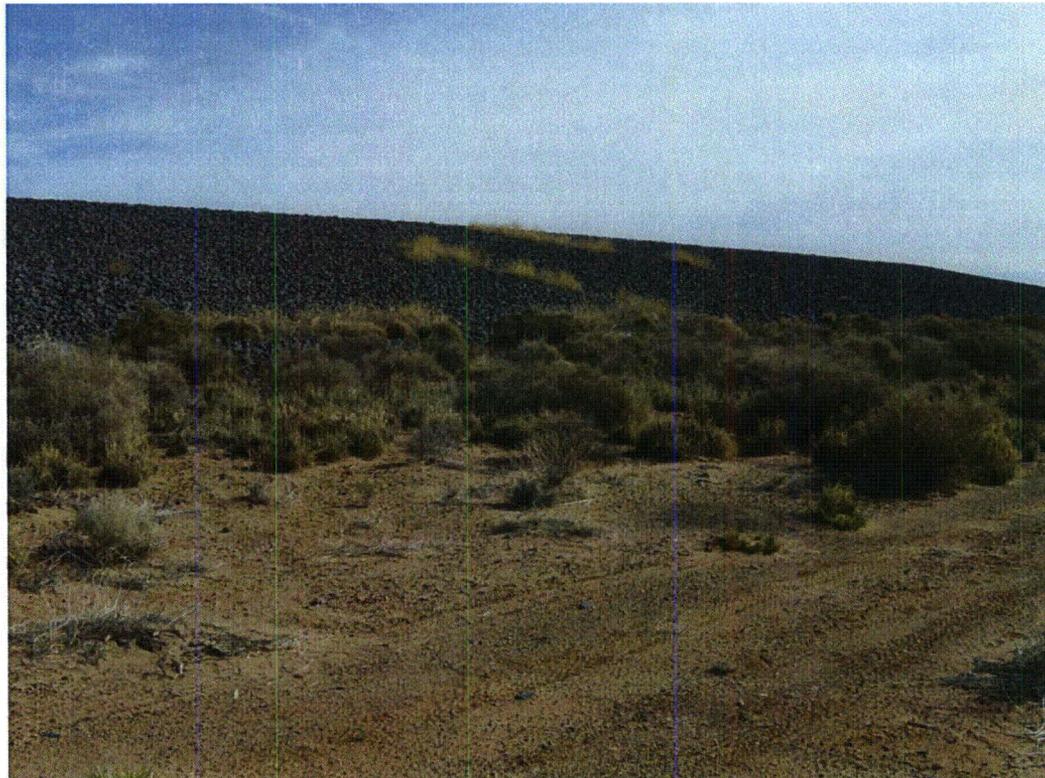
TUB 4/2012. PL-10. Vegetation encroachment on the south side slope of the disposal cell. Repeat photograph taken from extraction well 1105.

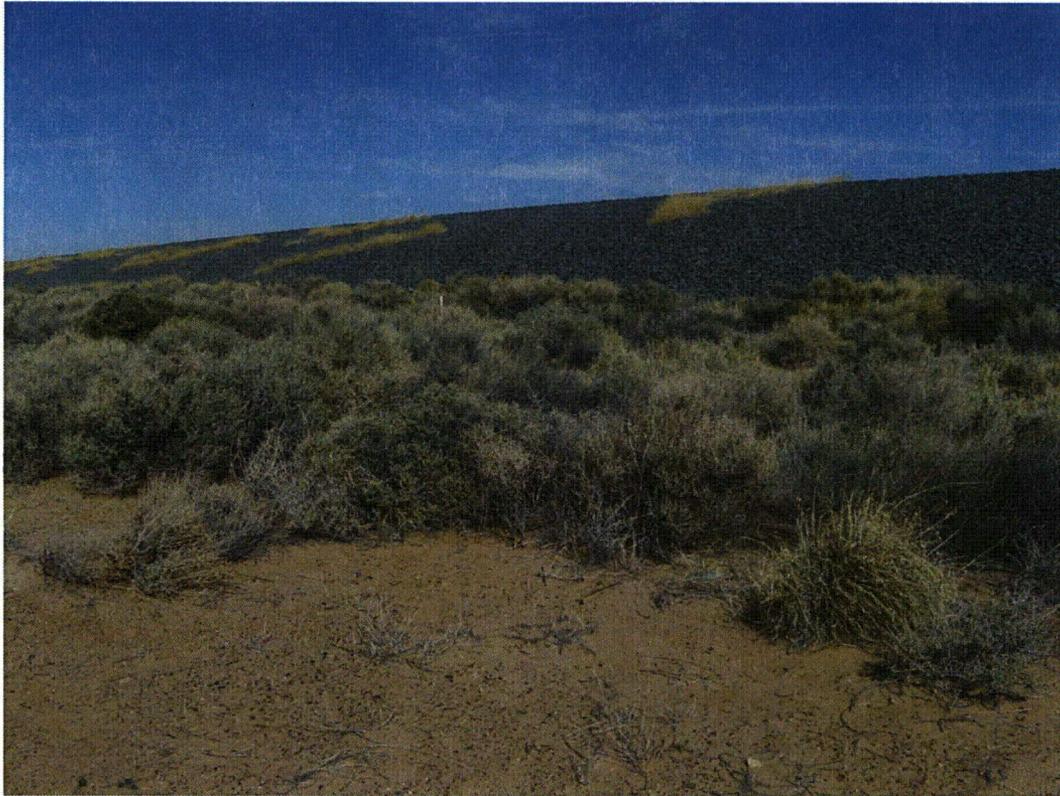
TUB 4/2012. PL-11. Vegetation encroachment on the south side slope of the disposal cell. Repeat photograph taken from monitoring well 0942.

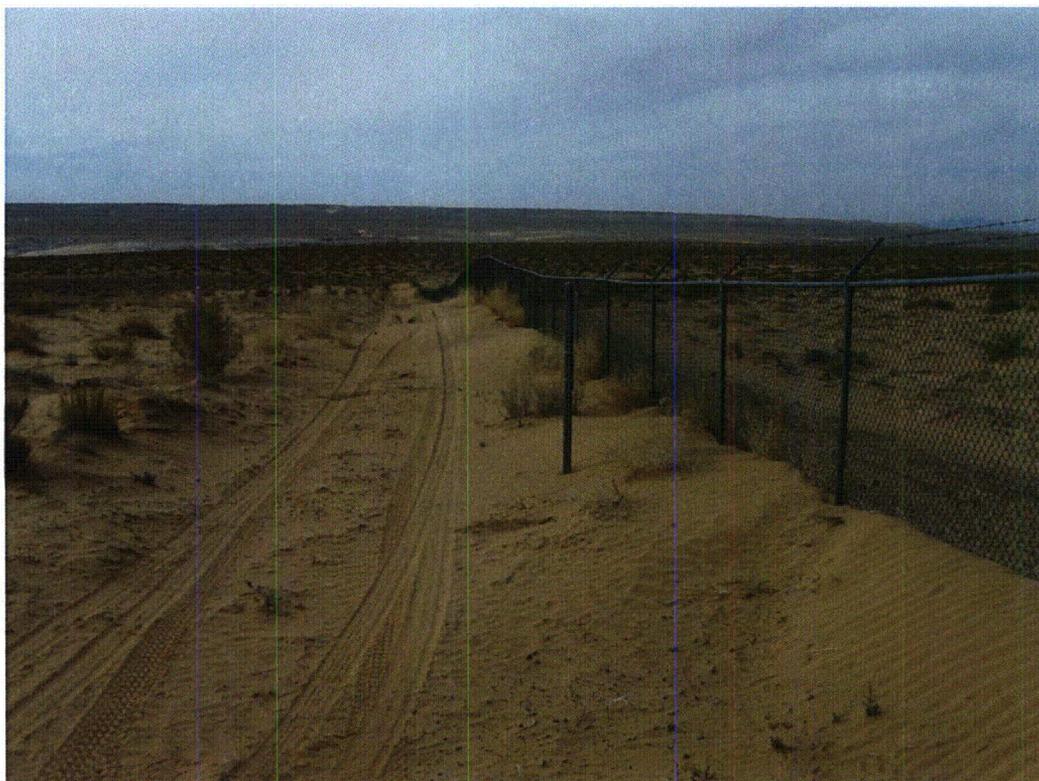
TUB 4/2012. PL-13. Sand accumulation along the west fence line.

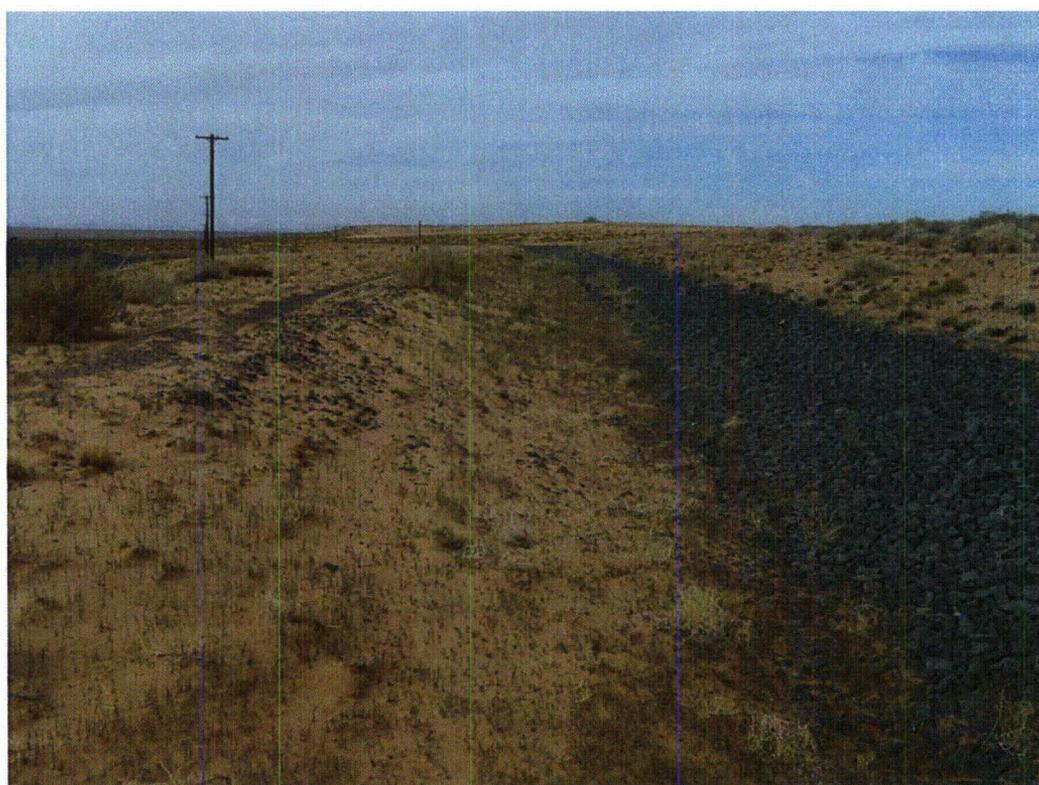
TUB 4/2012. PL-14. Windblown sand deposition on the south bank of the west diversion channel.
Repeat photograph taken from the footbridge.
