South Texas Project
Unit 2
Docket No. STN 50-499
Request for Relief from ASME Section XI Code Requirements for Periodic Inspection
of Reactor Coolant Pressure Boundary Check Valves with Seal Cap Enclosures
(Relief Request RR-ENG-3-12)

SOUTH TEXAS PROJECT
UNIT 2
REQUEST FOR RELIEF FROM ASME SECTION XI CODE REQUIREMENTS
FOR PERIODIC INSPECTION OF REACTOR COOLANT PRESSURE BOUNDARY
CHECK VALVES WITH SEAL CAP ENCLOSURES
(RELIEF REQUEST RR-ENG-3-12)

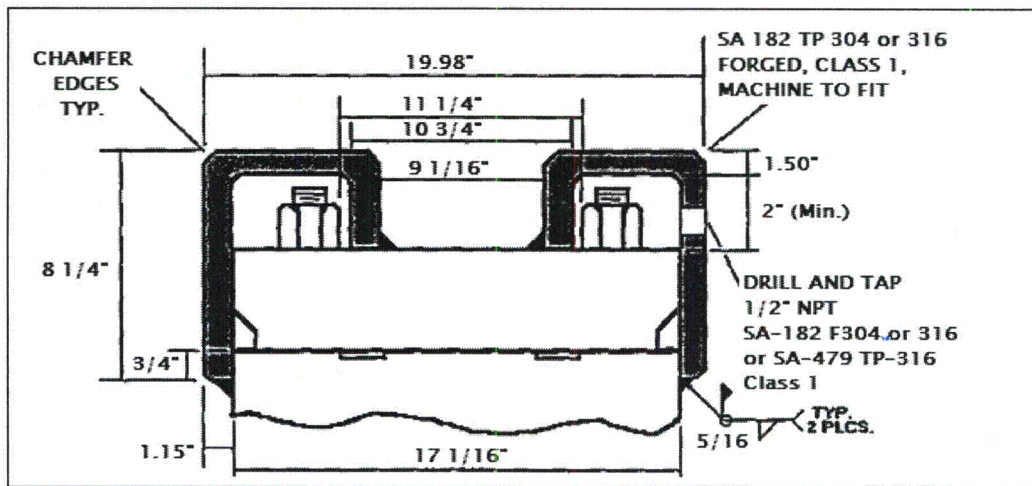
Seal cap enclosures had been previously welded over the bonnets and studs to address external valve leakage at the body to bonnet flange such as a gasket leak. Modifications to the CVCS valves were completed in the late 1980's. The seal cap enclosure was originally installed on SI-0010A in 1997 due to identified leakage from the body-to-bonnet gasket. Figure 1 shows a typical seal cap enclosure. As discussed in References 2 and 3, a concern with the installation of seal cap enclosures as mitigation for non-pressure boundary leakage is the potential for unmanaged degradation, since direct inspection of the pressure-retaining bolted joint enclosed by the valve seal cap is prevented.

Figure 1. Diagram of seal cap enclosure for SI-0010A, typical for affected RCPB check valves

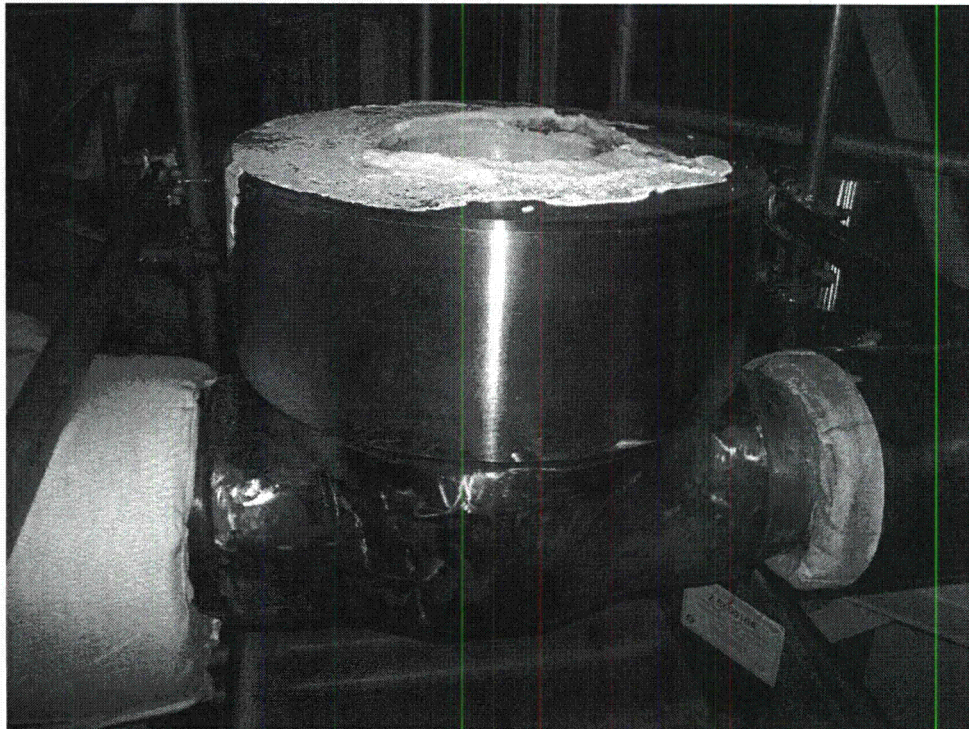
Detection of failures of the welds joining the valve to enclosure may be possible by detection of leaks. In previous examples (see References 2 and 3), failures were detected by insulation removal and identification of boric acid deposits (see Figure 2). Any significant leakage in this condition would be expected to clearly exhibit boric acid accumulation that would be discernible during the required VT-2 visual examinations. RCS leakage would be evident on the insulation on the valves, as indicated by water and boric acid crystals.

During the STP Unit 2 refueling outage in 2011 (2RE15), leakage from the SI-0010A seal cap was discovered on October 30, 2011. The weld attaching the cap to the bonnet had several defects which were removed and re-welded during the outage. The NRC raised a question regarding the structural integrity of the studs encapsulated by the seal cap, stemming from the potential for corrosion of the studs due to the environment inside the seal cap and the fact that inspection of the studs was not possible with the cap installed.

Figure 2. Seal cap enclosure for SI-0010A exhibiting boric acid deposits as a result of seal weld leakage (not pressure boundary leakage)

All of the stud bolts and nuts for the affected STP Unit 2 check valves are scheduled to be replaced as part of the permanent valve repairs and removal of seal cap enclosures planned for the next scheduled refueling outage in 2013 (2RE16). Similar to the repairs previously completed on Unit 1 CVCS check valves, the work planned to be completed includes:

- For each affected CVCS check valve, replacing the existing studs and bonnets with new studs and new bonnet designed to apply a body to bonnet seal weld within the bolting circle of the joint; and
- For the SI-0010A valve, replacing the existing studs and reusing the existing bonnet which already allows a seal weld of the body to bonnet joint within the bolting circle of the joint.
