San Onofre Nuclear Generating Station, Unit 2 & 3 REPLACEMENT STEAM GENERATORS

Root Cause Analysis Report for tube wear identified in the Unit 2 and Unit 3 Steam Generators of San Onofre Nuclear Generating Station

**Root Cause Analysis Report for tube wear
identified in the Unit 2 and Unit 3 Steam Generators of
San Onofre Nuclear Generating Station**

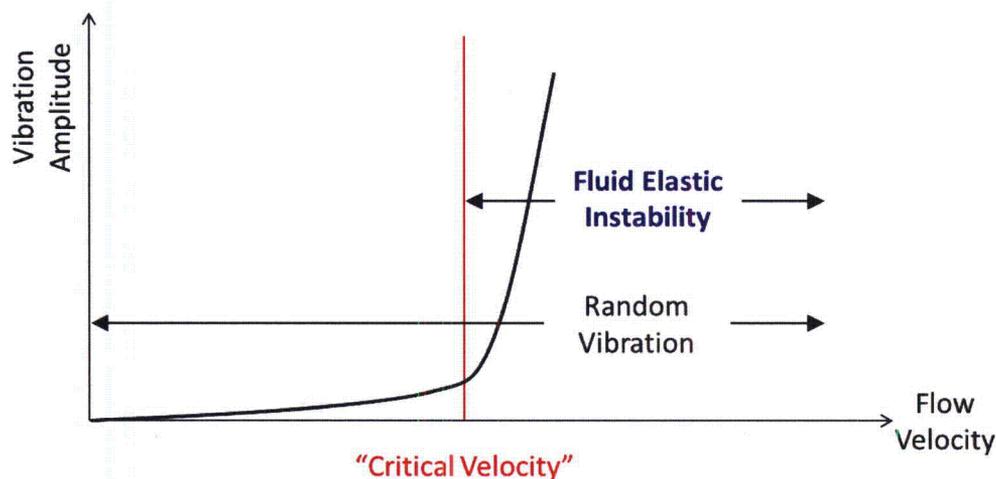
Figure 1

Fluid Elastic Instability (FEI) is a term used to describe a range of tube vibrations that starts at a point on a curve of vibration amplitude versus flow velocity. As depicted in Figure 1, one axis (Y) of that curve is vibration amplitude and the other (X) is flow velocity. The graph shows that as flow velocity increases vibration amplitude increases at a small linear rate until it reaches a point where the slope of the curve increases abruptly. The point in the curve where the slope changes is termed "critical velocity". The critical velocity is a function of several variables. These include tube natural frequency, which is dependent on the tube geometry and support conditions, damping,

which is a function of the steam-to-water ratio, flow velocity, which is dependent of the tube spacing.

As discussed below and in the technical reports referenced above (See Supplemental Technical Evaluation Report), MHI has determined that, due to ineffective support for the tubes in the in-plane direction resulting from the very small and uniform tube-to-AVB gaps, some of the tubes exceeded the fluid elastic critical velocity resulting in in-plane FEI, which in turn produced the large amplitude tube-to-tube wear. This mechanism is influenced by the local thermal hydraulic conditions around the tube. Regions of high void fraction have lower tube damping, which reduces the fluid elastic critical velocity threshold. High void fraction regions also have higher cross flow velocities. Therefore, tubes with low or no contact force in the region of highest void fraction are most susceptible to this mechanism.

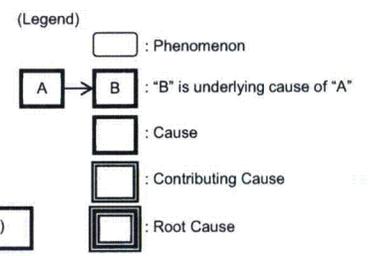
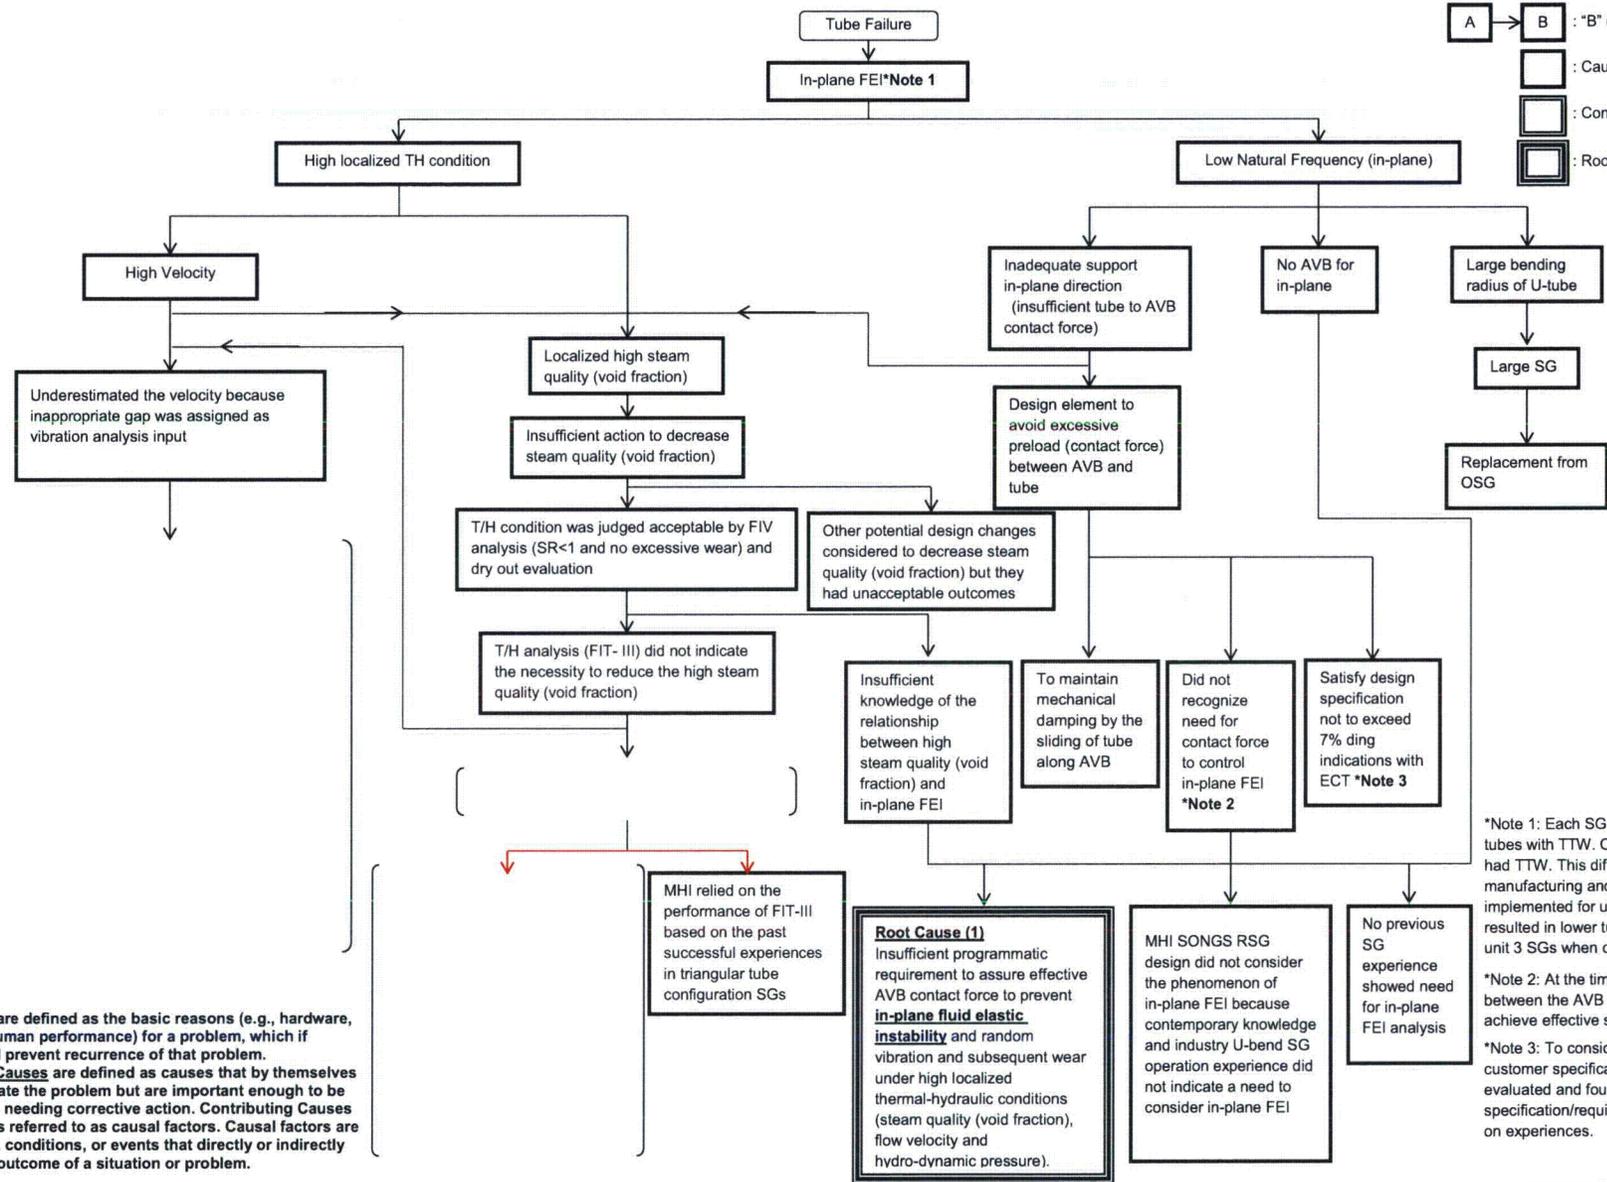
Cause-effect analysis for the tube to tube wear

*Note 1: Each SG on unit 3 had about 160 tubes with TTW. Only 2 tubes in one unit 2 SG had TTW. This difference was caused by manufacturing and fabrication improvements implemented for unit 3. These improvements resulted in lower tube to AVB contact force in unit 3 SGs when compared to unit 2 SGs.
 *Note 2: At the time of design a narrow gap between the AVB and tube was believed to achieve effective support condition.
 *Note 3: To consider identifying specific customer specification but also note that MHI evaluated and found such specification/requirement acceptable based on experiences.
