**Burst Resistance vs. Percent Degraded Area Acceptance Limit**  
**11/16" x 0.040" Alloy 600TT SG Tubes at 650°F ETSS 20510.1**  
**Indication Measured PDA = 11% assuming through-wall**

**From:** Wideman Steve G  
**Sent:** Tuesday, February 26, 2013 8:29 AM  
**To:** 'Lyon, Fred'  
**Cc:** Muilenburg William T; Peabody Charles A; 'Ron.Kopriva@nrc.gov'; Wagner Pat G; Herrman Paul J; Broschak John P; Westman Mike J; Fredrickson Kenneth L  
**Subject:** RE: Steam Generator Inspections for Upcoming RFO

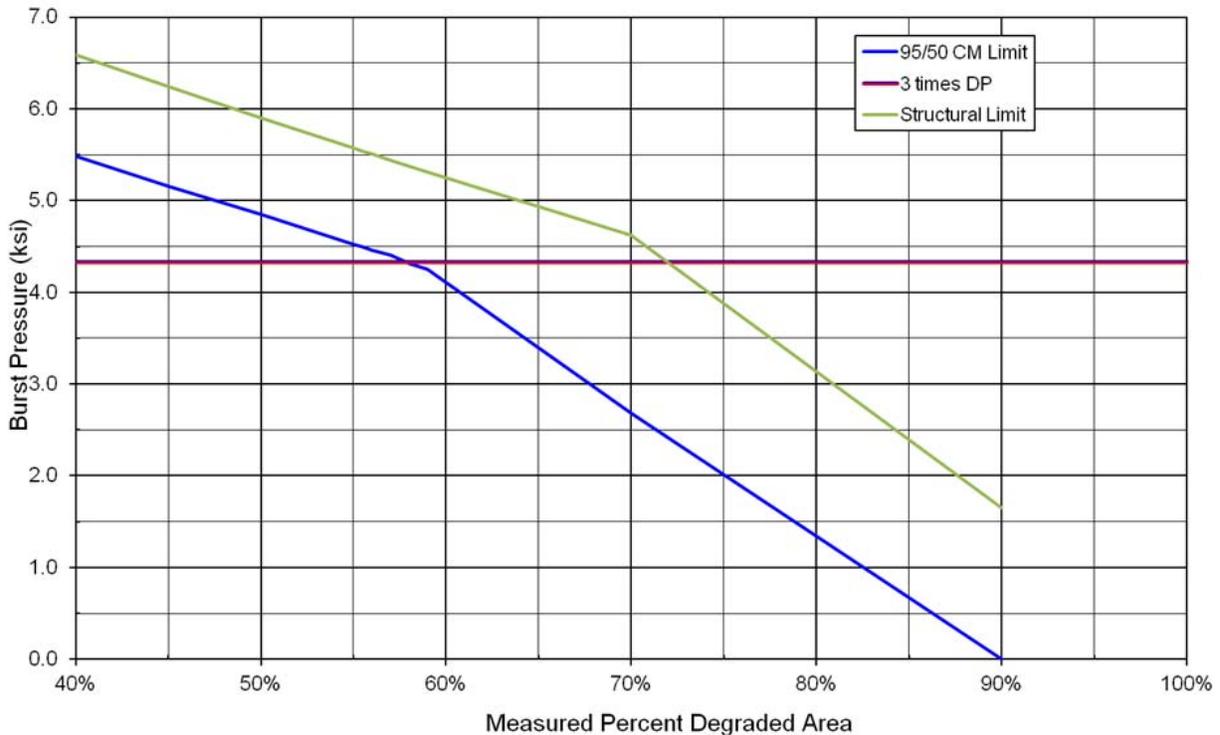
Related to Item 2, See the following graph related to the Condition Monitoring limit for the circ indication.

The steeper slope is tensile instability which relates to separation within the tubesheet. The shallower slope presumes that tube could bend at top of tubesheet and is conservative relative to locations within the tubesheet. In any case, the allowable percent degraded area (PDA) for 3 delta P considering all uncertainties is 58% and the measured PDA is 11%.

Item 2 - During the Top-of-Tubesheet eddy current inspection, a circumferential indication was confirmed in SG 'B' Hot Leg (17,89) ~TTS -6.46" which is located at a bulge indication. Due to this indication, 100% of the tubes containing BLG and/or OXP will be inspected in SG 'B' within the inspection region. Also, 20% of the tubes containing BLG and/or OXP within the inspection region for SGs 'A', 'C', and 'D' will need to be inspected. It should be noted that as part of the original inspection program that greater than 20% of the BLG and/or OXP within the tubesheet in SG 'A', 'C', and 'D' are already being inspected. Therefore, currently there is no additional testing required in SG 'A', 'C', and 'D'.
