February 25, 2013

Subject: Wedge Pin Failure of an Anchor/Darling Double- Disc Gate Valve at Browns Ferry Nuclear Plant Unit 1

Reference: Tennessee Valley Authority's 10CFR Part 21 Notification Letter Dated January 4, 2013 and Flowserve Letter to the NRC dated January 25, 2013.

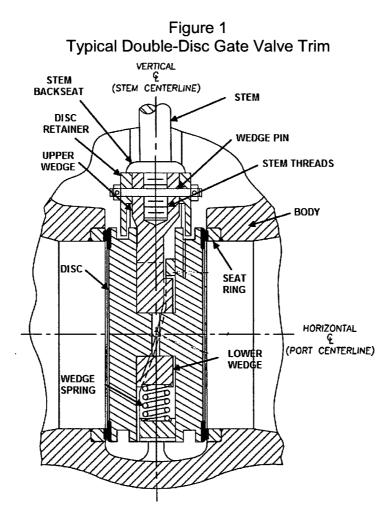
Flowserve has been working with the Tennessee Valley Authority's (TVA) Browns Ferry Nuclear Plant to investigate the failure of a Size 10, Class 900 Anchor/Darling motor-operated double-disc gate valve. The failure was due to the shearing of the wedge pin which serves a joint locking function at the threaded interface between the valve stem and upper wedge. The pin is designed to ensure that the joint does not loosen due to vibration and other secondary loads. On some valve designs, the pin also is used to attach the disc retainers to the upper wedge. The pin shearing allowed rotation of the stem during the closing stroke when the valve was seating and ultimately resulted in loss of the stem to upper wedge joint integrity.

Flowserve has completed an evaluation of the failure and concluded the root cause of the wedge pin failure was excessive load on the pin. The stem operating torque exceeded the torque to tighten the stem into the upper wedge before installation of the wedge pin. The additional stem torque produced a load on the wedge pin creating a stress which exceeded the pin shear strength causing the failure. The recommended assembly stem torque did not envelope the operating torque for the TVA application providing the potential for an over load situation and ultimate failure. The operating torque for the TVA valve was unusually high due to the fast closing time of the actuator and very conservative closing thrust margin.

The stems on most double-disc (DD) gate valves larger than size 2" are attached to the upper wedge using UN threads. A pin is installed through the hub of the upper wedge and stem threaded section to prevent the stem from loosening and eventually unscrewing from the wedge. In addition, the disc retainers on some DD gate valves are attached using the wedge pin. See Figure 1. The output torque of the actuator is transmitted to the stem/wedge joint through the stem and is resisted by the disc wedge pack, therefore the stem to wedge connection is loaded by the stem torque and thrust. The wedge pin is not designed to withstand the full actuator output torque. The actuator torque direction tends to tighten the stem into the wedge during closing and tends to loosen the stem during opening.

Flowserve recommends that all critical Anchor/Darling Double-Disc Gate valves with threaded stem to upper wedge connections and actuators that produce a torque on the stem be evaluated for potential wedge pin failure. Valves with electric motor actuators which produce high output torques are the most susceptible to failure. Valves which were assembled with stem torques that exceed the operating torque are not candidates for failure.

There is no test or inspection method to determine if the stems were completely torqued into the upper wedge prior to pin installation. Abnormal rotation of the stem immediately after valve seating or unseating, short valve stroke, or poor, unusual operation are signs of possible issues and should be investigated. Valve stems which have any gap between the stem backseat and top of the upper wedge need to be re-torqued. Valves with operating torques greater than the stem installation torque should be corrected by increasing the stem installation torque to at least the maximum expected operating stem torque. As provided in the Anchor/Darling 12/05 instruction manual, the existing stem can be reused by torqueing and drilling for a new pin if it is greater than 1.50" diameter and not reused previously. Stems of 1.50" and less diameter or stems which cannot be re-drilled for a new pin should be replaced.
