SUBJECT: MITSUBISHI HEAVY INDUSTRIES – REQUEST FOR WITHHOLDING ROOT CAUSE ANALYSIS AND SUPPLEMENTAL TECHNICAL EVALUATION REPORT INFORMATION FROM PUBLIC DISCLOSURE

San Onofre Nuclear Generating Station, Unit 2 & 3 REPLACEMENT STEAM GENERATORS

Root Cause Analysis Report for tube wear identified in the Unit 2 and Unit 3 Steam Generators of San Onofre Nuclear Generating Station

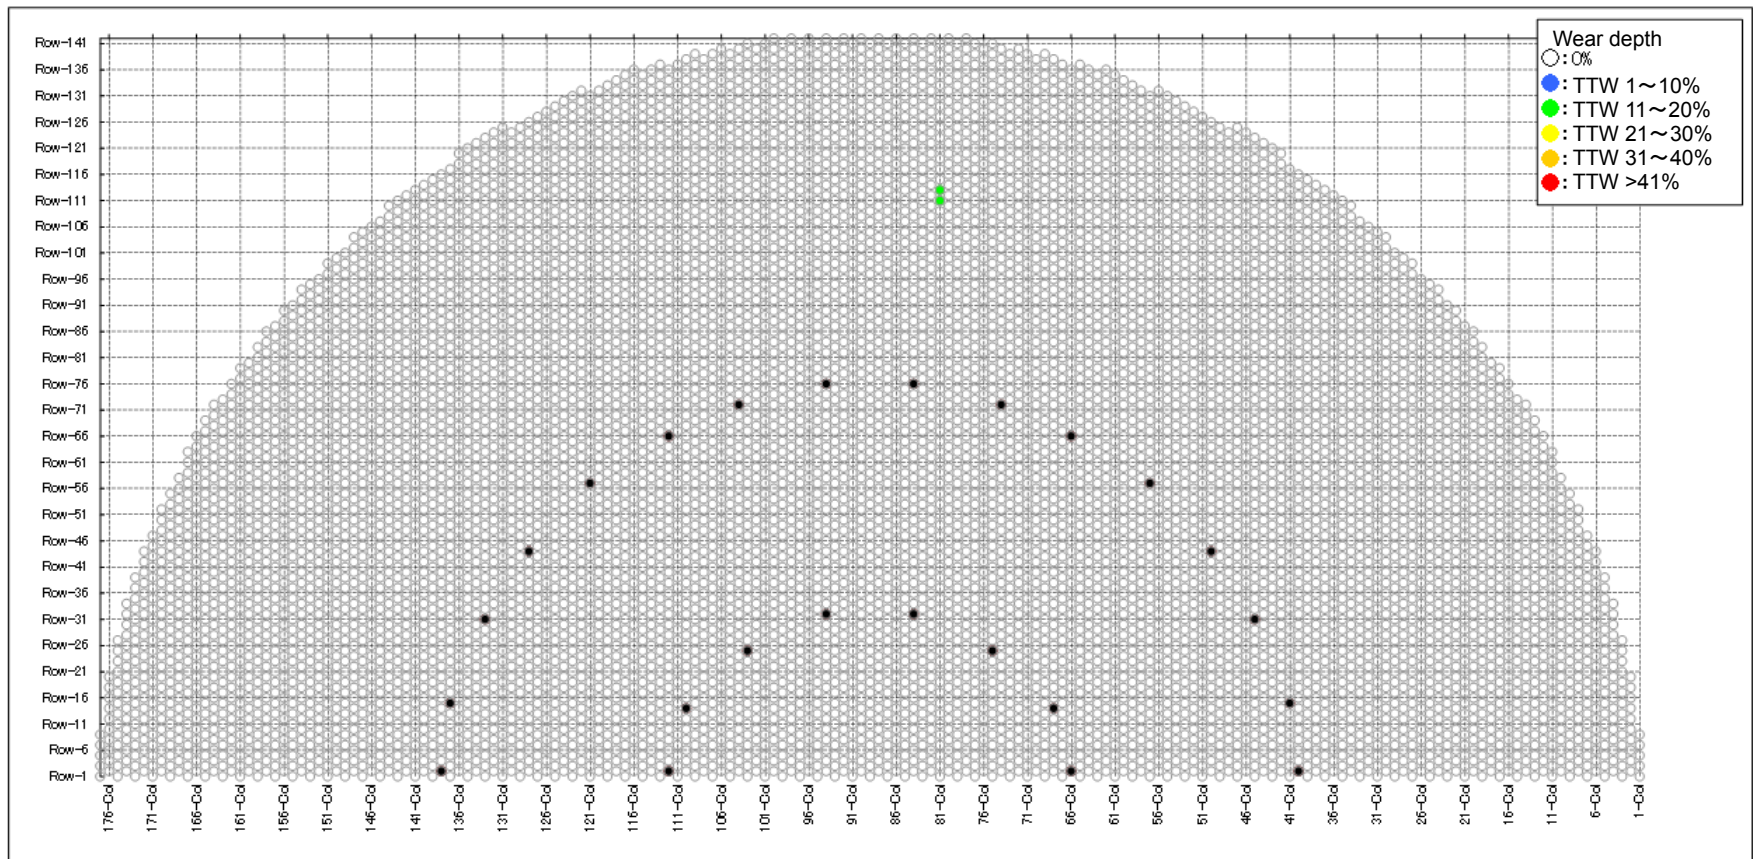
Fig 2.1-1 (1/2) Unit 2 Tubes with TTW indications

2A-SG (Unit 2 E089)

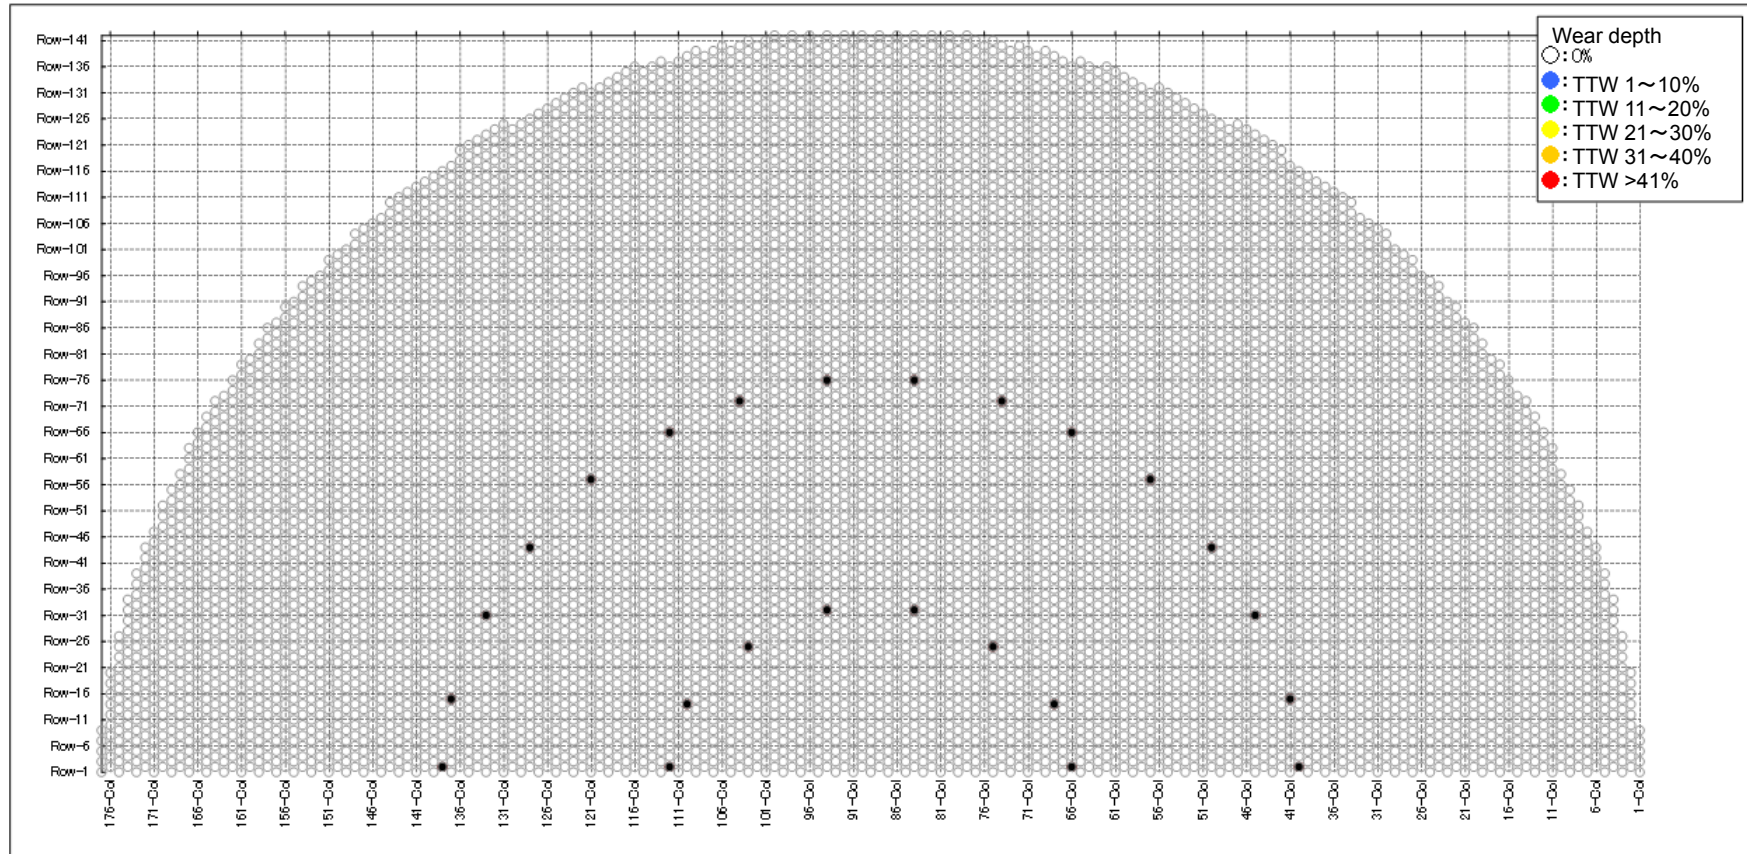
Fig 2.1-1 (2/2) Unit 2 Tubes with TTW indications

2B-SG (Unit 2 E088)

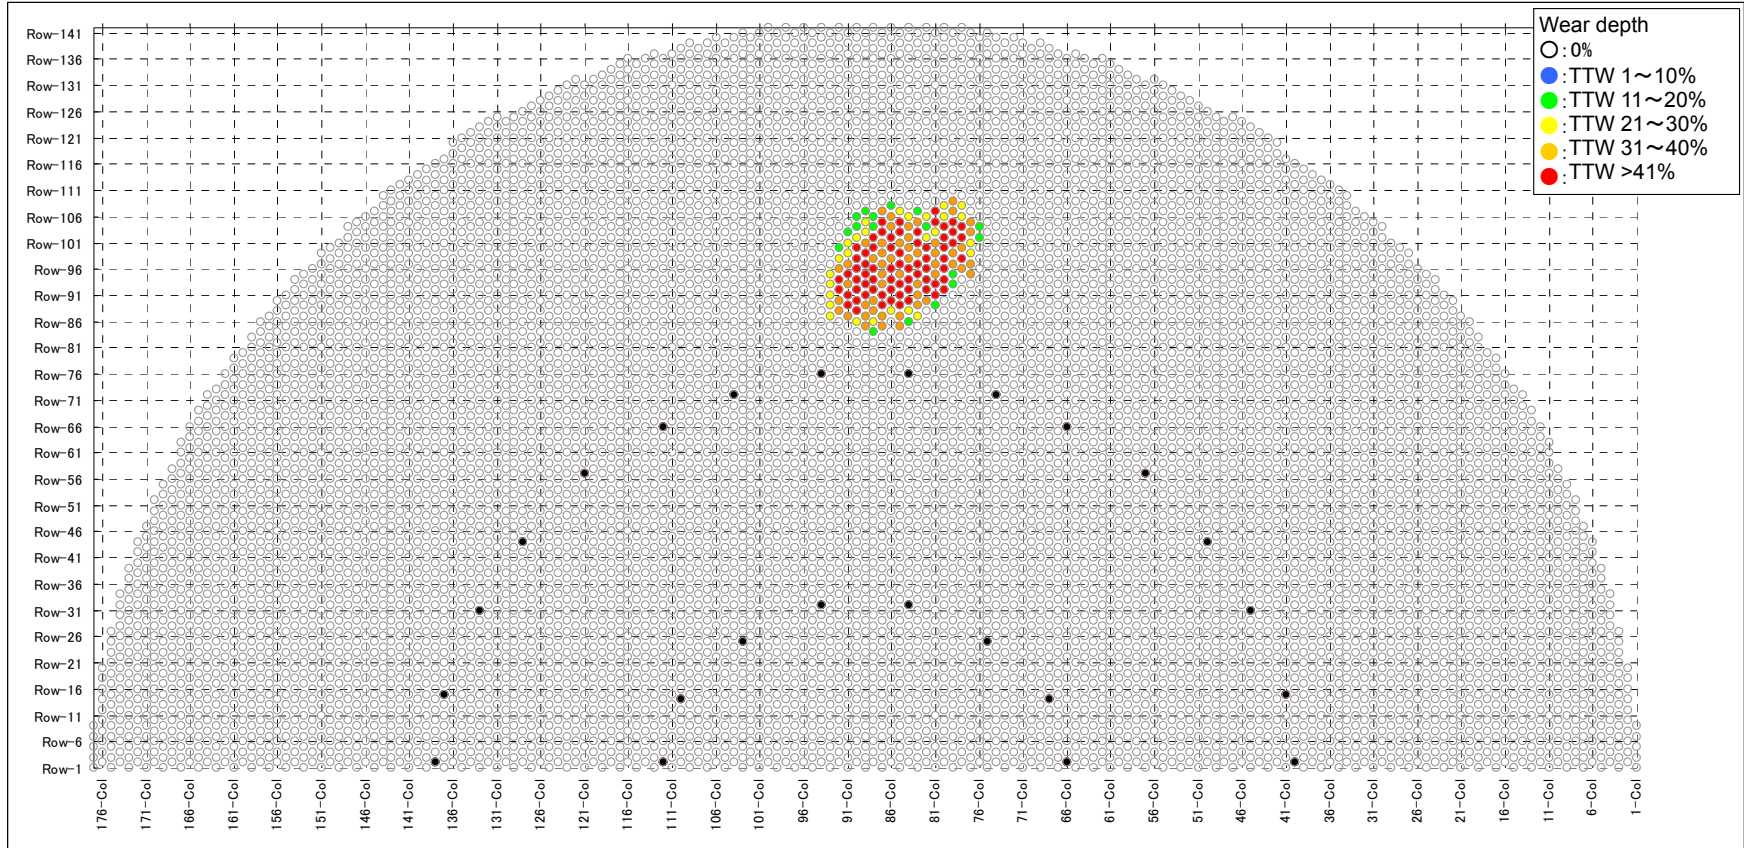
Fig 2.1-2 (1/2) Unit 3 Tubes with TTW indications

3A-SG (Unit 3 E089)

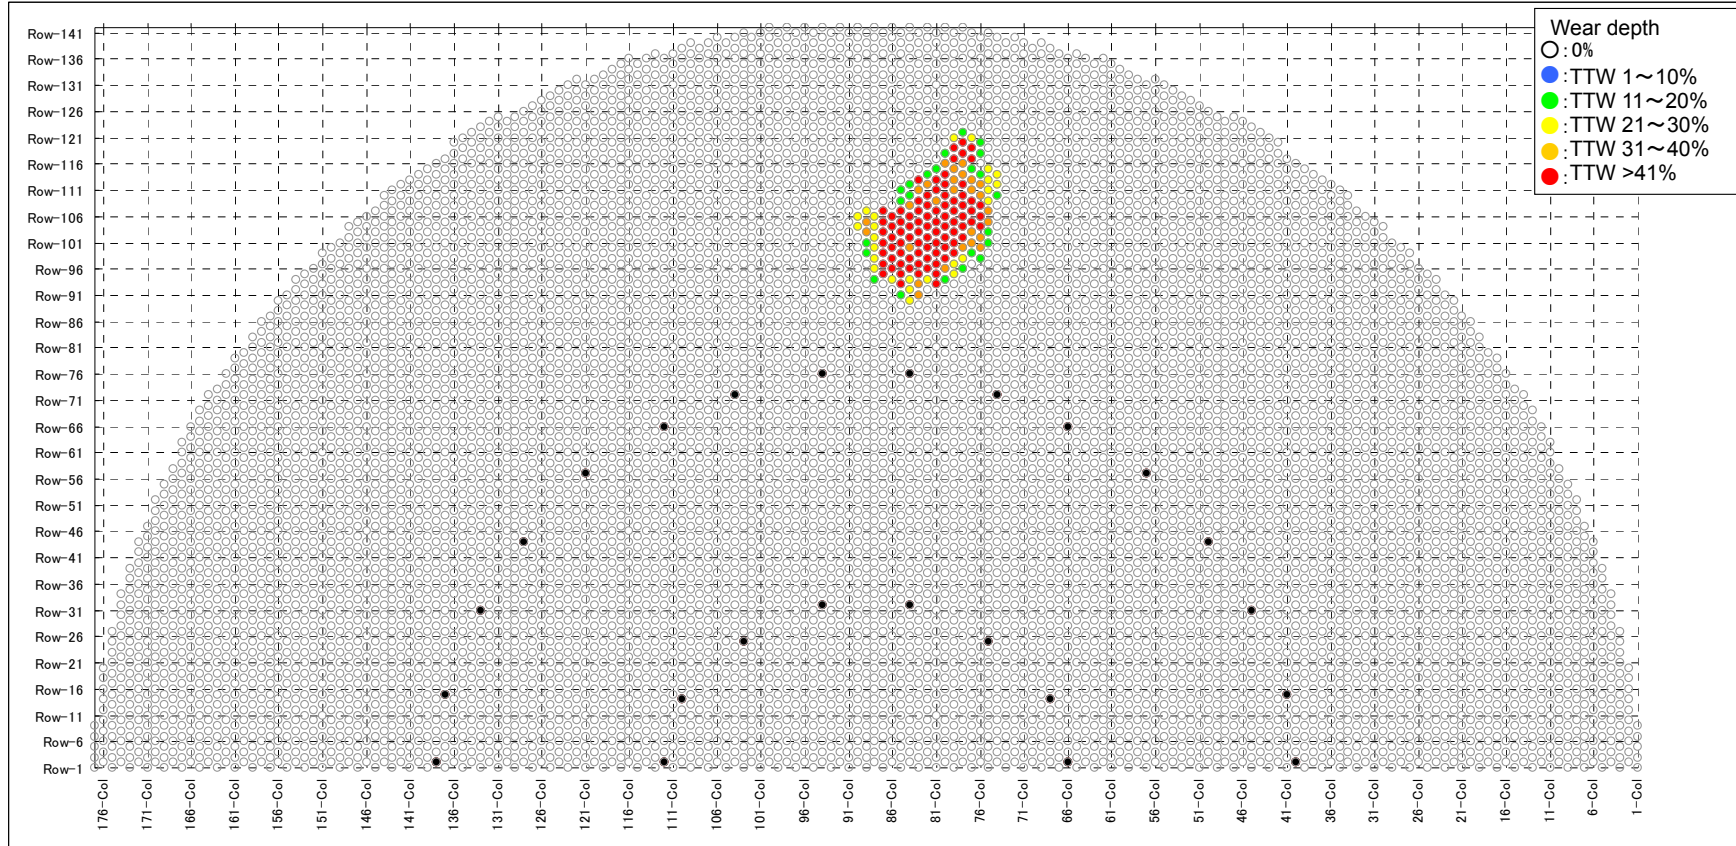
Fig 2.1-2 (2/2) Unit 3 Tubes with TTW indications

3B-SG (Unit 3 E088)

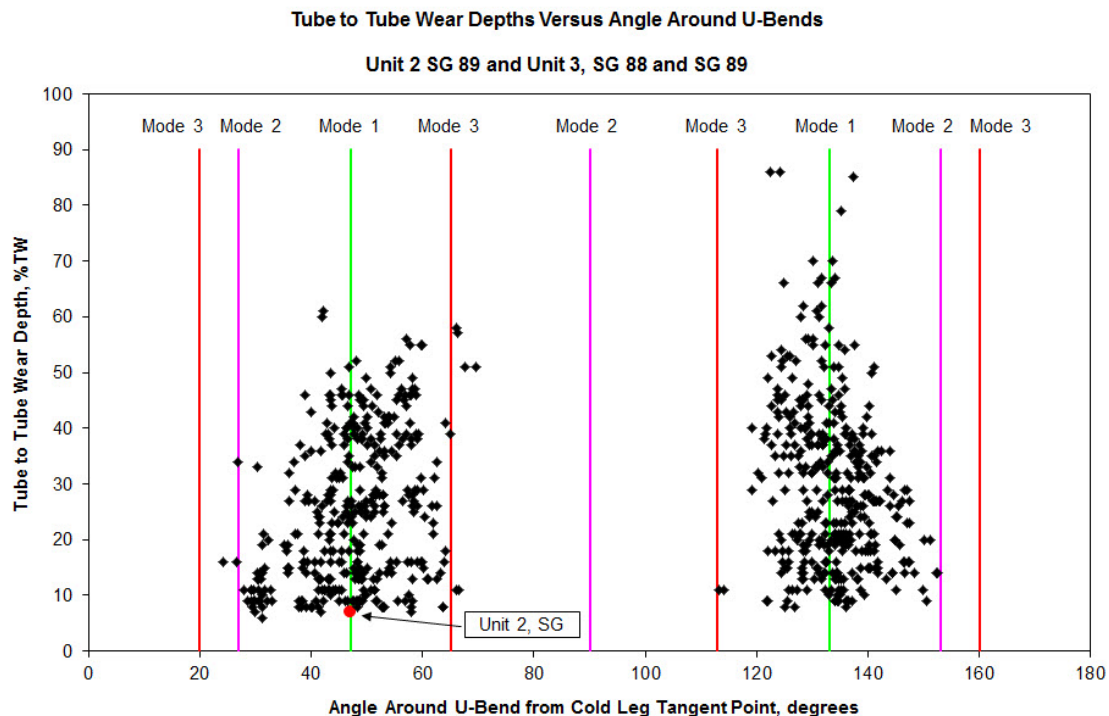
Fig. 2.3.3-1 Location of deepest wear along the length of each TTW wear scar

The locations of the Unit 3 and Unit 2 TTW wear indications along the U-tube arc length are depicted in Fig. 2.3.3-1 taken from AREVA's "SONGS U2C17 Steam Generator Operational Assessment for Tube-to-Tube Wear " No. 51-9187230-000 (Ref. 4).

From this figure it can be seen that the TTW indications are grouped at the 45/135 degree positions of the U-bend. This figure also identifies the theoretical tube-to-tube contact points associated with the first three natural frequency modes for in-plane tube vibration. The Mode-1 tube-to-tube contact points are also located at the 45/135 degree positions of the U-bend.

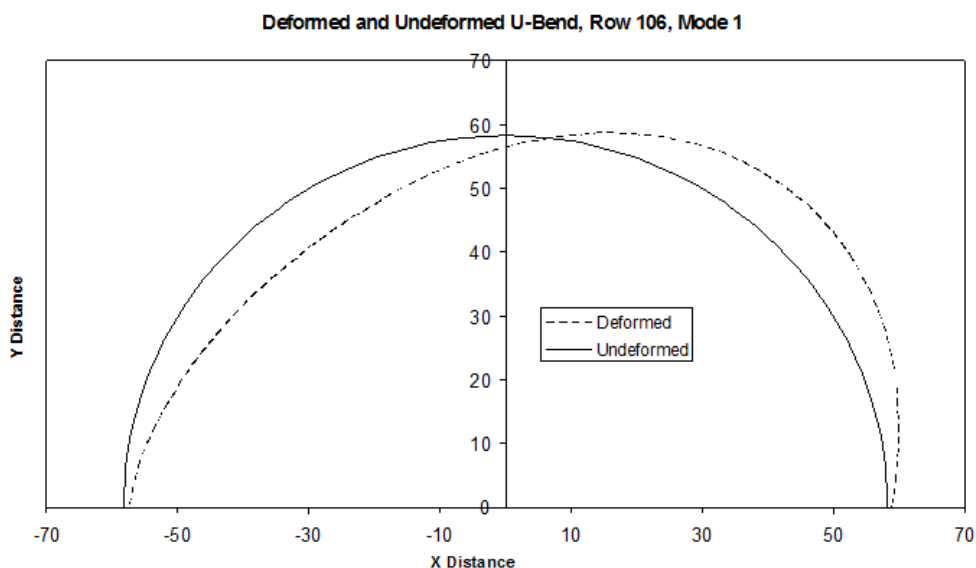
Fig.2.3.3-2 The large amplitude deformation of a U-tube in the first in-plane mode

Fig. 2.3.3-2 is also taken from the AREVA Operational Assessment report (Ref. 4). This figure shows the large amplitude deformation of a U-bend tube in the first in-plane mode (i.e. Mode 1).

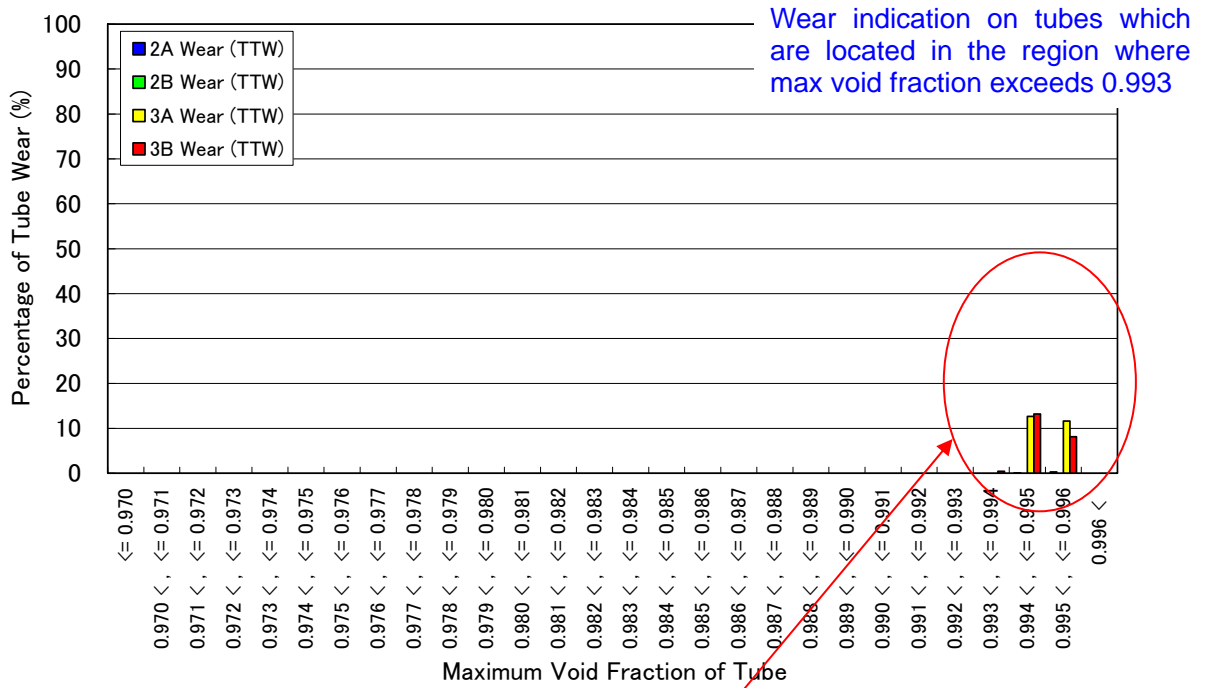
Fig.2.3.4-4 Correlation between Type 1 Wear (TTW) and Void Fraction (Steam Quality)

Fig. 2.3.4-4 shows the correlation between void fraction and steam quality with the percentage of tubes at different levels of void fraction and steam quality that have Type 1 wear. The 328 tubes that had Type 1 wear fall within the region of steam quality of [] to [] and void fraction of [] to 0.996. However, less than [] of the Unit 3 tubes in this region of high steam quality and high void fraction have Type 1 wear. Fig. 2.3.4-4 displays the same data as shown in Fig. 5.1-2 in the TER (Ref. 1). The TER (Ref. 1) also discusses the relationship between high velocity and Type 1 wear for which the correlation is not as strong.

Strong correlation between the number of tubes with wear and void fraction (steam quality)

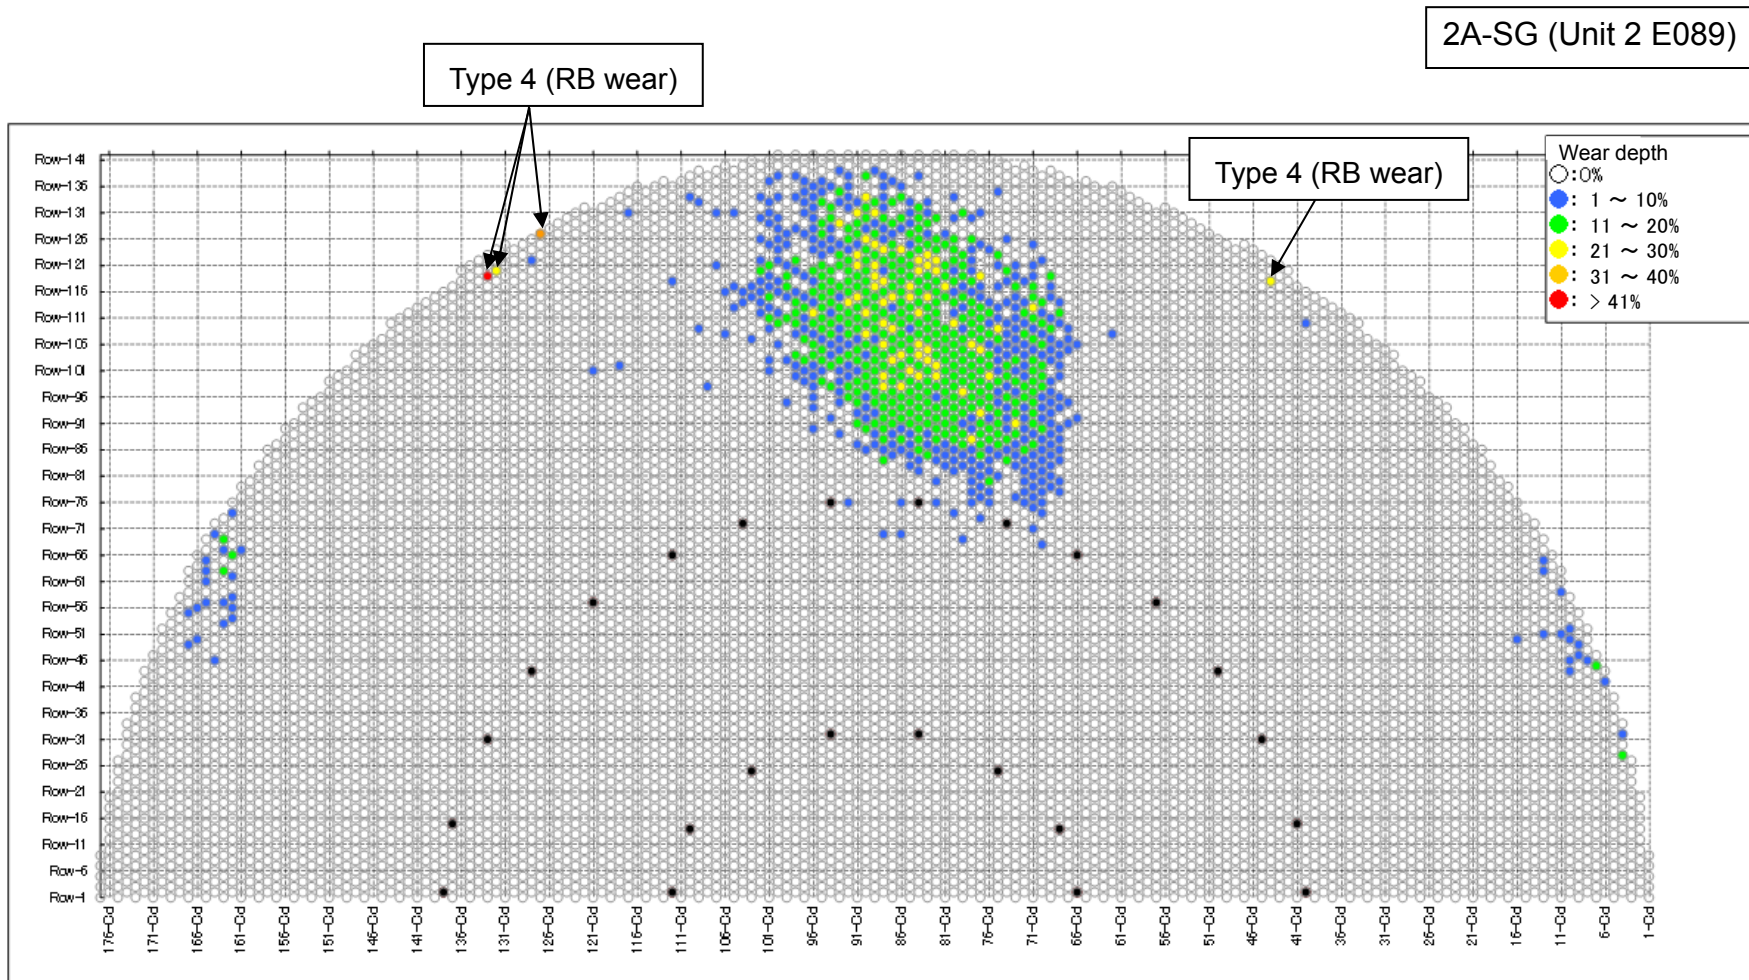
Fig 3.1-1 (1/2) All Unit 2 U-bend tube indications
(Type 1 TTW, Type 2 Tube-to-AVB and Type 4 Retainer Bar to Tube)

Tubes with Type 2 (AVB wear) indications are characterized by wear at the tube-to-AVB intersections with no free-span wear indications. They are produced primarily by U-bend tube vibration without any contribution from straight leg vibration although there are a few TSP wear indications on some of them. The locations of the tubes with wear indications at the tube-to-AVB intersections, including Type 2 wear, are shown in Fig. 3.1-1 (Unit 2) and Fig. 3.1-2 (Unit 3). The same data is shown on Fig 4.1.1-2 of the TER (Ref.1).

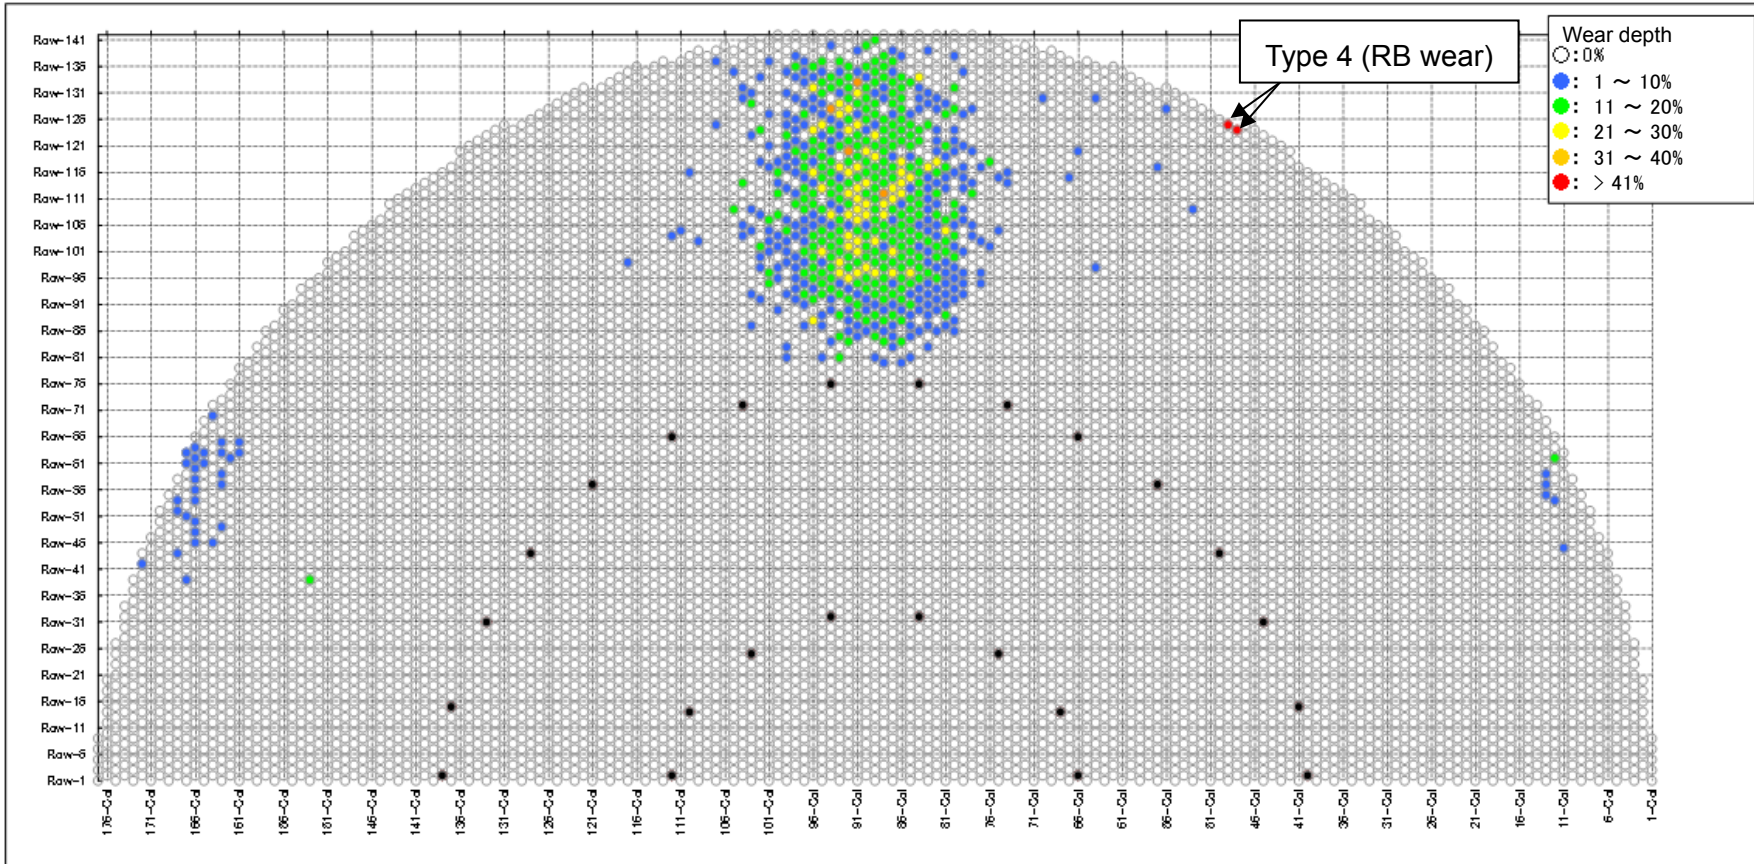
Fig 3.1-1 (2/2) All Unit 2 U-bend tube indications
(Type 1 TTW, Type 2 Tube-to-AVB and Type 4 Retainer Bar to Tube)

2B-SG (Unit 2 E088)

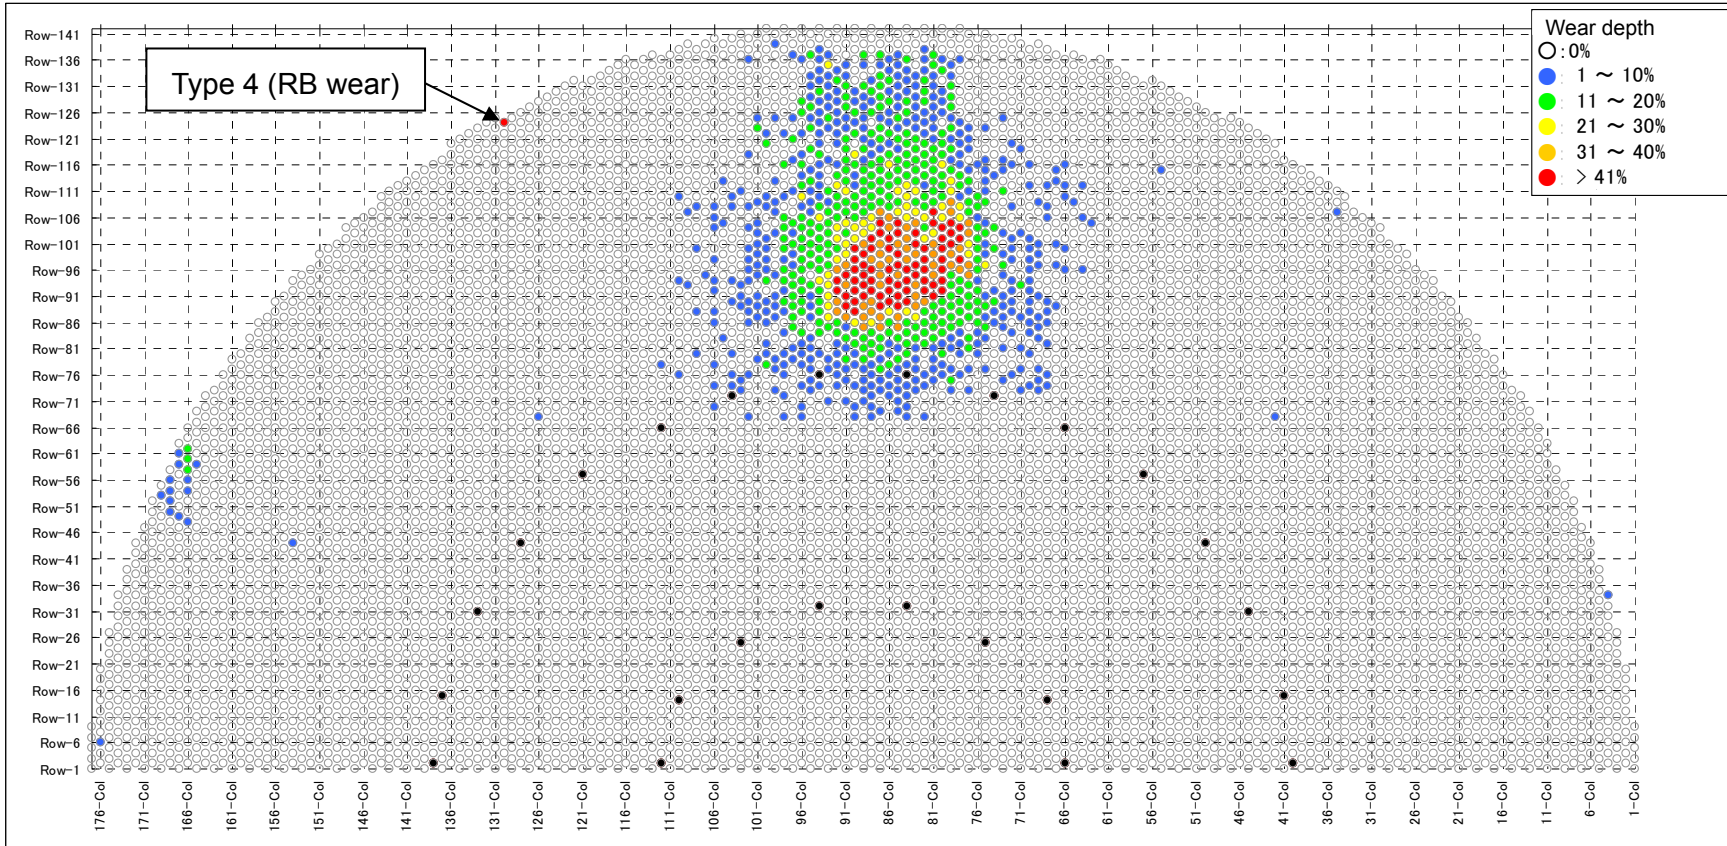
Fig 3.1-2 (1/2) All Unit 3 U-bend tube indications
 (Type 1 TTW, Type 2 Tube-to-AVB and Type 4 Retainer Bar to Tube)

3A-SG (Unit 3 E089)

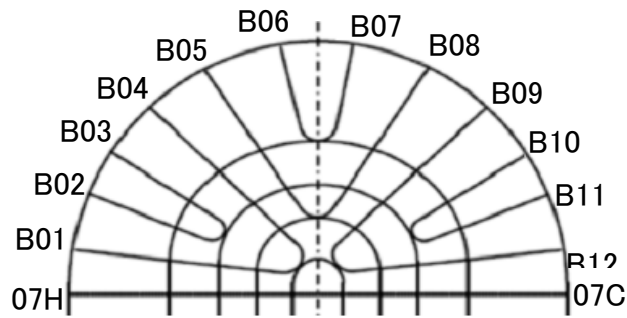
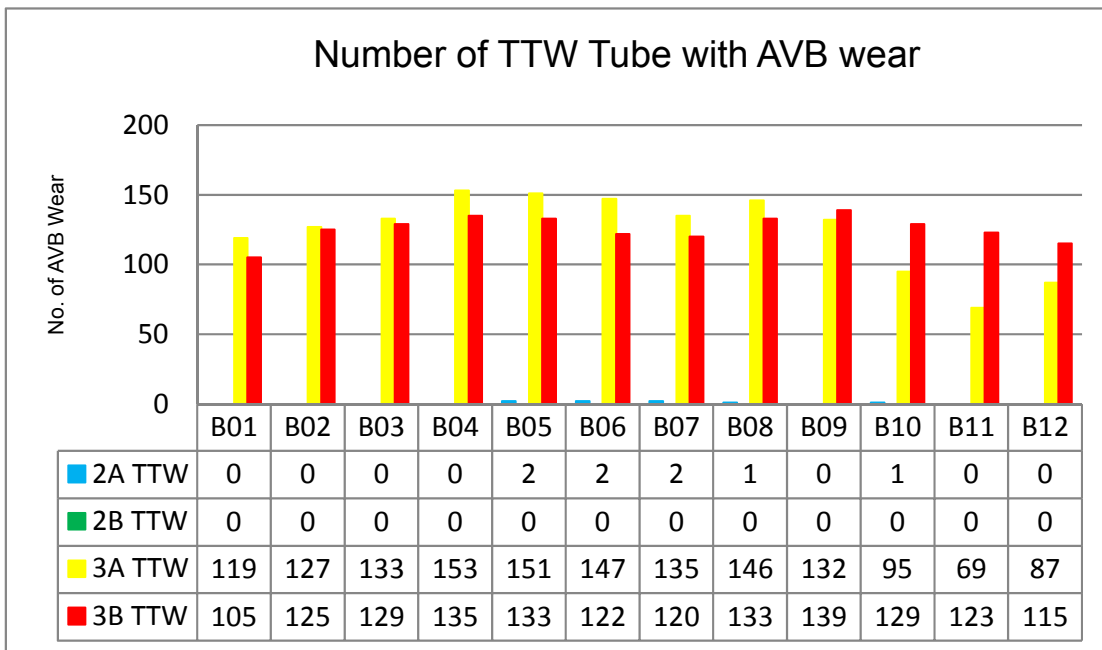
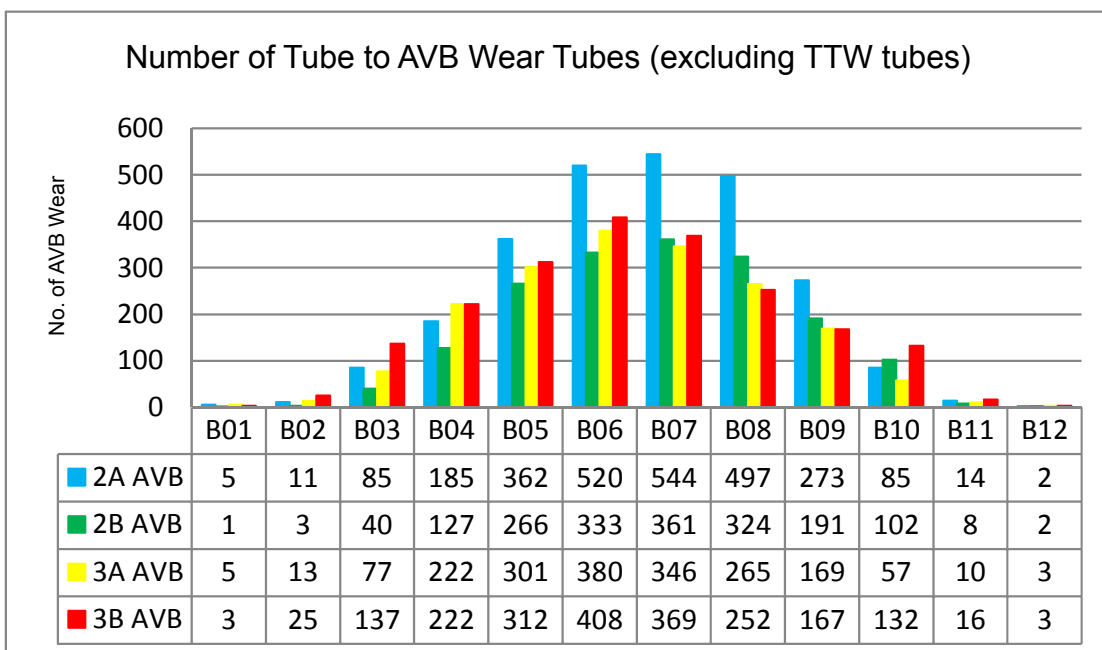
Figure 3.5-1 AVB Tube Wear Number Comparison

- 3) The average 10% of AVB wear depth in Unit 2 and Unit 3 excluding TTW tubes is almost the same. (See Fig. 3.5-2.) Therefore, if random vibration were a precursor to in-plane FEI one would expect to see a similar number of tubes with tube-to-tube wear in the two RSG units. However, Unit 2 only has 2 tubes with TTW.
