**Subject: October 2012 Inspection Report
Cameco Resources, Permits 603 & 633**

OCTOBER 2012 INSPECTION REPORT

PERMITS 603 & 633

LOCATION: North of Glenrock, Converse County (Smith-Highland Ranch Uranium Project)

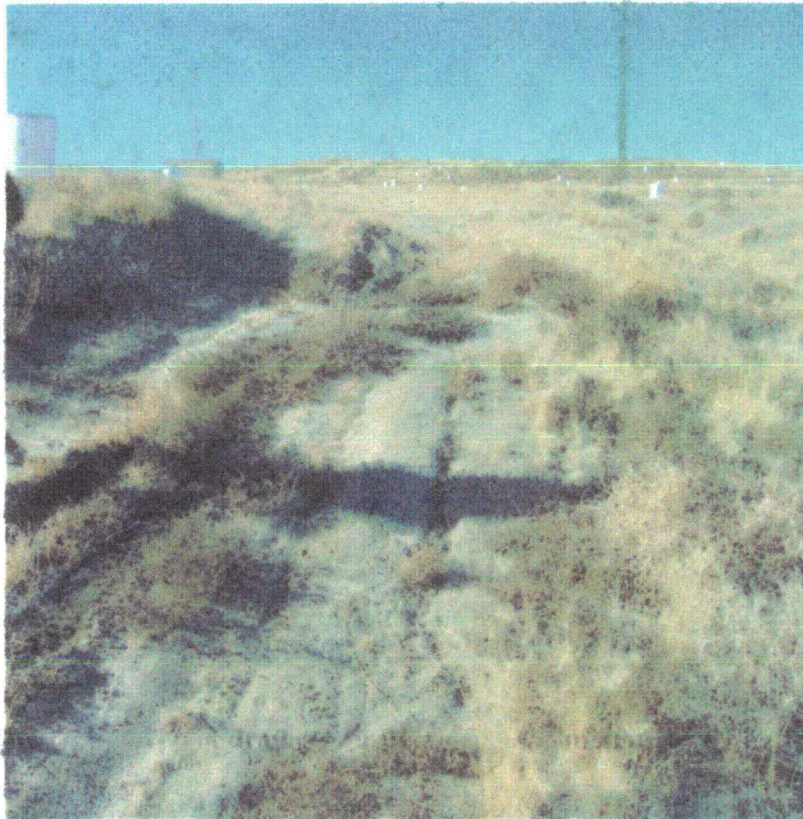
The release that occurred on October 16, 2012 at injection well 91-209 was observed during the inspection. The affected area of the spill was not delineated on the ground surface with flagging or markers. The affected area was speculated by CR during the inspection. The spill included approximately 50 gallons of injection fluid. The release was thought to have traveled along a two track, and then diverted downslope into a dry draw. Straw waddles or other protection was not identified to restrict flow from the spill. It is believed that the fluid was rapidly absorbed into the native soils negating the need to provide protective barriers. The actual affected area of the dry draw could not be determined during the inspection (Figure 1).

Figure 1 Flow path of wellfield release from Well 91-209; not delineated.

To allow opportunity for inspection verification of potential pollution to surface waters of the State, it is requested that all wellfield releases or other spills of radiologic or non-radiologic fluids/materials that enter surface waters of the State, be delineated with obvious markings for the inspectors to observe when on-site. These markings must be maintained until the State inspector has had opportunity to observe the spill area unless otherwise instructed by LQD. Please delineate with pin flags or other adequate surface delineation methods, the spill area for all releases that potentially affect waters of the State.

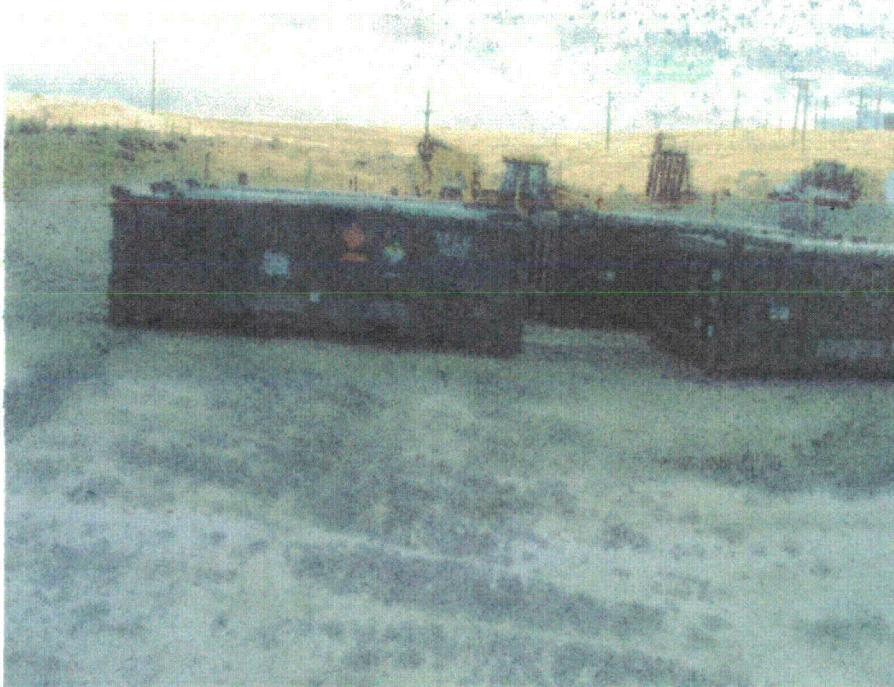
The ongoing investigation of the East Impoundment, believed to have subsurface leaks, was inspected. CR was in the process of moving the perimeter fence to make room for equipment to install a new liner and to install waste disposal tanks (Figure 2) for pre-disposal filtering of

waste water discharged to the impoundment. The plan is to use 60 mil, High Density Polyethylene (HDPE), which is an upgraded heavier material, to line the pond. It will be placed on top of the old liner (XR-5 30 mil). The previous liner was replaced in 2005. Currently, the pond construction consists of a low permeability clay liner as the base material. A fine sand layer lies on top of the clay. The sand is overlain with the XR-5 30 mil poly liner. An accumulation of contaminated sediment has built up on top of the poly liner. CR intends to remove the sediment and dispose into the new imported waste tank. The tank will store 11e(2) by-product waste requiring disposal at an accepting facility in Utah. Following removal of the contaminated sediment, CR will place the new liner on top of the old liner.

Due to leakage through the old poly liner, contaminated waste water has been detected in the sand layer as detected by a monitor well which monitors the sand layer. CR does not plan to replace the sand layer during the repairs to the liner.

Figure 2 View of tanks imported for disposal of clean-out sediment (11e(2) byproduct) from the East Impoundment.

- 2 The addition of storage tanks for the byproduct waste at the East Impoundment facility will need to be added to the surety, if it not already included in the surety. Please add this cost to the 2012-2013 surety estimate.

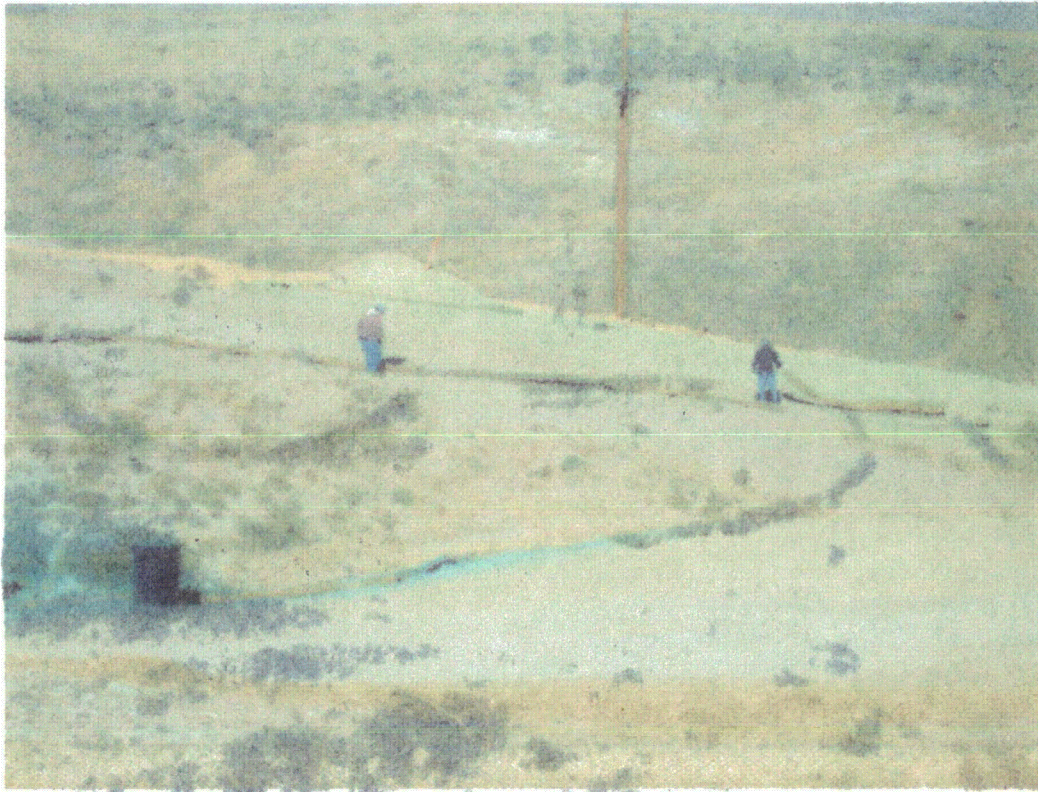
The sandy soil condition of the southwest permit area has resulted in disturbance that is difficult to reclaim. Reclamation crews were actively installing straw waddles along a channel that has been disturbed by well installation operations (Figures 3&4). CR emphasized that this was a second attempt to stabilize and revegetate the drainage disturbance. It was noted that earthen dams are installed across drainages to contain surface runoff. It appears these impoundment features are utilized to protect the wells located downstream of the dams (Figure 5&6).

Figure 3 View of drainage protection installation in MU-9.

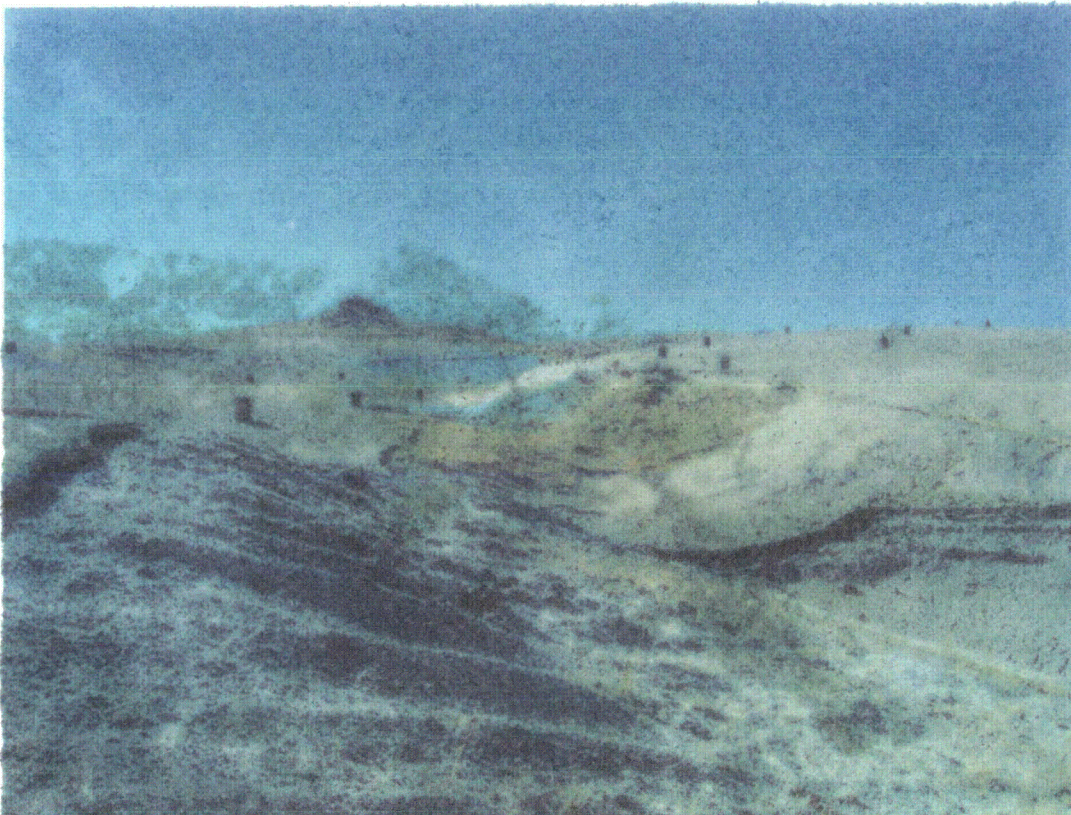
Figure 4 View of hydro seeded areas of the drainage in Figure 3.

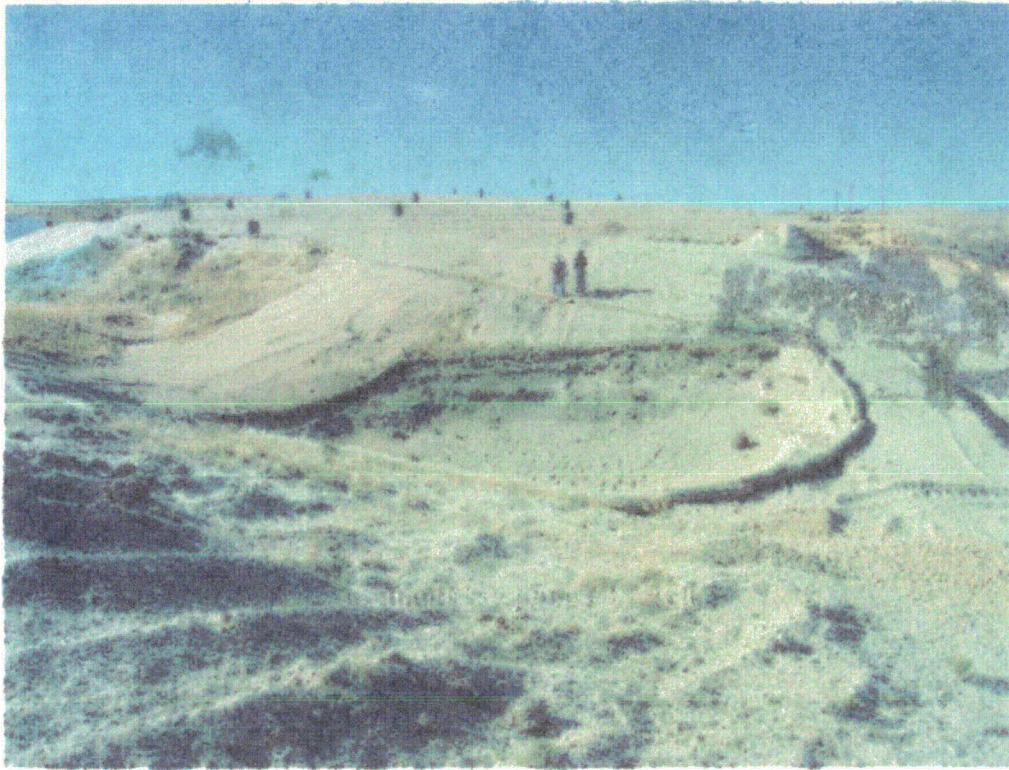
Figure 5 View of earthen dam across drainage in Figure 4.

- 4 CR has constructed earthen dams across channels as flood control and/or erosion control structures to protect wells in the mine units and to enhance surface reclamation success following installation of a wellfield. The inspector has noted these structures during wellfield inspections of several mine units. LQD Guideline 4, Reference Document 5 provides minimal discussion of these structures as it has not been intuitively obvious that these structures are routinely used at ISL mine sites. LQD Guideline 13, Section V provides more detailed discussion for *Pit Protection or Flood Control Structures* including *designs should be directly incorporated into the permit.*

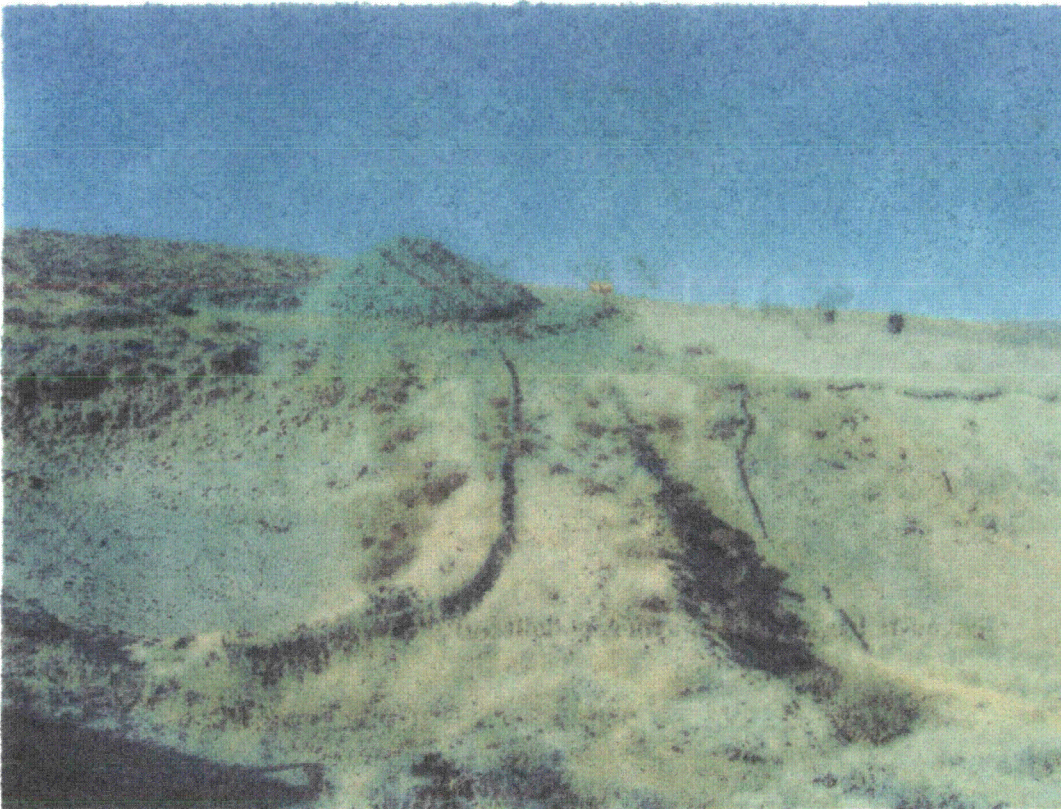
Figure 6 View of earthen dam across drainage.

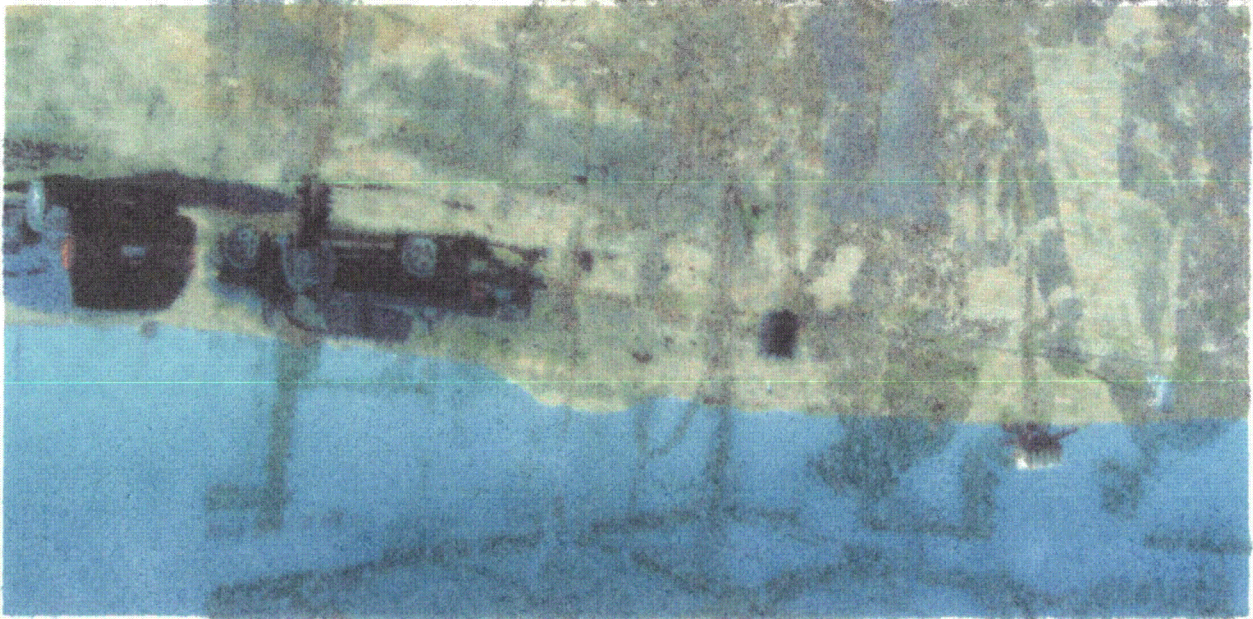
A brief inspection stop was made where Telesto (consultant) was sampling wells installed for the CLI. The CLI wells are distinguished by black well covers (Figure 7). The 3rd Quarter Report will include hydrostatic characteristics. CR has questions regarding restoration requirements for the contaminated aquifers. These will be addressed during a later meeting with LQD.

Figure 7 View of Telesto consultants sampling CIL well.

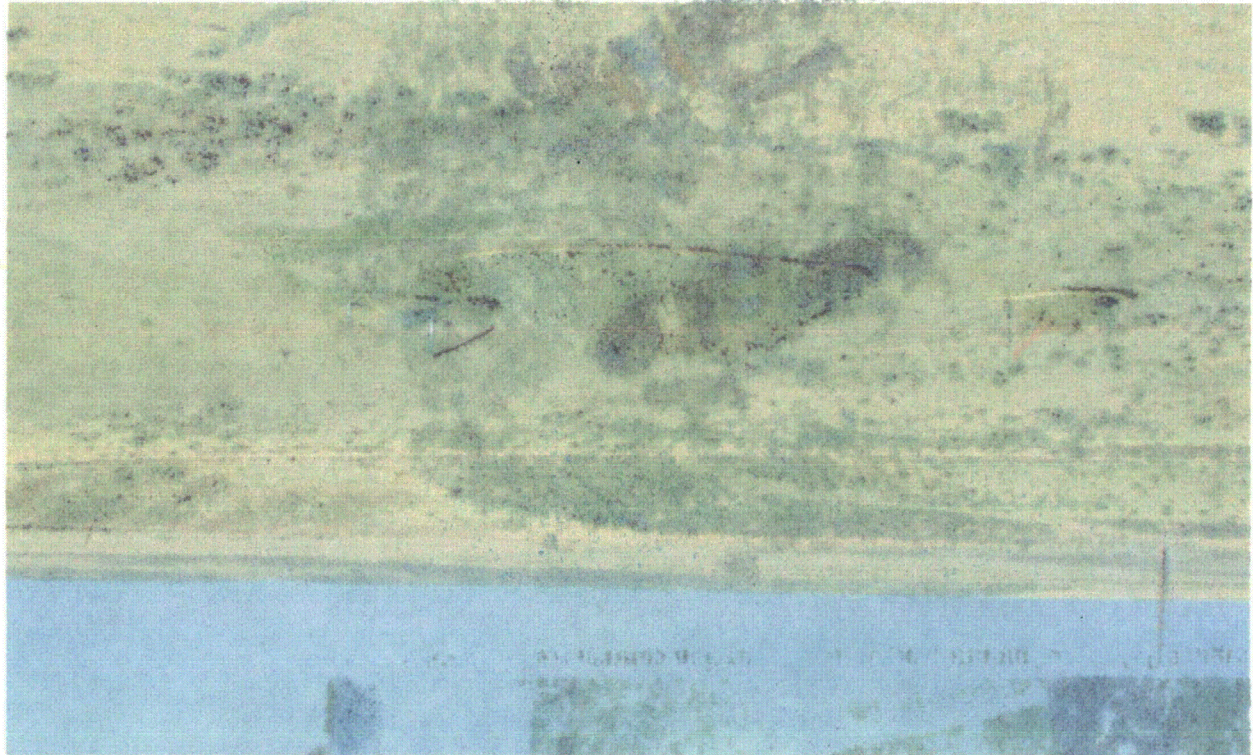
A new monitor well (**Figure 8**) was installed approximately 15 feet from well FM-009 in effort to draw excursion fluid back into the wellfield (as detected at FM-009). Production well FP-170 was re-piped into header house F-11 (**Figure 9**). Currently, no effect due to pumping of FP-170 has been identified at the either monitor well and well FM-009 remains on excursion.

Figure 8 View of new monitor well, installed to control excursion at FM-009.

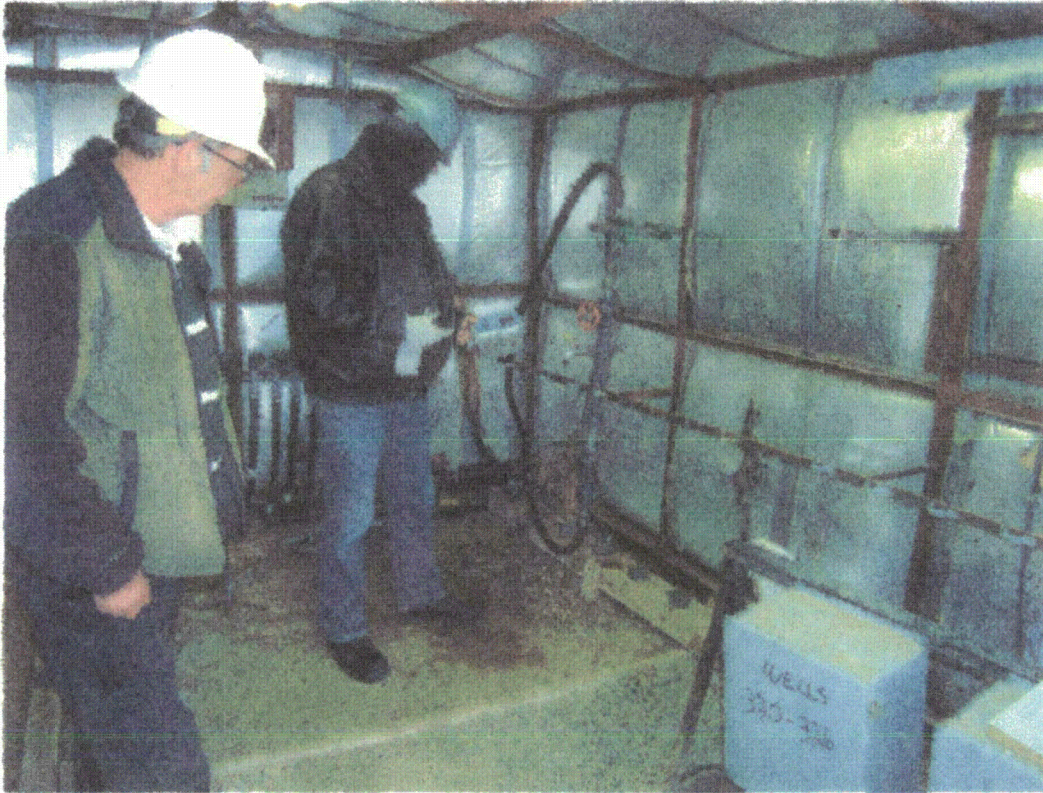
Figure 9 View of monitoring of new excursion control well (FM-009).

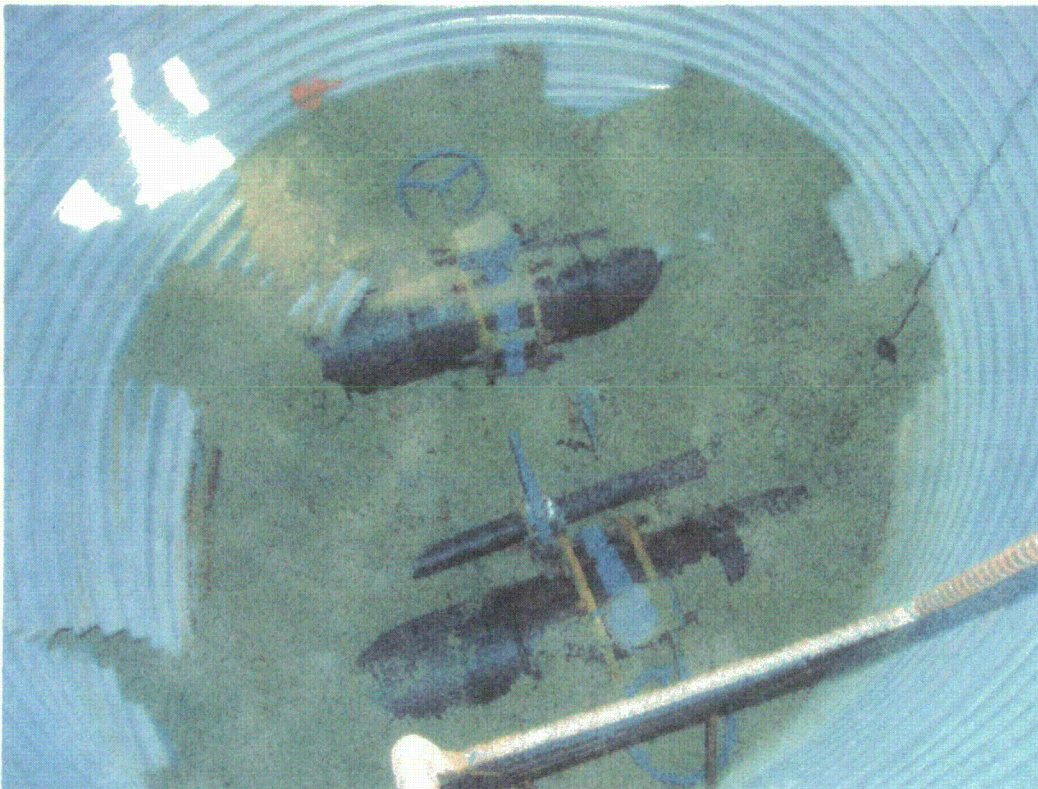
A production fluid release was reported from Bellhole No. 41 on March 10, 2012 adjacent to Mine Unit H. The cause was identified as failure of a steel tee in the bellhole. CR showed the replaced steel joints of the bellhole to the inspector using High Density Polyethylene (HDPE) pipe (**Figure 10**). CR is replacing the steel tees at bellholes in Mine Units H, F, and E to reduce the likelihood of a failure in additional bellholes.

Figure 10 Replaced pipe with HDPE in Bellhole 41.
