Re: **Summary of Bi-weekly Inspection of Lost Creek ISR LLC's Permit 788**

Wyoming Department of Environmental Quality (WDEQ)- Land Quality Division (LQD)
Inspection Memorandum

File: Lost Creek ISR, LLC – Permit 788

Date of Inspection: March 13, 2013

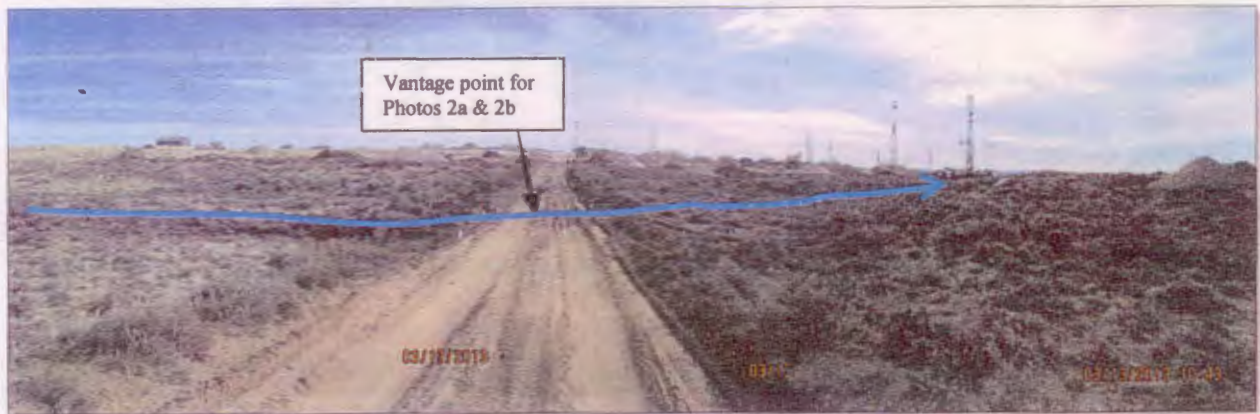
Photo Number 1: This panoramic is looking toward the east across the MUI Pattern Area from its west side. In the middle of the photo (blue line) is the large north-south drainage depicted in Photos 2a and 2b below.

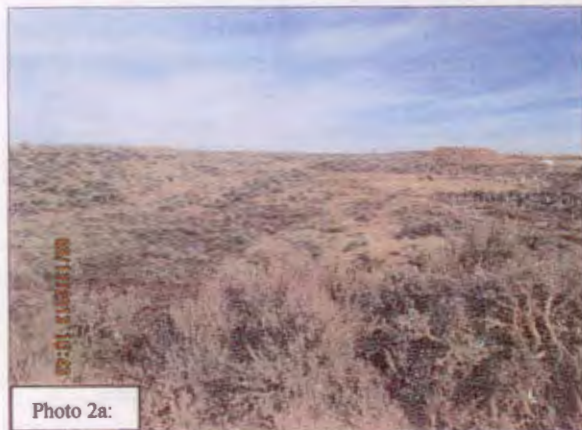
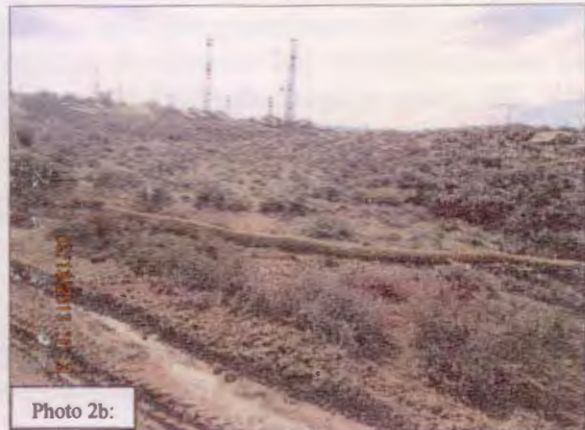
Wattles: LCI personnel have installed straw wattles in the western access road's ditches at culvert locations. This is still a work-in-progress and will continue to the eastern access road. Wattles have also been placed within the large ephemeral drainage that runs north-south through the MU1 Pattern Area (see attached Photo Addendum). **These wattle installations are applauded, as the project approaches its first spring run-off event.**

Photos Number 2a and 2b: Photo 2a is view looking toward the north (up gradient) in the large north-south drainage at the west end of the MUI Pattern Area. Photo 2b is a view looking south down the same drainage.

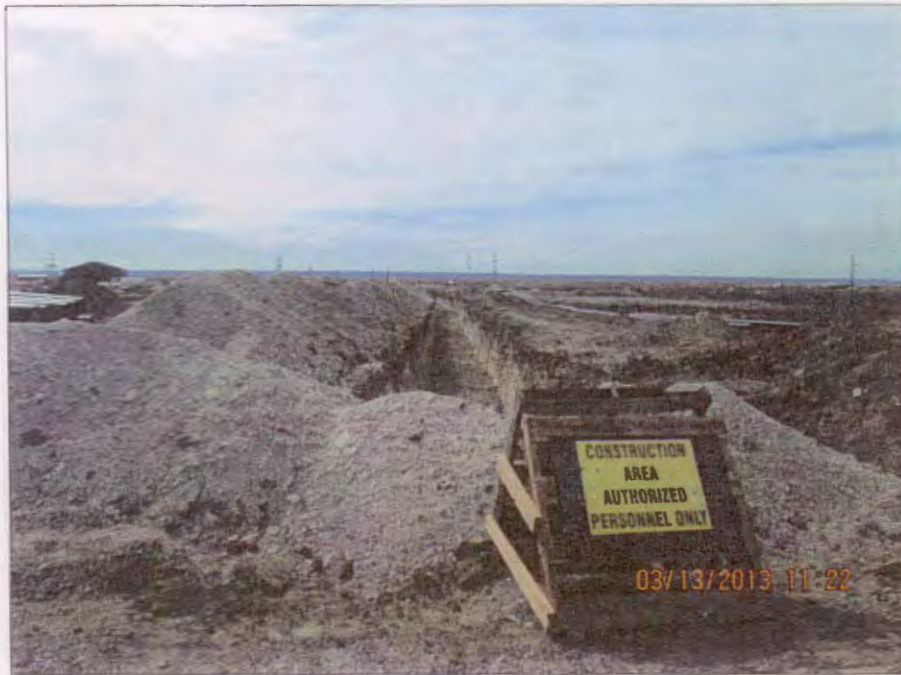
The Main Trunkline Trench, noted in previous weeks' Inspection reports has been lengthened and extended to the north significantly. During this Inspection, the trench was open to the main east-west access road (see Photo Addendum). Mr. Lueders indicated the portion of the trench that will run under the access road is anticipated to be dug, populated with pipe, and backfilled this upcoming Saturday (March 16). Pipe has begun to be placed in the trench in other locations (see attached Photo Addendum). **There are no concerns with the trench.**

Photo Number 3: This depicts the northern extent of the main trunk line trench, where it meets the access road. View is looking south.

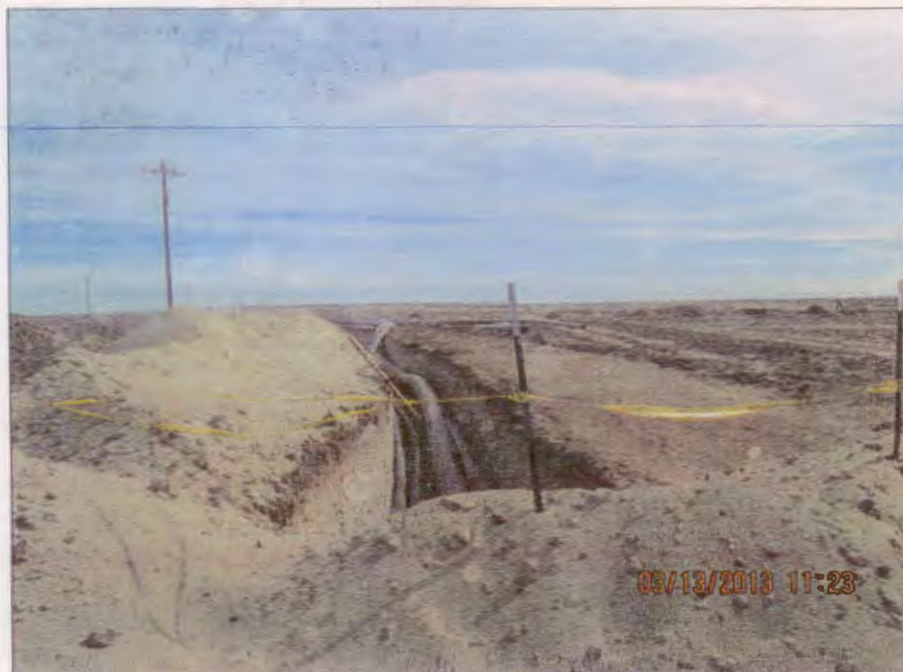
Photo Number 4: This depicts the portion of the main trunk line trench immediately north of the MU1 Pattern Area, where pipes were being laid. View is looking to the east.

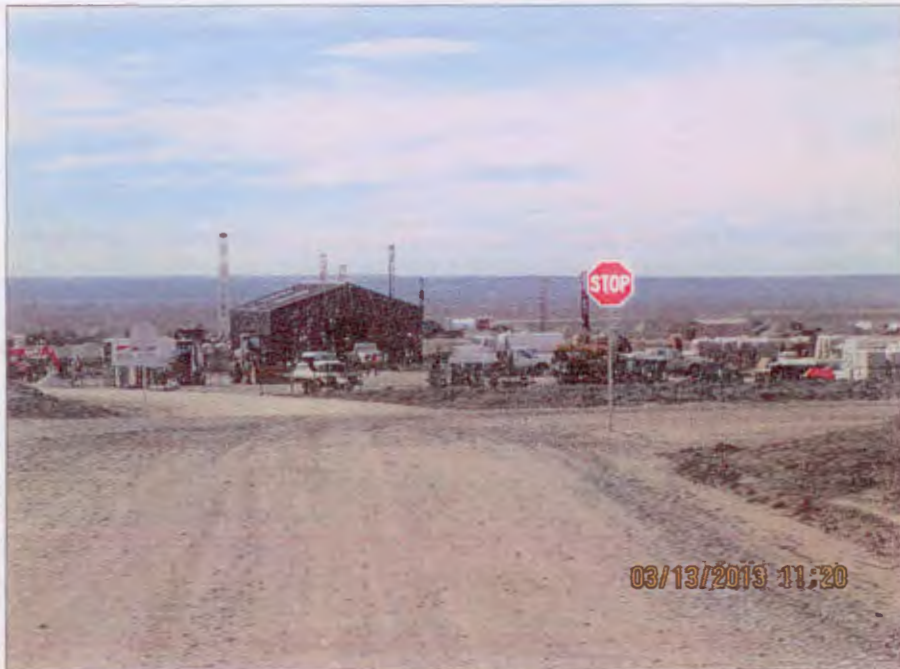
Photo Number 5: This depicts one of the four standard sized Stop signs that have been installed at the four-way intersection where the site's access road meets the road connecting the Plant to MU1. View is looking south.

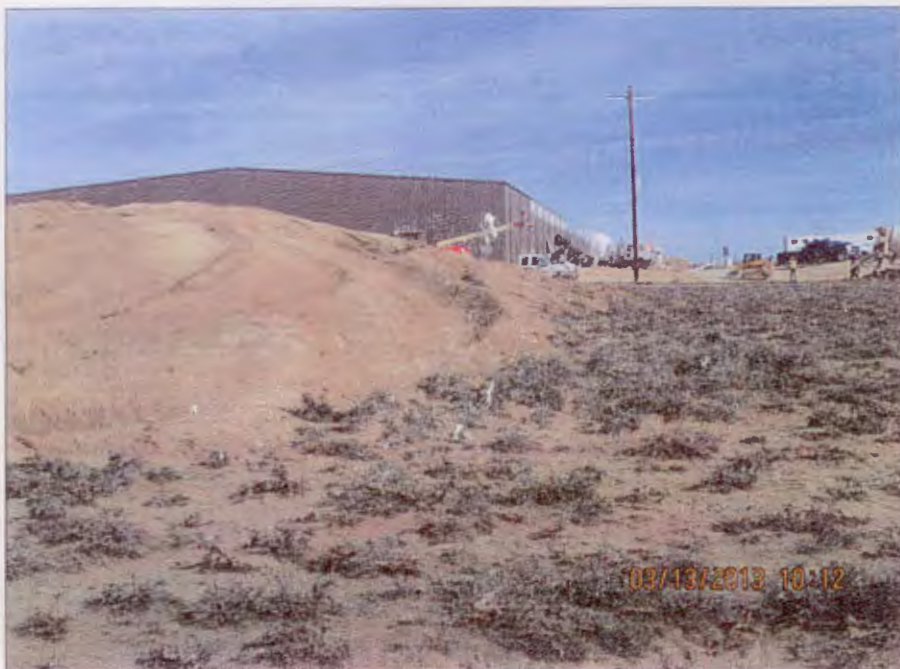
Topsoil stockpile v-ditches: The perimeter of some of the site's topsoil stockpiles are showing some sloughing of topsoil. That is, topsoil is falling off the stockpile onto native lands. This only occurring in minor amounts; however, it speaks to the **need to construct a toe ditch (v-ditch and berm) around the perimeter of the site's topsoil stockpiles**. This is not an immediate action item but should occur within the next couple of months.

Photo Number 6: This is a view looking north along the east edge of the topsoil stockpile (TS-15?) that is directly across the road from the temporary office complex. It has early indications of topsoil sloughing onto native lands. A toe ditch is needed around this (and other) site topsoil stockpile(s).

2. Toe ditches (v-ditch and berm) should be constructed around the perimeter of the site's topsoil stockpiles in the next couple of months.
3. If LCI plans to do a spring seeding, it should occur between now and mid-April.

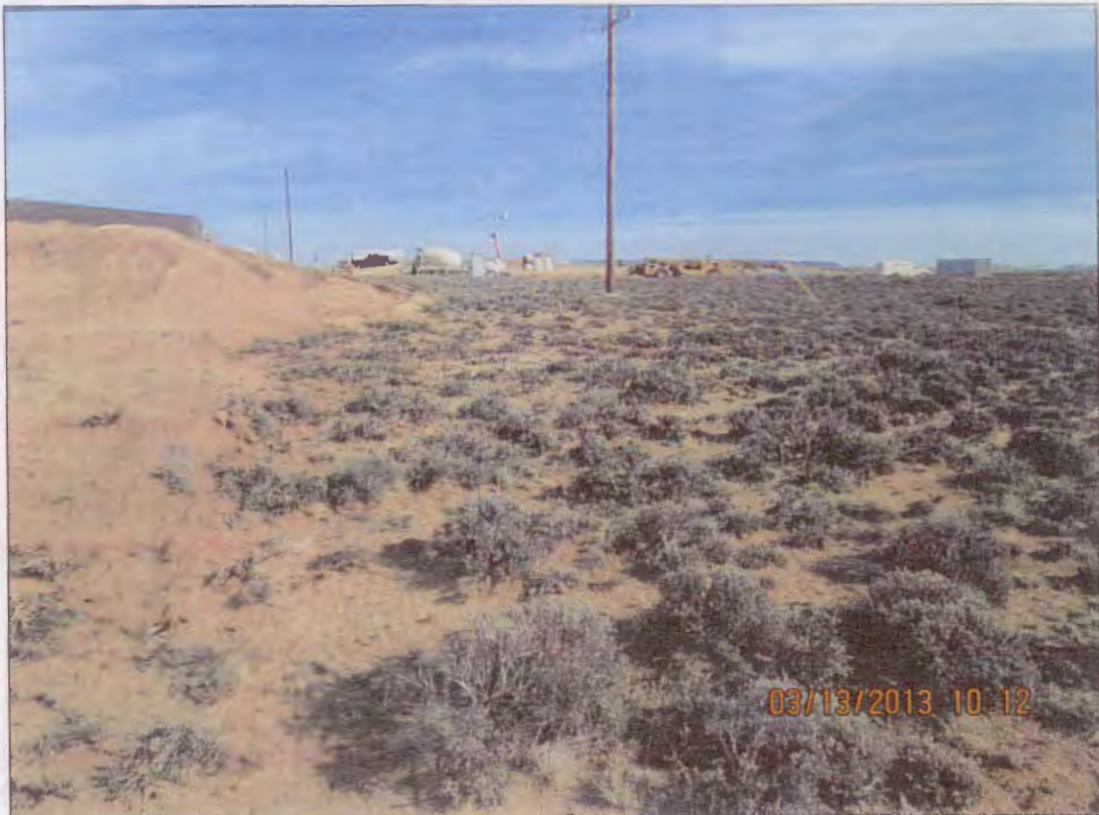
Photo Number 7: This depicts the south edge of the topsoil stockpile depicted in the photo above. In the foreground of this photo, topsoil from the stockpile can be seen on native ground. This speaks to the need to install toe ditches around the site's topsoil stockpiles.

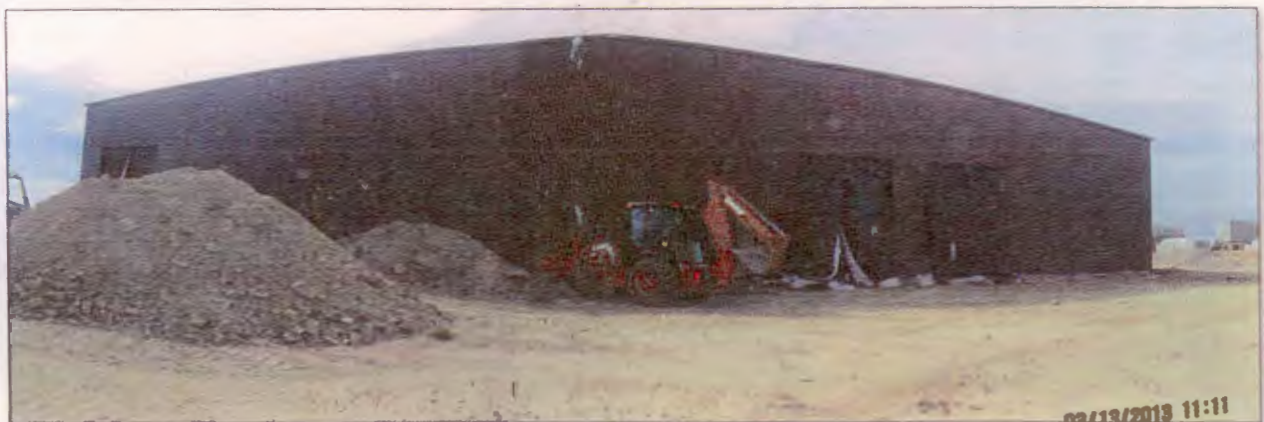
Since the last Inspection, the construction of the Plant building has been progressing. All of the building's walls and ceiling have been erected. Only minor (non-foundational) concrete-pours remain to be done within the building (E.g. containment barriers, grouting of cinder block walls). The attached Photo Addendum depicts the activities occurring and ground conditions at the Plant site. **There are no concerns with the Plant Site.**

Photo Number 8: This panoramic depict the north side of the Plant Building. The view is looking to the south.

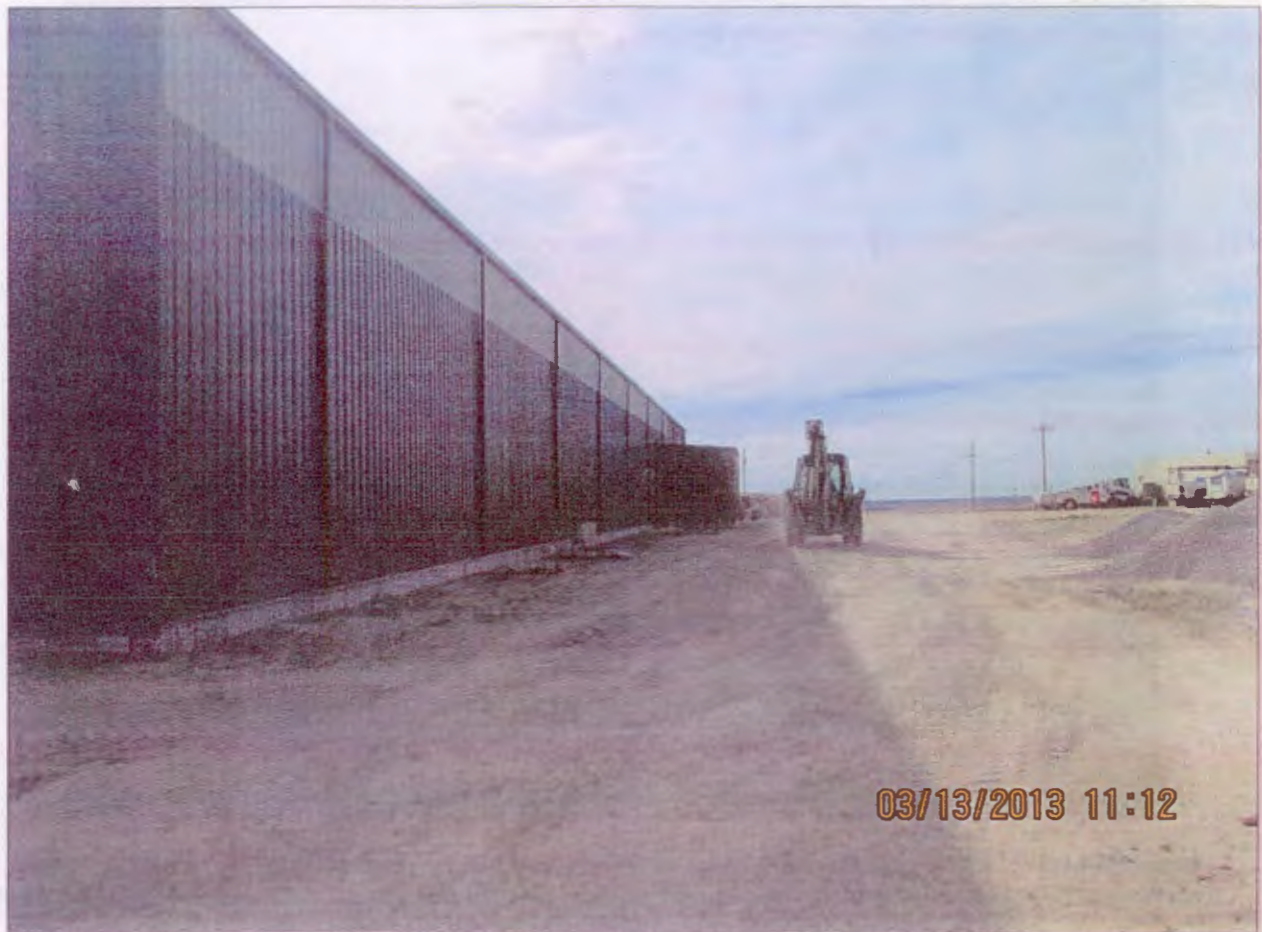
Photo Number 9: This is a view looking south along the west side of the Plant Building.

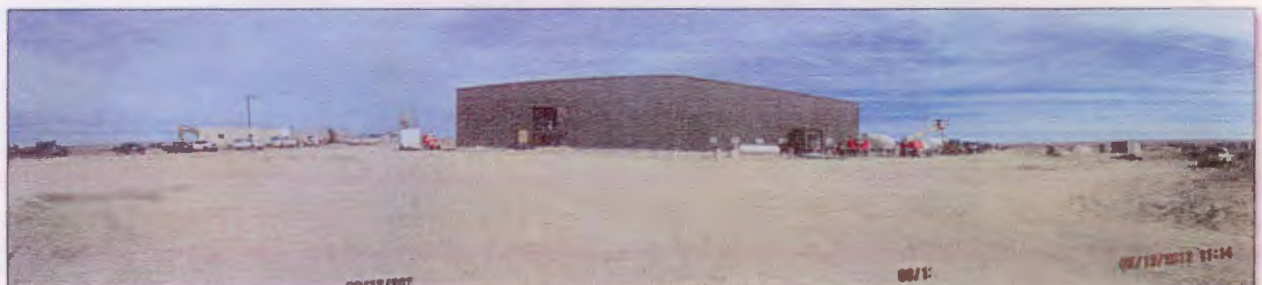
Photo Number 10: This is a panoramic looking toward the north at the south face of the Plant Building. This is the same vantage point as the majority of pictures of the Plant Site over the past several months.
