Subject: Licensee Event Report (LER) 2013-002-00  
Waterford Steam Electric Station, Unit 3 (Waterford 3)  
Docket No. 50-382  
License No. NPF-38

Entergy is hereby submitting Licensee Event Report (LER) 2013-002-00 for Waterford Steam Electric Station, Unit 3 (Waterford 3). This report provides details associated with an Emergency Feedwater system flow control valve failing to close due to valve positioner failure.

1. FACILITY NAME						2. DOCKET NUMBER				3. PAGE					
Waterford 3 Steam Electric Station						05000 382				1 OF 8					
4. TITLE															
Emergency Feedwater System Flow Control Valve Fails To Close Due To Valve Positioner Failure

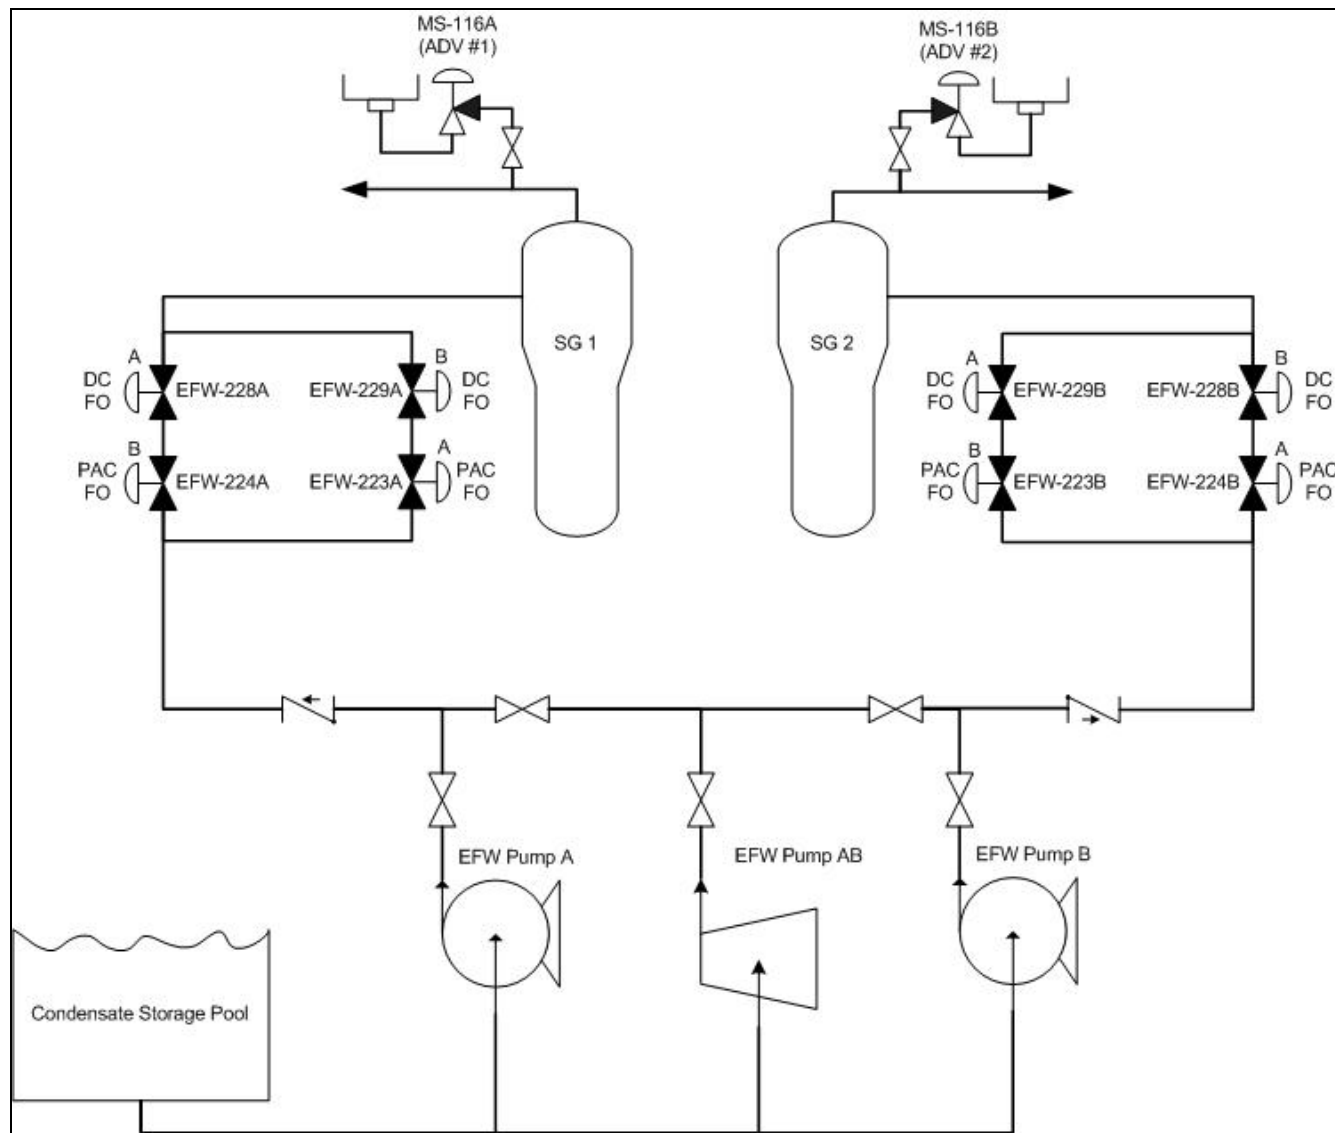
Figure 1: Emergency Feedwater System Basic Flow Diagram

Following the reactor trip, actuation EFAS-1 was received due to SG 1 level decreasing below setpoint. At this time the EFW pumps started, both SG 1 EFW isolation valves opened, and both SG 1 EFW flow control valves received a permissive to open (see Figure 1). EFW flow to SG 1 varied by several hundred gallons per minute (Point ID C26229). Control Room operators noted that EFW-223A (EFW to SG1 Backup Flow Control Valve) level controller output on panel CP-8 was oscillating rapidly from 10% to 50% and EFW flow to SG 1 was oscillating rapidly from 500 GPM to maximum flow. In addition, controller output for EFW-224A (EFW to SG1 Primary Flow Control Valve) [FCV] was noted to be stable.

The EFW system supplies this demand via three EFW pumps through two supply paths. Both supply paths are supplied with redundant flow control valves and isolation valves, all of which fail open on loss of air. The control and isolation valves are arranged with "A" and "B" powered valves in series. This ensures that, in the event of a single failure, water can be supplied and controlled to either one or both SGs by the operable valves since the valves fail open. Water could also be prevented from entering the ruptured SG during a postulated Feedwater or Main Steam Line Break Accident by the operable EFW control and isolation valves. The valves can be operated locally using the manual handwheel.
