UES-20120254 Rev.0 (1/64) Non-Proprietary

San Onofre Nuclear Generating Station, Unit 2 & 3 REPLACEMENT STEAM GENERATORS

Root Cause Analysis Report for tube wear identified in the Unit 2 and Unit 3 Steam Generators of San Onofre Nuclear Generating Station

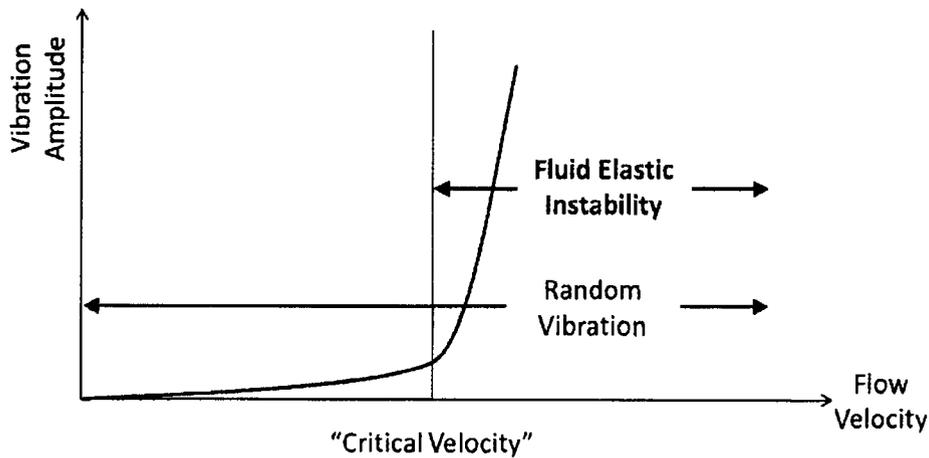
Figure 1

Fluid Elastic Instability (FEI) is a term used to describe a range of tube vibrations that starts at a point on a curve of vibration amplitude versus flow velocity. As depicted in Figure 1, one axis (Y) of that curve is vibration amplitude and the other (X) is flow velocity. The graph shows that as flow velocity increases vibration amplitude increases at a small linear rate until it reaches a point where the slope of the curve increases abruptly. The point in the curve where the slope changes is termed "critical velocity". The critical velocity is a function of several variables. These include tube natural frequency, which is dependent on the tube geometry and support conditions, damping,

which is a function of the steam-to-water ratio, flow velocity, which is dependent of the tube spacing.

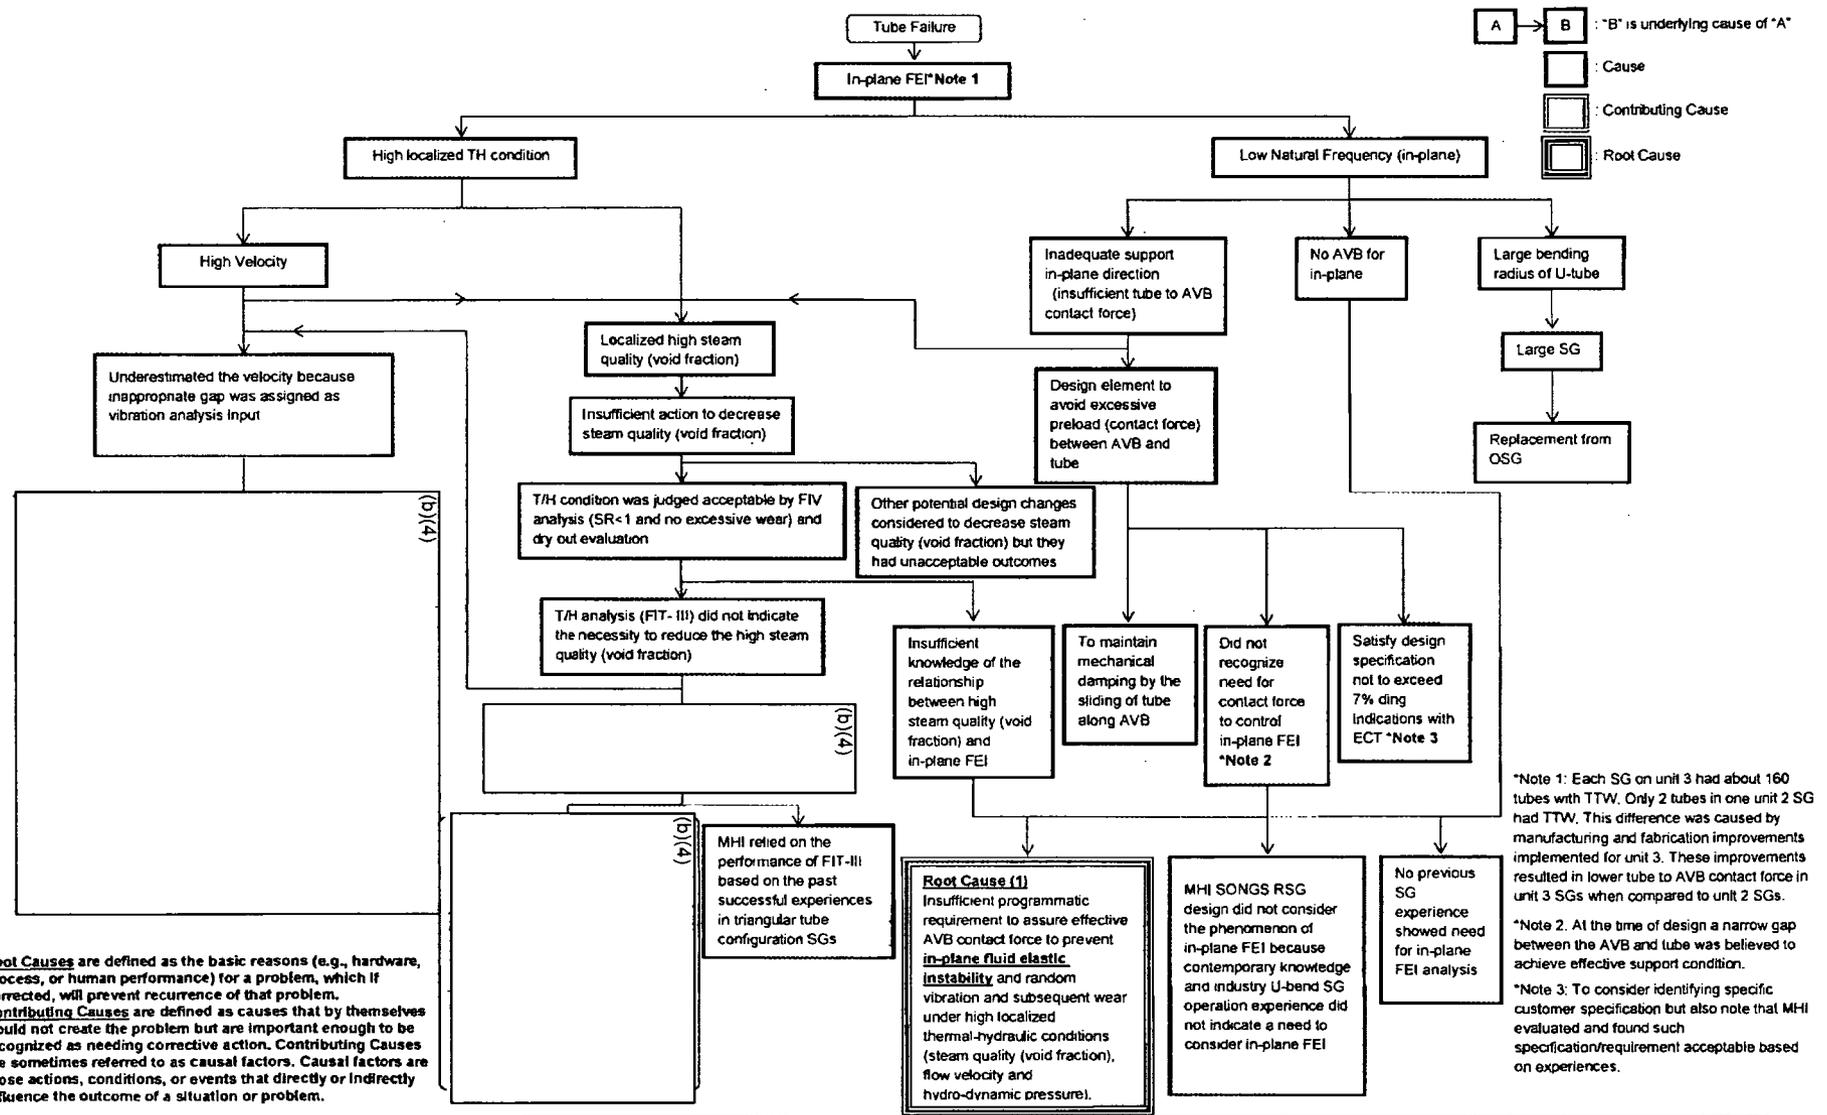
Cause-effect analysis for the tube to tube wear

*Note 1: Each SG on unit 3 had about 160 tubes with TTW. Only 2 tubes in one unit 2 SG had TTW. This difference was caused by manufacturing and fabrication improvements implemented for unit 3. These improvements resulted in lower tube to AVB contact force in unit 3 SGs when compared to unit 2 SGs.
 *Note 2: At the time of design a narrow gap between the AVB and tube was believed to achieve effective support condition.
 *Note 3: To consider identifying specific customer specification but also note that MHI evaluated and found such specification/requirement acceptable based on experiences.

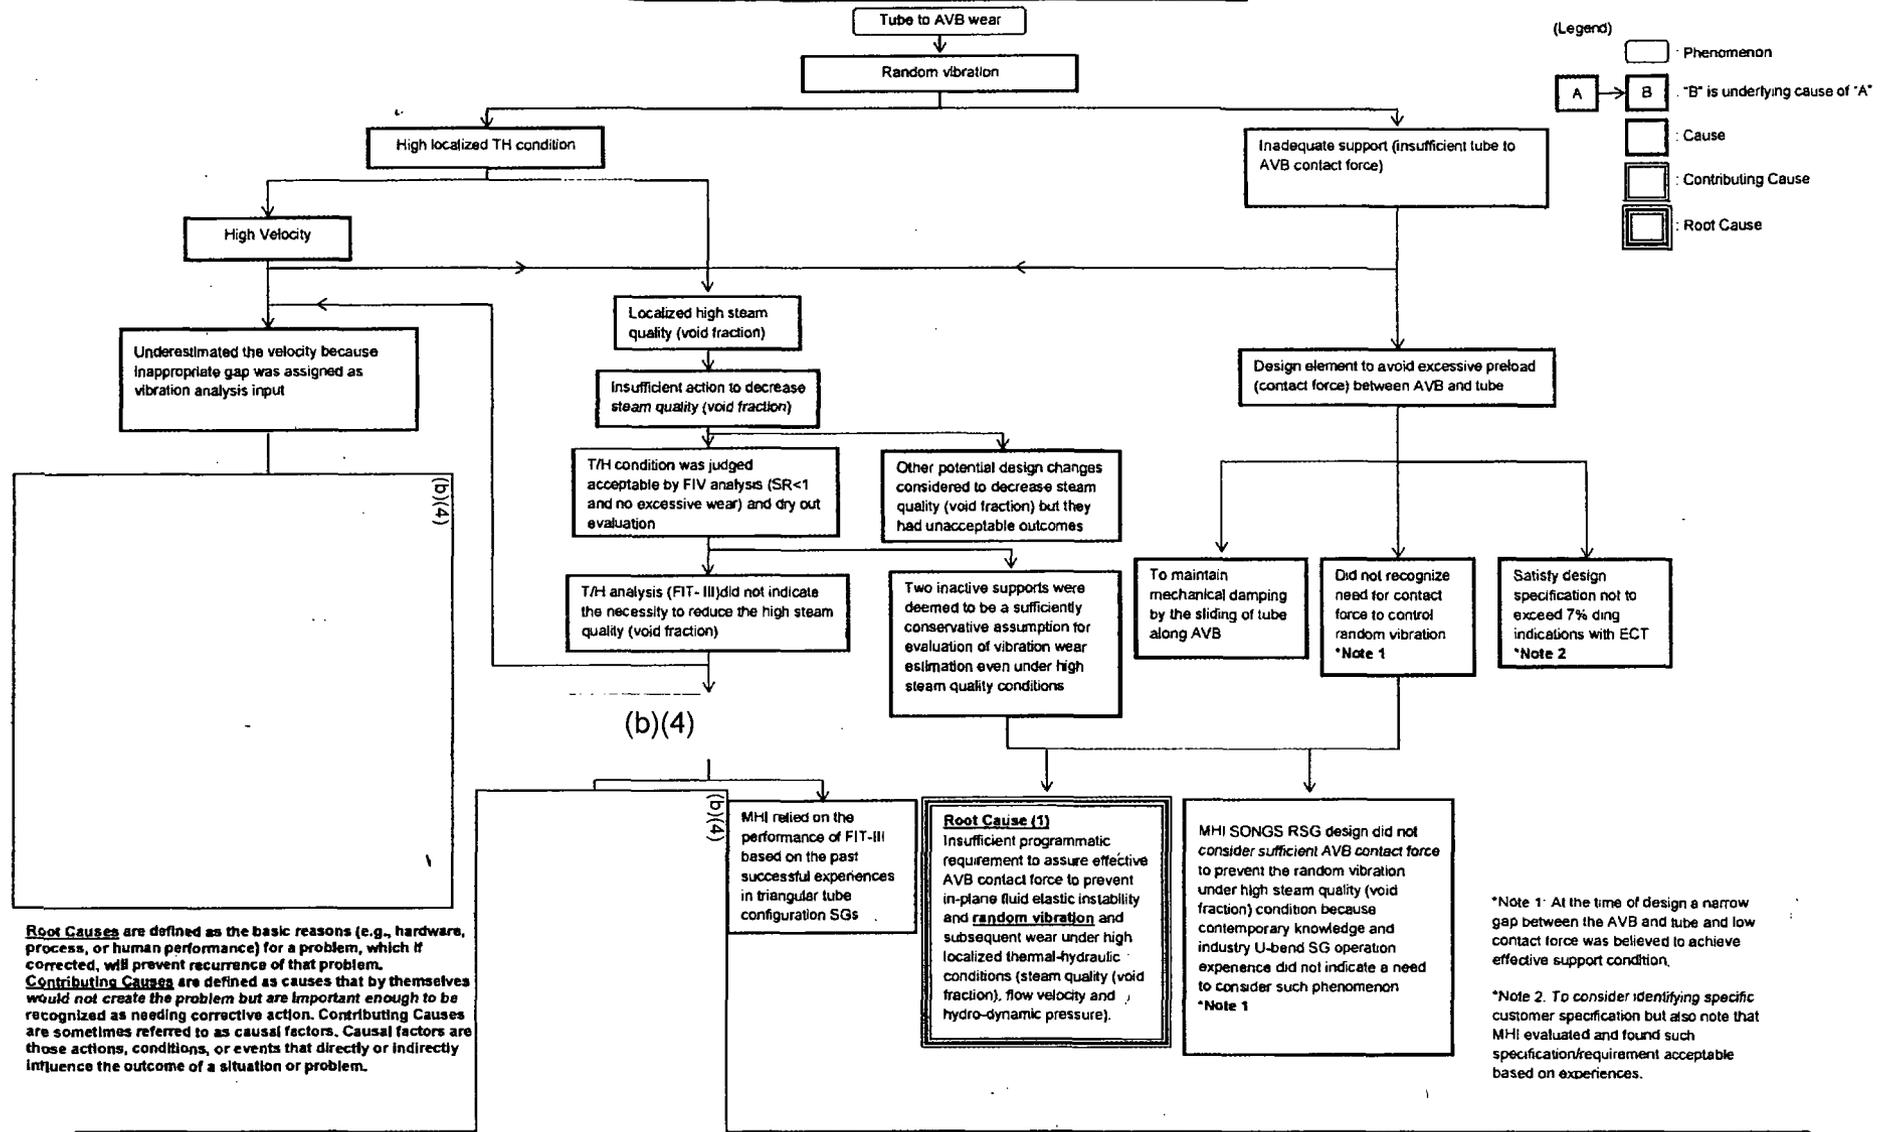
Cause-effect analysis for the tube to AVB wear

***Note 1:** At the time of design a narrow gap between the AVB and tube and low contact force was believed to achieve effective support condition.
***Note 2:** To consider identifying specific customer specification but also note that MHI evaluated and found such specification/requirement acceptable based on experiences.
