Watts Bar Nuclear Plant, Unit 1
Facility Operating License No. NPF-90
NRC Docket No. 50-390

Subject: Licensee Event Report 390/2011-004 Revision 1, Reactor/Turbine Trip due to Loss of Main Generator Excitation

4. TITLE
Reactor / Turbine Trip due to Loss of Main Generator Excitation

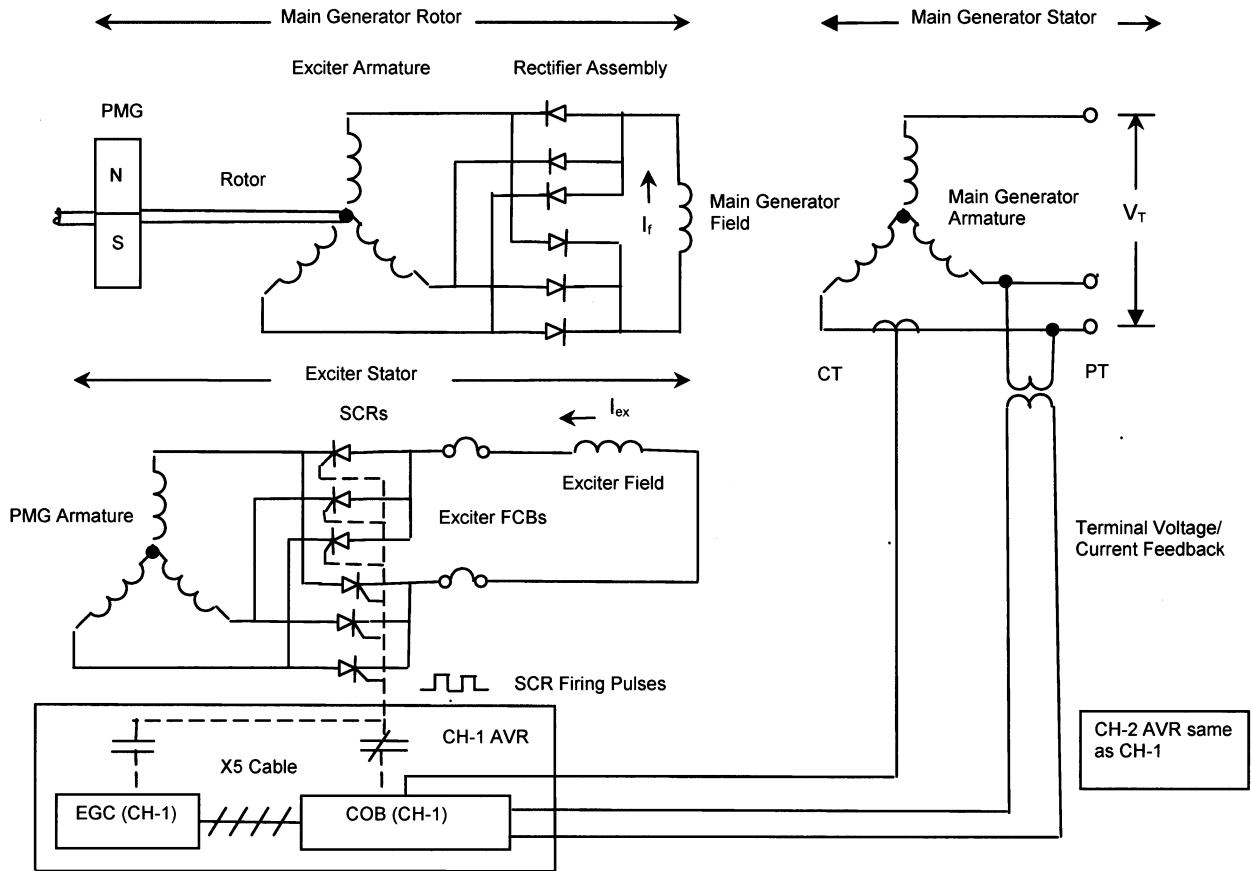
Figure 1
Simplified Brushless Excitation System Block Diagram

The major electrical components that make up the main generator excitation system are the AVR, exciter field windings, exciter armature windings, rotating rectifier assembly, and the main generator field windings (see Figure 1). The AVR is a dual-channel digital control system designed by ABB that was installed during U1 Refueling Outage 10, which ended May 21, 2011. Each AVR channel has one Control Board (COB) module and one Extended Gate Controller (EGC).
