Subject: **COLUMBIA GENERATING STATION, DOCKET NO. 50-397 PROPOSED RELIEF REQUEST 3ISI-13 FOR TEMPORARY NON-CODE REPAIR OF REACTOR WATER CLEANUP SYSTEM PIPING**

***Columbia Generating Station
Relief Request Number 3ISI-13 for
Temporary Non-Code Repair of Reactor Water Cleanup Piping***

RWCU Regenerative Heat Exchanger Piping Repair Patch Analysis

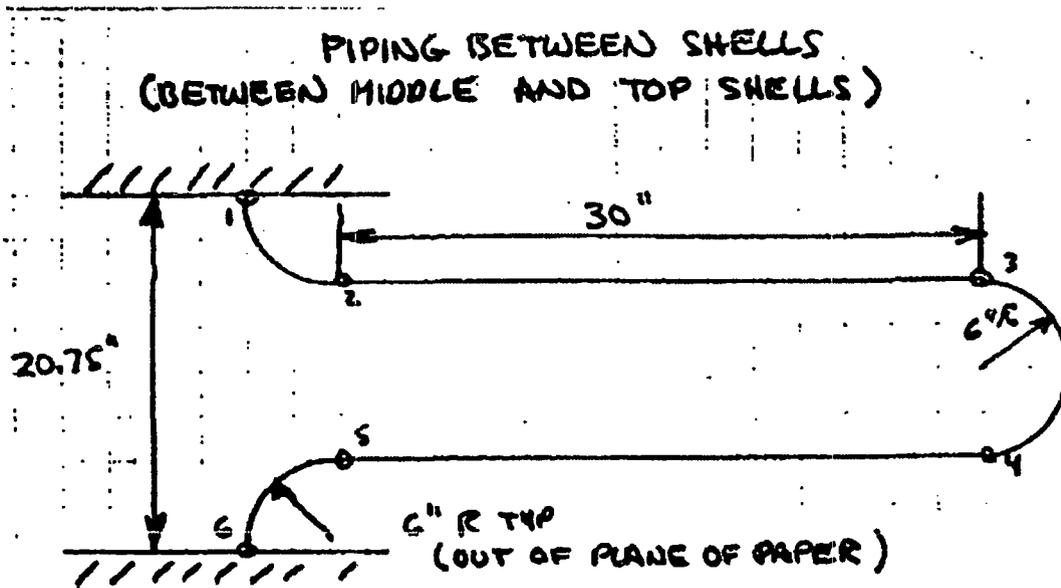
Figure 1 – Piping Schematic

The RWCU piping between the heat exchangers is 4 inch schedule 80 carbon steel. The piping connects heat exchanger nozzles and is provided with a short thermal expansion loop as it connects the heat exchangers. The heat exchangers are stacked vertically and the piping loops vary in length from less than two feet to less than four feet horizontally. The piping loop is free to thermally expand since it is supported from the vessel nozzles with no intermediate supports. The total length of the unsupported 4" diameter piping for each loop is less than 10 feet. This is far less than the pipe span spacing table recommendation of 14 feet for 4" pipe as noted in Table 121.5 of the B31.1 Code. The sustained load bending stress for a 14 ft spacing is 2300 psi. This is the basis for determining the patch does not impact sustained load bending stress. To confirm this assessment the ANSYS model evaluated in Attachment 2 was extended to include the full piping expansion loop. (See Figure 1 below.)

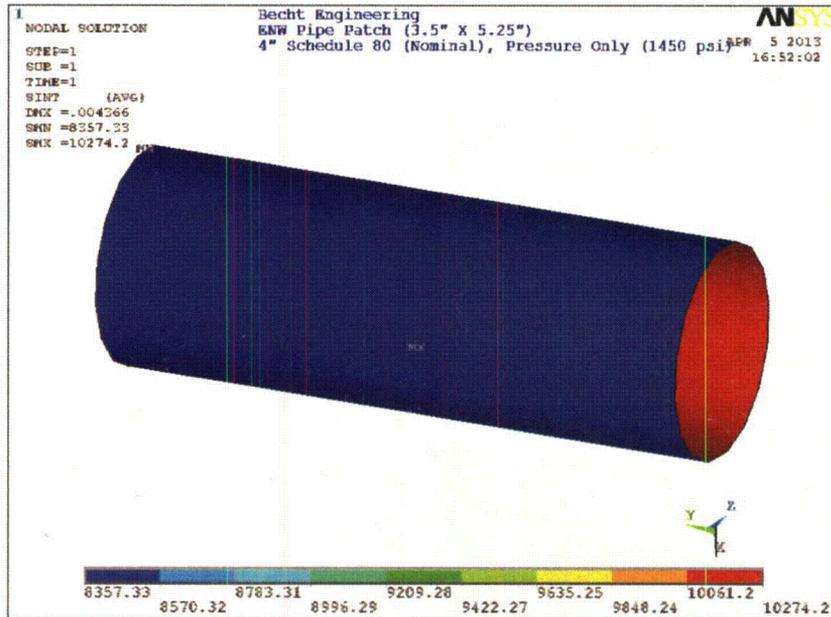
Figure 2 – Hoop Stress for Design Pressure Only

Figure 2 shows the calculated hoop stress at 1450 psig design pressure. Figure 3 removes pressure to show the sustained bending stresses. The results show a maximum bending stress intensity of 668 psi. This result confirms the assessment in the previous analysis that bending stresses due to weight are insignificant. A summary of the modal analysis of the ANSYS model resulted in a first mode frequency of 42.6 Hz. Since the 1st fundamental frequency of the piping system is greater than 33Hz, the seismic loadings are evaluated for the piping system by conservatively using the maximum zpa seismic SSE horizontal (0.424) and SSE vertical (0.6062) values multiplied by 1.5 in this analysis. The piping system is evaluated using equivalent static analysis technique. The vertical loading is 1.0g (DW) + 0.9093g (Seismic Vertical) and 0.636g in both horizontal directions simultaneously. Figure 4 through 8 show the stress intensity plots for the piping and patch. Table 1 documents the resulting stresses versus allowables.

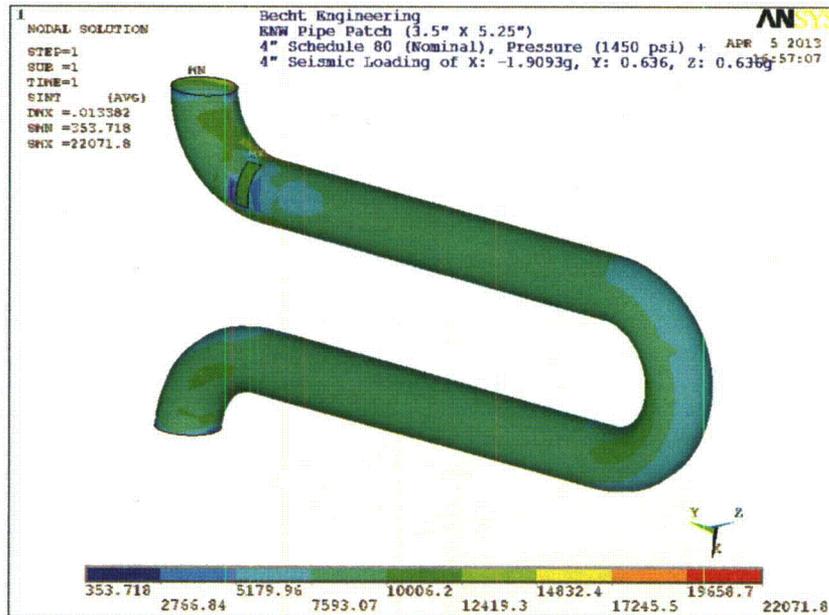
Figure 4 – Maximum Membrane + Bending Stress Intensity Plot of Pipe with Stress concentration of corroded area removed with Pressure + DW+ Seismic ZPA (1.5) in all three directions applied simultaneously

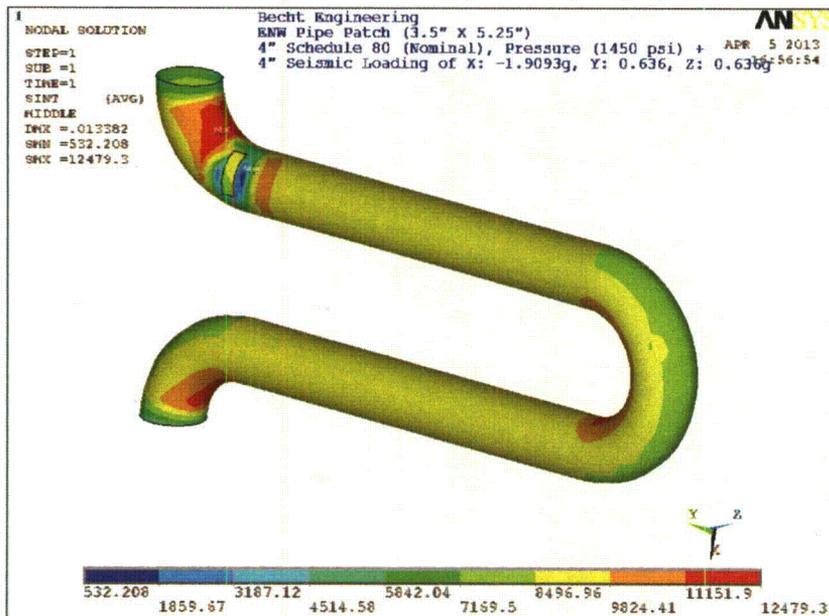
Figure 5 – Membrane Stress Intensity Plot of Pipe with Stress concentration of corroded area removed with Pressure + DW+ Seismic ZPA (1.5) in all three directions applied simultaneously

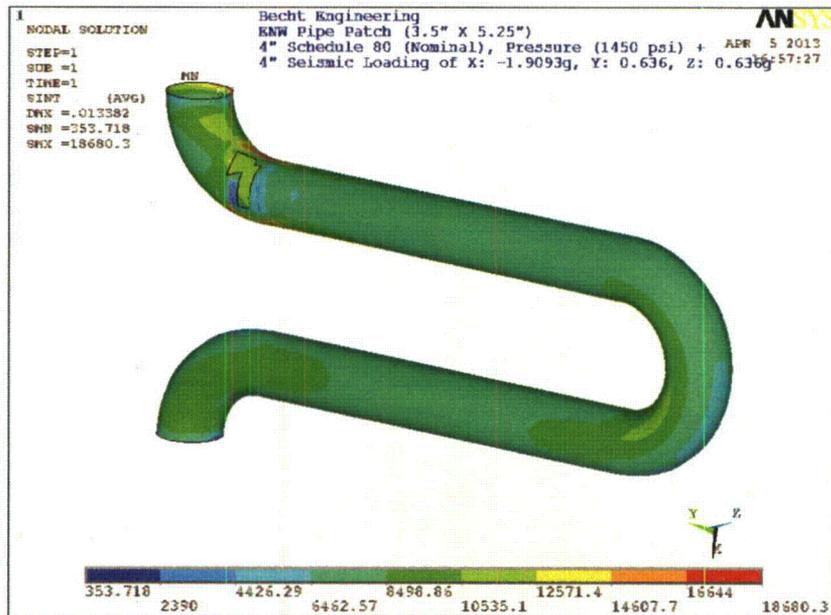
Figure 6 – Membrane + Bending Stress Intensity Plot of Pipe with Stress concentration of corroded area removed with Pressure + DW+ Seismic ZPA (1.5) in all three directions applied simultaneously

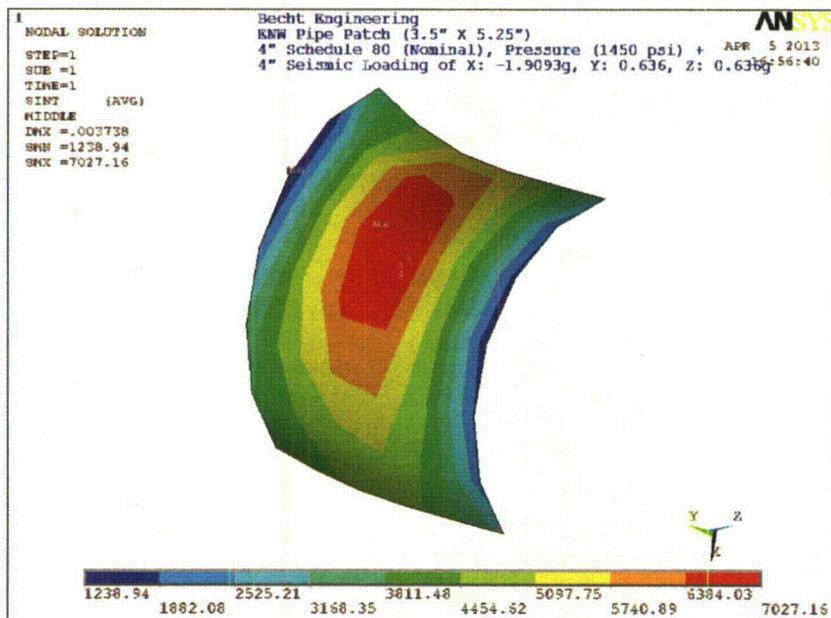
Figure 7 – Membrane Stress Intensity Plot of Patch Plate with Pressure + DW+ Seismic ZPA (1.5) in all three directions applied simultaneously

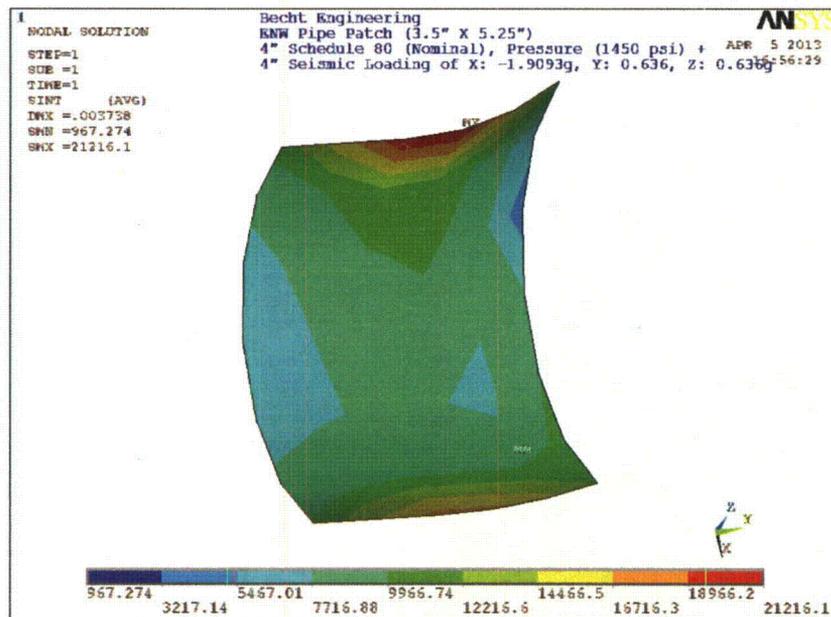
Figure 8 – Membrane + Bending Stress Intensity Plot of Patch Plate with Pressure + DW+ Seismic ZPA (1.5) in all three directions applied simultaneously

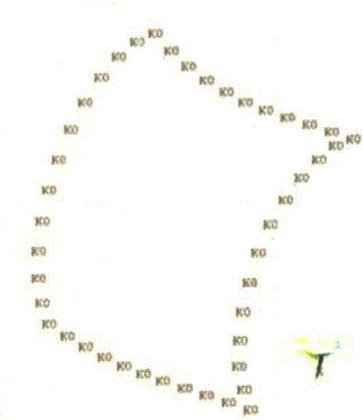
Weld analysis for rectangular line weld

Weld Analysis of 5/16" (0.313") Fillet Weld between the Elbow/Pipe Patch and the existing Pipe.

$\max(weld, weld_b) = 0.271 \text{ in} < 0.313 \text{ in}$, therefore a 5/16 in. fillet weld is OK.
