Subject: Duke Energy Carolinas, LLC (Duke Energy)  
Oconee Nuclear Station, Unit 3  
Docket No. 50-287  
Unit 3 End of Cycle (EOC) 26 Refueling Outage  
Request for Additional Information (RAI) Response to  
3EOC26 Steam Generator Inspection

Duke Response to RAI's dated December 6, 2012

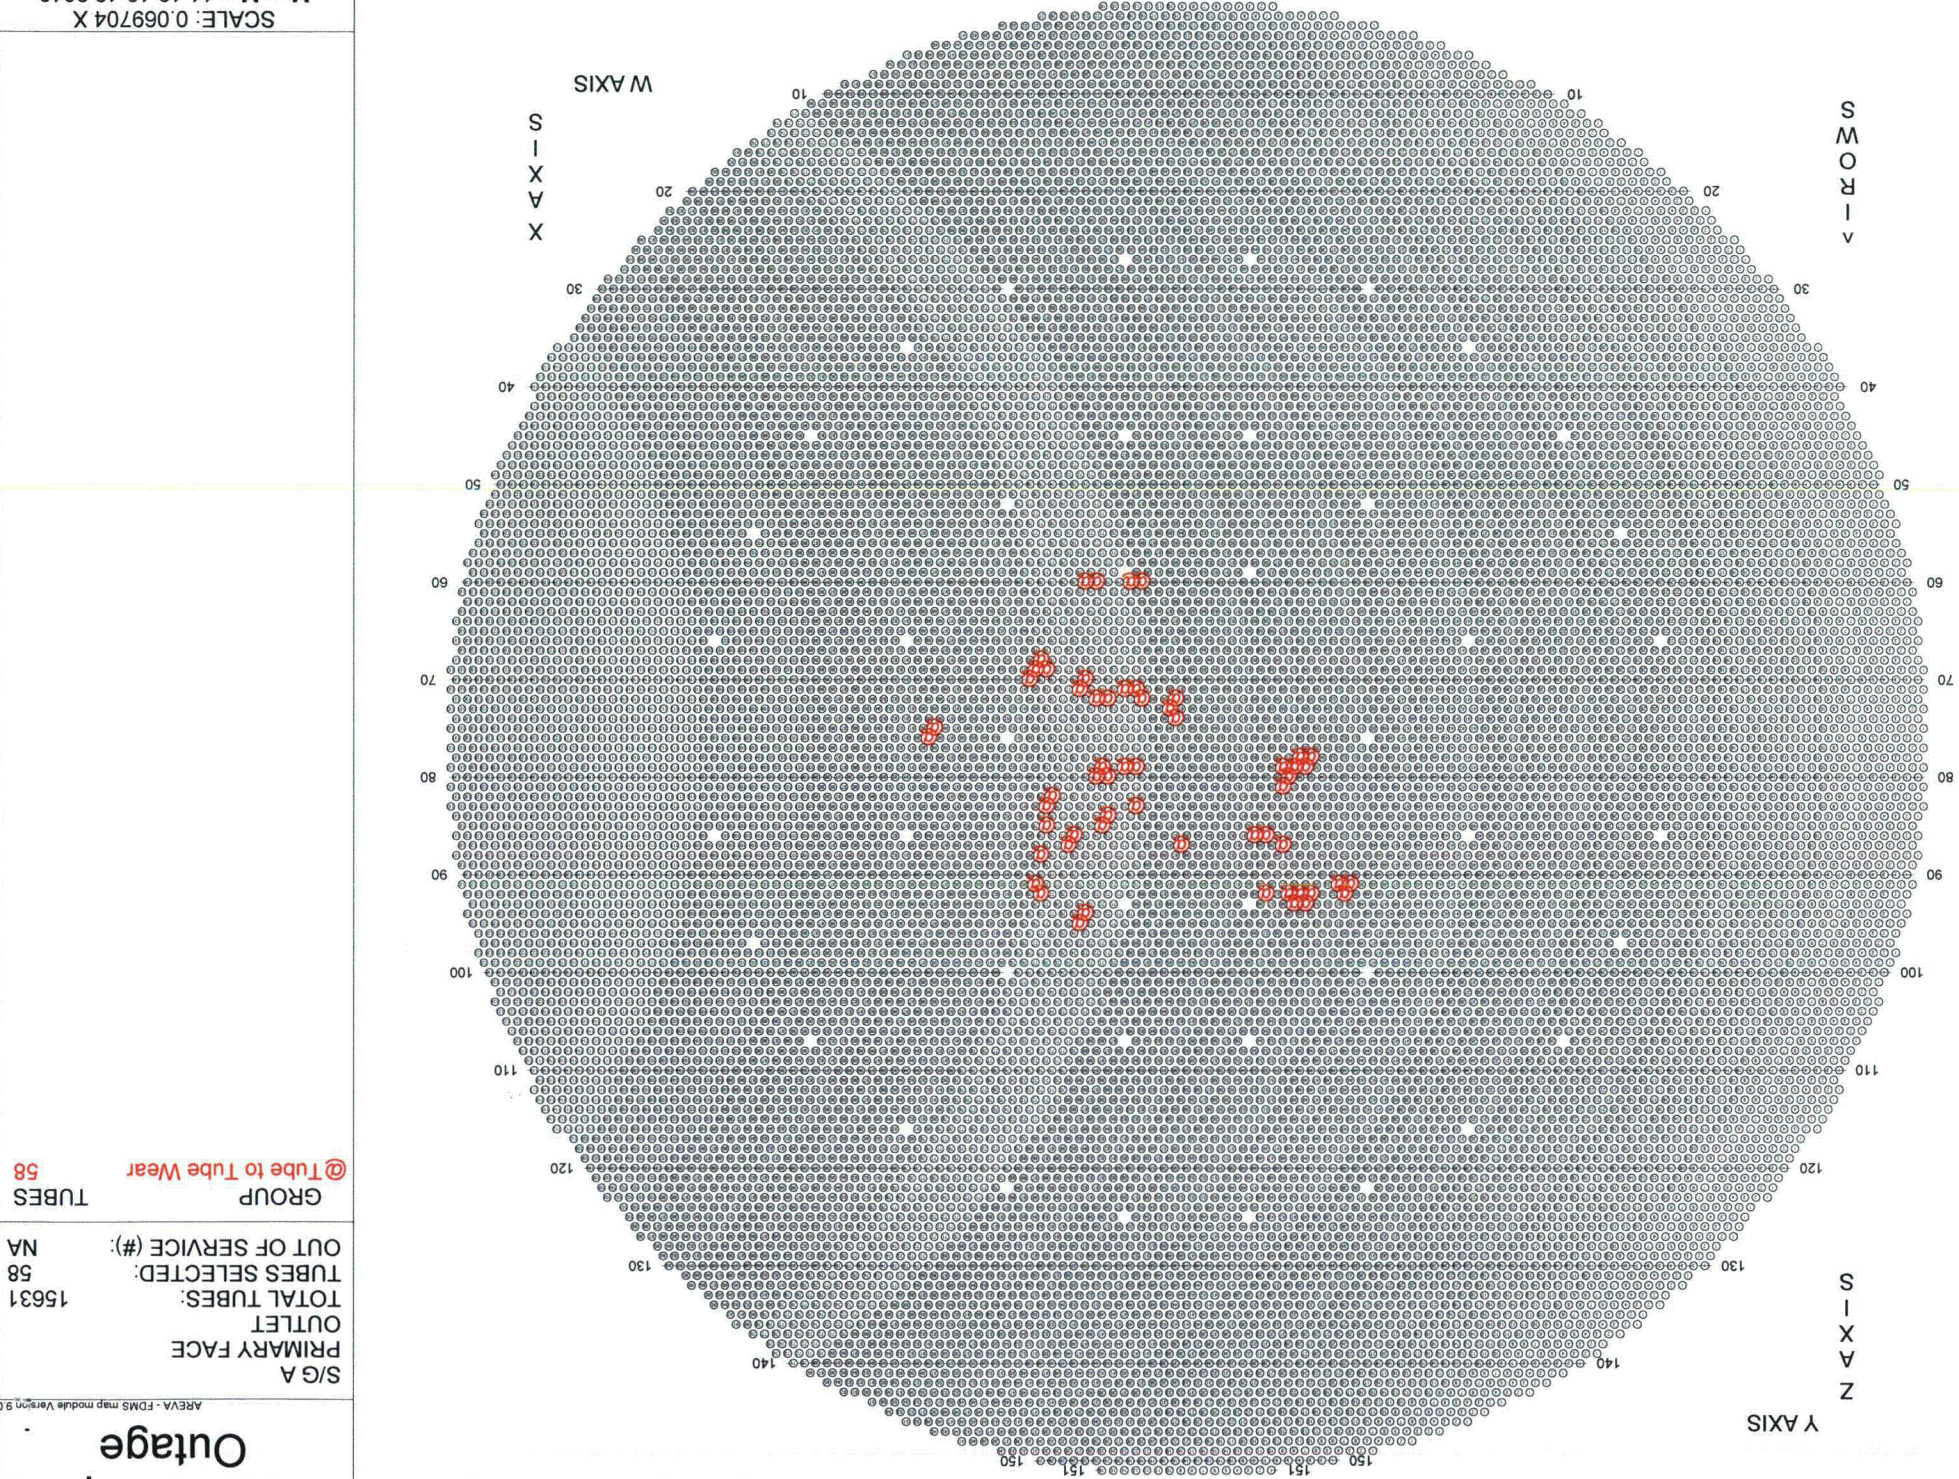
S/G A

The worst case observed tube-to-tube wear indication was 8.6 inches in length. The indication reported as 9.17 inches long in row 91 column 51 of SG 3A was with a bobbin probe. This indication was further characterized with an array probe and it was determined that two indications were actually present. One indication measured 8.05 inches in length and the other measured 5.93 inches in length. A bounding length of 20 inches was conservatively used for structural integrity analysis.

The cause of the tube-to-tube wear is believed to be lateral deflection of the tubes during heat-up when the shell is cooler than the tubes. The tubes with the highest compressive forces are most subject to this effect.

@ Tube to Tube Wear 58

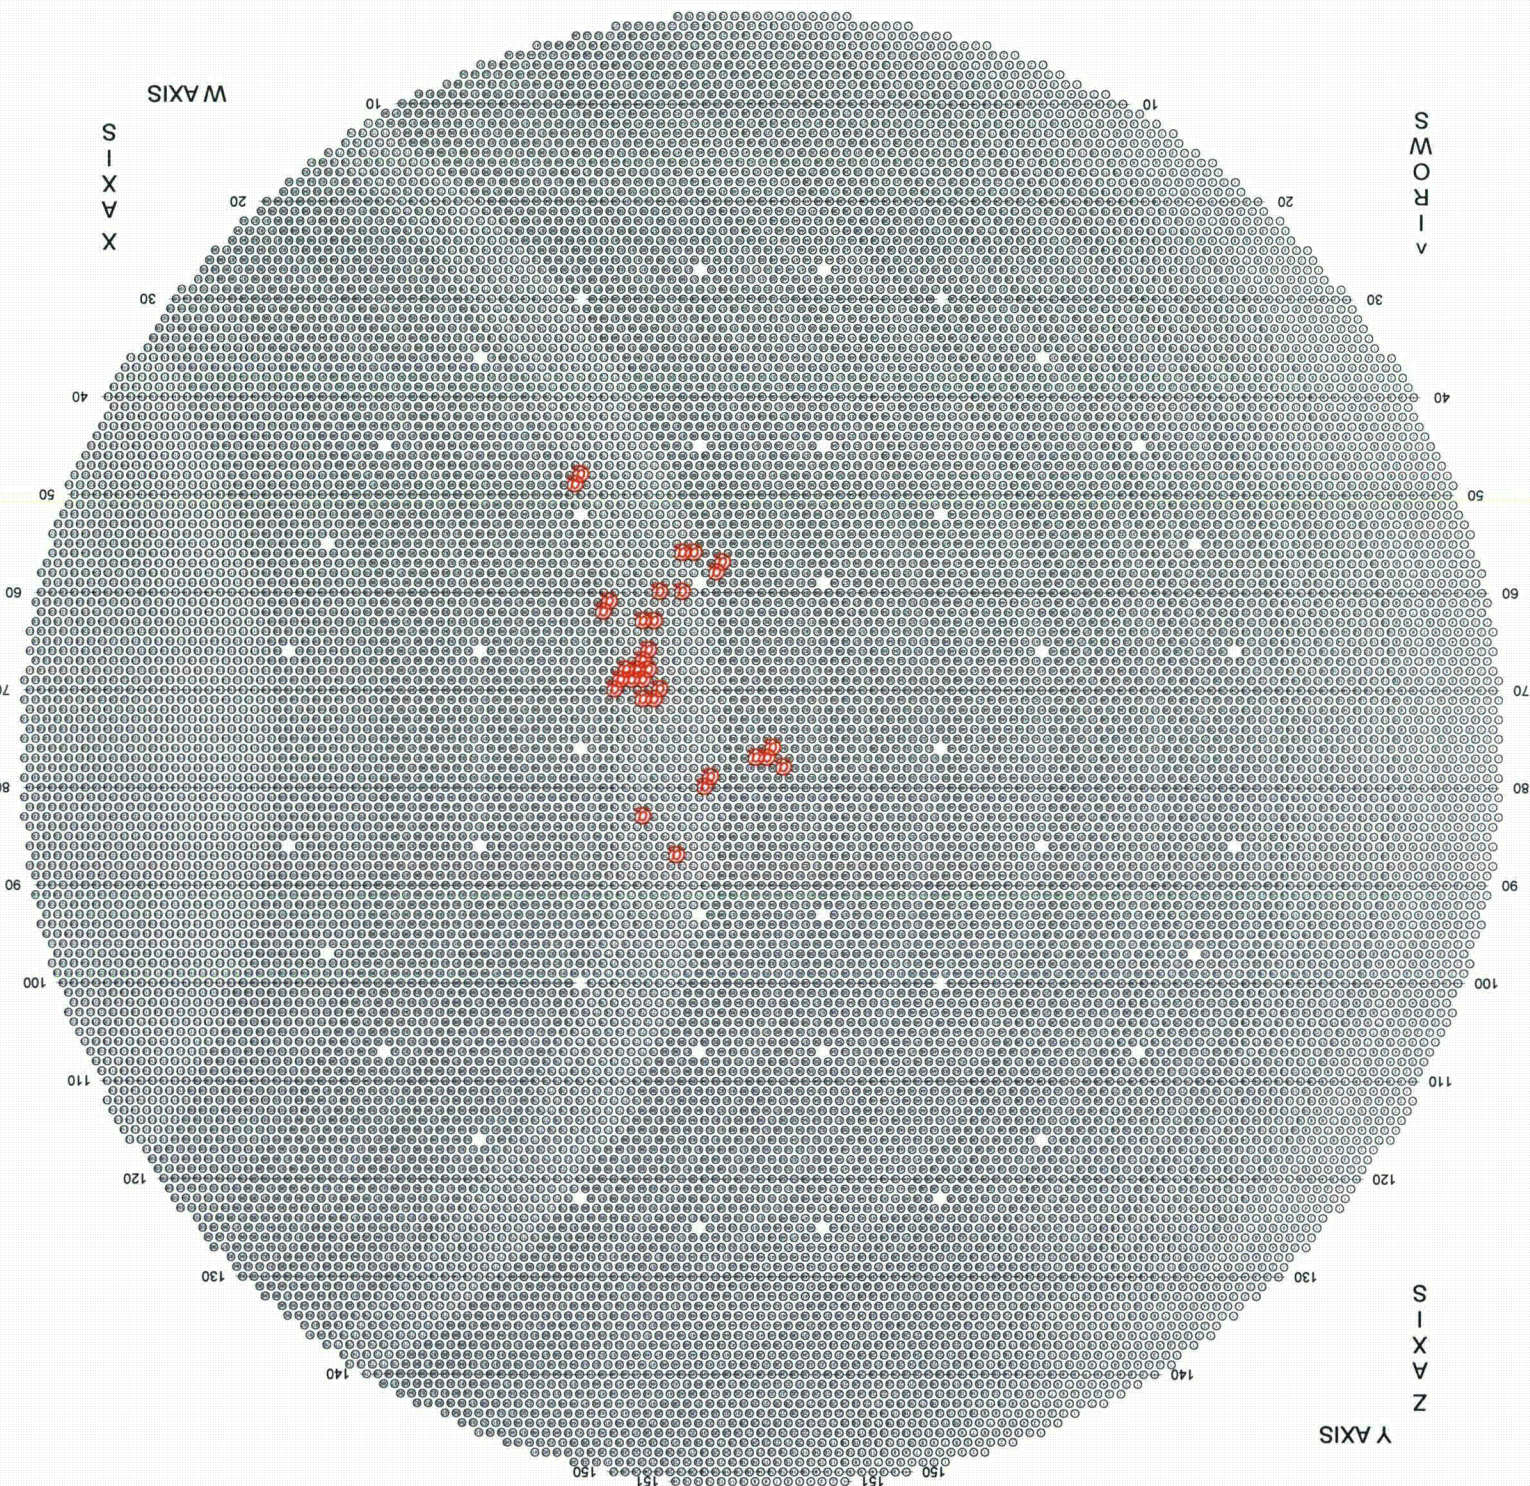
S/G B

GROUP @Tube to Tube Wear TUBES 32
