PNP 2013-029

SUBJECT: Relief Request Number RR 4-16, Proposed Alternative, Alternate Leak Repair Addition of Safety Injection and Refueling Water Tank Bottom Liner, Fourth 10-Year Inservice Inspection Interval

Palisades Nuclear Plant
Docket 50-255
License No. DPR-20

**ENTERGY NUCLEAR OPERATIONS, INC.
PALISADES NUCLEAR PLANT
Relief Request Number RR 4-16 Proposed Alternative
in Accordance with 10 CFR 50.55a (a)(3)(i)
Alternative Provides Acceptable Level of Quality and Safety**

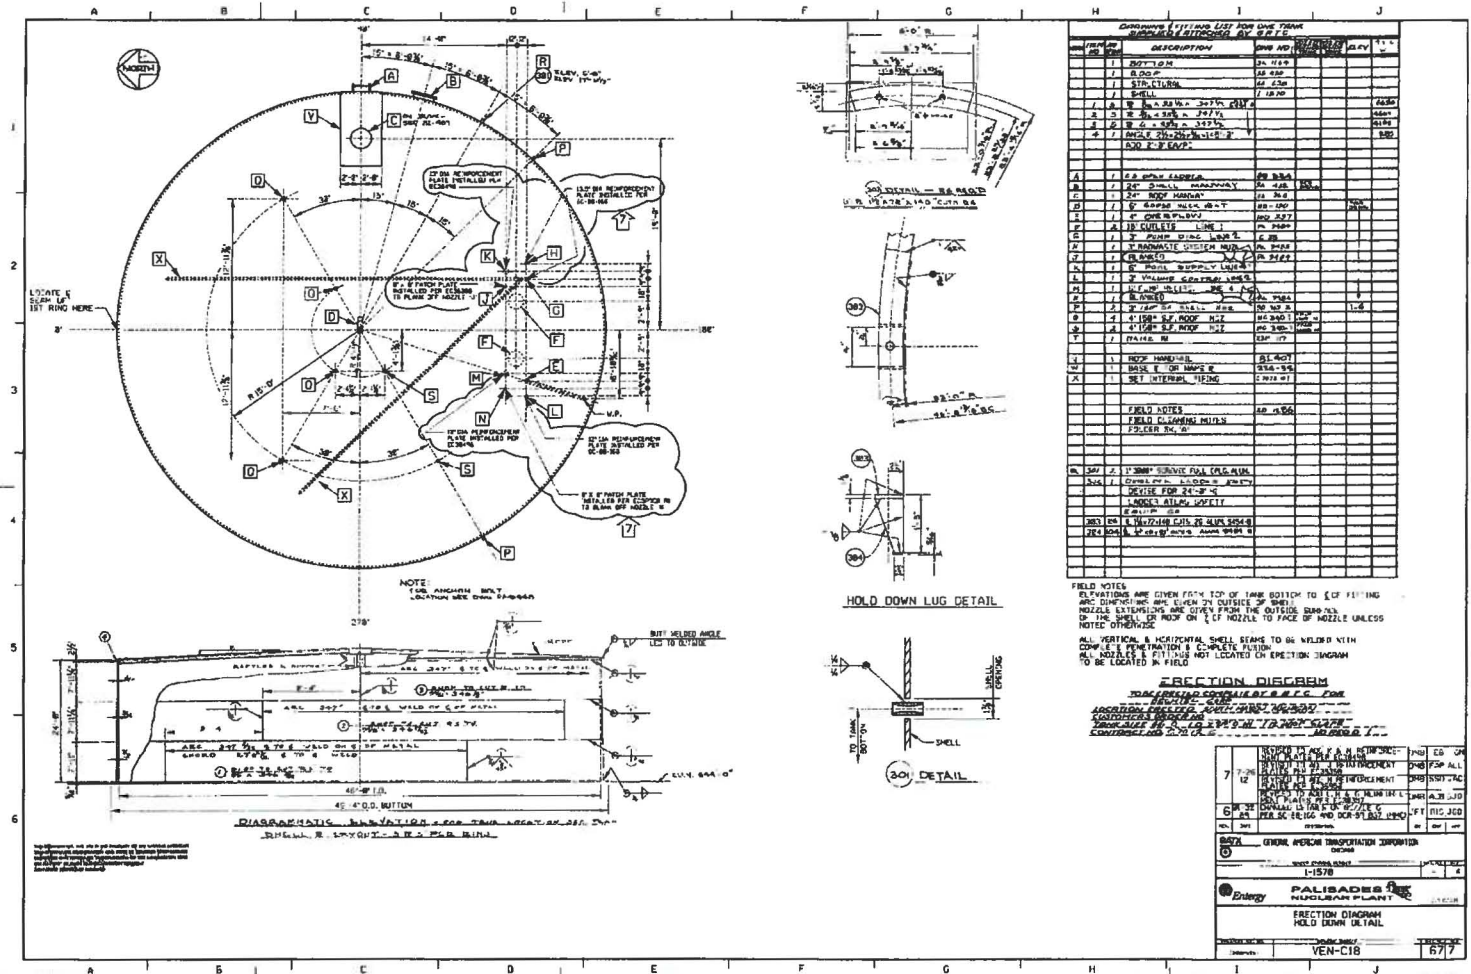
The SIRWT is a welded 5454-0 aluminum atmospheric vertical storage tank with discharge nozzles located in the bottom of the tank (see Attachment 1 for tank drawing). The tank is located on the catacomb roof of the PNP auxiliary building, directly above the control room. The tank was designed and erected in accordance with ASA B96.1-1967 (also known as United States of America Standard (USAS) B96.1-1967). The tank bottom is lap welded with fillet welds and sits on a sand base with a roof support center post. Overall, the tank shell and sand base are supported by a concrete foundation with a concrete grout ring, and is anchored directly to the concrete foundation. The nozzle-to-bottom joints have been modified with reinforcement plates around the nozzles. The tank provides the PNP technical specification 3.5.4, "Safety Injection Refueling Water Tank (SIRWT)," surveillance requirement SR 3.5.4.2 required volume of 250,000 gallons of water containing boron in the range of 1,720 ppm to 2,500 ppm. This assures adequate volume is available for injection during emergency

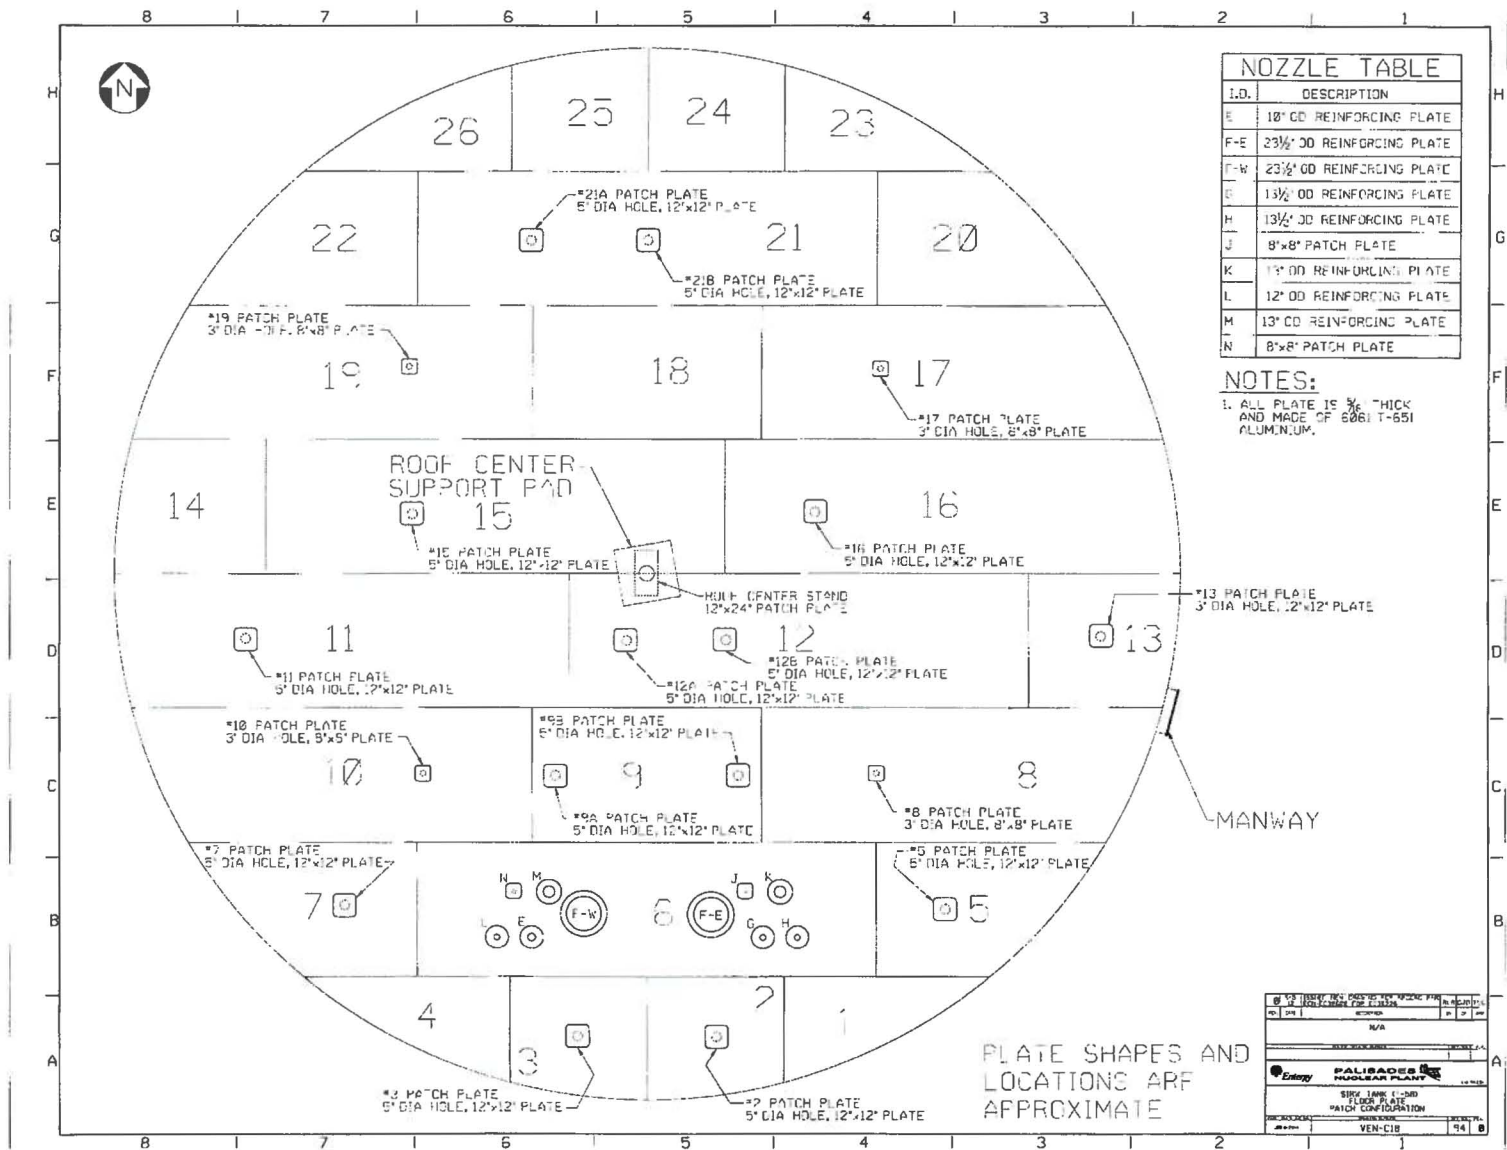
PNP Drawing VEN-C18 Sheet 94 Revision 0, SIRW Tank
(T-58) "Floor Plate Patch Configuration"

retain the nominal thickness. Bottom lap welds were examined by nondestructive methods and were found to be structurally sound. In 2012, sections of the tank bottom plates were removed at 18 locations in order to facilitate sand base restoration. The removed plate sections were inspected and no general corrosion was noted. These sections had welded patch plates installed. The tank bottom, nozzle to bottom, and bottom to shell welds have been nondestructively examined. Identified rejectable weld defects have been repaired and reinforcing plates have been installed around the nozzles. These repairs have addressed the identified cause of nozzle leakage and further degradation of the nozzle to bottom welds is not expected. This will be confirmed by the pre-installation inspections.
