Part 21 (PAR)

PART 21 REPORT - ESI REFURBISHED EMERGENCY DIESEL GENERATOR CYLINDER HEADS MAY HAVE VALVE KEEPER SEALS MISSING

Report No. 10CFR21-0108

COMPONENT: KSV Cylinder Head with Missing Keeper Seals
Head Part Numbers 10-KSV-11-3-RR, 12-KSV-11-3-RR, and 13-KSV-11-6-RR

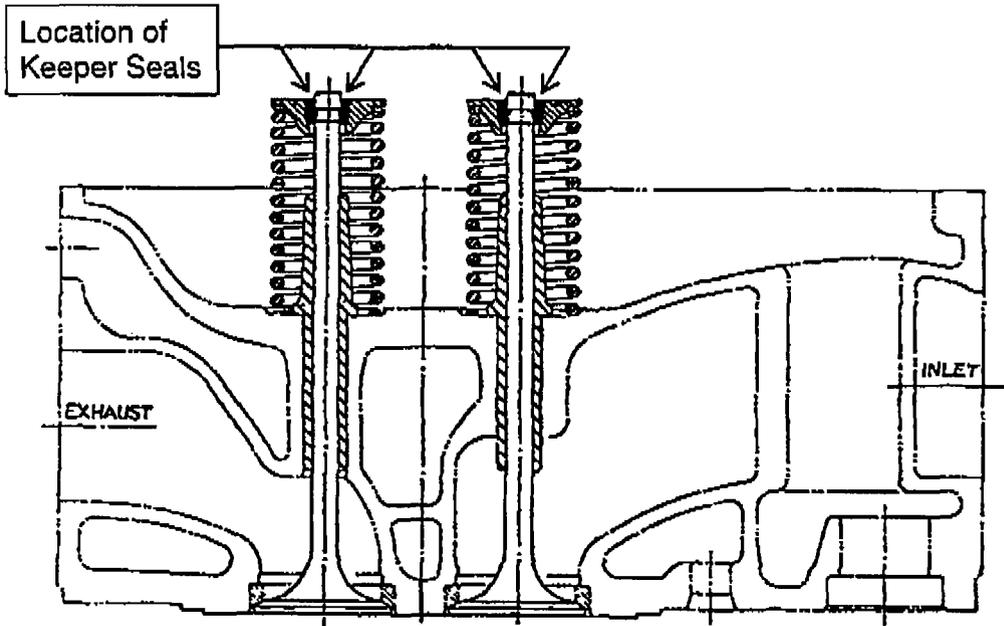
Figure 1: Showing Location of Keeper Seals

The seals are made of an elastomeric material in the form of a rectangular block and they are replaced during a rebuild as standard practice. Each cylinder head has eight seals (with two required for each valve and there are four valves per head). The seals are installed between the keeper halves on opposite sides of the valve stem. See figure and photo on the following page for a visual representation of the seal location.
