Re: **Summary of Bi-weekly Inspection of Lost Creek ISR LLC's Permit 788**

Wyoming Department of Environmental Quality (WDEQ)- Land Quality Division (LQD)
Inspection Memorandum

File: Lost Creek ISR, LLC – Permit 788

Date of Inspection: April 18, 2013

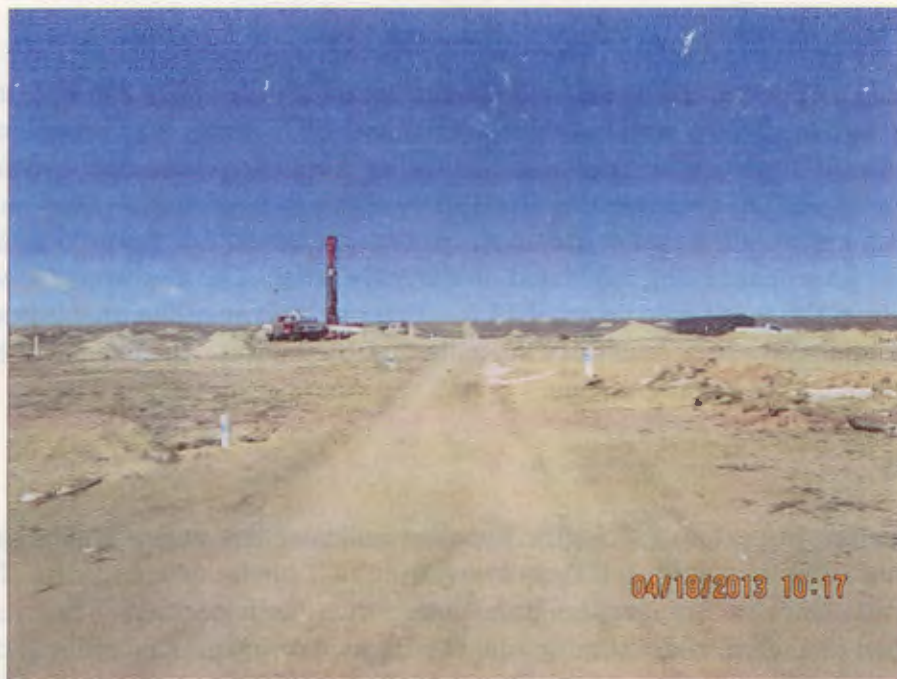
Photo Number 1: This depicts the MU1 Pattern area. Many of the mud pits associated with well installation have been backfilled since the last inspection. This view is looking west.

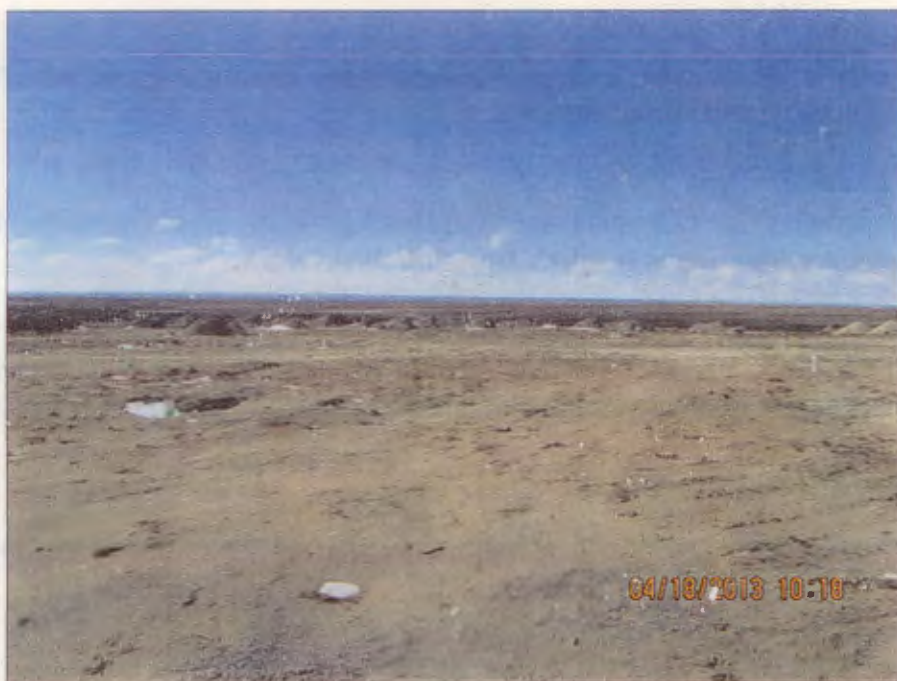
Photo Number 2: This is another view of the MU1 Pattern Area, looking to the south.

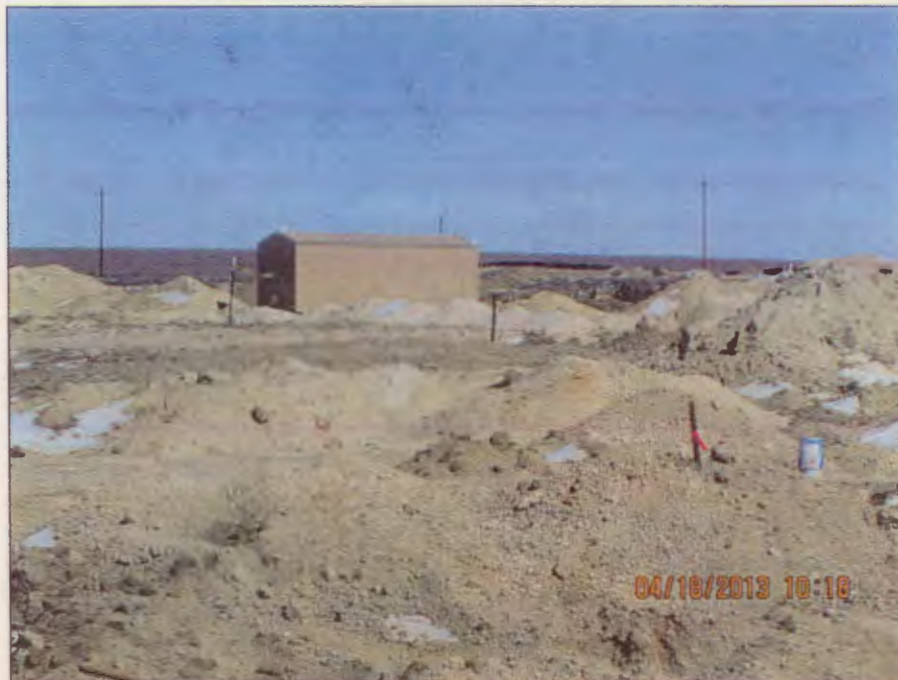
Photo Number 3: This depicts Header House Number 1 in the MU1 Pattern Area. It will be the first to be used when pumping commences.

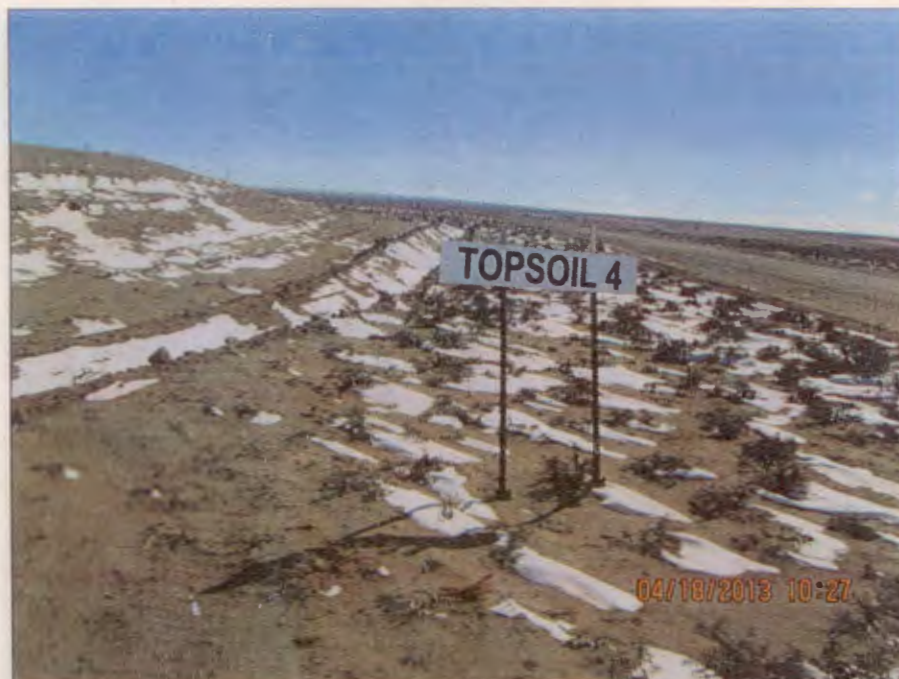
Topsoil stockpile sloughing: The installation of v-ditches at the base of all of the site's topsoil stockpiles is nearly complete. Only two (2) topsoil stockpiles (at the east end of the site's access road) still require this work. **This addresses one of the action items identified in the last Inspection Report.**

Photo Number 4: This depicts the new sign for topsoil stockpile number 4 as well as its newly-constructed v-ditch (red line). View is looking east-southeast.

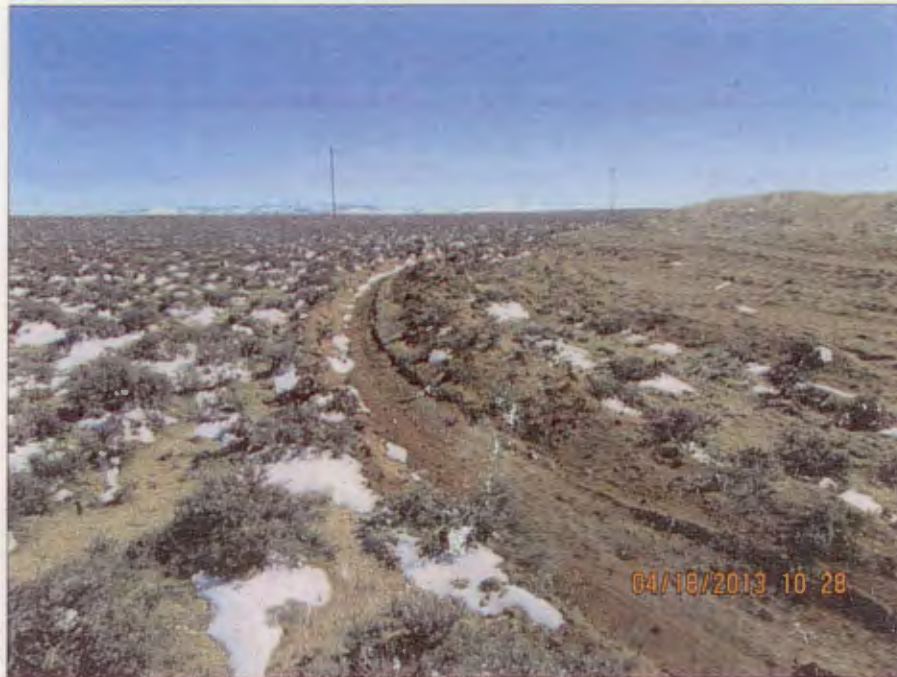
Photo Number 5: This is another view of the v-ditch around the base of topsoil stockpile 4. The v-ditch is well-constructed.

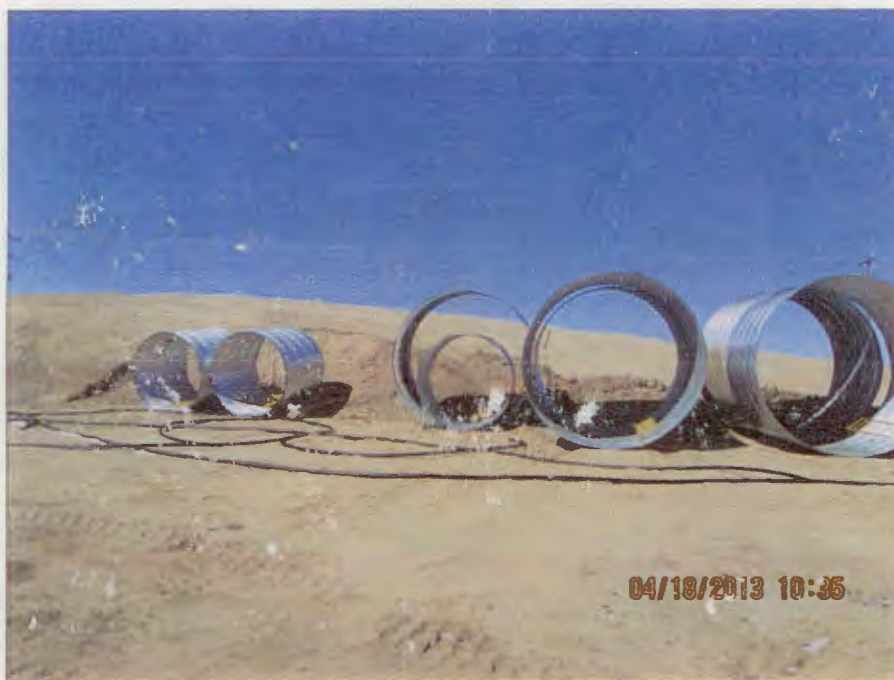
DDW-4: Several 10,000-gallon water tanks are staged at this drill pad and are currently being used for drilling water. Also staged at the DDW-4 drill pad are several 8' diameter (or larger) corrugated "culverts" (see Photo Addendum) which will be used as "galleries" for accessing the manifolds between the header houses and the main pipeline.

Photo Number 6: This depicts the large-diameter corrugated "culverts" that are being staged at the DDW-4 drill pad site before they are installed in the MU1 Pattern Area as "galleries" for housing manifolds.

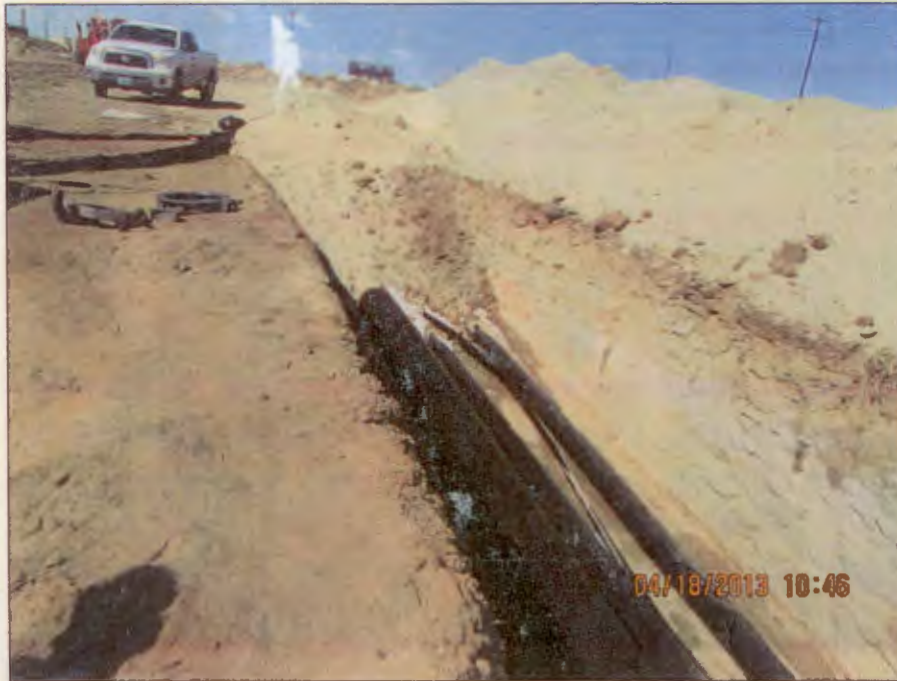
The Main Trunk Line Trench has been backfilled from its northernmost extent to south of the access road to about ¼ mile into the MU1 Pattern Area. The backfilling was done after pressure testing of the pipeline was completed. The attached Photo Addendum depicts various locations along the trench. **There are no concerns with the trench.**

Photo Number 7: This depicts the main trunk line trench in the MU1 Pattern Area. The trench is in the process of being backfilled after pressure testing on Friday April 12, 2013 revealed the pipeline was sound.

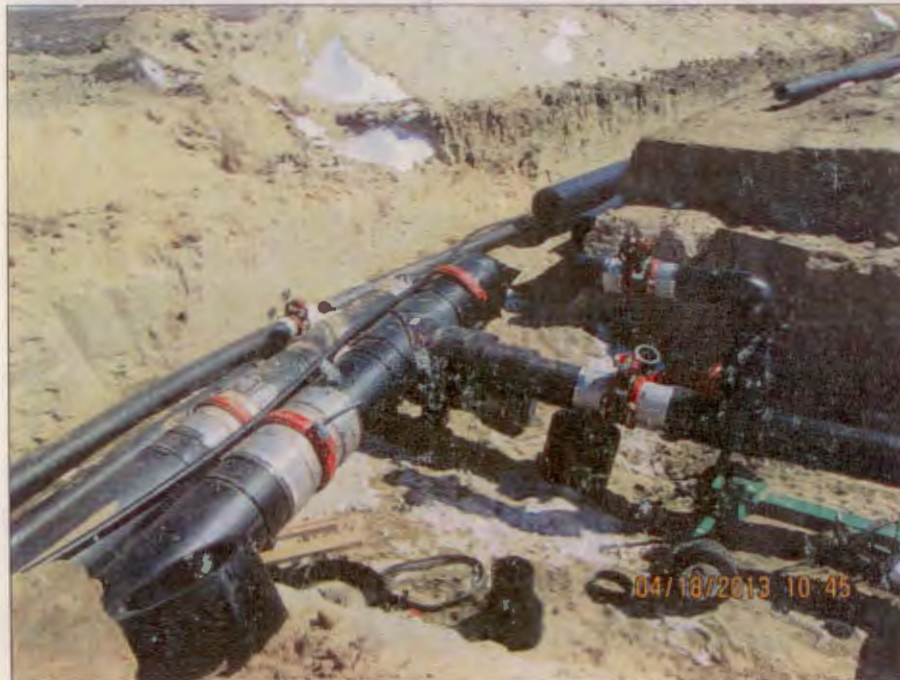
Photo Number 8: This depicts an intersection of the main trunkline (left) and a subsidiary pipe line trench to the MU1 Pattern Area.

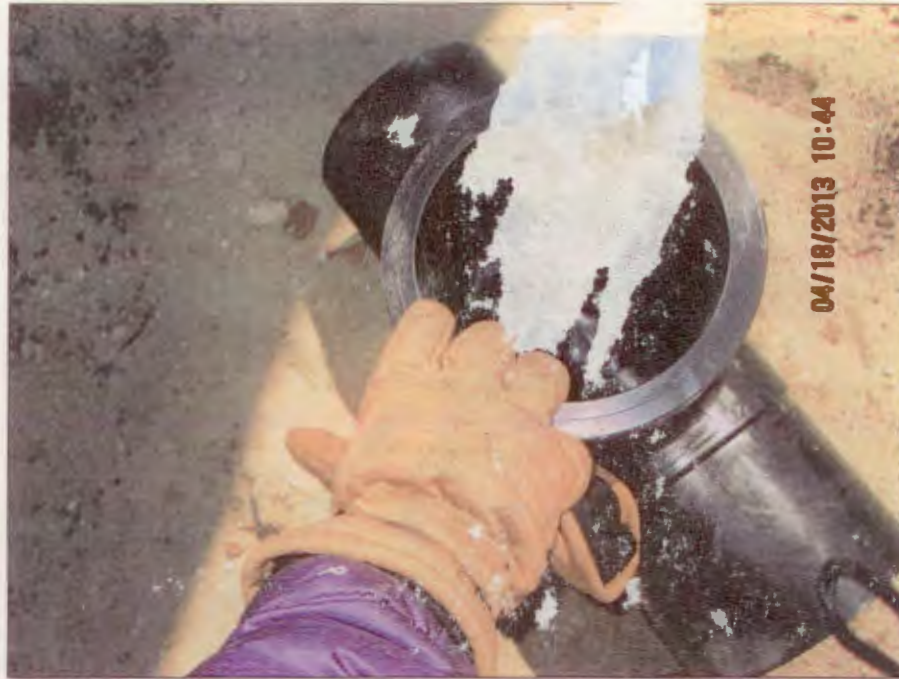
Photo Number 9: This depicts a T-intersection in a piece of 8" diameter pipe.

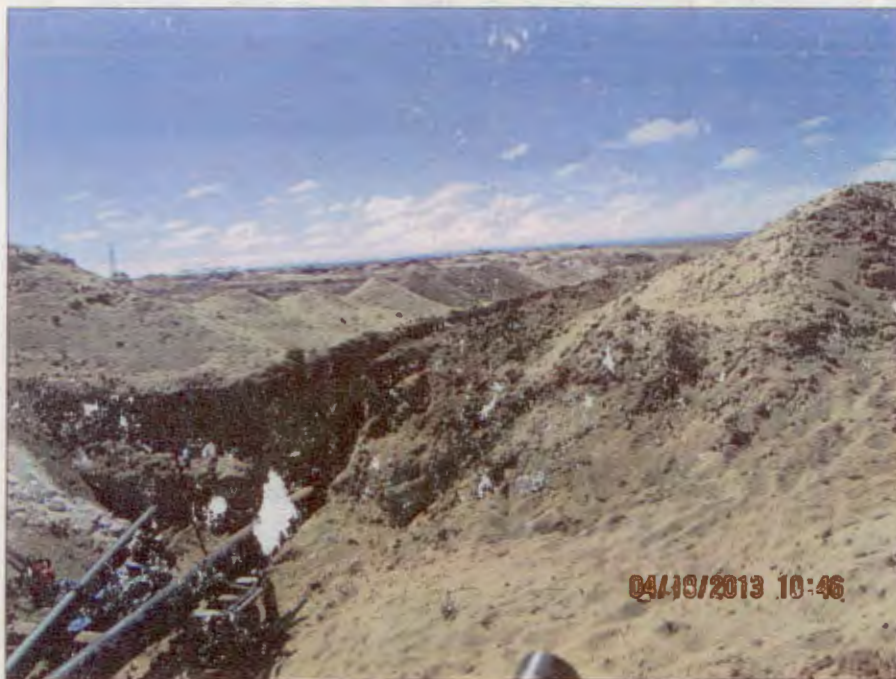
Photo Number 10: This depicts a trench coming off of the main trunk line trench heading south toward the heart of the MU1 Pattern Area.

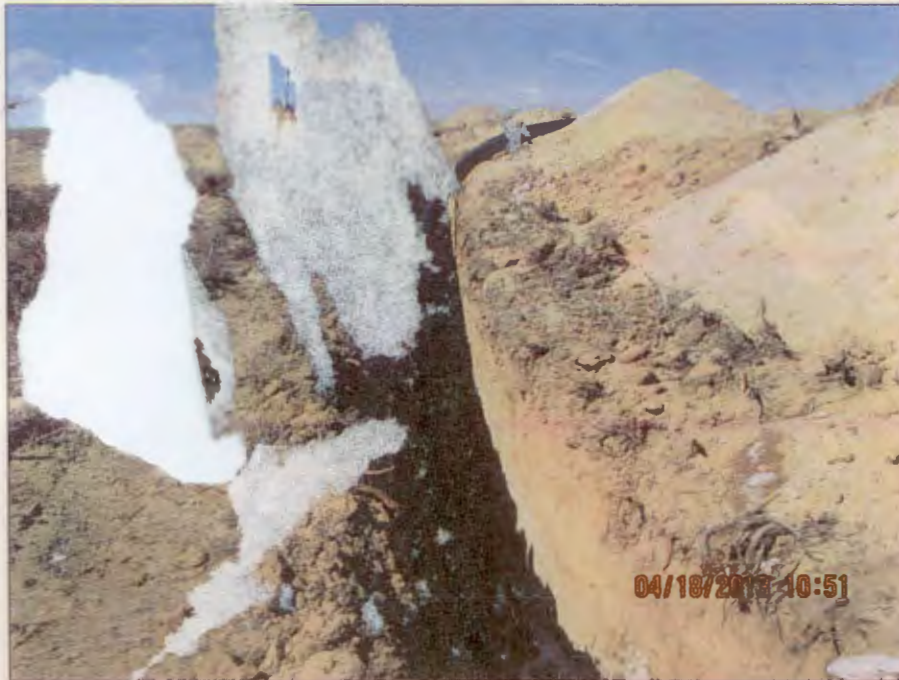
Photo Number 11: This depicts another subsidiary trench in the MU1 Pattern Area.

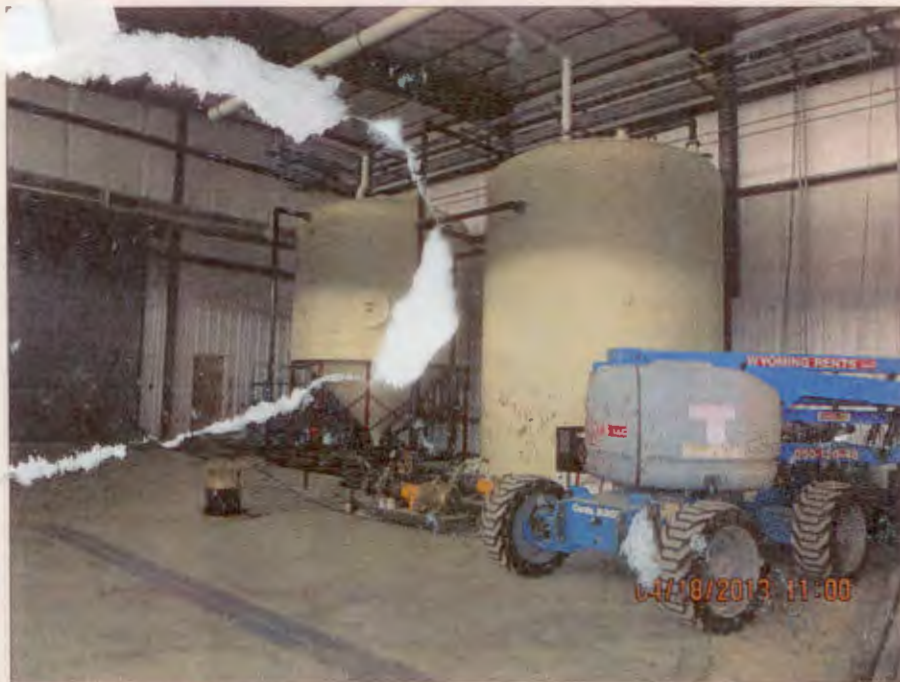
Photo Number 12: This depicts some tanks with piping installed around their base. This is from the north end of the Plant Building.

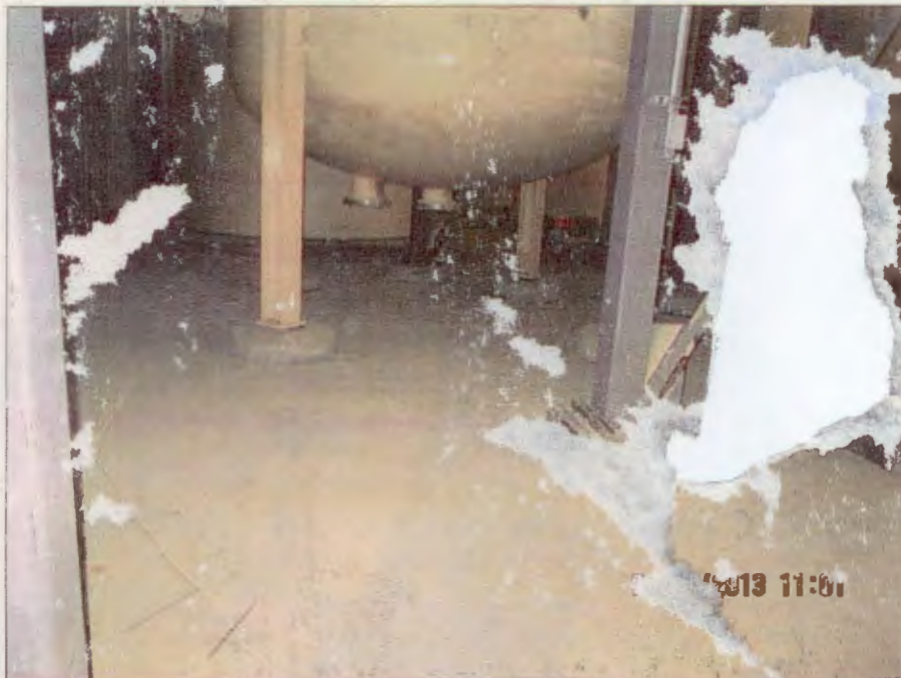
Photo Number 13: This depicts the footings of some tanks mounted onto pilons in the Plant Building.

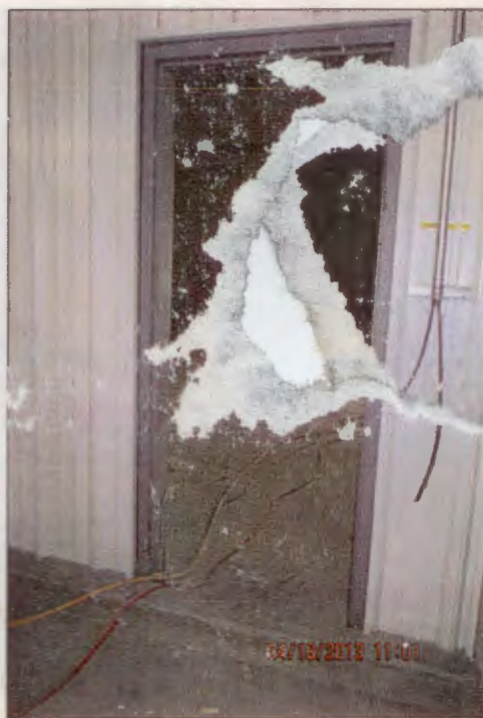
Photo Number 14: This depicts a doorway inside the Plant Building. Note the containment berm at the foot of the doorway. Every portion of the Plant Building is separated from the adjacent section with a containment berm.

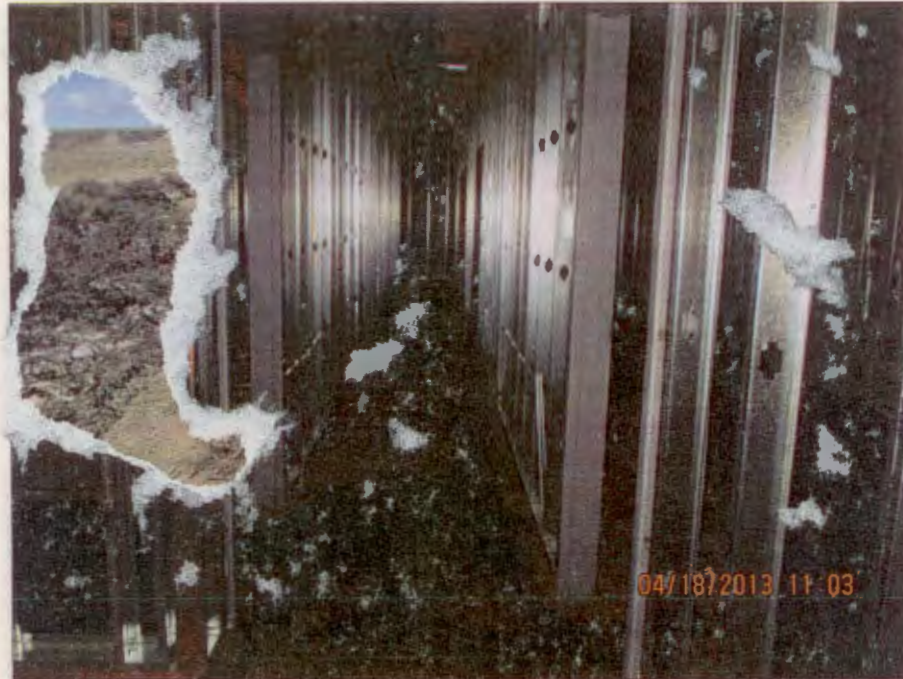
Photo Number 15: This is a hallway in the office area of the Plant Building. Its concrete floors were being stained during this Inspection.

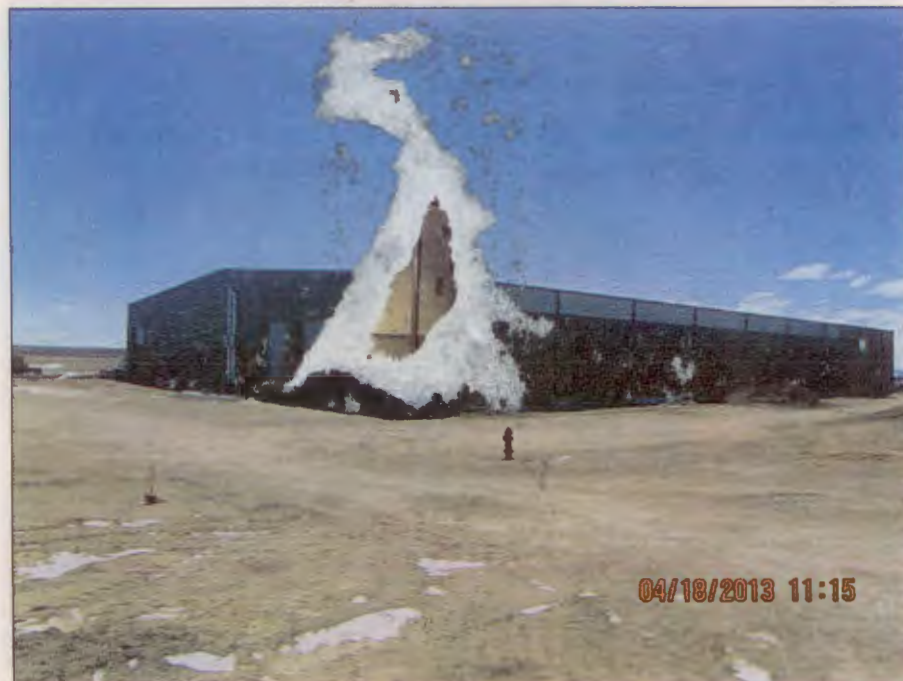
Photo Number 16: This is a view of the Plant Building looking at its northwest corner. Note the fire hydrant to the right of the center of the photo.

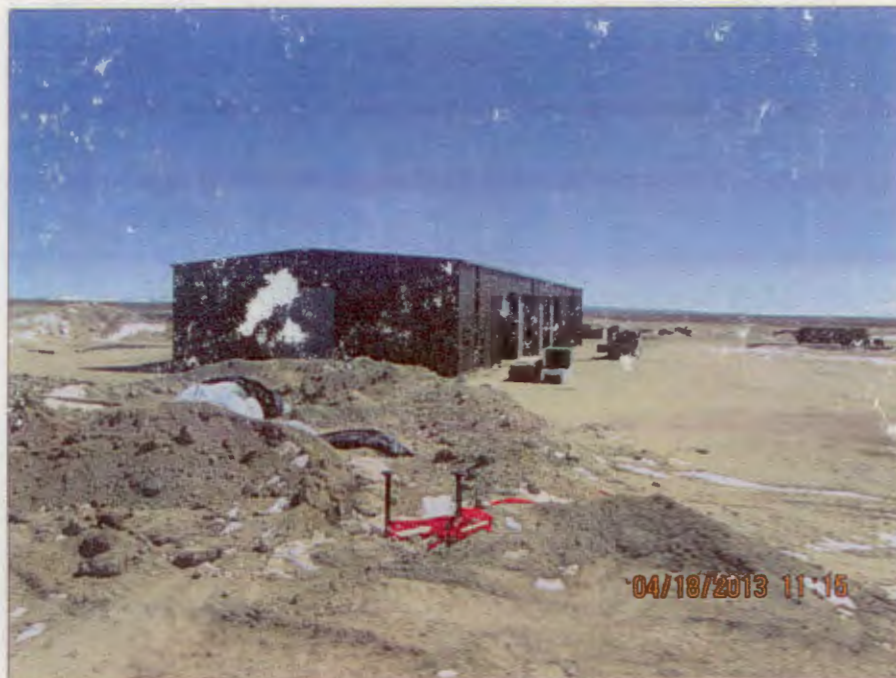
Photo Number 17: This depicts the shop/maintenance building which is directly north of the Plant Building. This view is looking east. The Plant Building is just off the right edge of this photo.

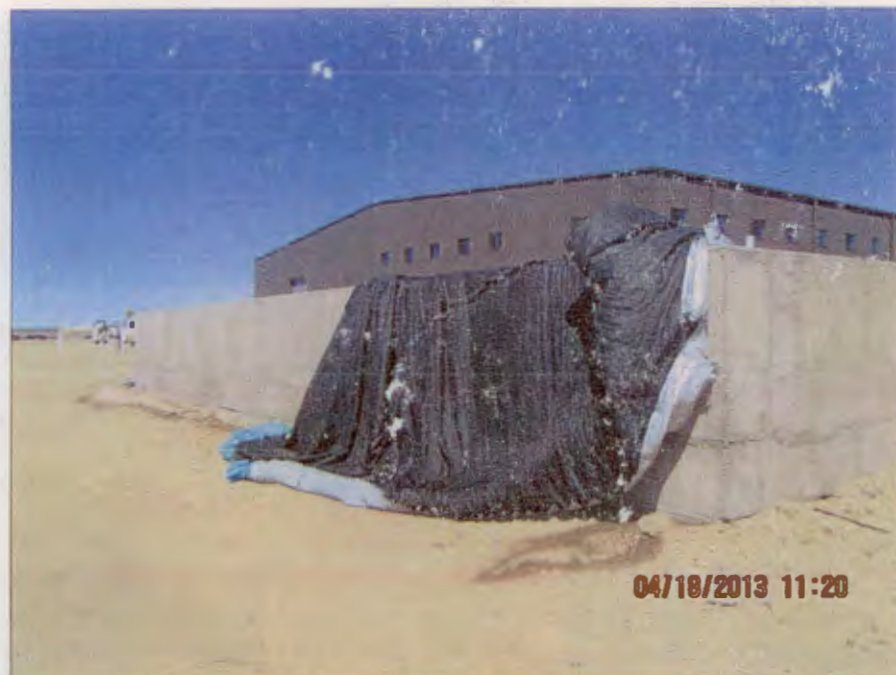
Photo Number 18: This depicts the southeast corner of the hydrochloric acid storage area which is southeast of the Plant Building (in the background).

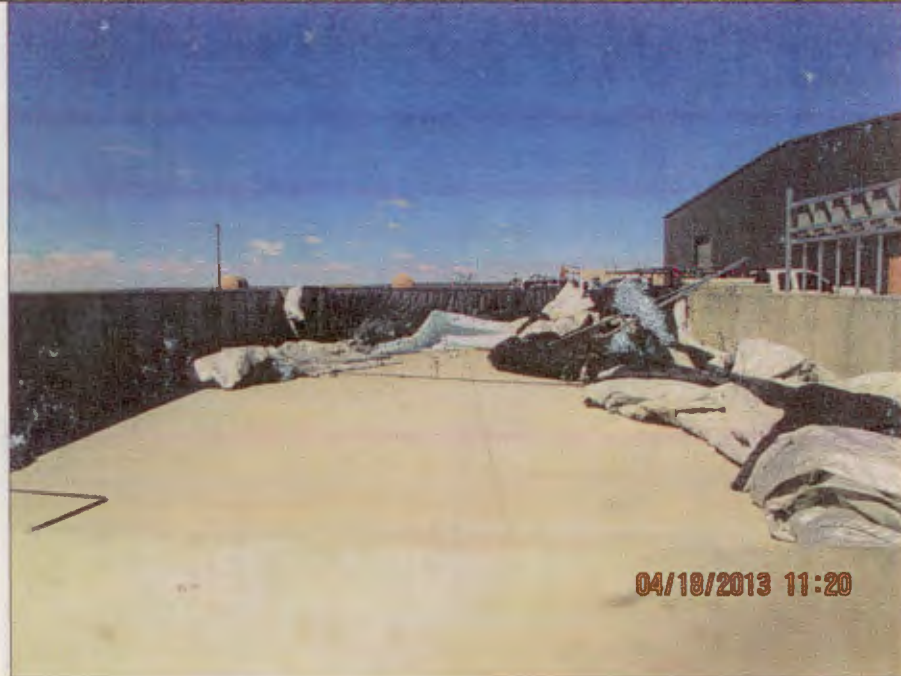
Photo Number 19: This is a look at the inside of the hydrochloric acid storage area.

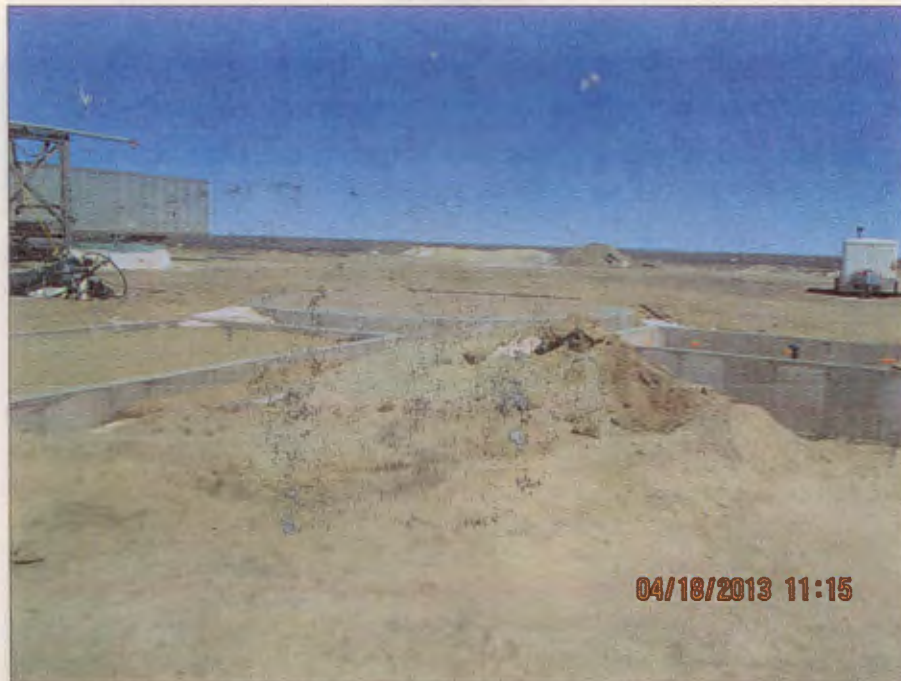
Photo Number 20: This depicts the footings for the 80,000 gallon tank that will be staged northwest of the Plant Building for fire suppression.

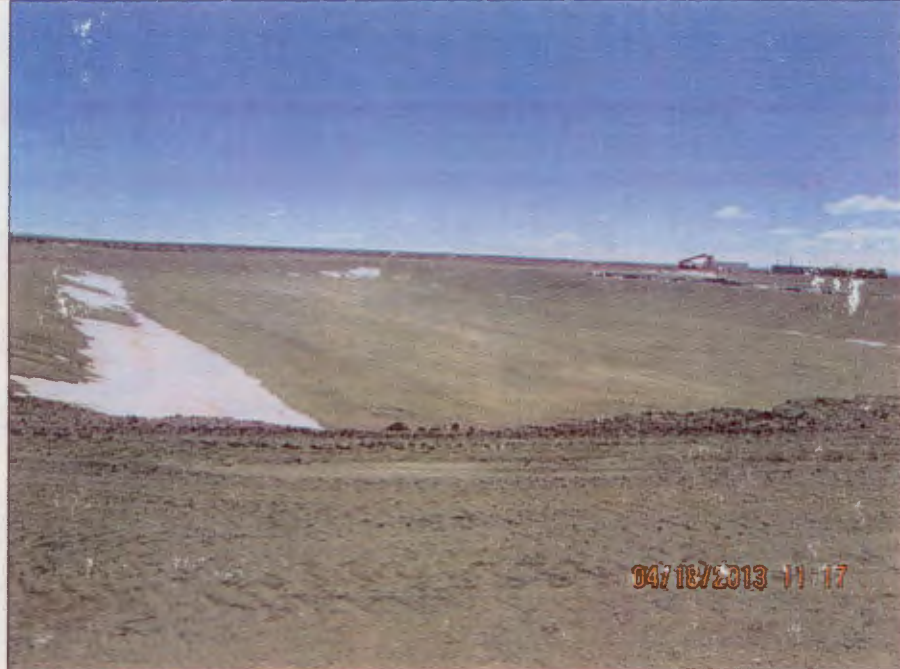
The Pond Site construction (dozer work) was completed in the late fall of 2012. Since the last site Inspection (three weeks ago) the clearing of minor sloughing of the ponds' edges as well as compaction within the ponds has occurred. The next stage of Pond construction includes verification of adequate hydraulic conductivity in the ponds' floors, followed by liner installation, and then installation of the leak detection system. LCI's Catherine Bull anticipates

Photo Number 21: This depicts the northern pond just east of the Plant Building. Both ponds (north and south) were recently re-graded to clean up minor sloughing that had occurred over the winter. This view is looking east.

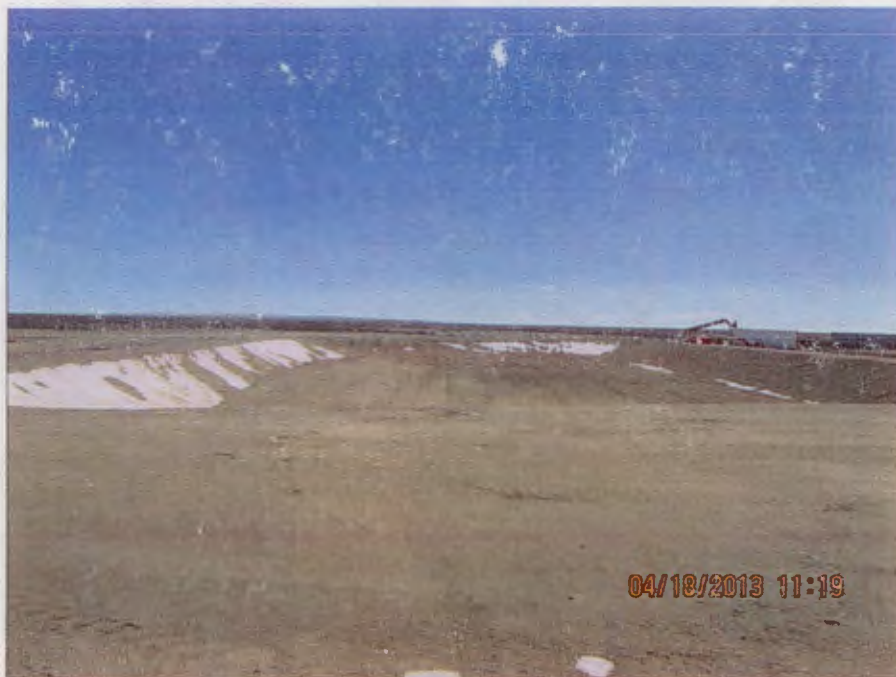
Photo Number 22: This depicts the south pond immediately east of the Plant Building. View is looking east.

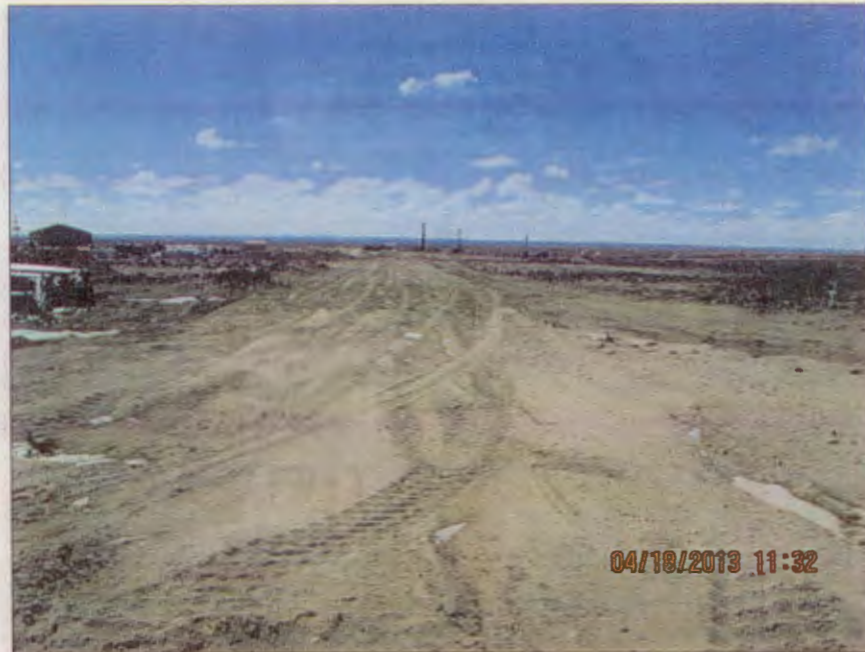
Photo Number 23: This is a view looking south at the main trunk line trench just south of where it goes under the site's access road. The trench was recently backfilled at this location. This photo can be compared with Photo Number 6 in the March 27, 2013 Inspection Report, which depicts the same trench when it was still open.

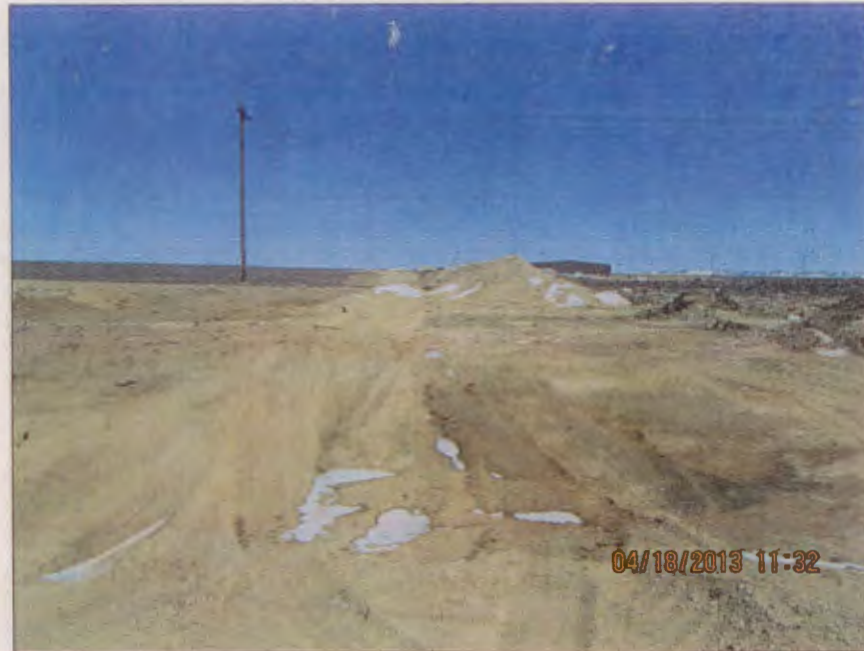
Photo Number 24: This is a view looking north at the main trunk line trench just north of where it goes under the site's access road. The trench was recently backfilled at this location. This photo can be compared with Photo Number 7 in the March 27, 2013 Inspection Report, which depicts the same trench when it was still open.

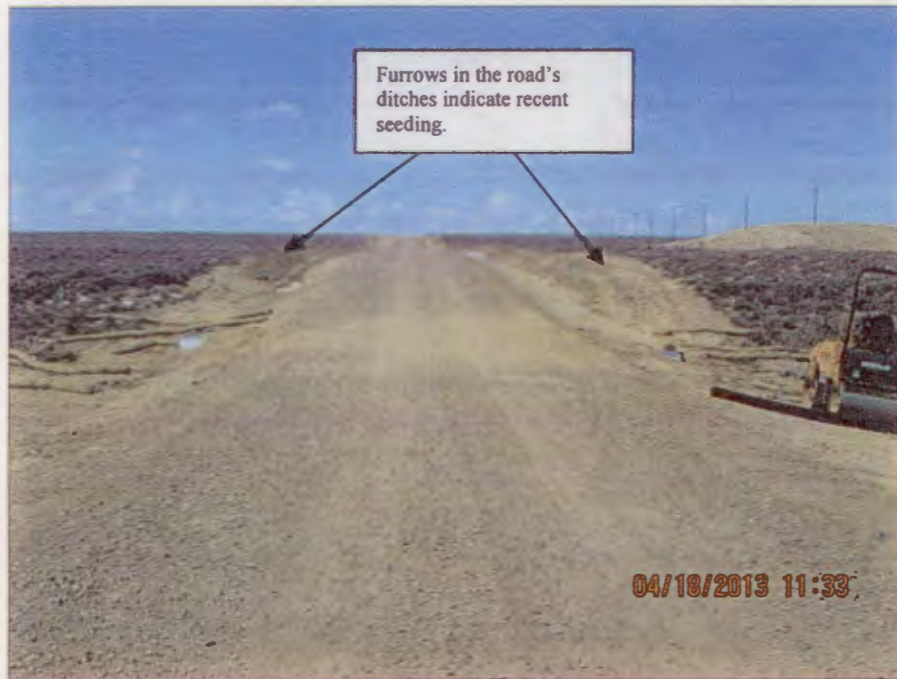
Seeding: During this Inspection Mr. Lueders indicated that the seeding of the site's road ditches has commenced. That effort is about 50% completed. The next areas to be seeded will be the site's topsoil stockpiles. **Spring seeding addresses one of the action items identified in the last Inspection Report.**

Photo Number 25: This depicts the site's access road west of the MU1 Pattern Area where LCI personnel have recently seeded the road's ditches. Note the disc furrows in the ditches. This view is looking west.

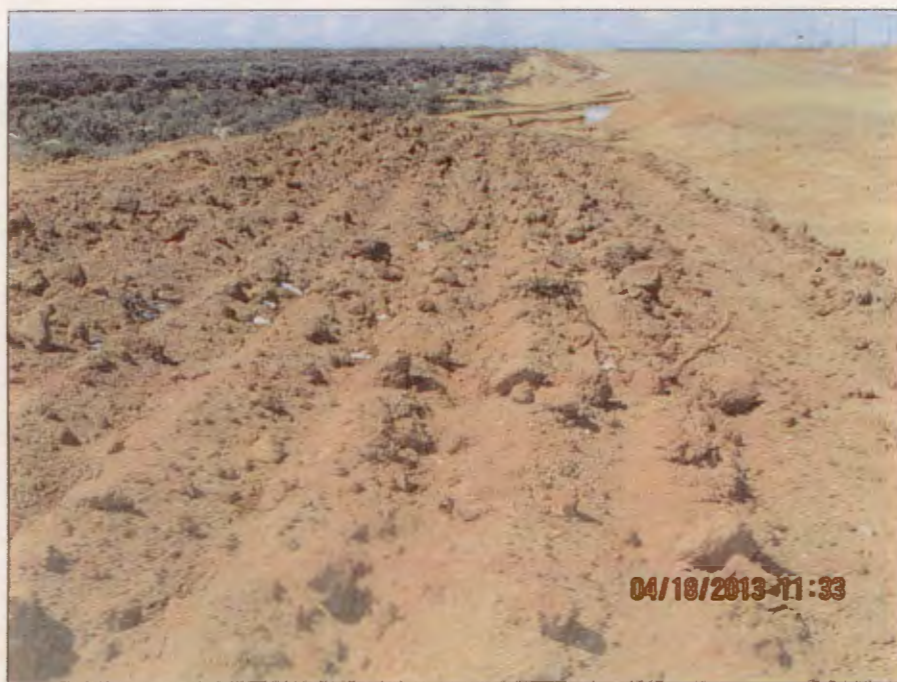
Photo Number 26: This is a close-up of the recently seeded road ditch. View is looking west.
