PART 21 REPORT - FUEL INJECTORS FAILED PRESSURE TEST

Telephone: 252/977-2720
Fax: 252/446-1134Report No. 10CFR21-0109
Rev. 0: 05/03/13**10CFR21 REPORTING OF DEFECTS
AND NON-COMPLIANCE**COMPONENT: EMD Fuel Injectors
P/N 40084720 & 40099335

Report No. 10CFR21-0109
Revision: 0
Date: 05/03/13
Page: 1 of 5

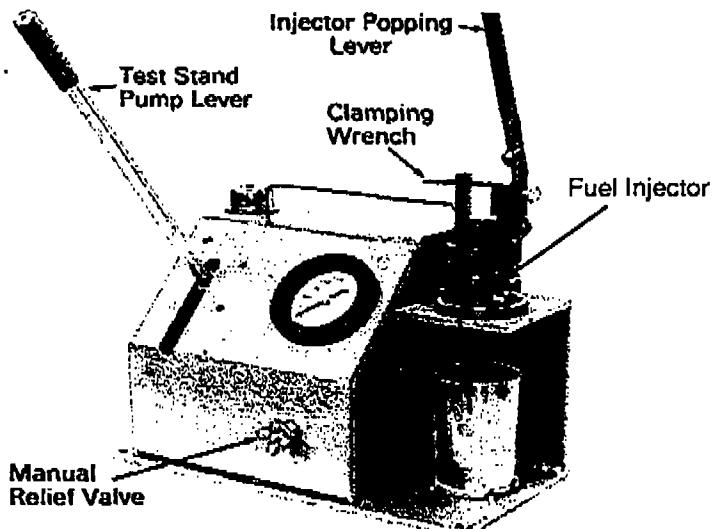
Figure 1: EMD Fuel Injector Tester

The standard holding pressure and leakage test specified for the EMD fuel injectors requires applying 2000 psi to the fuel injector and verifying the pressure does not fall below 1500 psi after 30 seconds. This test is performed on an Injector Tester designed specifically for this purpose. See Figure 1 below.

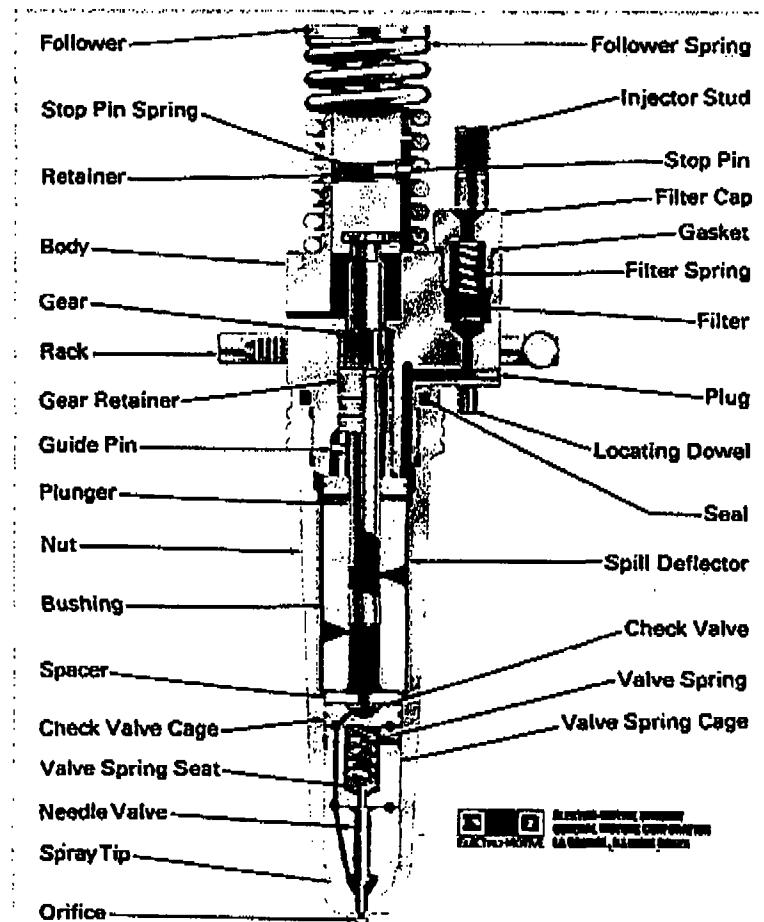
Cut-away of EMD Fuel Injector

- TVA injectors (S/N 12K20318, 12K20385, & S/N 12K20330)
 - Non-metallic material was found along the plunger/bushing, spacer, check valve cage, valve spring cage, and the nozzle. The material was very small and difficult to see by the naked eye. Using a video microscope, the material was identified as small strands of fiber similar to nylon string. In some instances, the material was so small that it would disintegrate when moved around. A larger piece was found within injector s/n 12K20385, located in the nozzle oil passage.

- Davis-Besse injector (S/N 12H23003)
 - Metallic material was found between the nozzle and the spring body cage and at the interior of the nozzle. The debris found in the nozzle was flattened at one end, indicating it was trapped between the nozzle tip and the needle valve preventing the needle valve from achieving a proper seal.

- Non-nuclear customer injectors (S/N 12K20404 & 13A23943)
 - Metallic material was found in both of the fuel injectors. The material was a very small strand of wire that resembled the wire mesh of the injector filter elements. Parts of the wire were also flattened indicating that it was compressed between two surfaces, i.e. the needle valve and nozzle tip, which would prevent the needle valve from seating. S/N 13A23943 also contained a small piece of metallic material that resembled casting flash.

It has been determined that the debris entered the fuel injectors during assembly of the filter elements into the injector body at the manufacturer. Inspection of the filter element storage container revealed an excess of metallic and nonmetallic contaminants. The metallic material resembled the wire like material found in the injector nozzles; this was determined to be pieces of the injector filter material (0.004" diameter wire). There was also nonmetallic material present in the container as well; this is suspected to originate from packaging materials.

- The fuel injector manufacturer has implemented a work instruction to ensure cleanliness of the filter elements and the corresponding container in which the elements are placed prior to being issued for insertion into the fuel injector. This container will also be labeled to indicate that it has been through the cleanliness process.
- ESI will add an additional injector pressure test requirement for all EMD fuel injectors supplied on nuclear safety related sales orders. The additional test will be performed by ESI after calibration/performance testing is completed. This will be implemented for new and rebuilt fuel injectors as an additional verification of injector performance/operability prior to shipment to the customer.
