5.4 Industry Standard Nondestructive Evaluations

6 Destructive Validation of Nozzle 63

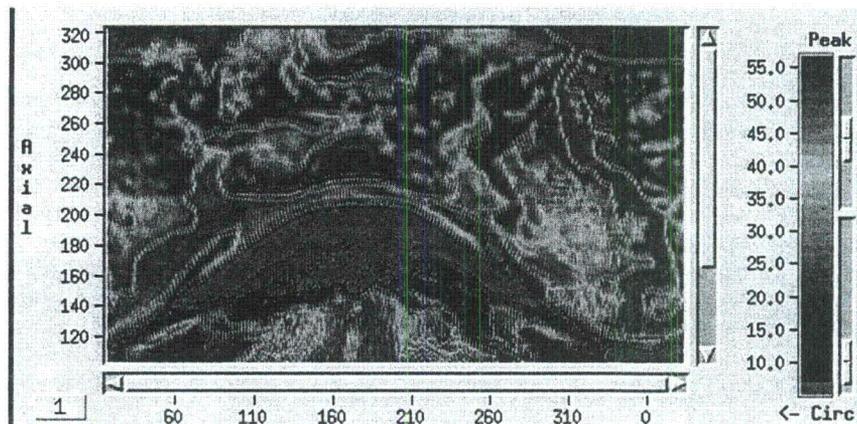
The Figure 5.17 image can be compared to the PNNL's results in Figure 5.15. Both data sets were acquired with probes having nominal center frequencies of 5 MHz and they show the main leak path as a high-amplitude signal. In the WesDyne data, this is represented by the magenta color. Both data images capture other partial leak paths and show similar areas of high and low reflectivity. The PNNL data however possess better data registration in the odd and even scan lines as well as improved resolution and focusing. These images demonstrate that PNNL was successful in achieving a better evaluation of the interference fit as compared to a qualified industry procedure.

Figure 5.17 Ultrasonic Data from Nozzle 63 as Obtained by WesDyne International. The image was acquired with a 5-MHz probe. The horizontal axis represents the nozzle circumference in units of degrees. The vertical axis represents the nozzle axis in units of millimeters.

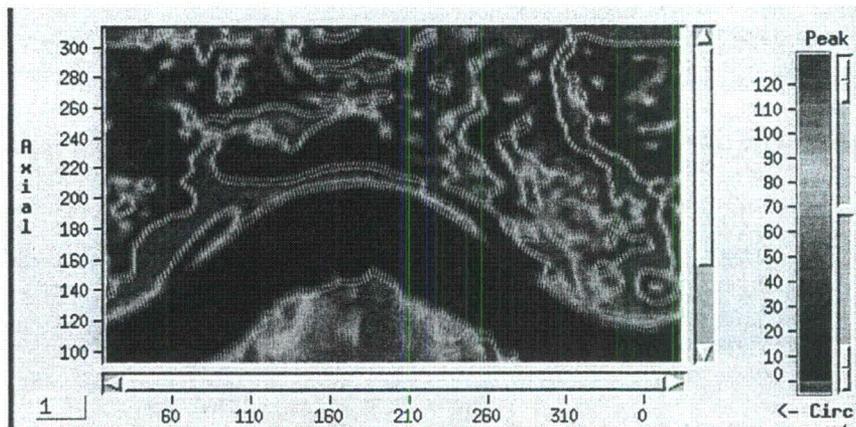
Figure 5.18 Ultrasonic Data from Nozzle 63 as Obtained by WesDyne International. The image was acquired with a 2.25-MHz probe. The horizontal axis represents the nozzle circumference in units of degrees. The vertical axis represents the nozzle axis in units of millimeters.

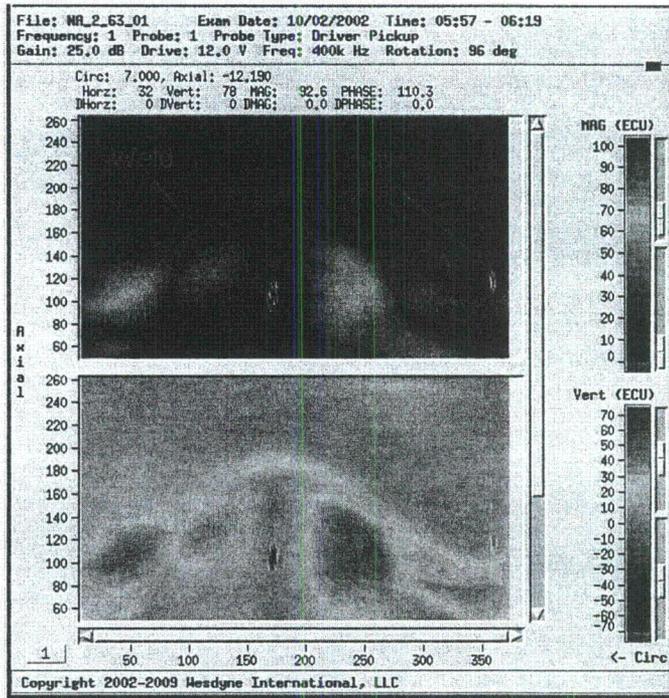
Additionally, an eddy current inspection conducted by WesDyne International detected two axial flaws. These were found at the locations shown in Figure 5.19 (data supplied by JP Lareau). The specific circumferential locations were noted at 172 and 360 degrees with 0 or 360 degrees representing the downhill position. The axial length for flaw 1, below the weld, was 25.4 mm (1.0 in.) and for flaw 2, above the weld and in the main leak path, was 19.3 mm (0.76 in.). These cracks were ID surface-connected and reported as shallow flaws.

While PNNL did not specifically perform an evaluation for axial cracking in the Alloy 600 tube, the two axial cracks noted by industry were detected. The zero-degree PNNL inspection was not optimized for crack detection as an axial crack presented only a knife-edge profile to the ultrasonic beam and did not reflect much energy. Nevertheless, the cracks were visible in the interference fit response and on further analysis also marginally detected in the water-to-Alloy 600 tube reflection (ID surface of the tube). Figure 5.20 shows the uphill images for the ID tube and interference fit responses. Similarly Figure 5.21 shows the responses for the downhill images. Both flaws appear to be ID surface-connected as they were detected in the data acquired at the ID surface of the Alloy 600 tube. These two flaws are also evident in the image in Figure 5.15. The ultrasonic data did not provide any depth-sizing information.

Figure 5.19 Eddy Current Data (WesDyne International) Showing Two Axial Flaws. The horizontal axis represents the nozzle circumference in degrees. The vertical axis represents the nozzle axis in millimeters.

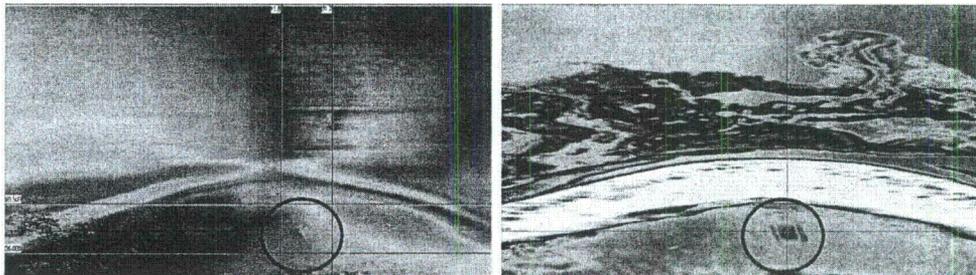
Figure 5.20 Uphill Nozzle ID Response on the Left and Interference Fit Response on the Right with the Axial Flaw Indication Circled. The horizontal axes represent 189 degrees and the vertical axes represent 360 mm (14.2 in.).

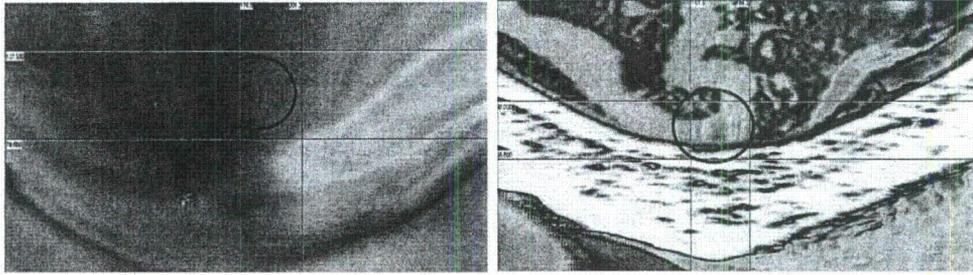
Figure 5.21 Downhill Nozzle ID Response on the Left and Interference Fit Response on the Right with the Axial Flaw Indication Circled. The horizontal axes represent 188 degrees and the vertical axes represent 155 mm (6.1 in.).

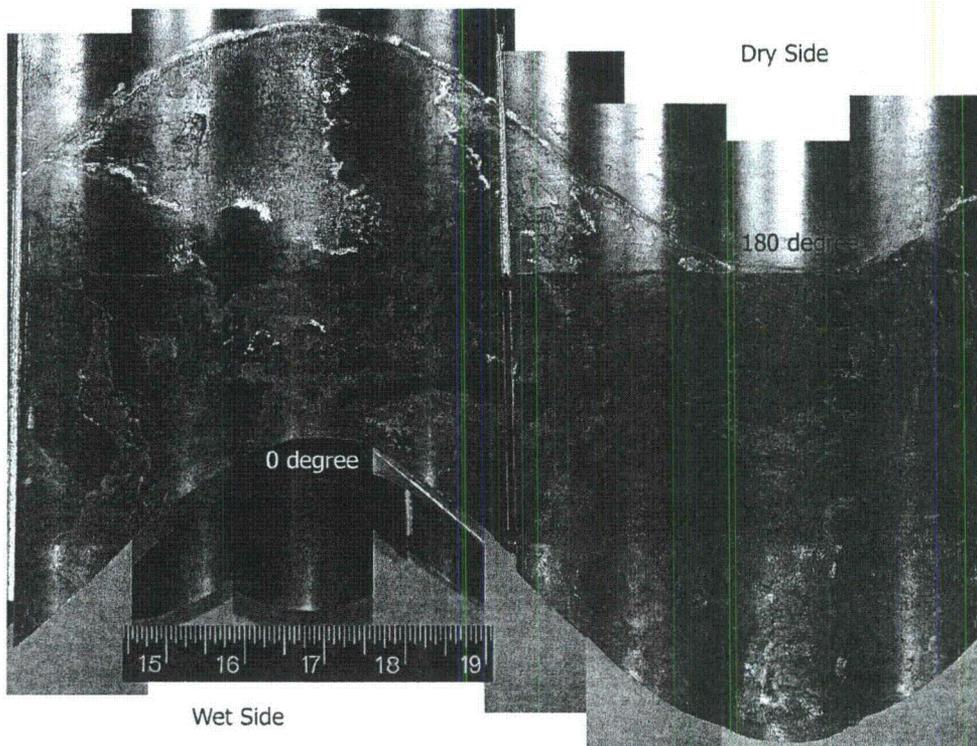
This section compares the phased-array ultrasonic results to the visual results obtained by cutting through the nozzle assembly to reveal the interference fit surfaces. The nozzle outer diameter surface was photographed in 45-degree increments with the individual photographs cropped and stitched together to form the montage image in Figure 7.1. Some evidence of thin boric acid deposits is visible in the white regions while a thin corrosion layer is seen in the rust-colored regions. The red line marks the interference fit region.

Figure 7.1 Nozzle Surface. The red line marks the interference fit region.

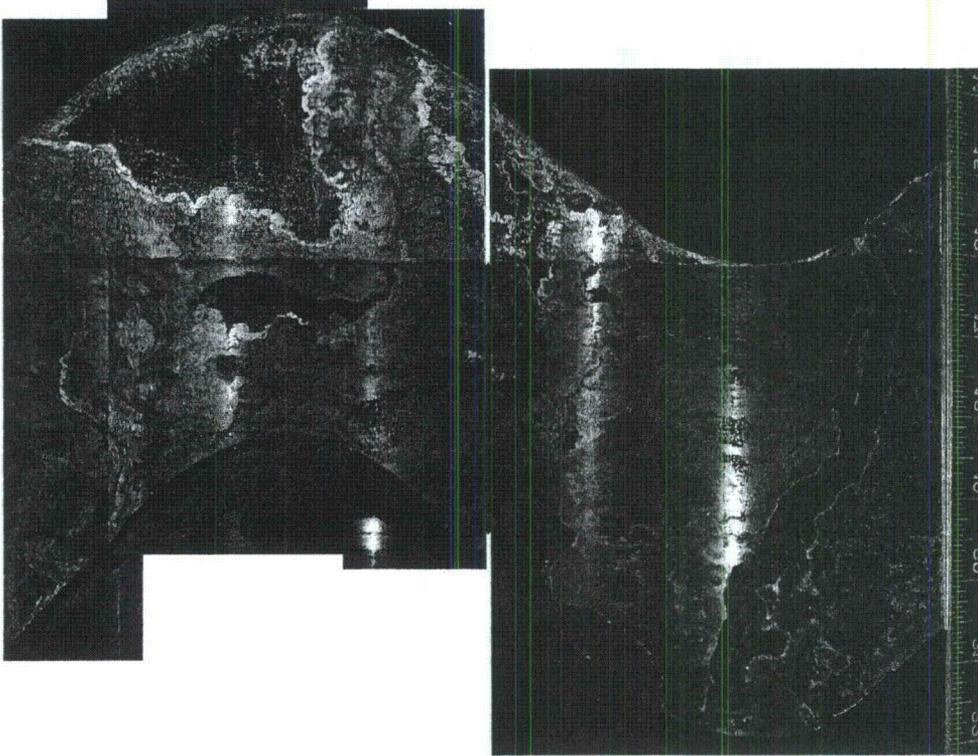
Similarly, the exposed reactor pressure vessel (RPV) head was photographed and the stitched image is displayed in Figure 7.2. The main leak path and other features seen in the ultrasonic images are clearly evident. Boric acid deposits are visible in white and corrosion products in the rust color. The interference fit region is evident in the photograph and is marked with the red line.

Figure 7.2 RPV Head Surface. The red line marks the interference fit region.

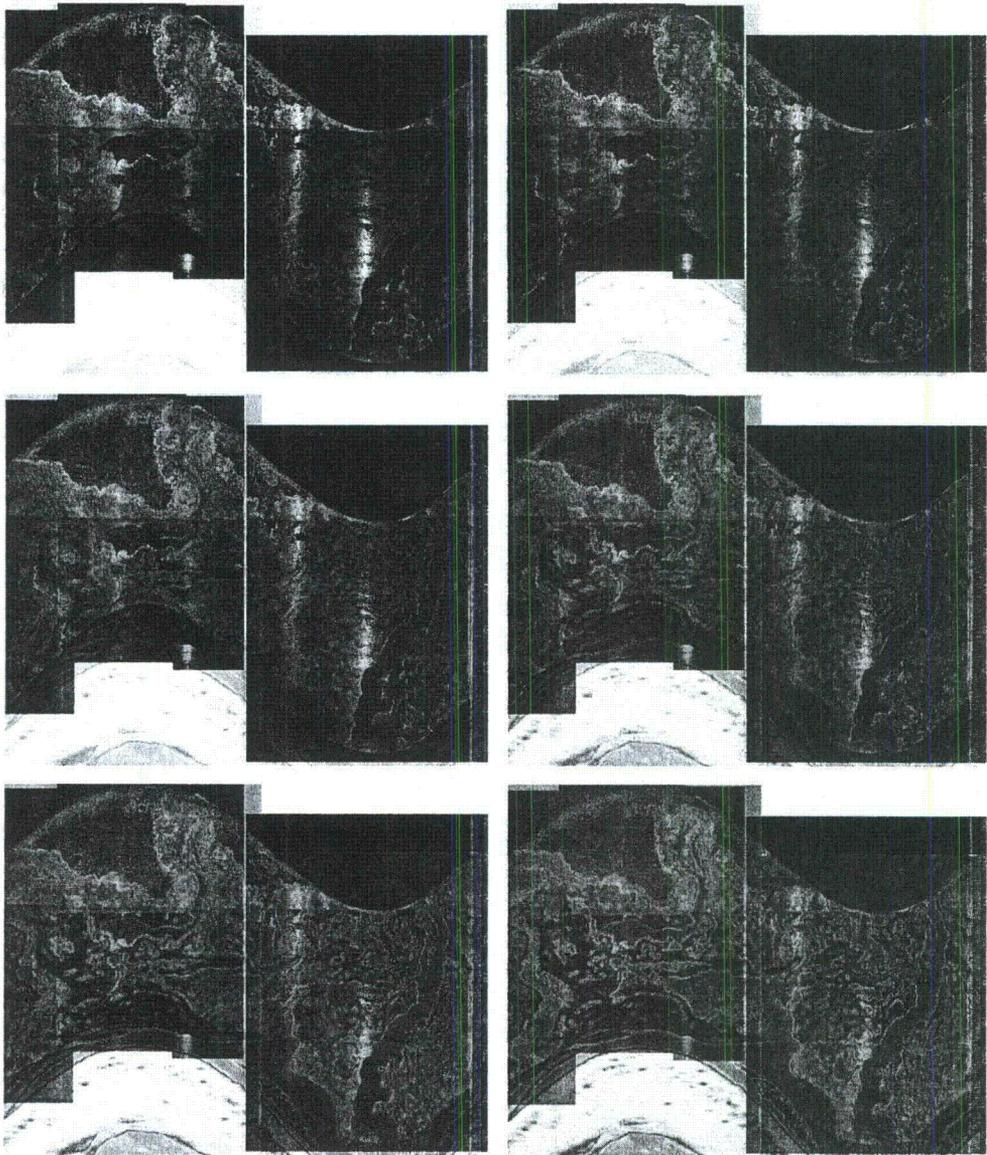
A comparison of the ultrasonic and visual images is next presented. The ultrasonic data is overlaid on the RPV head montage photograph in a series where the opacity of the ultrasonic data is varied from 10 to 60%, in increments of 10%. Figure 7.3 displays the results with increasing opacity from left to right, top to bottom. The ultrasonic image was stretched to best fit the visual data but the match is not perfect due to the curved surfaces. Nevertheless, the ultrasonic features well match the features seen visually on the RPV head annulus. Clearly, the main leak path was precisely imaged and other partial leak paths are evident as well.

Figure 7.3 Ultrasonic Data Overlaid on RPV Head Photograph with Opacity Varying from 10 to 60%, Top to Bottom

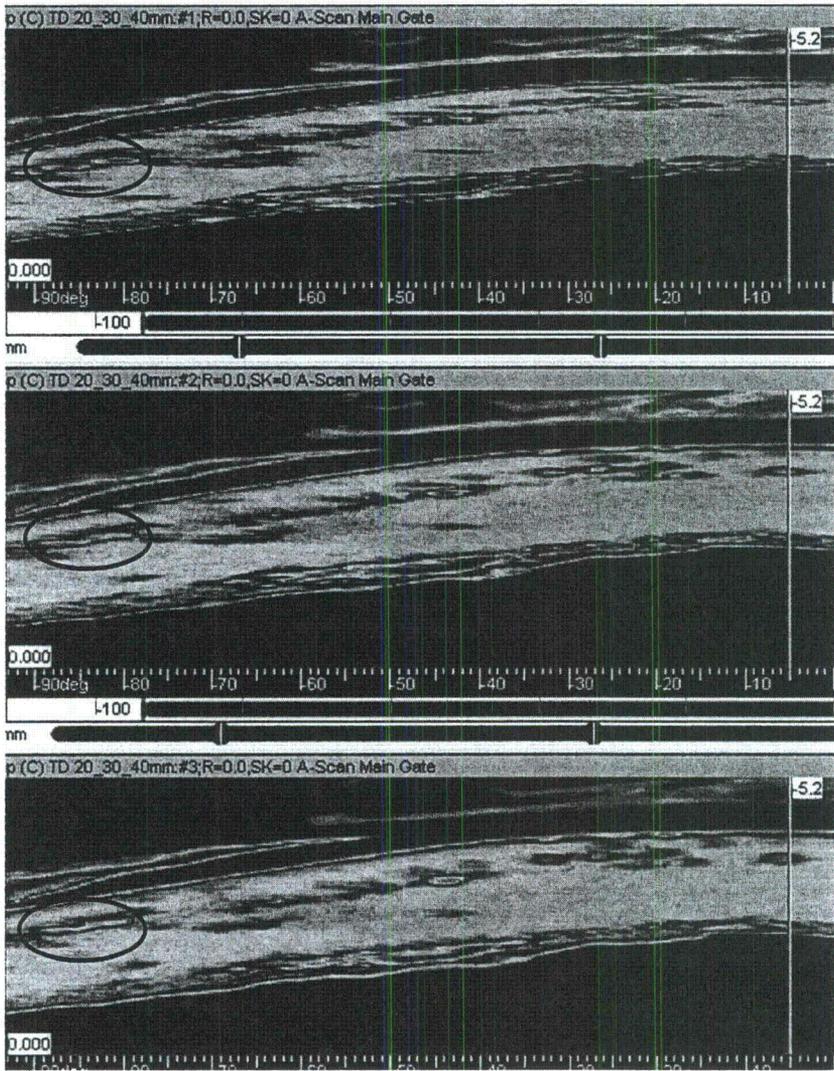
Figure 8.1 Weld Images with Focal Depths at 20, 30, and 40 mm (0.79, 1.18, and 1.56 in.) from Top to Bottom, Respectively. The horizontal axis represents approximately 90 degrees and the vertical axis represents approximately 150 mm (5.9 in.). A 20-mm (0.79-in.) focus provided the best resolution in this data.

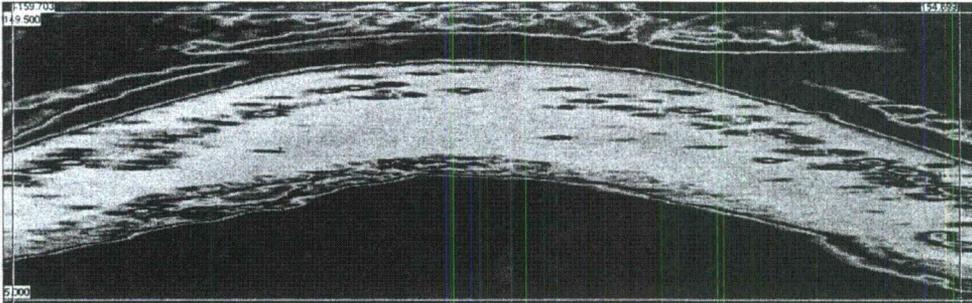
A composite view of the ultrasonic indications in the weld are presented in the C-scan top view or plan view images in Figures 8.2 and 8.3 for the uphill and downhill halves of the weld, respectively. Each figure represents approximately 150 mm (5.91 in.) in the vertical or axial direction and 180 degrees in the horizontal or circumferential direction. The indications were generally all located at the Alloy 600 tube-to-weld interface, or near surface, as will be discussed in more detail below. These indications appear to be volumetric in shape, indicative of fabrication flaws and assumed to be welding anomalies. The types of fabrication flaws expected would include incomplete or lack of fusion between individual weld beads, inclusions, voids, etc. Notice that the downhill image contains more indications. This is not unexpected due to the more difficult configuration at this position in the nozzle assembly. One would be welding upside down, in a deeper cavity, and with limited access at this location; and therefore more likely to introduce imperfections in the weld. A connected string of indications following the curvature of the weld are observed in Figure 8.3—likely a lack of fusion between weld bead passes. These indications are noted by the red arrow in the figure.

Figure 8.2 Uphill Half of the Weld. The horizontal axis represents approximately 180 degrees and the vertical axis represents approximately 150 mm (5.9 in.).

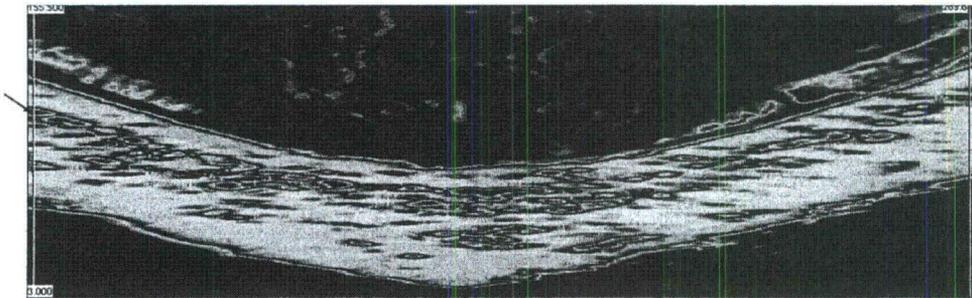
Figure 8.3 Downhill Half of the Weld. The horizontal axis represents approximately 180 degrees and the vertical axis represents approximately 150 mm (5.9 in.).

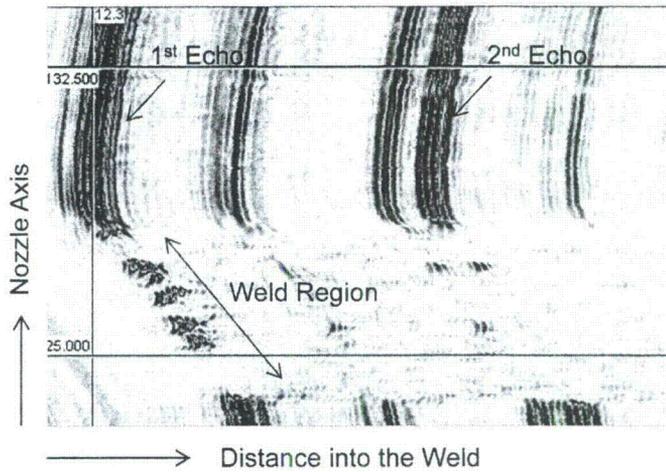
Figure 8.5 B-scan Side View at the 174-Degree Circumferential Position. Near-surface indications are visible in the weld material. The horizontal axis represents approximately 40 mm (1.6 in.) in metal and the vertical axis 155 mm (6.1 in.).

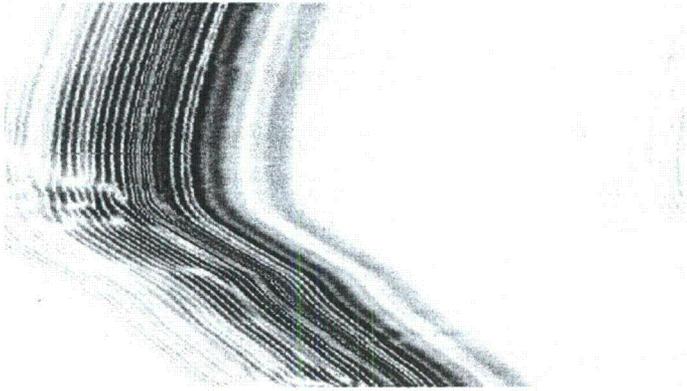
Figure 8.6 B-scan Side View of the Front Surface Echo Showing Surface Profile Distortion Due to Welding and Cooling at the 174-Degree Circumferential Position. The horizontal axis represents approximately 20 mm (0.8 in.) in metal and the vertical axis 155 mm (6.1 in.).

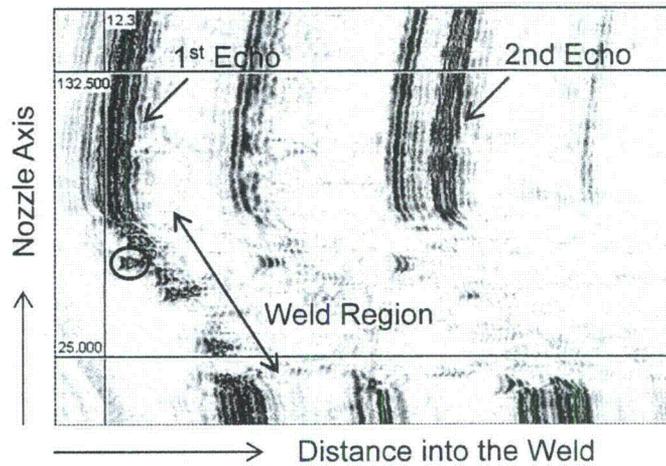
The weld region was evaluated for anomalies throughout the full 360-degree circumference. The indications fell along the Alloy 600 tube-to-weld interface at all but one circumferential position. At the 193-degrees position as noted in Figure 8.7, an indication appeared earlier in time than the other indications. The corresponding B-scan side view is shown in Figure 8.8 with the early indication circled. This earlier indication would plot into the tube material and could possibly be from a gouge in the tube and improper or no weld fill or repair. The indication displacement is shallow at approximately 1 mm (0.04 in.) in depth. No indications of circumferential cracking across or along weld beads were detected.

Figure 8.8 B-scan Side View at the 193-Degree Circumferential Position. Near-surface indications and one indication, circled in red, occurring earlier in time are visible. The horizontal axis represents approximately 40 mm (1.6 in.) in metal and the vertical axis 155 mm (6.1 in.).

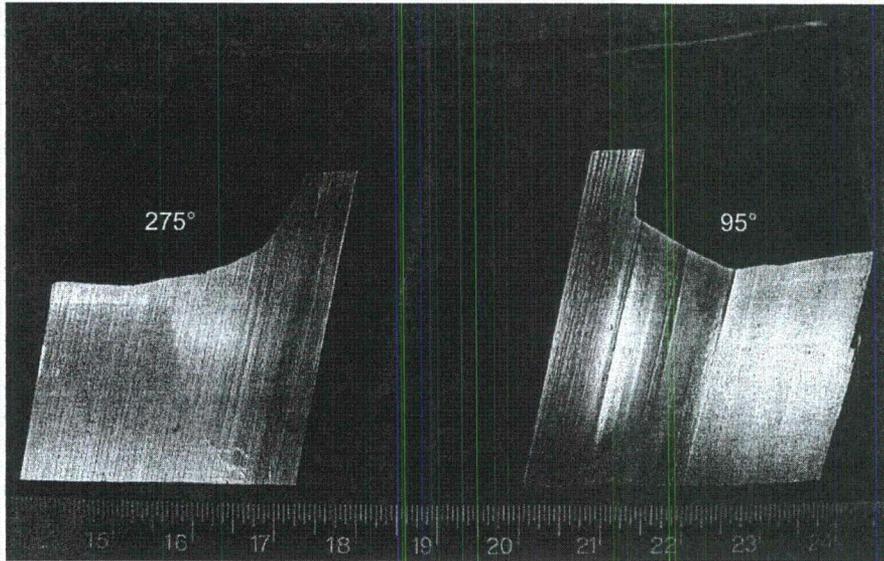
A comparison between the cut surface and ultrasonic data was made. It was observed that the 180-degree or low point on the weld was found to be located at 171 degrees in the ultrasonic image. Therefore, the ultrasonic data was shifted by 9 degrees to account for this offset. By this reasoning, the 95-degree cut surface corresponds to the 86-degree position in the ultrasonic data and the 275 cut surface corresponds to the 266-degree position ultrasonically. Again, note that these positions and the positions of the cut surfaces are estimated. The corresponding ultrasonic positions are noted in the ultrasonic C-scan top view image in Figure 8.11 with the left red vertical line at 87 degrees (on the left edge of the image) and the right blue vertical line at 266 degrees. The image did not extend to the 86-degree position so the 87-degree position is noted instead. The two indications marked by arrows at the 87-degree position in Figure 8.11 correlate to the two indications noted in Figure 8.10. An indication is also marked on the right side at the 266-degree position.

Figure 8.9 Cut Surfaces of the Nozzle Assembly at 95 Degrees on the Right and 275 Degrees on the Left. The scale is in inches.

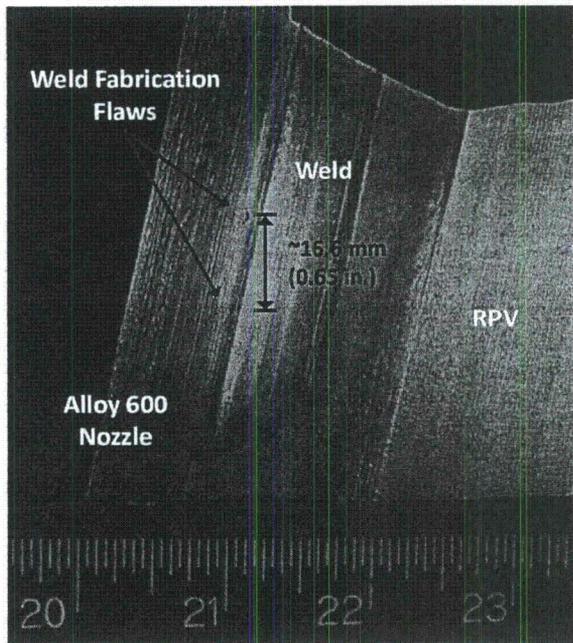
Figure 8.10 The 95-Degree Surface Shows Two Fabrication Flaws at the Alloy 600 Tube-to-Weld Interface

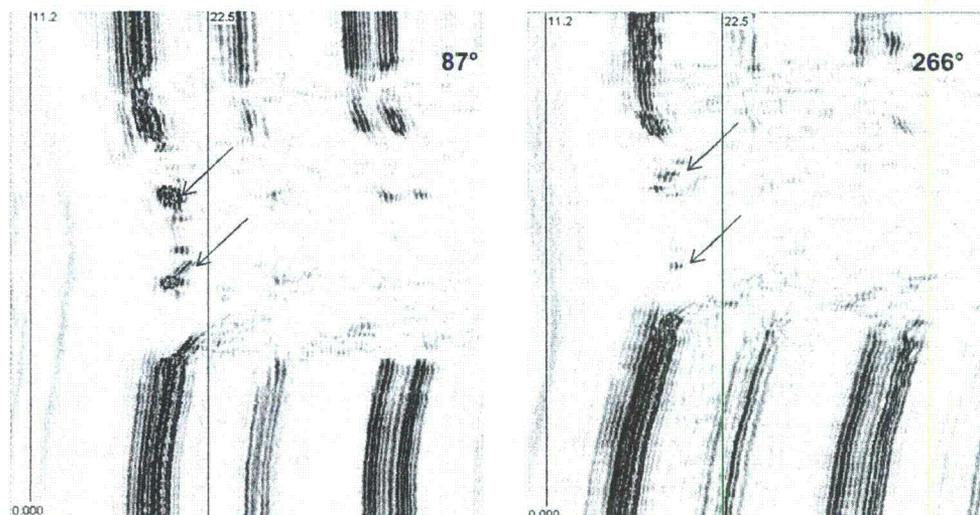
B-scan side view images are displayed in Figure 8.12 for the 87- and 266-degree positions from Figure 8.11. The left side view image in Figure 8.12 at the 87-degree circumferential position shows the two defects with anomalous signals in between. The right image at the 266-degree position shows two possible defects with much lower signal amplitude, indicating smaller flaws.

Figure 8.12 B-scan Views of the Data at 87 Degrees on the Left and 266 Degrees on the Right, Corresponding to the Cut and Exposed Surfaces in Figure 8.9. The horizontal axis in each image represents 40 mm (1.6 in.) in metal and the vertical axis represents 155 mm (6.1 in.) approximately. Flaw indications in the Alloy 600 tube-to-weld interface are noted with arrows.

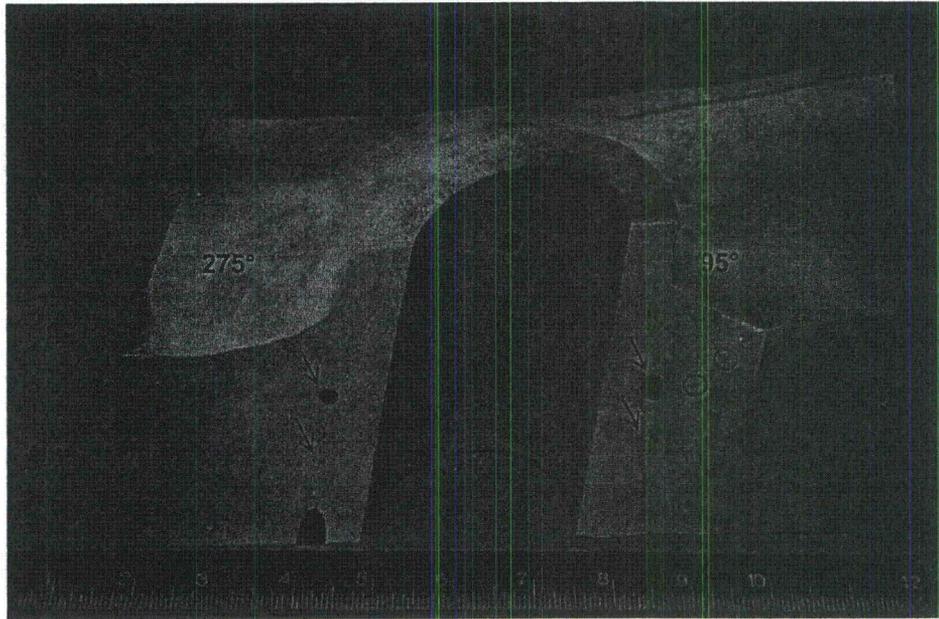
The presence of these flaws was further confirmed by the dye penetrant test results on the cut surfaces shown in Figure 8.13. The two flaws at the 95-degree and two at the 275-degree cut surfaces are marked with arrows. Furthermore, two additional flaws in the weld material are circled on the 95-degree surface. These weld flaws were not evident in the ultrasonic data for two likely reasons. First, the beam possibly did not focus well at those depths. Second, any flaws occurring earlier in time (depth) would return or reflect the ultrasonic energy causing a shadow region beyond or later in time (depth) that would not be insonified.

Figure 8.13 Dye Penetrant Test Results on the Downhill Dissection Cut Surface. The scale is in inches.
