APPENDIX B SEISMIC WALKDOWN CHECKLISTS (SWCs)

Seismic Walkdown Checklist (SWC)

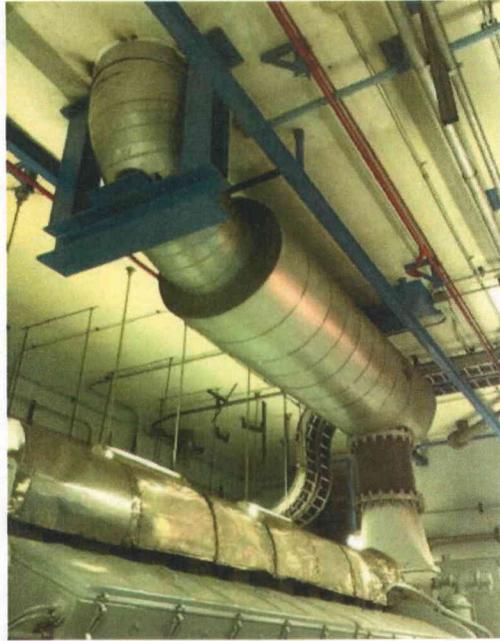
File Name: 2-63-8-1-20.jpeg
Description: View of marks surrounding DG exhaust pipe.

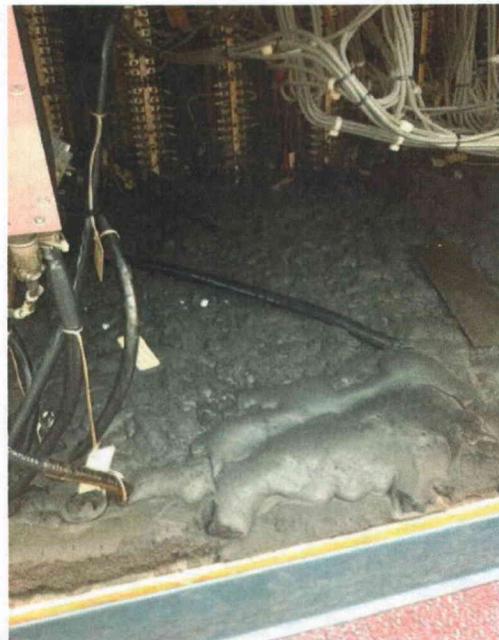
File Name: 2-62-5-1-18.jpeg
Description: View of insulating material covering component anchorage

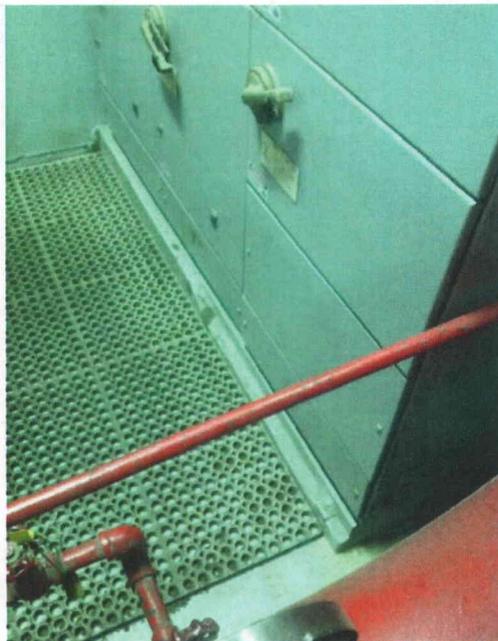
File Name: 2-63-1-1-27.jpeg
Description: View of spalled concrete at base of MCC

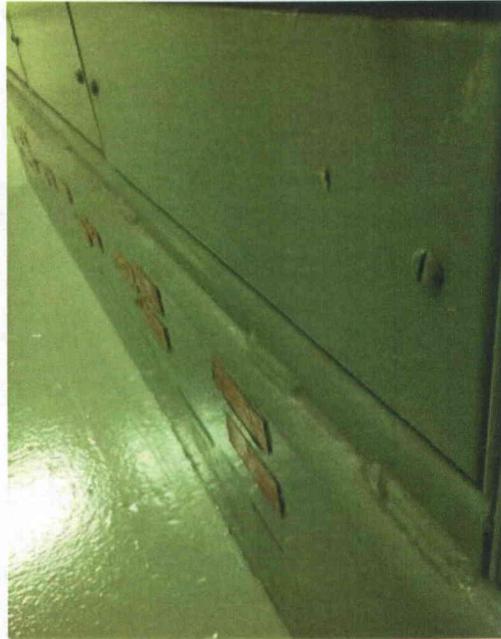
File Name: 2-63-9-1-32.jpeg
Description: View of MCC base stitch weld detail

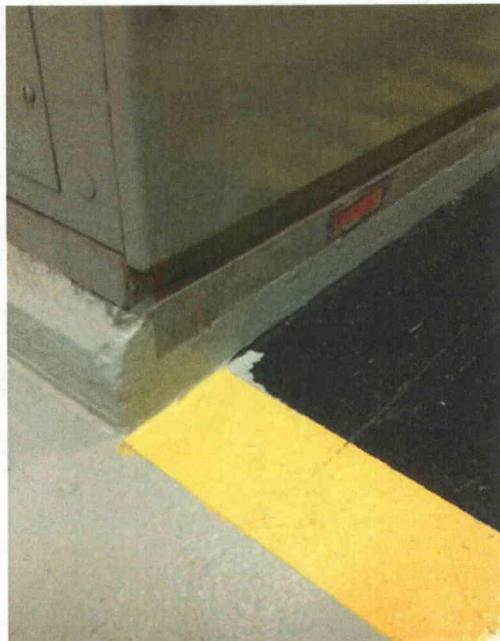
File Name: 2-64-1-1-47.jpeg
Description: View of MCC embedment and stitch weld detail
