Re: **Summary of Bi-weekly Inspection of Lost Creek ISR LLC's Permit 788**

**Wyoming Department of Environmental Quality (WDEQ)- Land Quality Division (LQD)**  
**Inspection Memorandum**

File: Lost Creek ISR, LLC – Permit 788

Date of Inspection: April 30, 2013

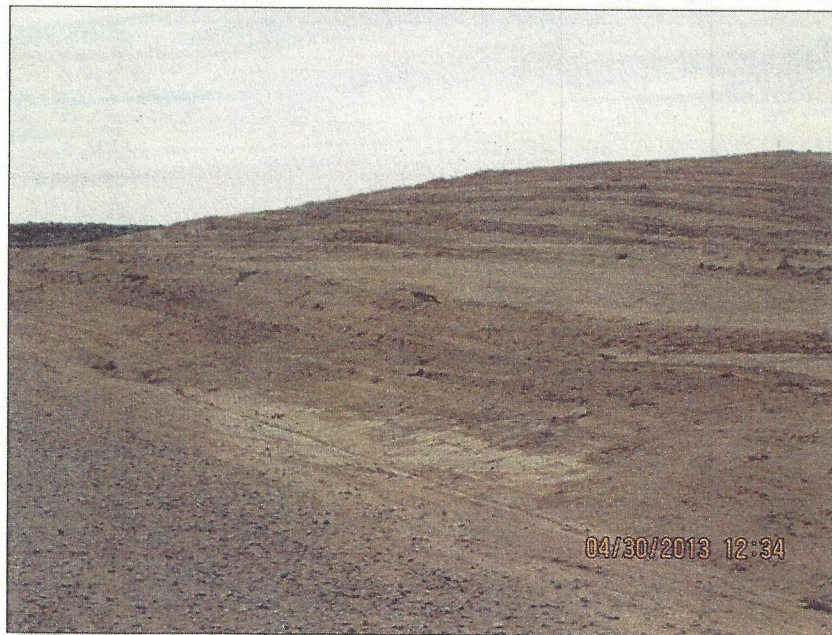
**Photo Number 1: This depicts a topsoil stockpile along the west site access road that was recently seeded.**

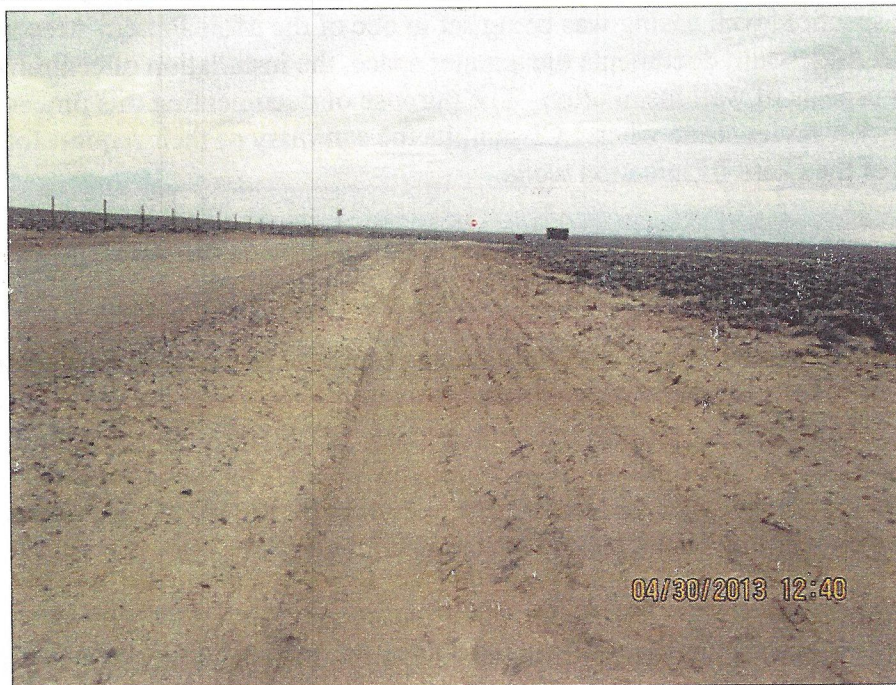
**Photo Number 2: This depicts the recently-seeded road ditch at the west edge of the access road.**

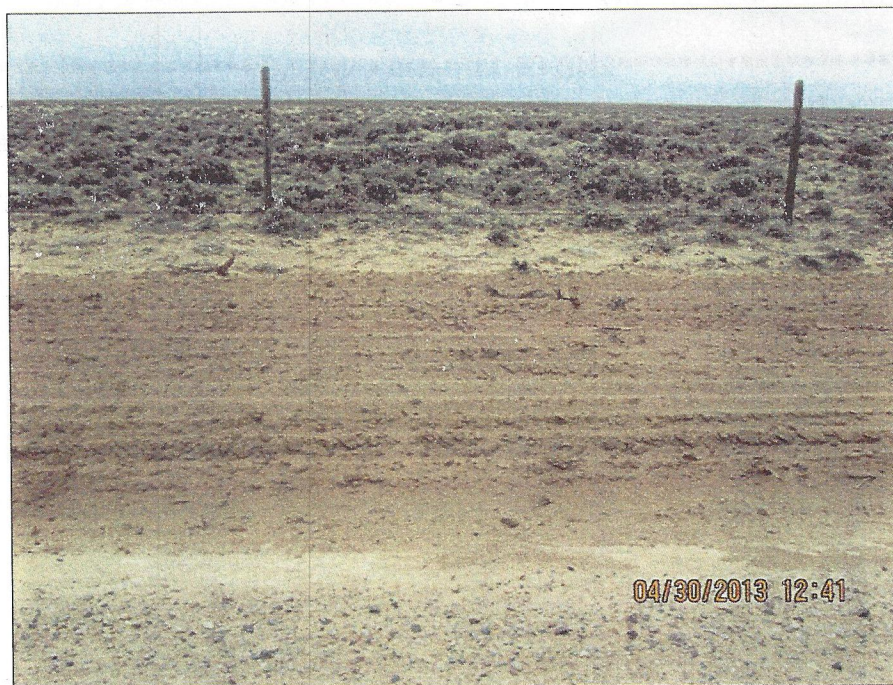
**Photo Number 3: This is another view of the recently-seeded road ditch at the west end of the access road.**

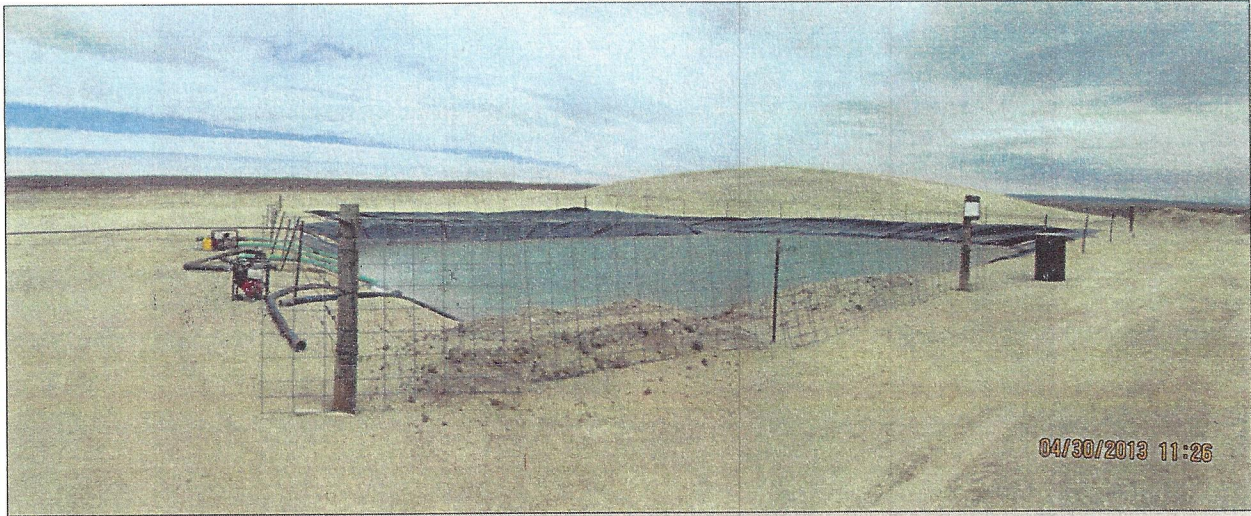
**DDW-3:** The water storage pond at DDW-3 is once again being used to fill water trucks for drilling; this time in the MU2 area. The tanks at the DDW-4 drill pad are currently being used for drilling water for the MU1 area.

**Photo Number 4:** This depicts the water storage pond at the DDW-3 drill pad. Its fencing and liner are well maintained.

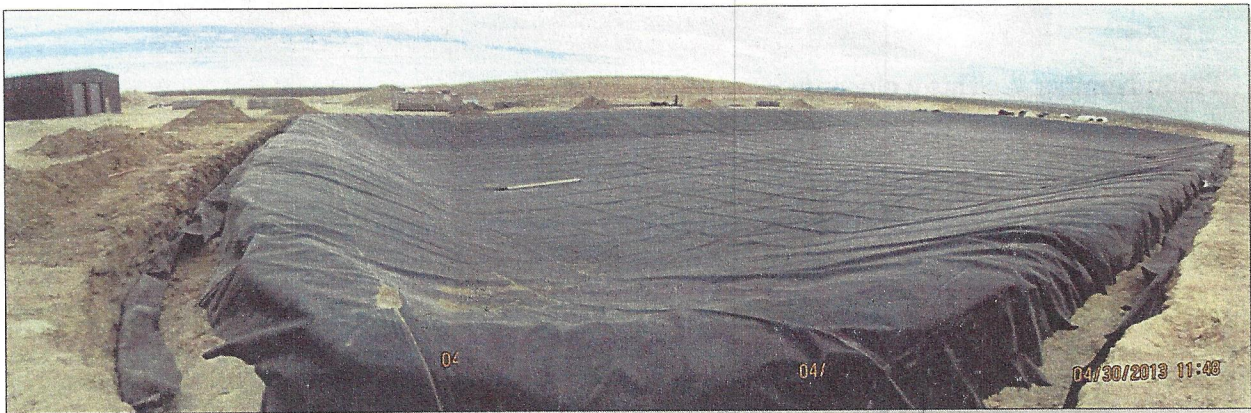
Pond Site construction work since the last Inspection has included verification of adequate hydraulic conductivity in the ponds' floors and liner installation (see Photo Addendum). The remaining activities related to Pond construction will be continued over the next couple of weeks.

**Photo Number 5:** This depicts the bottom (geomembrane) liner that was recently installed in the north Pond. Its leak detection system has been installed and this pond will receive a layer of sand before the second liner is installed.

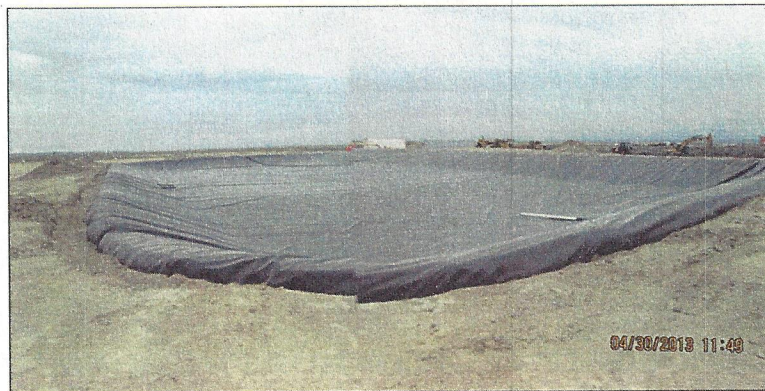
**Photo Number 6:** This depicts the south Pond's liner.

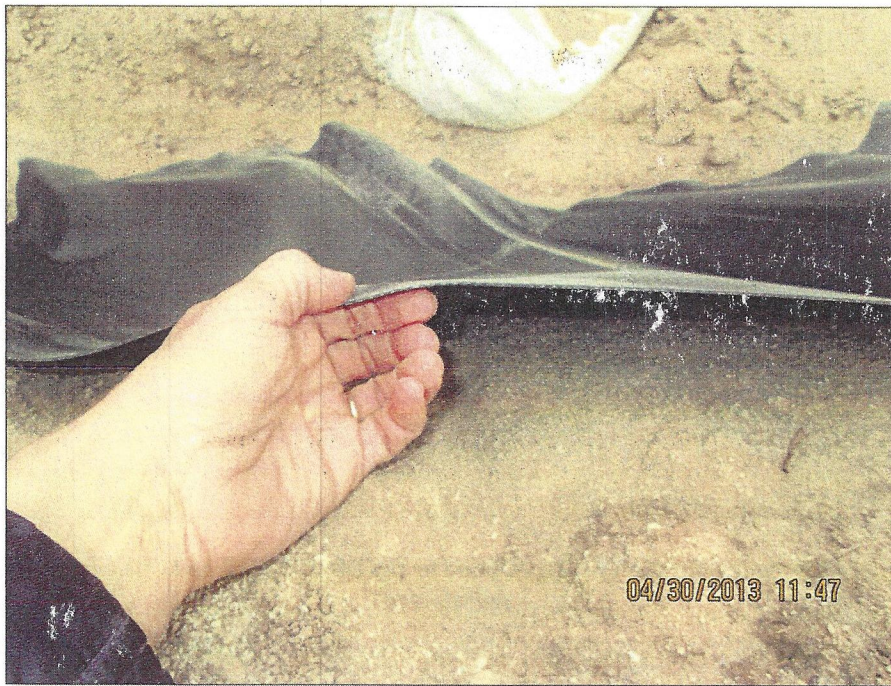
Photo Number 7: This a close-up view of the geomembrane liner material for the Ponds.

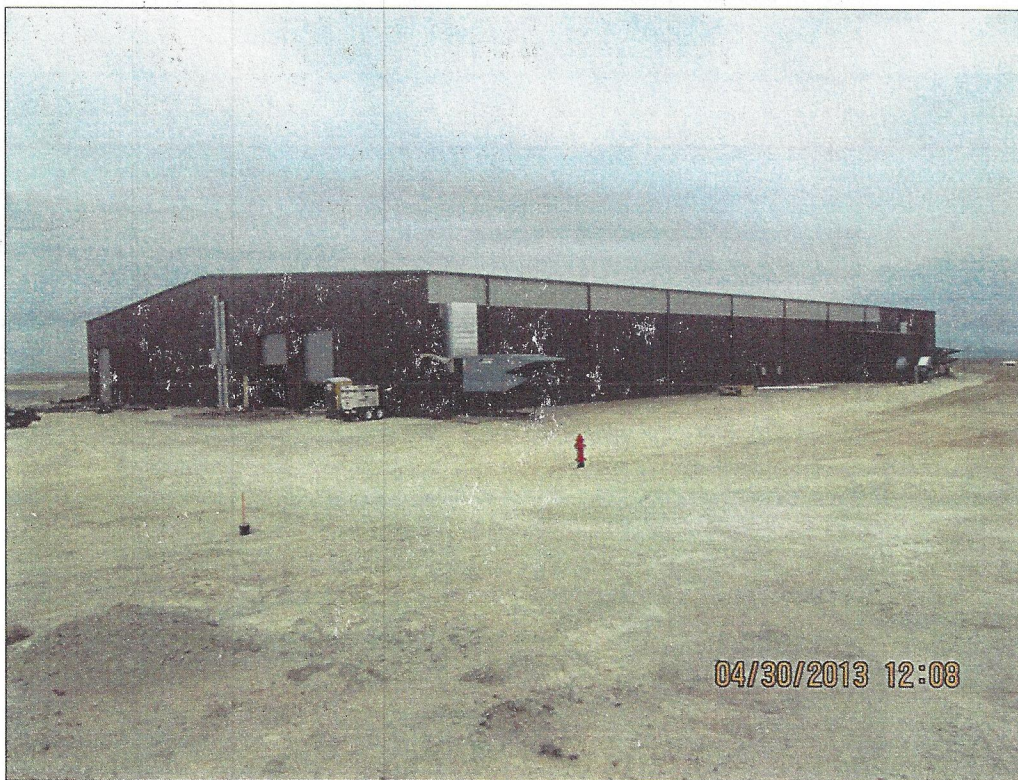
Since the last Inspection, finishing touches on the construction of the Plant building has continued. Valves are staged for installation and drywall is being installed in the office area.

Photo Number 8: This depicts the Plant Building's northwest corner; looking southeast.

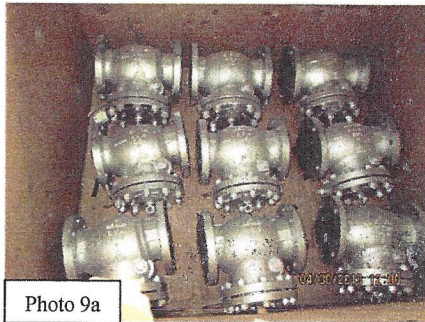
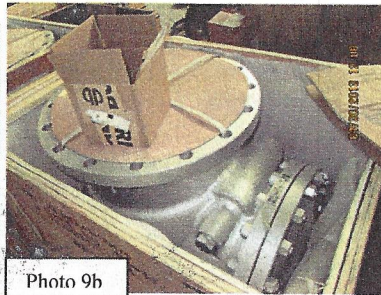
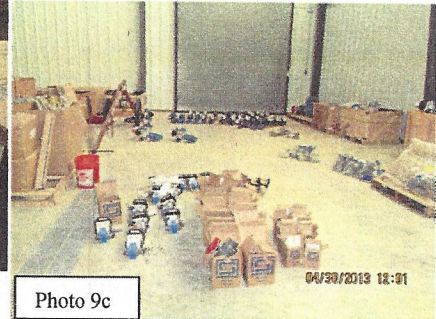
**Photos Number 9a-c: These photos depict the various valves that are staged in the Plant Building awaiting installation at various locations within the Plant.**

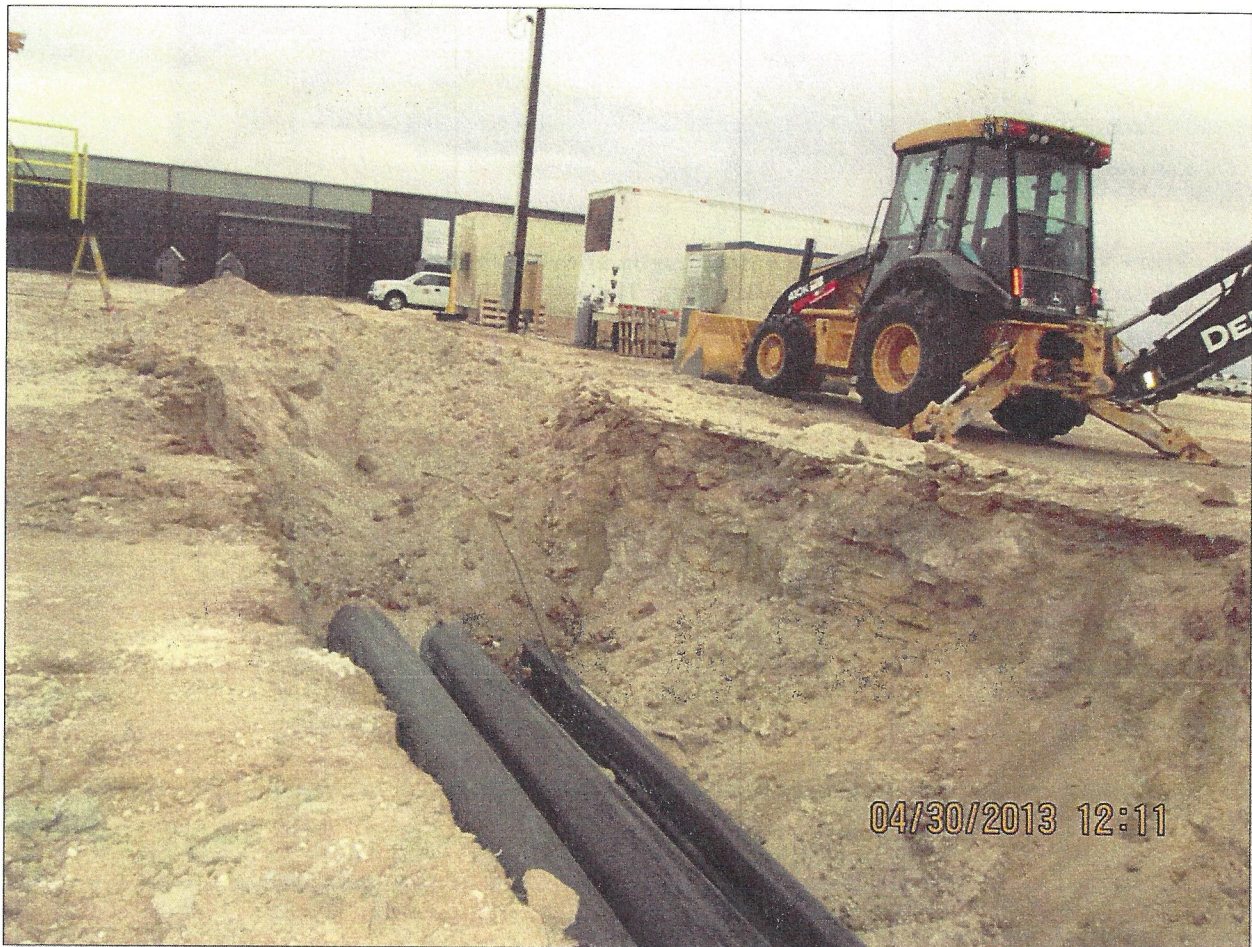
**Photo Number 10: This depicts the main trunk line trench just west of the Plant Building. The trench is backfilled from this point eastward to where it enters the Plant Building (in background).**

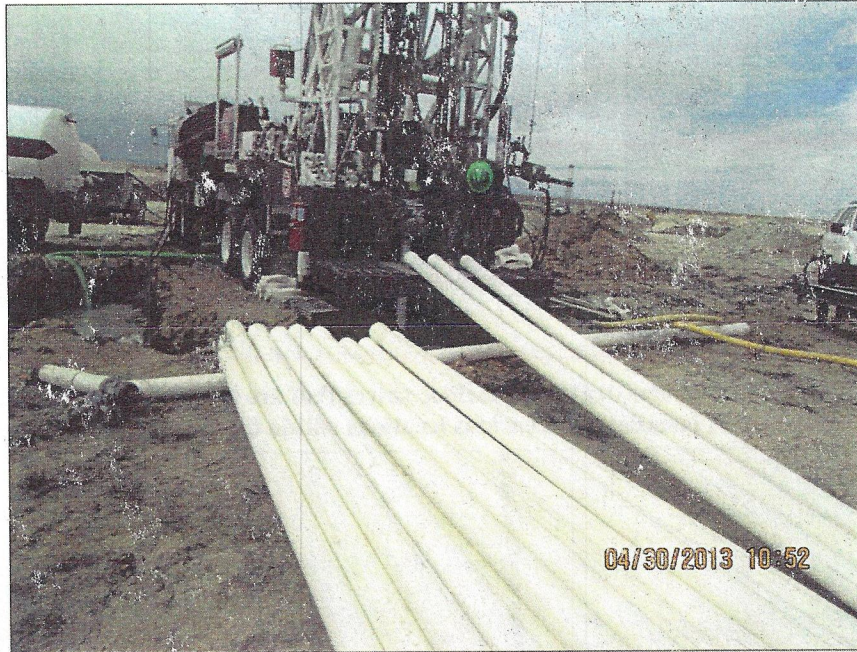
**Photo Number 11:** This depicts the 20-foot lengths of well casing that was staged behind one of the MU1 Pattern Area wells that was being cased today. The outer diameter of this casing is 4.95" and the inner diameter is 4.25".

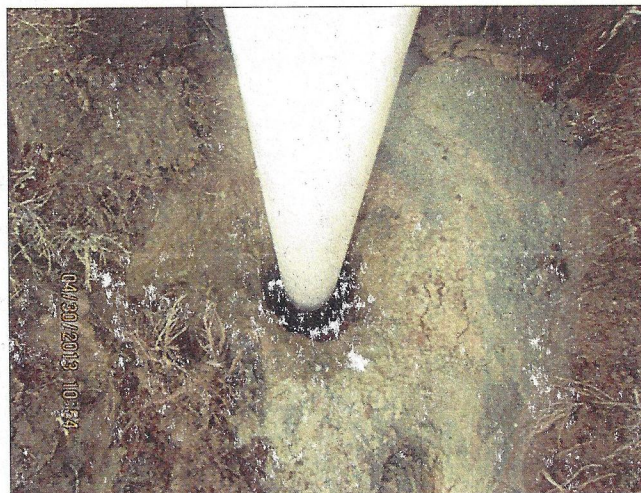
During this Inspection, well casing was being set in one of the MU1 Pattern Area wells. The attached Photo Addendum documents the annular space, the installation of centralizers every 40 feet and other aspects of well installation. The purpose of documenting this process is to facilitate a quicker review time when LCI submits the summary of their request for LQD authorization of the Class III injection wells.

**Photo Number 12:** This photo depicts the well casing within the 7 7/8" (7.875") pilot hole. The annular space is 2.925" (7.875" - 4.95"). The centralizers depicted in the photo on the next page ensure that the casing is centered within the 2.95" of annular space.

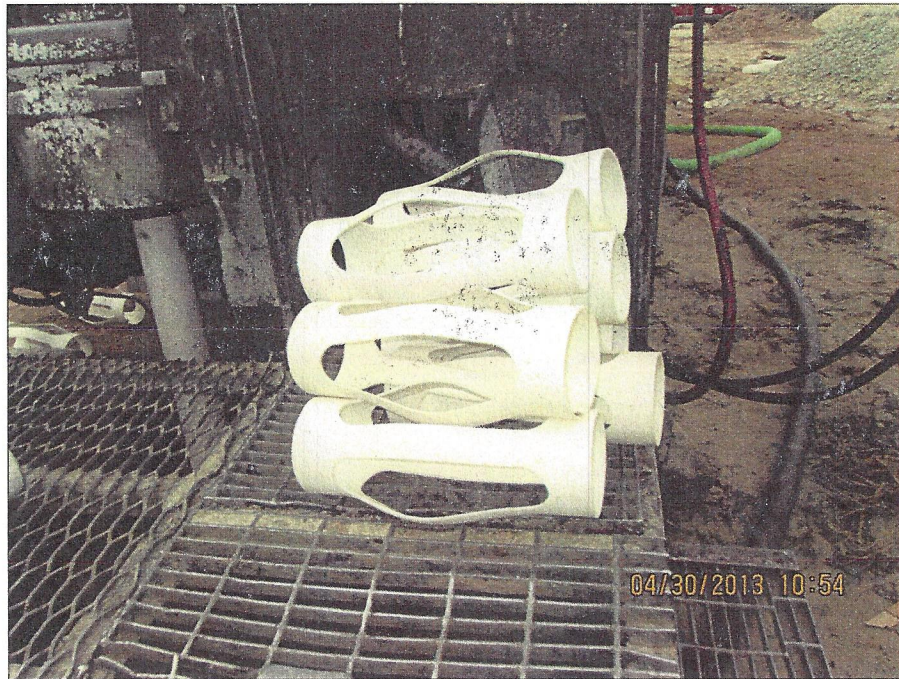
**Photo Number 13:** This depicts several centralizers staged behind the drill rig awaiting installation on the outside of the well casing.

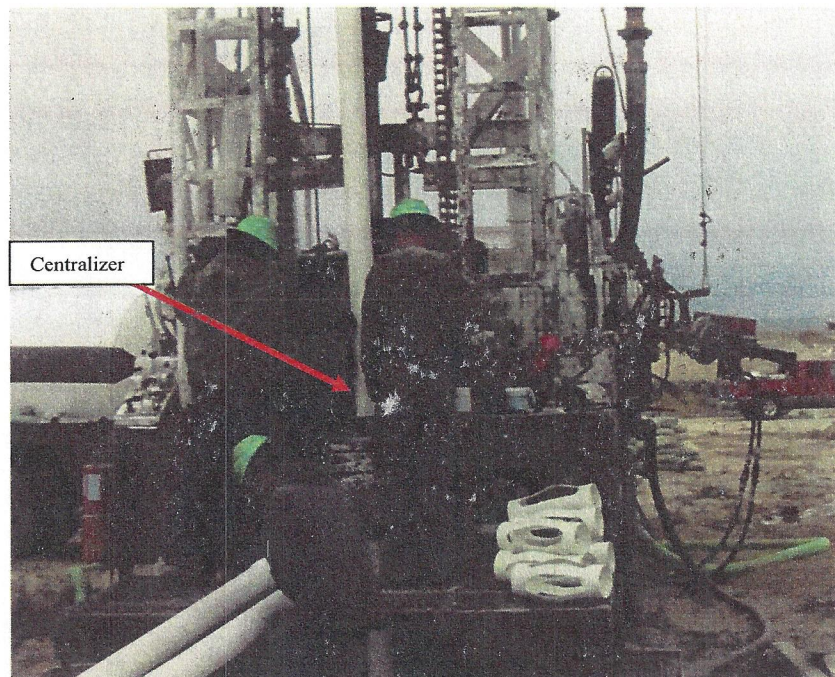
**Photo Number 14:** This depicts a centralizer that has been placed on the well casing, just prior to the lowering of the casing into the hole.

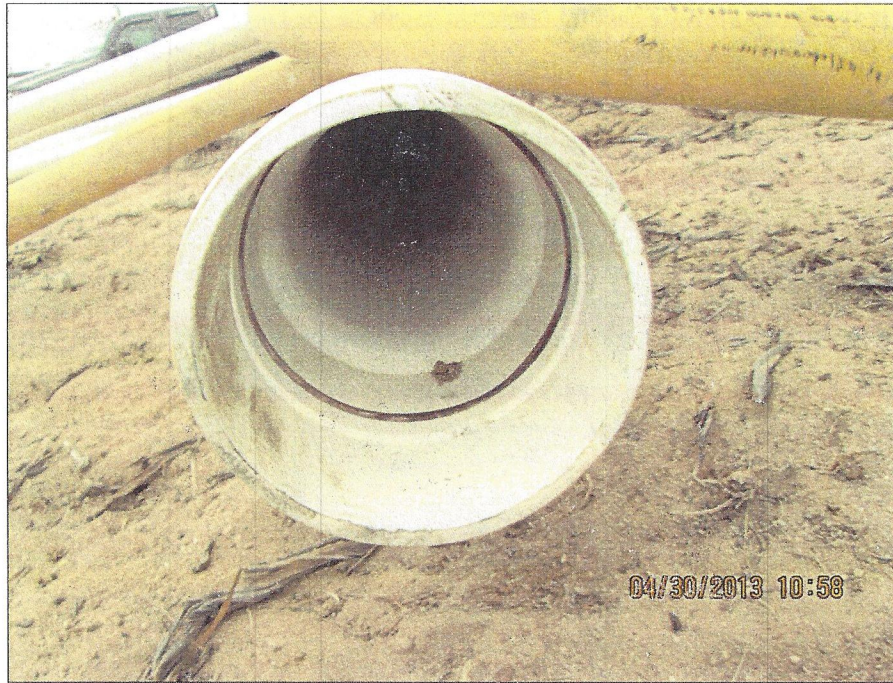
**Photo Number 15:** This depicts the bell end of one of the 20 foot sections of PVC well casing. The dark circle is an O-ring and part of the spline lock system. The groove in front of the black O-ring will receive the spline material (hard plastic “string”) once this casing is attached to the adjacent piece of casing.

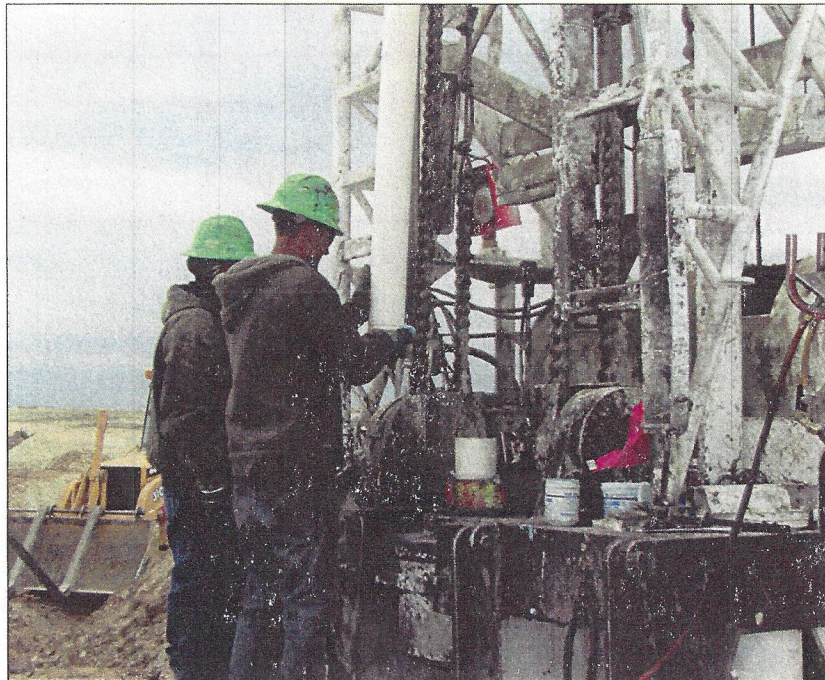
**Photo Number 16:** This depicts the application of the water-based lubricant at a casing joint.

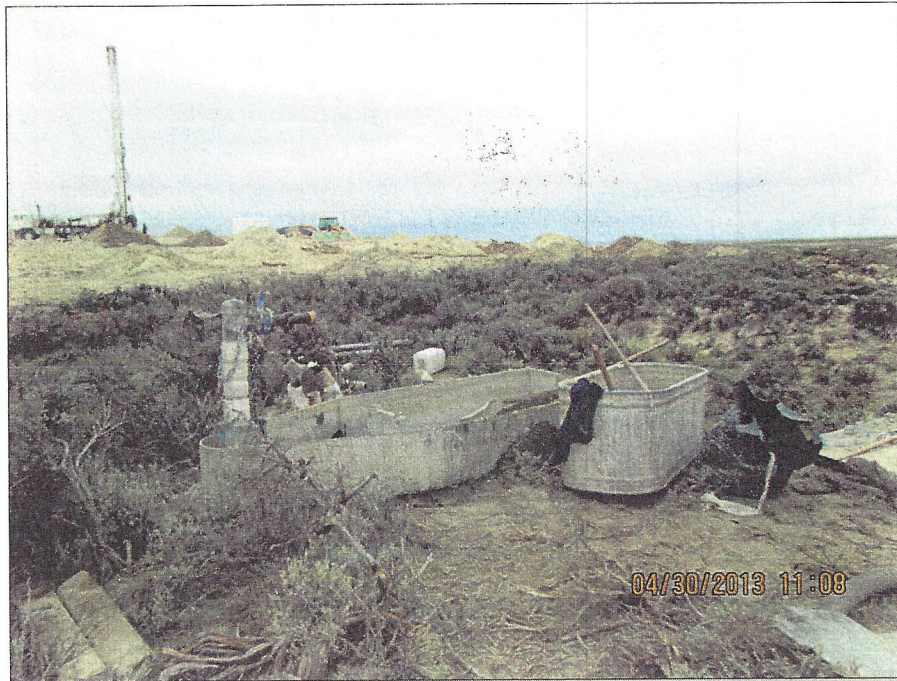
Pilot-hole drilling, well-completion, and well-casing continue in the MU1 Pattern Area while exploration/delineation drilling and monitoring well installation are occurring in MU2. A twelfth drill rig has been added to the site and two more rigs (for a total of 14 rigs) are staged to begin drilling later in this week. The new rigs will focus on monitor well installation in MU2. In some instances, a portable mud-pit was used for the installation of wells near ephemeral drainages. This effort appears to be successful (see Photo Addendum, Photos 17 – 21)

**Photo Number 17:** This depicts a portable mud-pit arrangement that was being used at one of the MU1 pattern area pilot holes that is located near an ephemeral drainage.

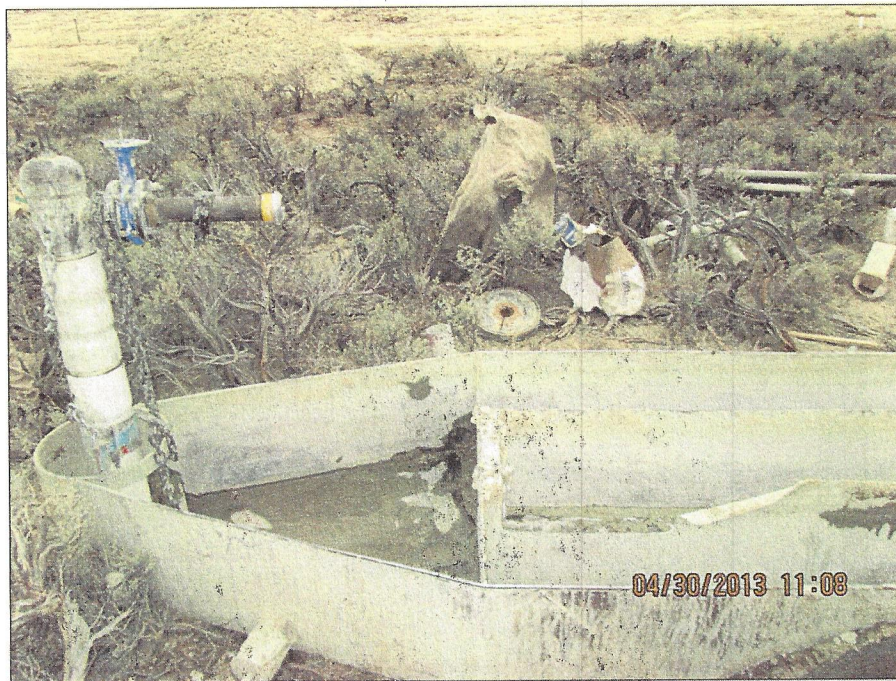
**Photo Number 18:** This is a view inside the portable mud-pit. It has partitions that route drilling mud through a labyrinth that allows mud to precipitate. The mud that accumulates in the portable mud-pit is transferred into a secondary tank (depicted on the right in Photo Number 17 above).

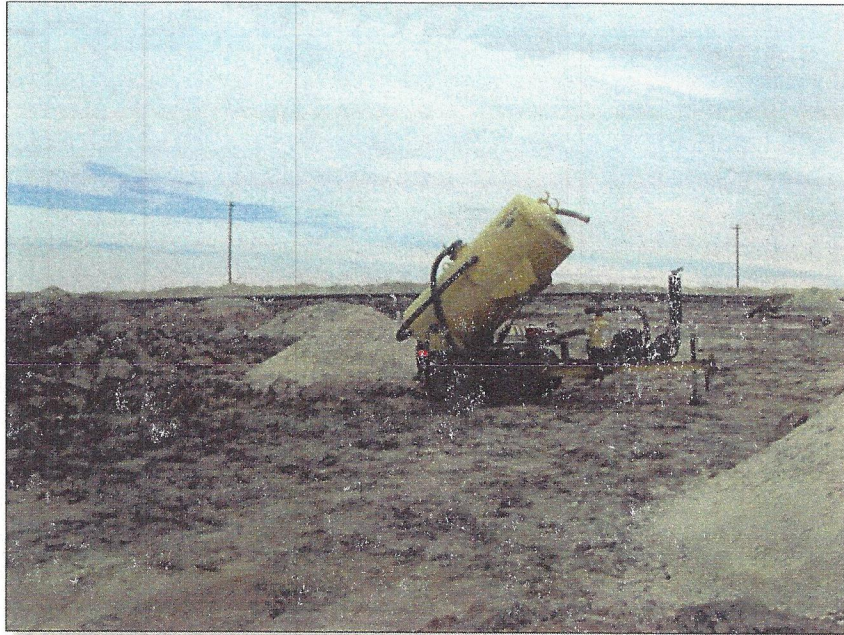
**Photo Number 19:** This depicts the mud-pit vacuum tank that is used to remove solids that accumulate in the oval-shaped tank depicted and described in Photos Number 17 and 18 above. The solids that are vacuumed by this device are being placed into existing in-ground mud-pits that are further away from the ephemeral drainage. If this method of drilling were to be utilized on a wide scale, a large pit would be needed to bury the mud/cuttings that are retrieved from the portable mud-pits' tanks.

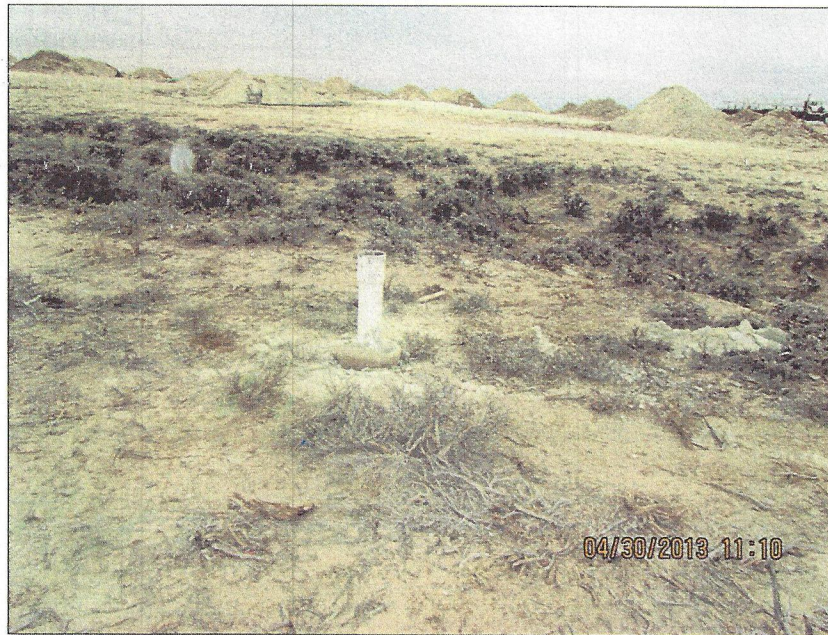
**Photo Number 20:** This depicts a cased well installed near an ephemeral drainage. The portable mud pit was used for this well's installation. The footprint of the affected area associated with this well is, not surprisingly, significantly smaller than wells drilled with in-ground mud-pits.

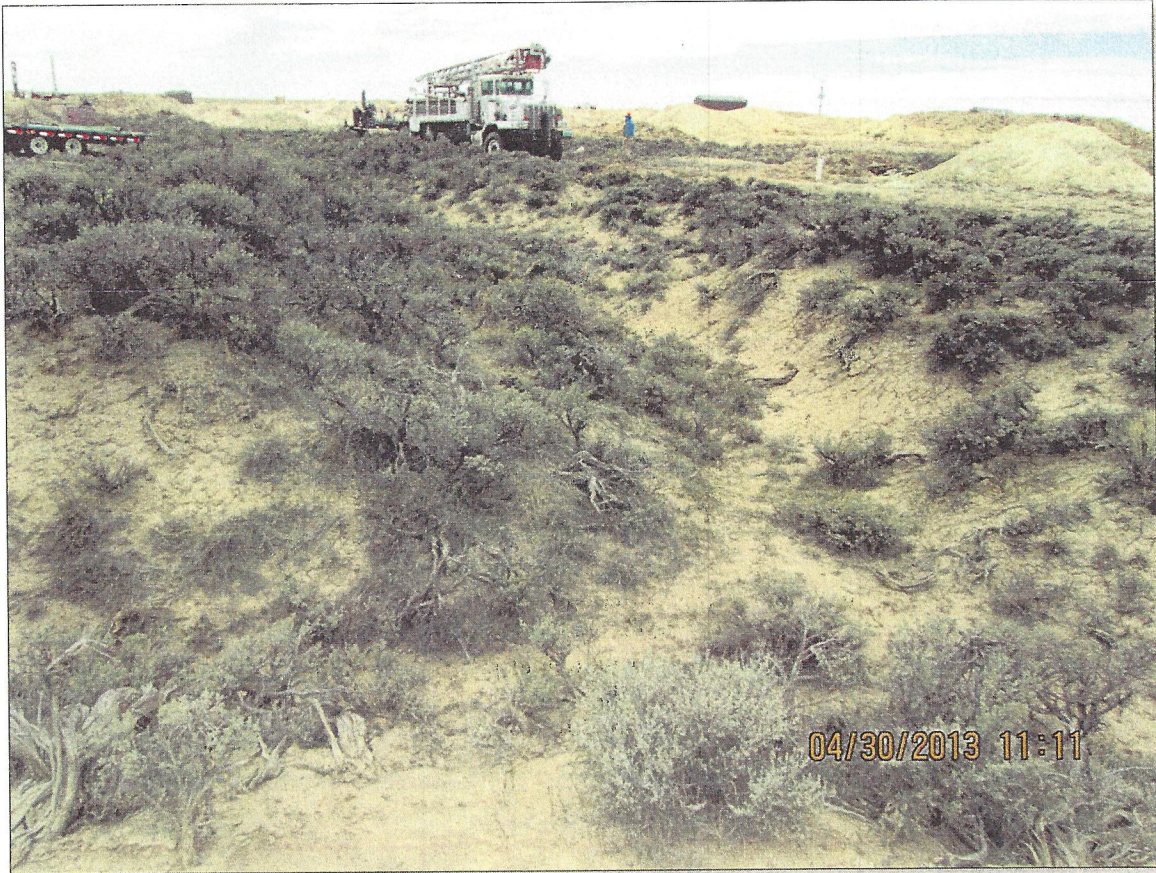
**Photo Number 10: This is a view looking down-gradient at the ephemeral drainage near the well depicted in the above photo. The main purpose in using portable mud-pits is to prevent any spillage of drilling mud down the drainage. No drilling fluids were released into this drainage during the installation of the well depicted above in Photo Number 20.**
