Subject: FORT CALHOUN STATION – NRC SPECIAL INSPECTION REPORT
05000285/2013-012

IR 05000285/2013-012; 01/28/2013 – 03/15/2013; Fort Calhoun Station; Special Inspection Report; IP 93812; Design Control and Corrective Action Violations.

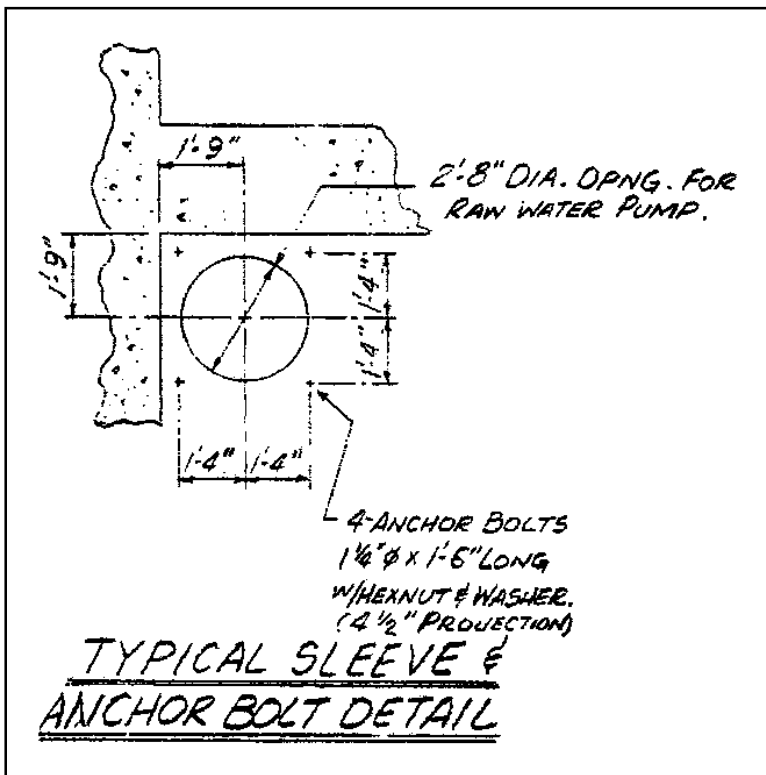
Figure 1 - DWG 11405-S-312 "design" drawing

The design drawing 11405-S-312, as shown in Figure 1, did not contain sufficient information about the anchor bolt details or potential interferences.

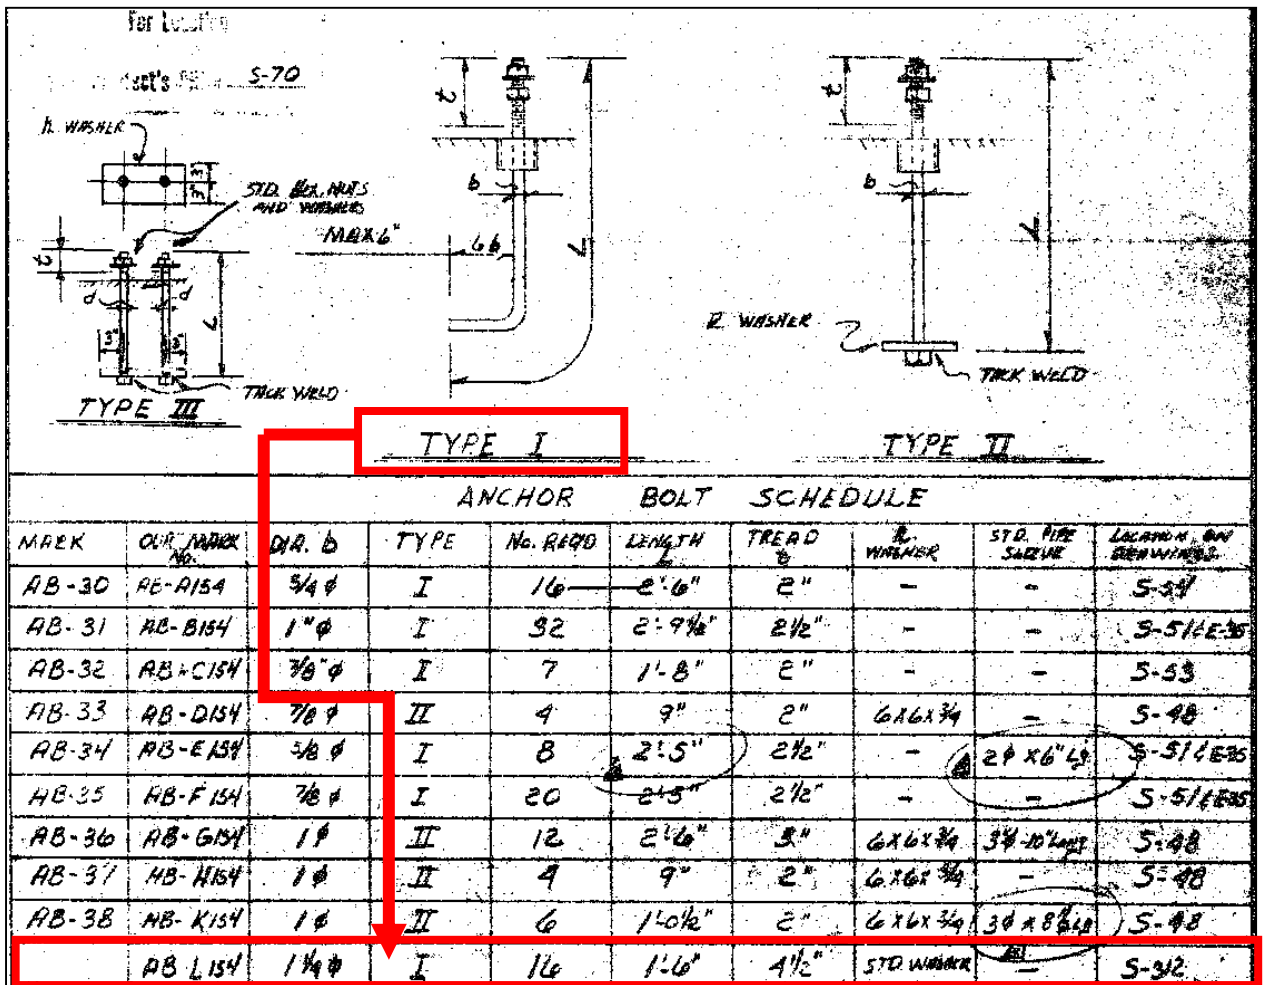
Figure 2 - DWG 154 "shop" drawing

The engineer then referred to "shop" drawing Number 154 (Figure 2) and the construction "pour" Drawing 7908-C (Figure 3).

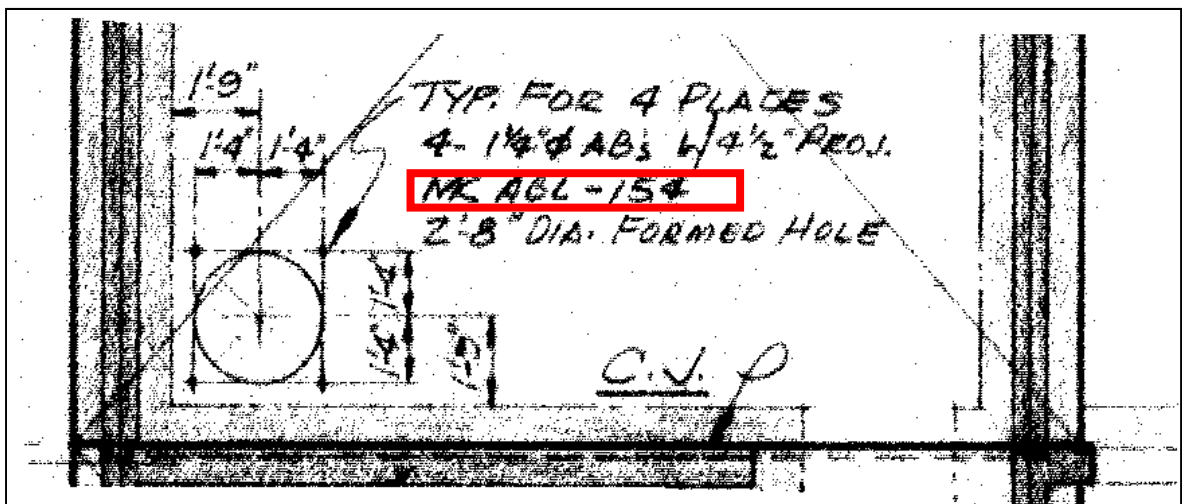
Figure 3 - DWG 7908-C "pour" drawing

The design specification for the raw water pump motors is designated MK ABL-154 as noted in Figure 3. The corresponding anchor bolt data for an MK ABL-154 anchor bolt is found in the “schedule” shown in Figure 2. Clearly, the design specification for the anchor bolts was a Type I J-style anchor bolt.
