United States Nuclear Regulatory Commission Official Hearing Exhibit	
In the Matter of:	Entergy Nuclear Operations, Inc. (Indian Point Nuclear Generating Units 2 and 3)

ENTERGY	ENGINEERING STANDARD	EN-EP-S-002-MULTI	REV. 1
	Underground Piping and Tanks General Visual Inspection		PAGE 14 OF 15

ATTACHMENT 7.2 PIPE/TANK COATING VISUAL INSPECTION CHECKLIST
Sheet 1 of 2

Line/Tank ID & Name: 8-in. City Water Line 1502 Work Order: 315720
 System: City Water Inspection Date: 10/10/2012
 Location: IP2 Transformer Yard Inspector: S. Guarnaccia
 Coating Material: coal tar enamel/saturated asbestos felt wrap Thickness: 1aw AWWA C203

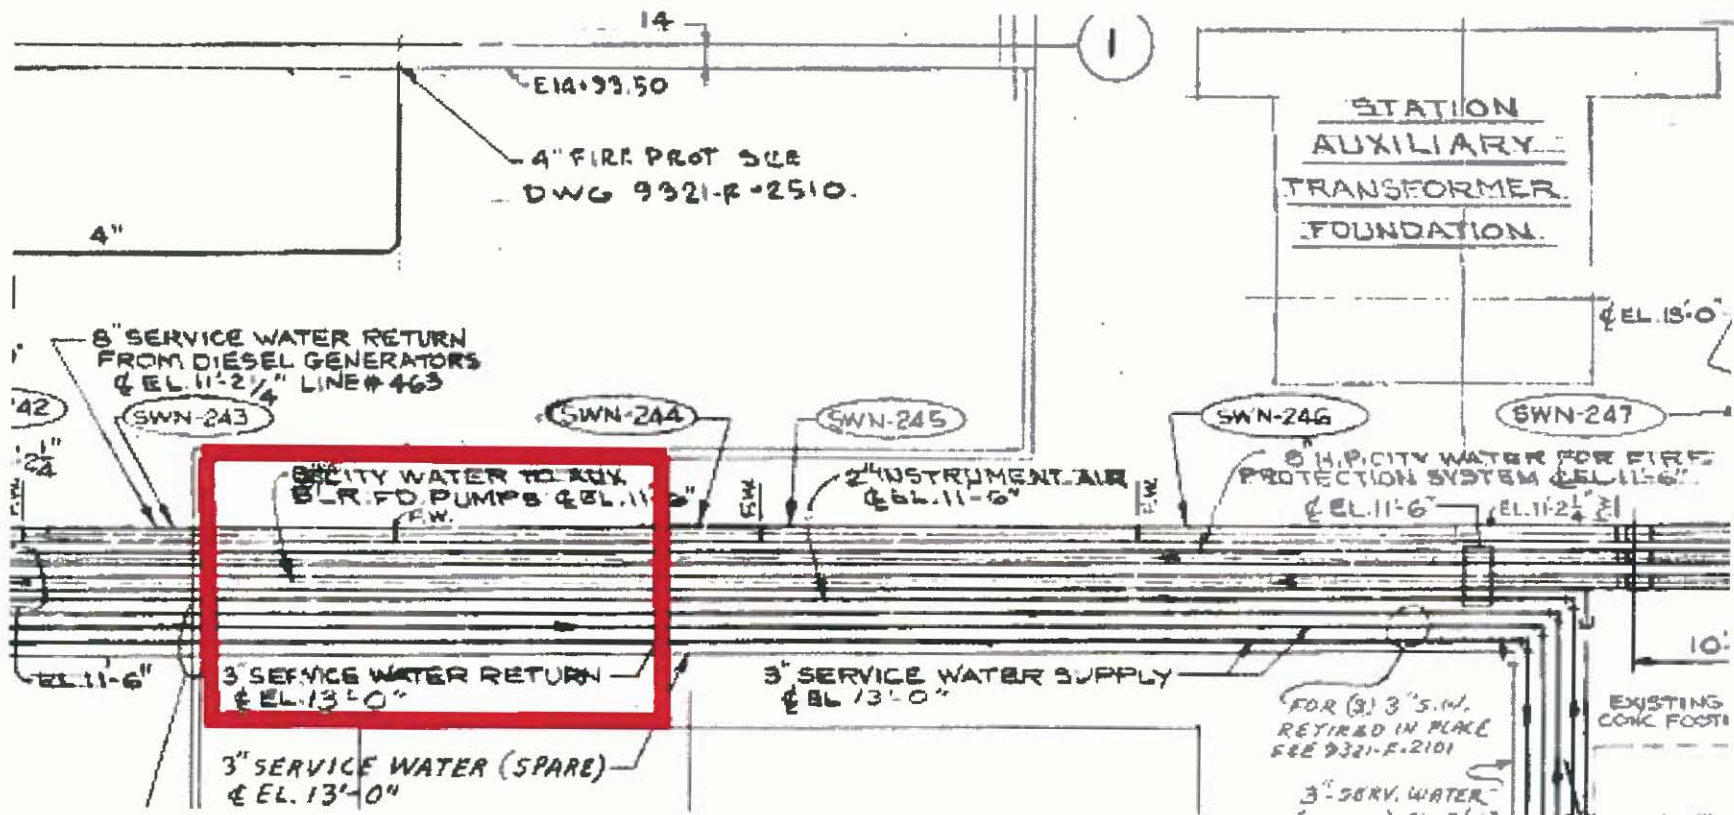
EXCAVATION OF 22 MT MOAT AREA

Piping Uncovered for Inspection: 8-inch SW Line 463 return to EDGs
8-inch HP Fire Protection Line
8-inch City Water Line 1502 to AFPs

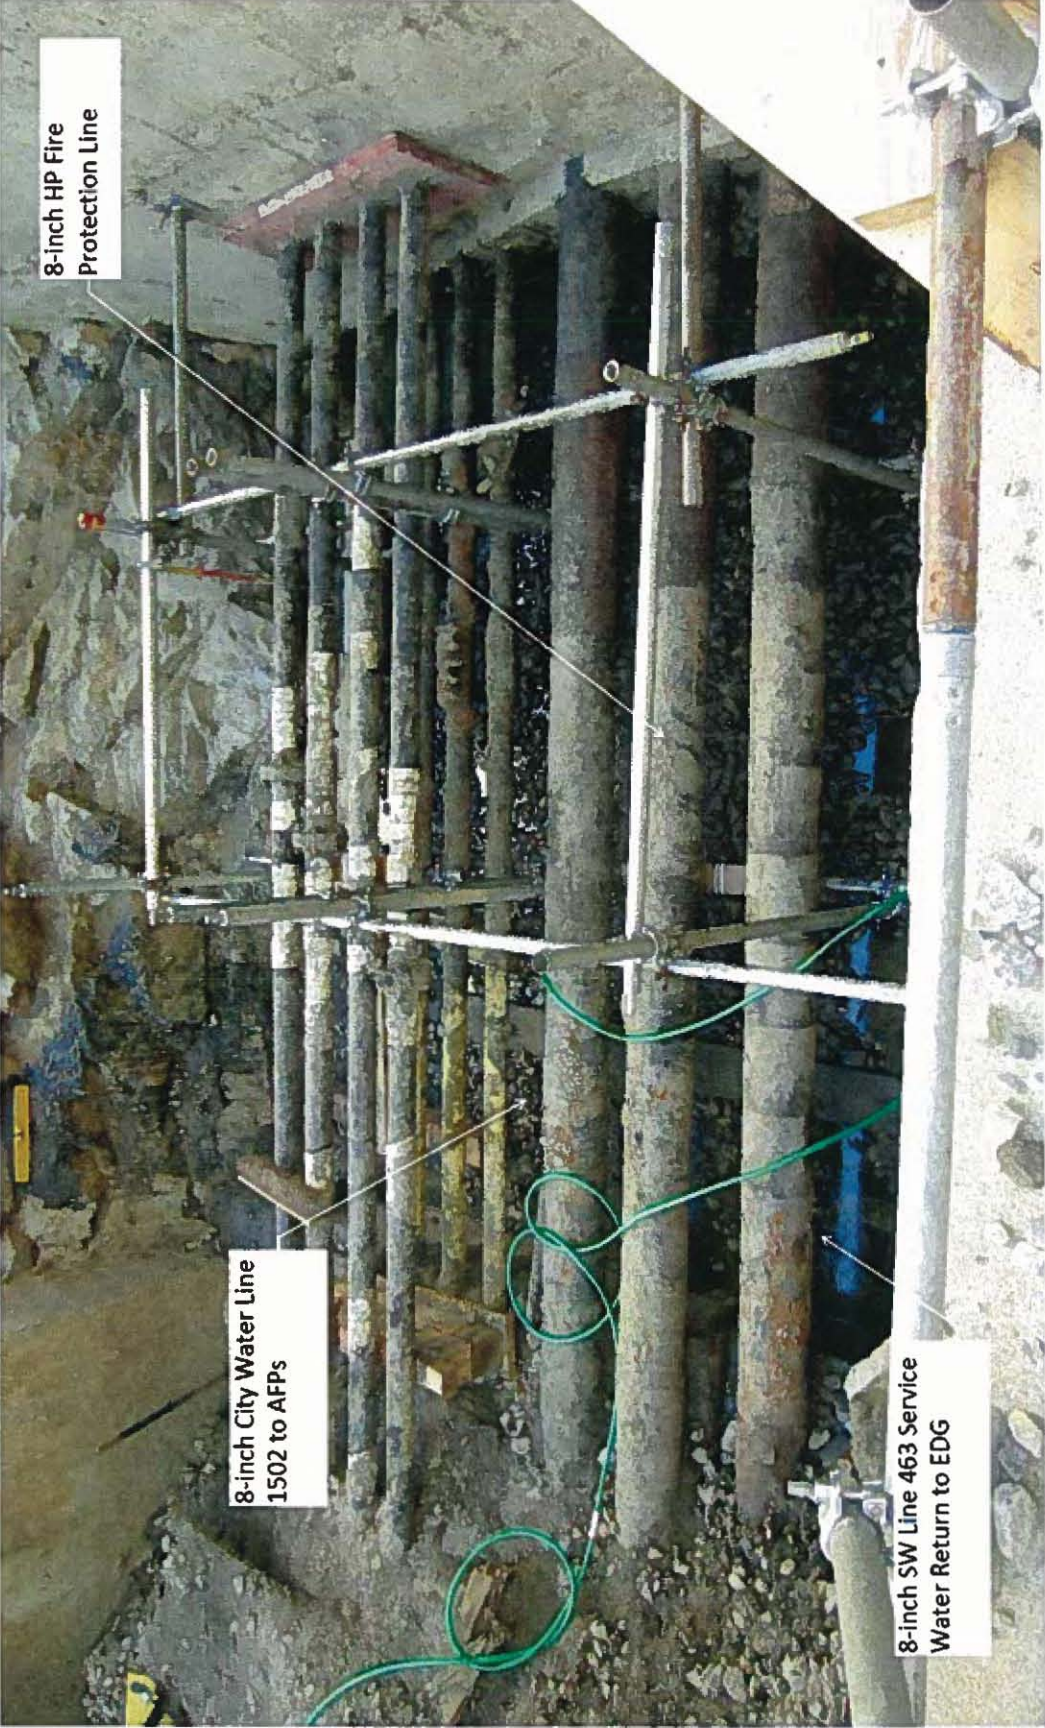
8-inch HP Fire Protection Line

8-inch City Water Line 1502 to APPs

8-inch SW Line 463 Service Water Return to EDG

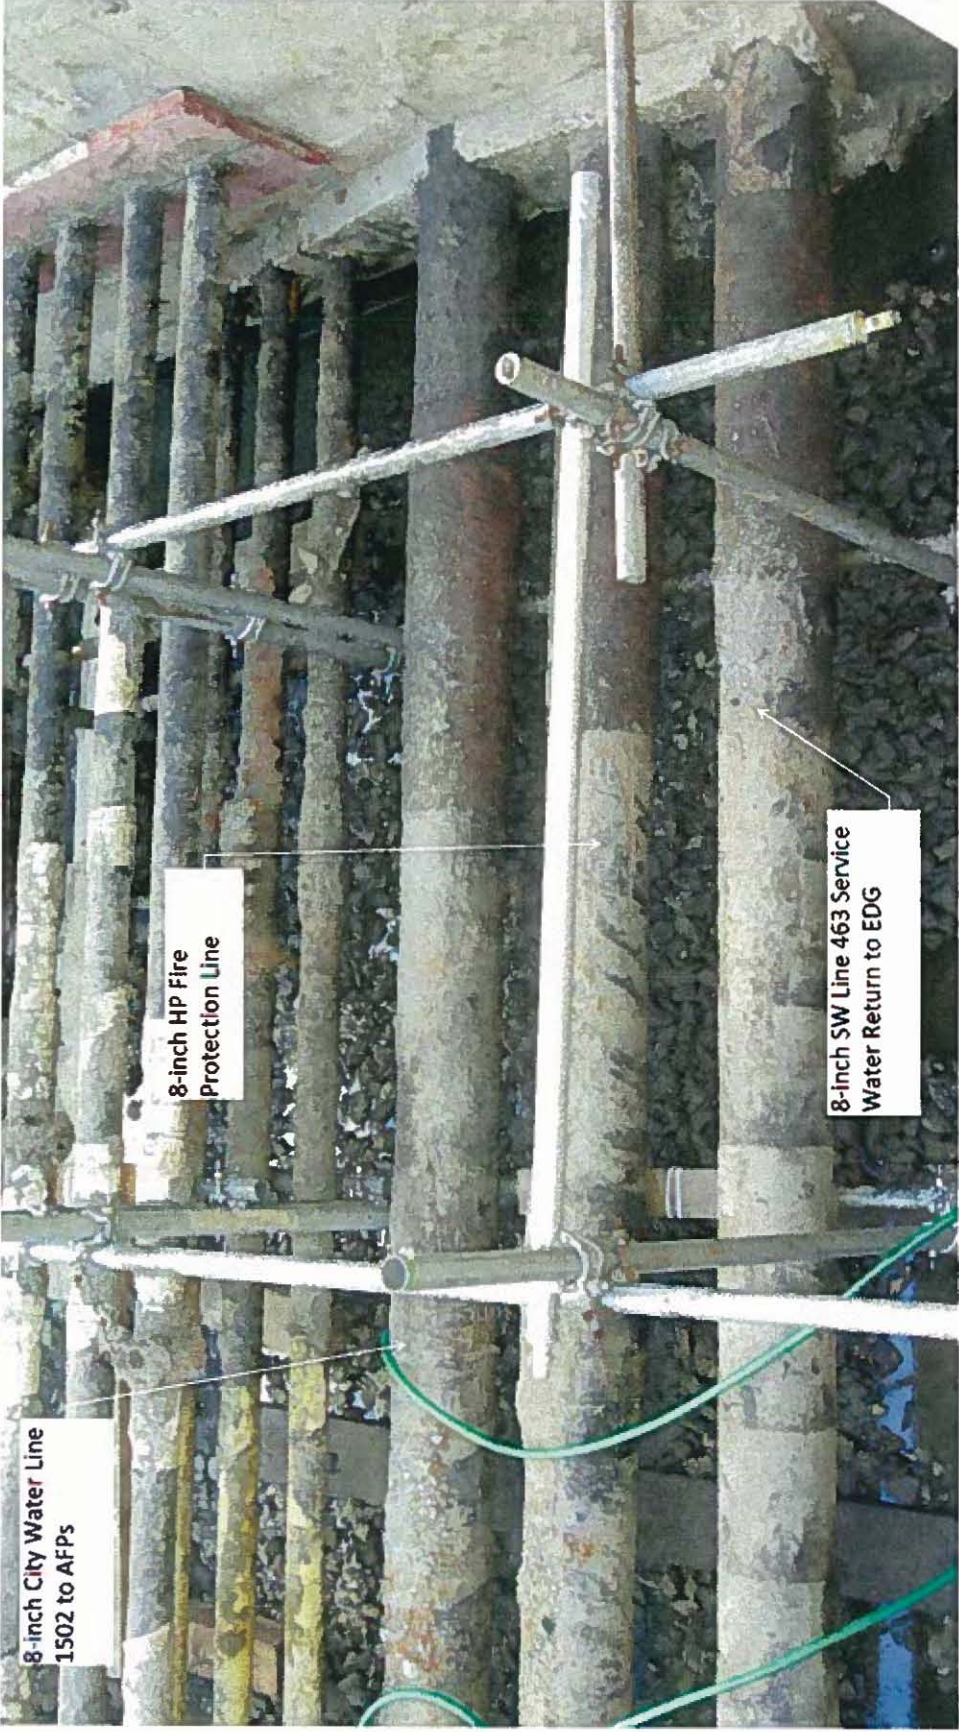
8-inch City Water Line
1502 to AFPS

8-inch HP Fire
Protection Line

8-inch SW Line 463 Service
Water Return to EDG
