AREA WALK-BY CHECKLIST

IP3

Status: Y N U Area Walk-By Checklist (AWC) AWC-010Location: Bldg. IS Floor El. 15'-0" Room, Area¹ _____SWEL Components: SWEL1-030, 031**Instructions for Completing Checklist**

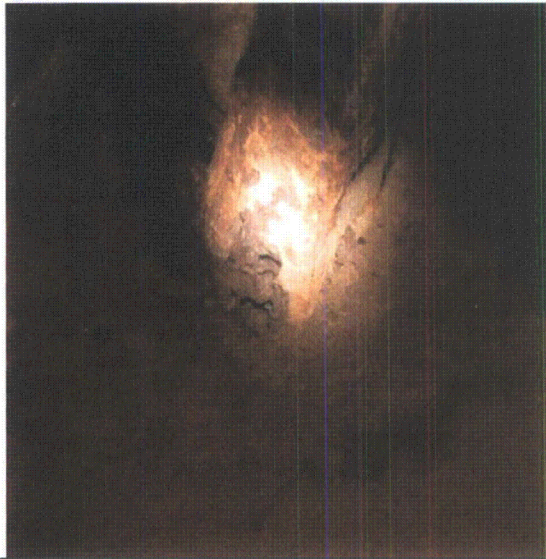
Panel (PID 08219) adjacent to the door: Unistrut legs corroded and broken at the base (see attach photos). The toe plate at the floor penetration between the Unistrut legs is loose and is not protecting the opening (see attach photo).

Note: Corroded and broken Unistrut near door.

The above conditions are addressed by CR-IP3-2012-03166.

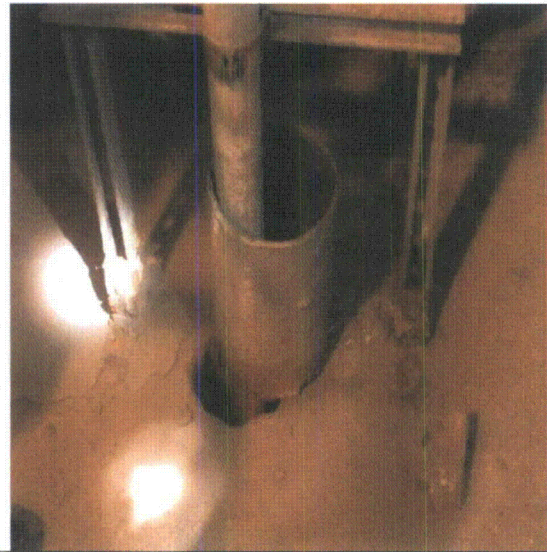
Note: Corroded and broken Unistrut near door and a loose pipe protection cover between the Unistrut legs

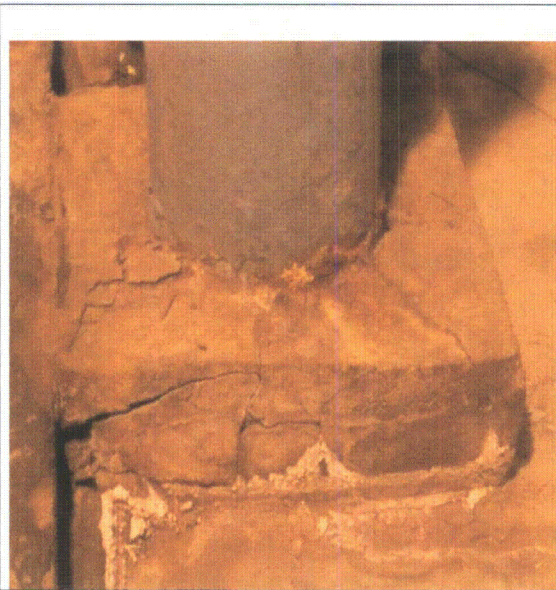
Piping grout penetration protection was found cracked and chipped at various locations allowing water seepage (see photos).

Note: Cracked grout penetration protection

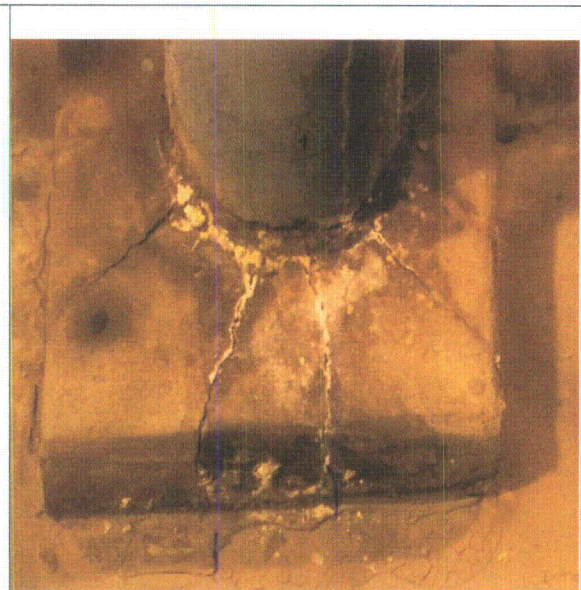
Note: Cracked grout penetration protection

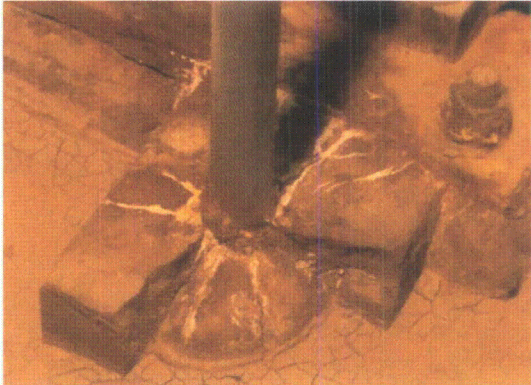
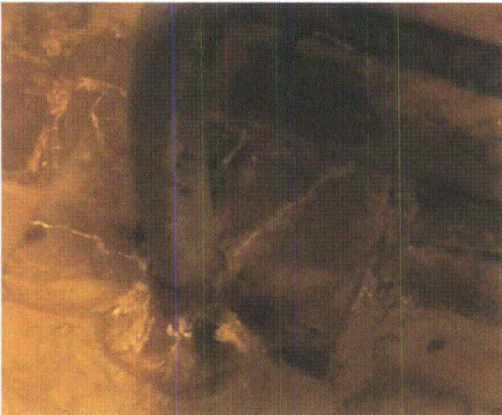
<p>Note: Cracked and chipped grout penetration protection</p>	<p>Note: Cracked and chipped grout penetration protection</p>

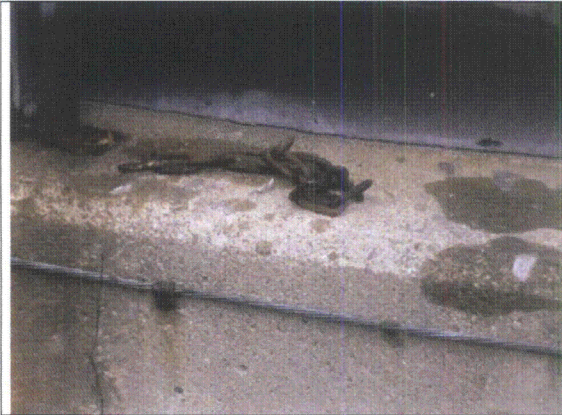
Observed a loose chain and a Unistrut on top of the RWST-31 foundation (see attached photos).

Note: Loose chain on top of RWST-31 foundation.

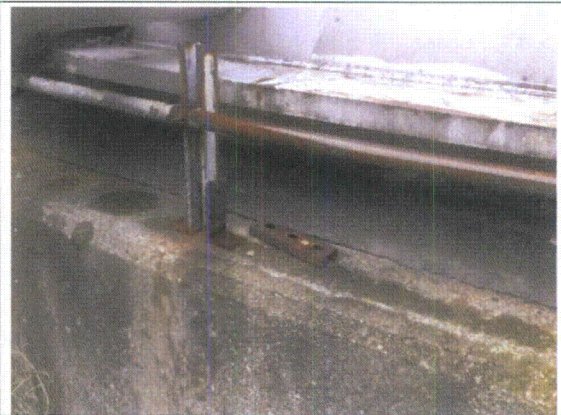
Note: Loose Unistrut on top of RWST-31 foundation.

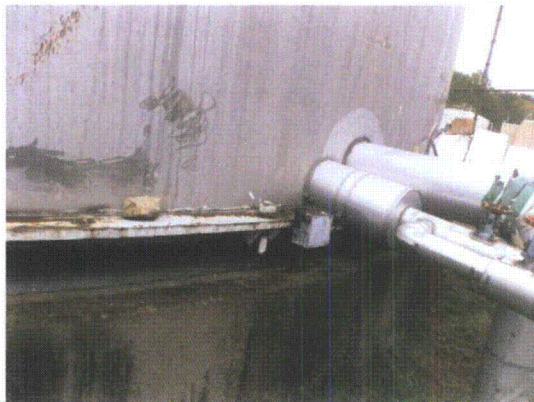
Observed a rock resting on the RWST-31 stiffener ring (see attached photo).

Note: Rock resting on the tank ring.

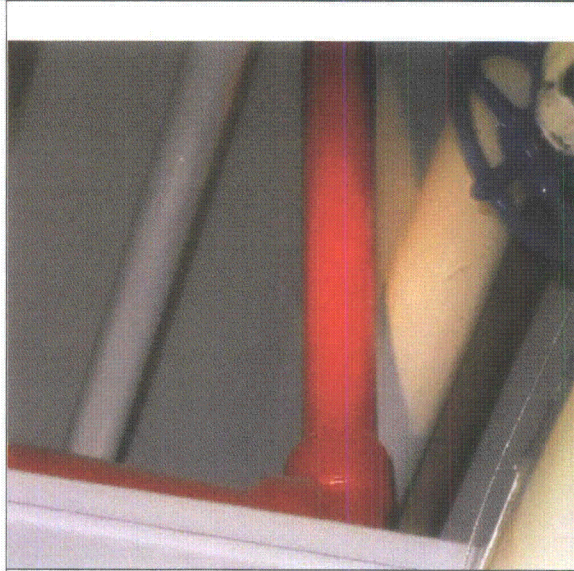
Branch risers from the main fire water line are threaded pipe and pass in close proximity (estimate 1" +/-) to large conduit. The conduit is well supported and the fire water line would have to move axially to cause an impact. The vertical rise of the pipe is very short so it is judged that the impact will not occur. See photos.

Note: Fire water line in close proximity to a conduit.

LB-18 was generated to evaluate this condition.

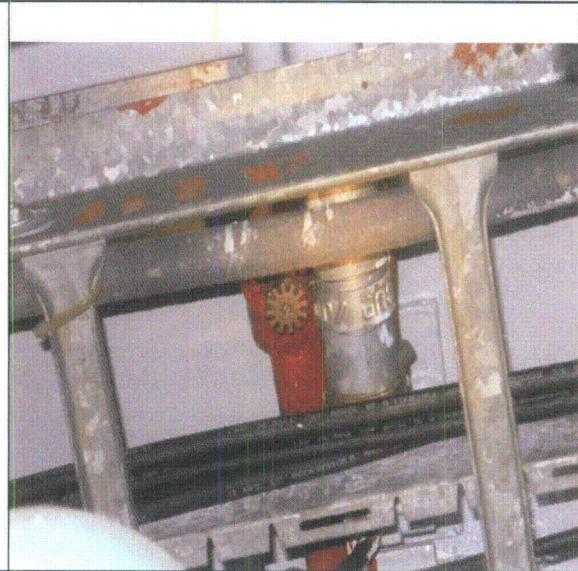
Note: Sprinkler head in close proximity to adjacent conduit.

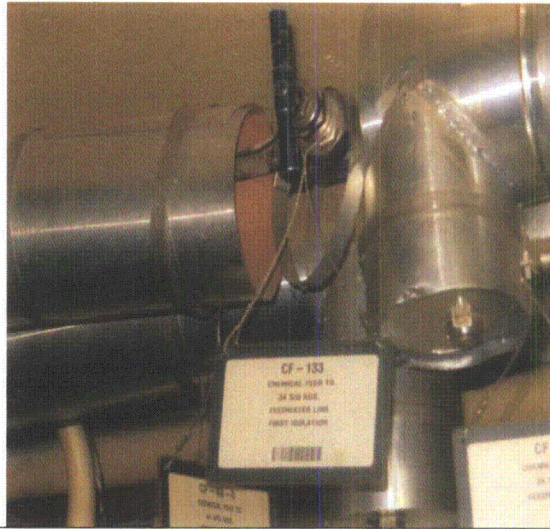
Insulation at CF-133 and Cf-44-4 is missing.

Note: *Missing insulation*

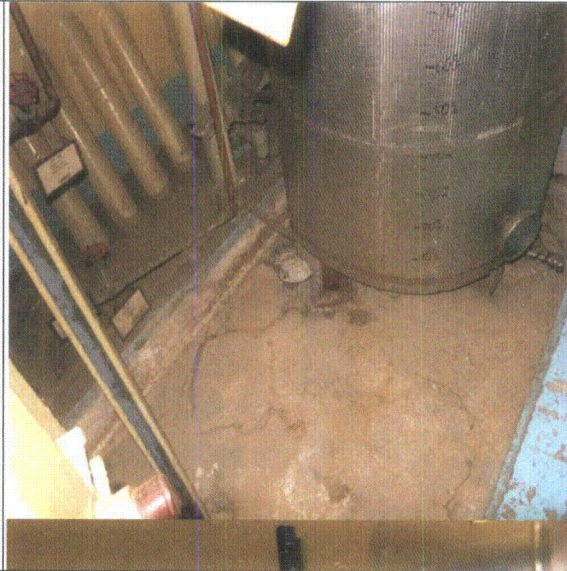
A pair of used gloves was found next to the 33 Chemical Feed Tank. See photo.

Note: *Used gloves on floor.*

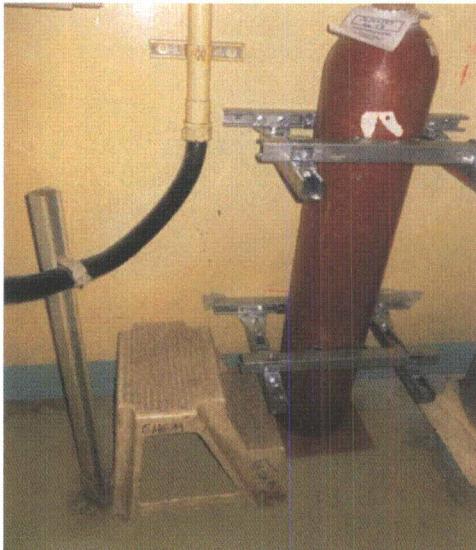
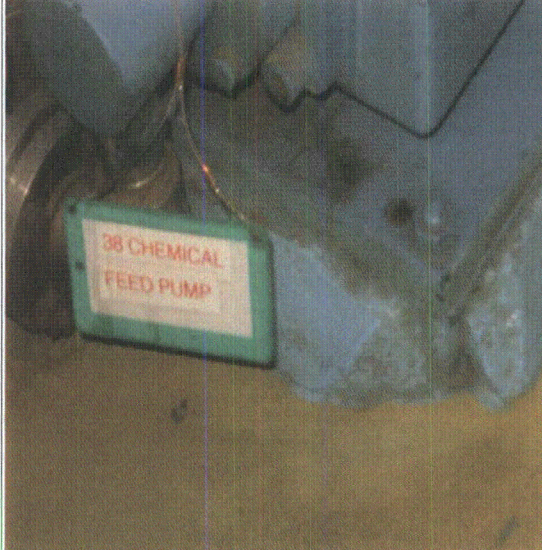
Grout at 38 Chemical Feed Pump is chipped off exposing one anchor bolt under the base plate. OK by judgment but should be repaired. CR-IP3-2012-03627 is written to address this problem.

Unsecured stool found stored next to nitrogen tank. Not judged a serious concern because of the light weight of the stool but should be addressed as a matter of good seismic housekeeping. CR IP3-2012-03627 was written to address this condition.

<p>Note: Unsecured stool next to nitrogen tank.</p>	<p>Note: Missing grout at anchor bolt at 38 Chemical Feed Pump</p>

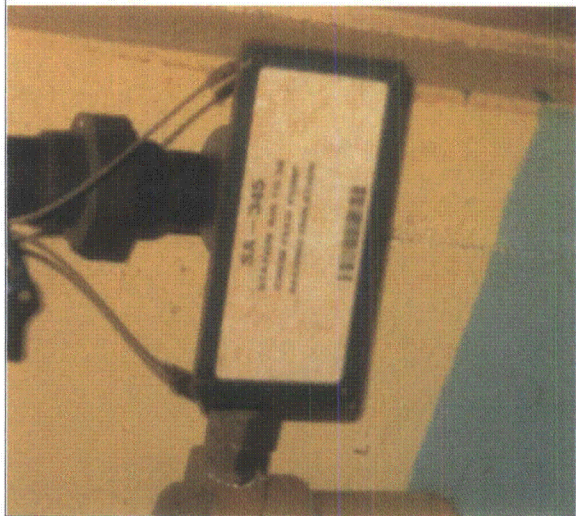
<p>Note: <i>Missing insulation at valve.</i></p>	<p>Note:</p>

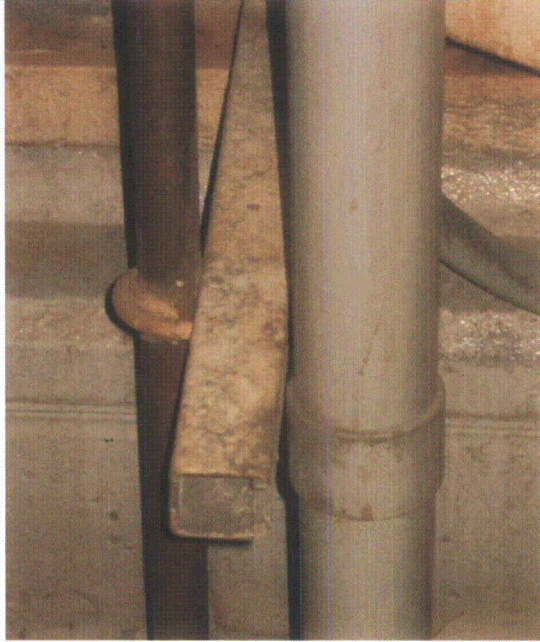
The horizontal Unistrut support next to column H8/19.5 missing a U-bolt connection to the vertical run of conduit. This condition is addressed by CR-IP3-2012-03547. The conduit span is estimated to be 16 feet between the floor and the upper support.

Note: The connection of the conduit riser next to column H8/19.5 is missing the U-bolt attachment to the Unistrut.

LB-09 evaluates this condition.

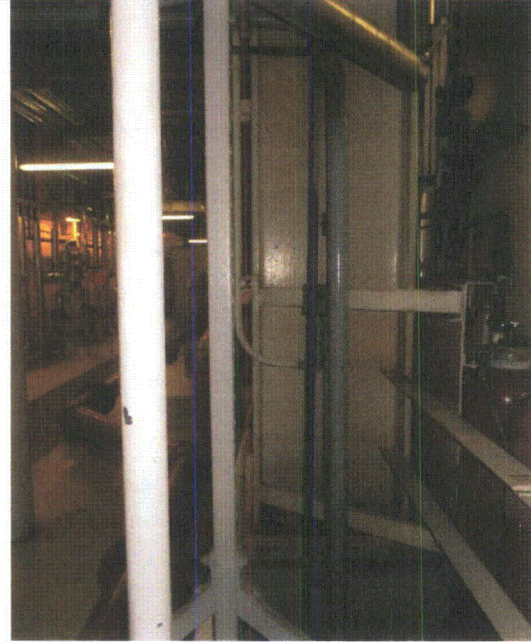
Note: View of the unsupported length of conduit shown in previous picture.

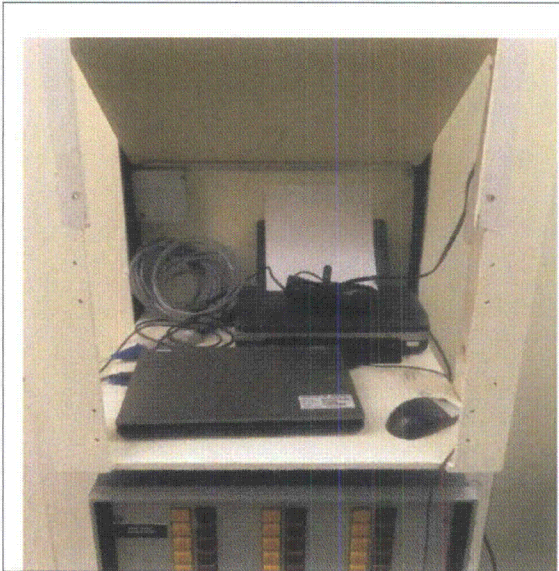
Note: Rack adjacent to Instrument Bus 31 has an unrestrained laptop and printer

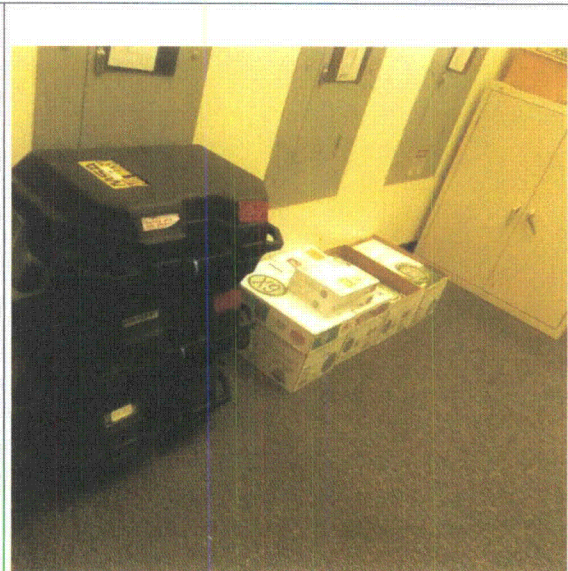
Note: Boxes against the west wall on the floor and a box resting on top of a cabinet at the northwest corner of the room

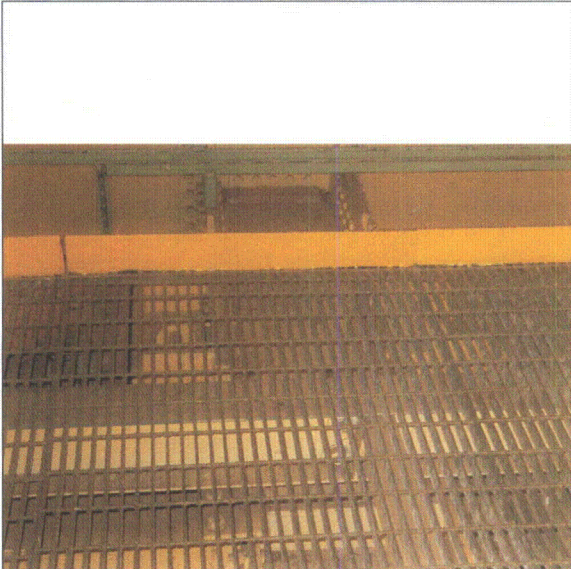
Note: *Some sections of grating are not attached to the steel beam below.*

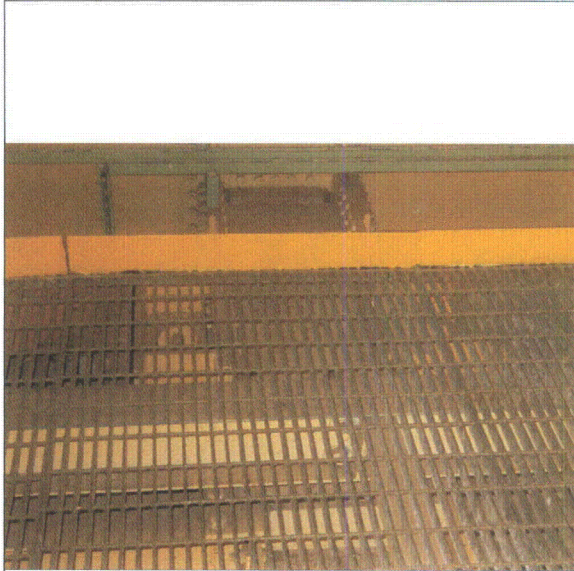
Note: Some sections of grating are not attached to the steel beam below.

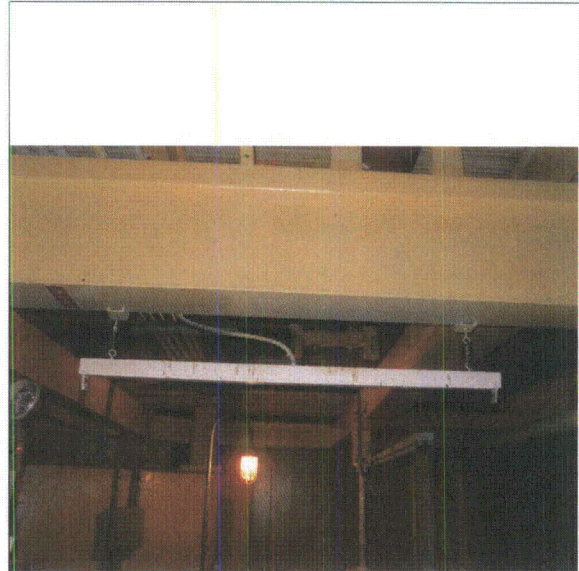
Note: Some fluorescent bulbs near south end of the platform are out and need to be replaced.

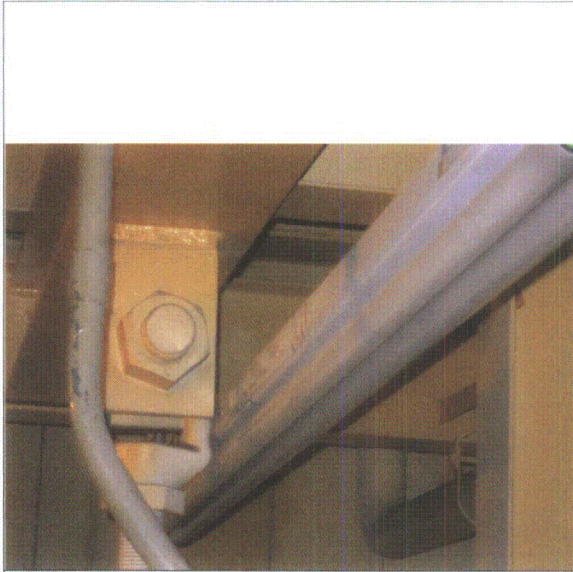
Note: One of the florescent fixtures is touching the steel hanger.

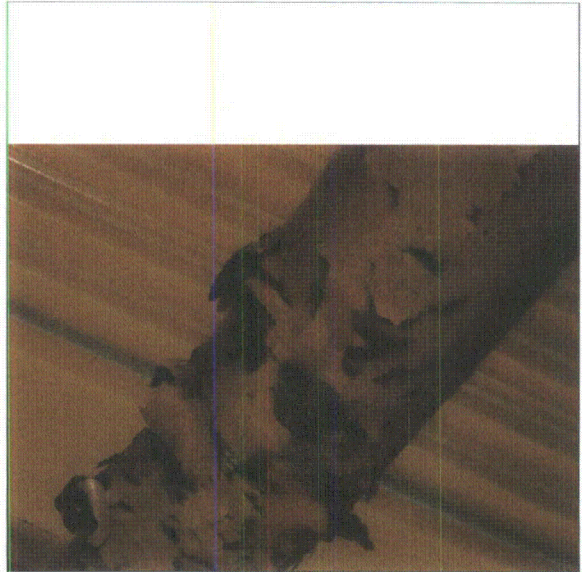
Note: The insulation cover of the overhead pipe is peeling off.

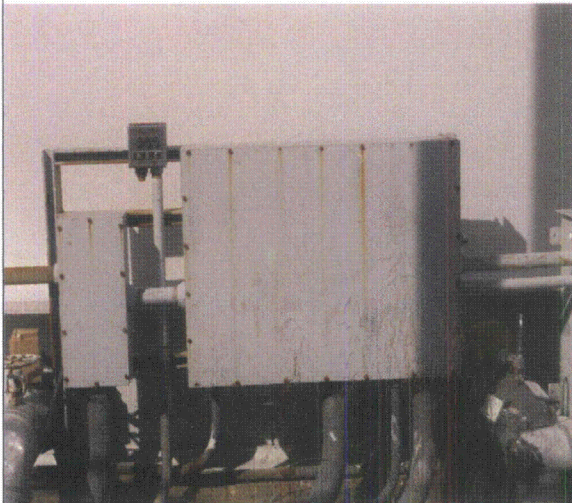
Note: Several screws are missing for the electric panels

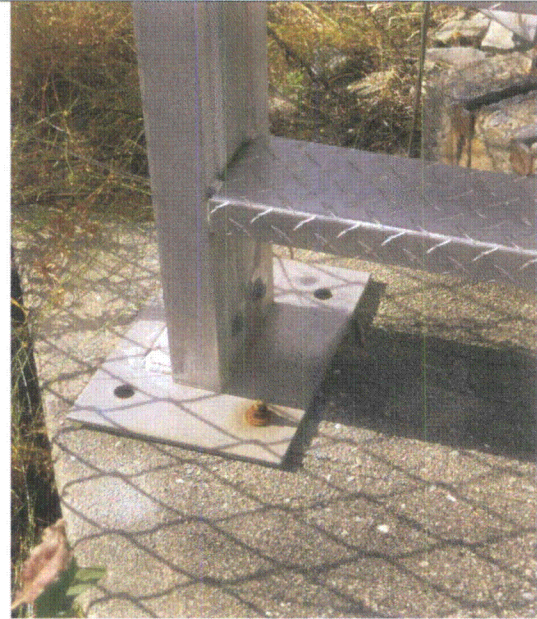
Note: The adjacent platform support base plate missing half number of anchor bolts.

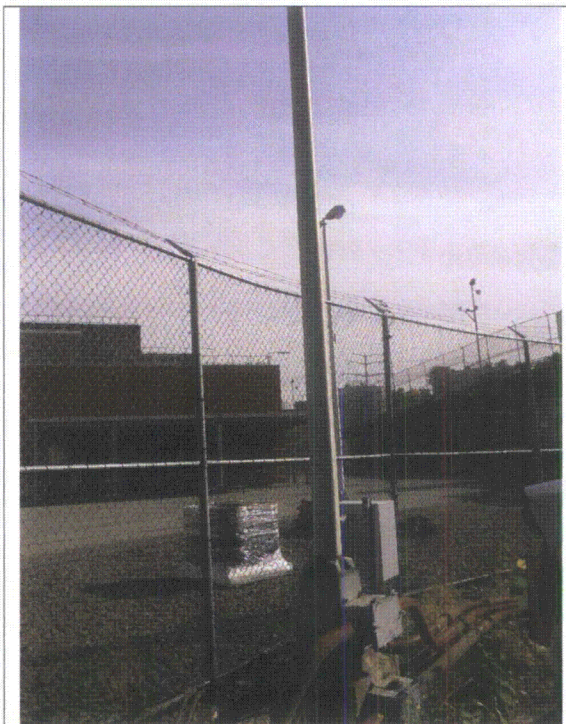
Note: *The lighting poles near the tank need to be verified for seismic adequacy.*

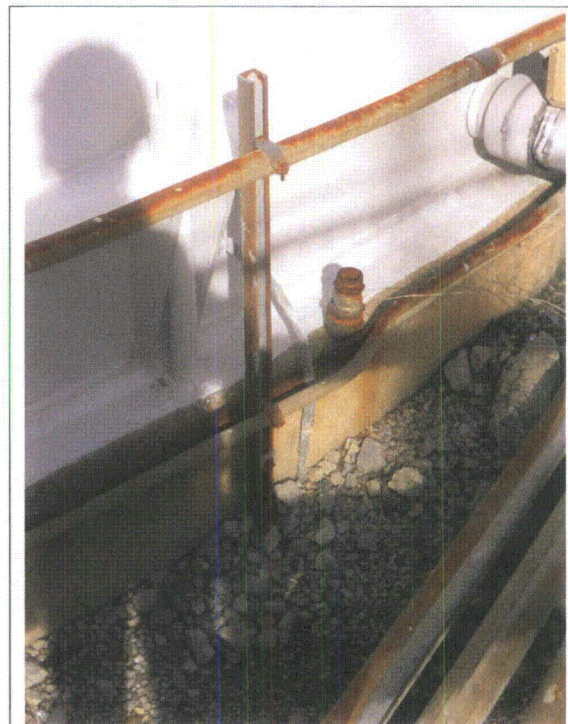
Note: *All the conduit and pipes show sign of various stages of corrosion.*

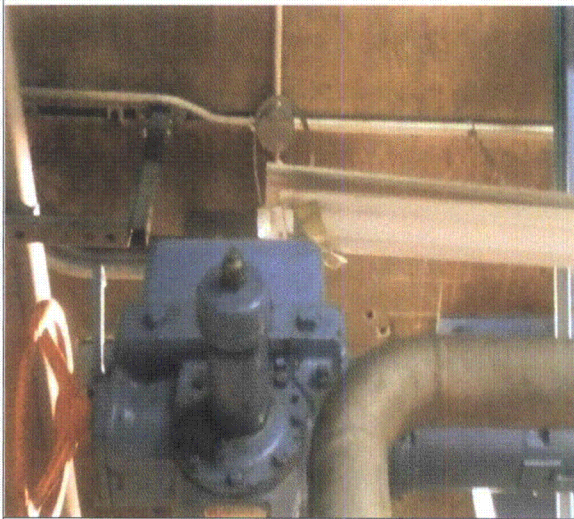
<p>Note: <i>broken fluorescent light fixture directly above CS Pump 32</i></p>	<p>Note:</p>

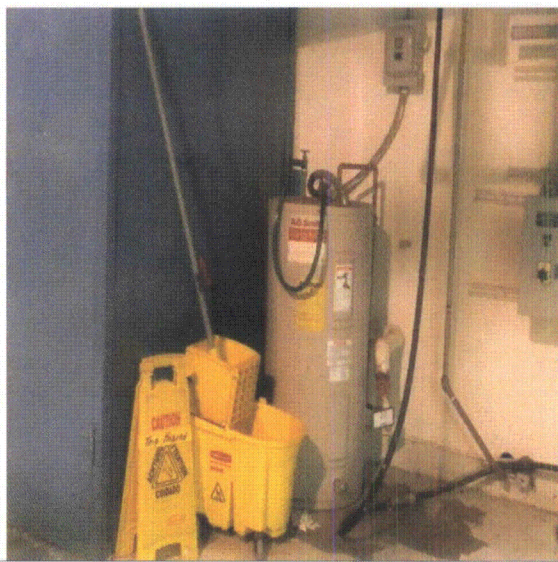
Note: wheeled bucket and a mop stick

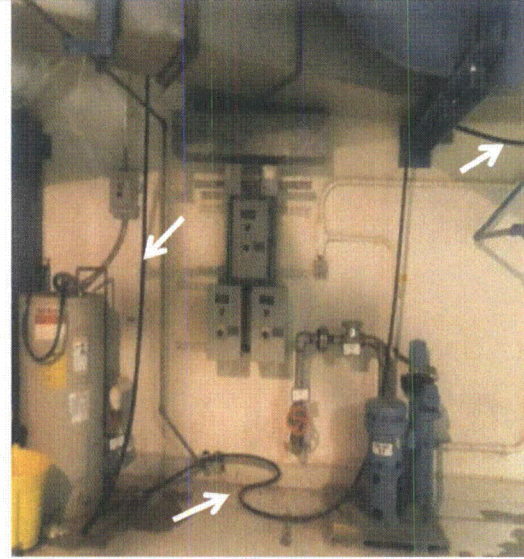
Note: loose hose laying on floor going to an upper elevation.

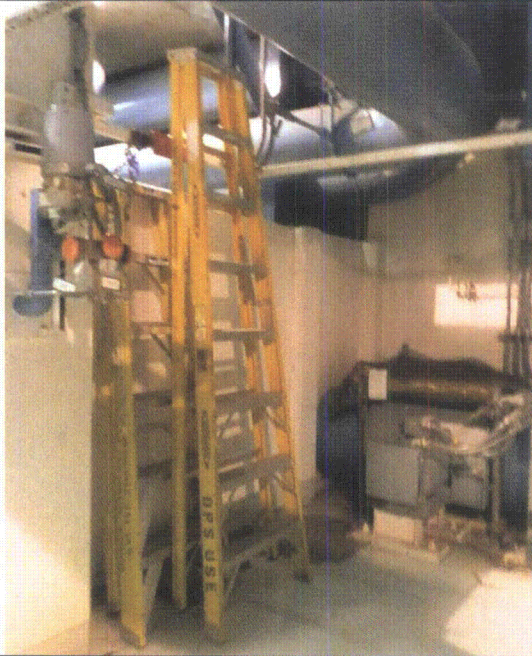
Note: Unrestrained ladder by the Appendix R safe shutdown ladder.

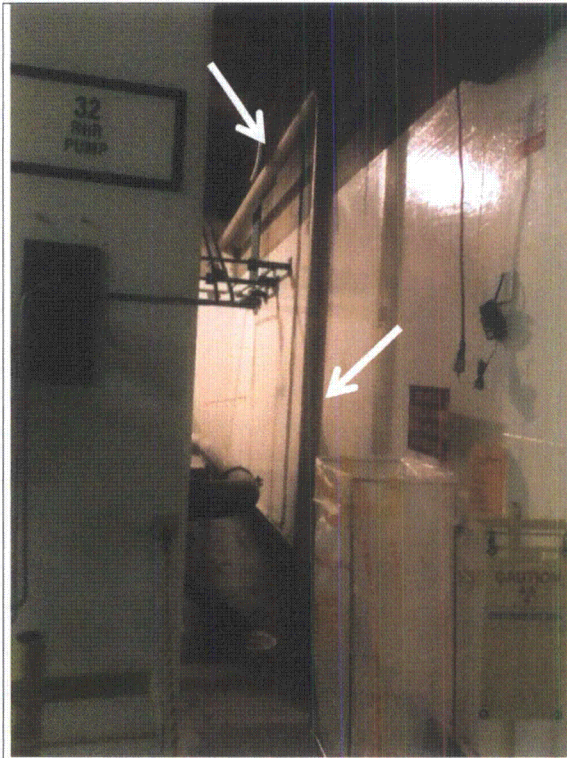
Note: piping with an unsupported length of approximately 25 to 30 ft.

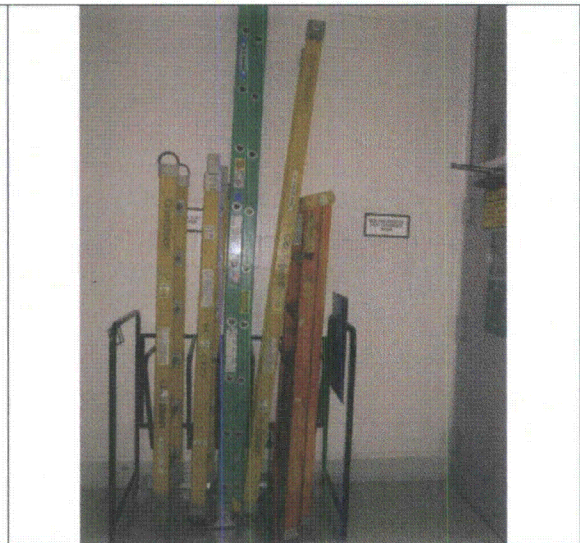
Note: Unsecured ladders at the Nonregenerative heat exchanger room

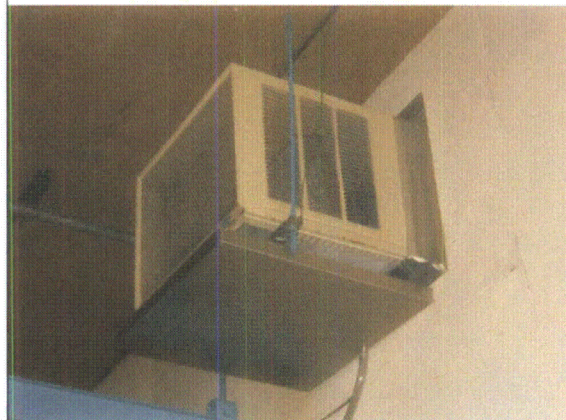
Note: Air conditioner with no apparent horizontal support.

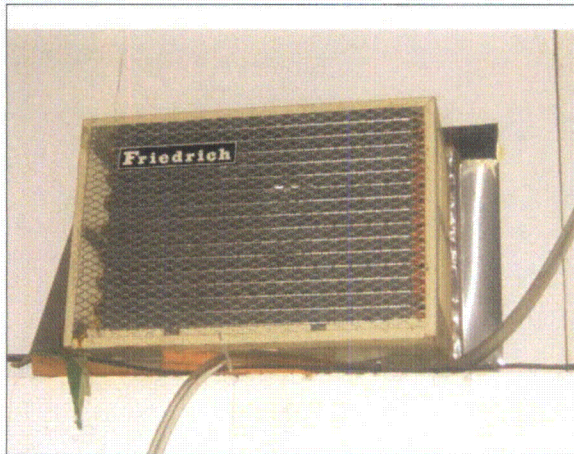
Note: Air conditioner with no apparent lateral support

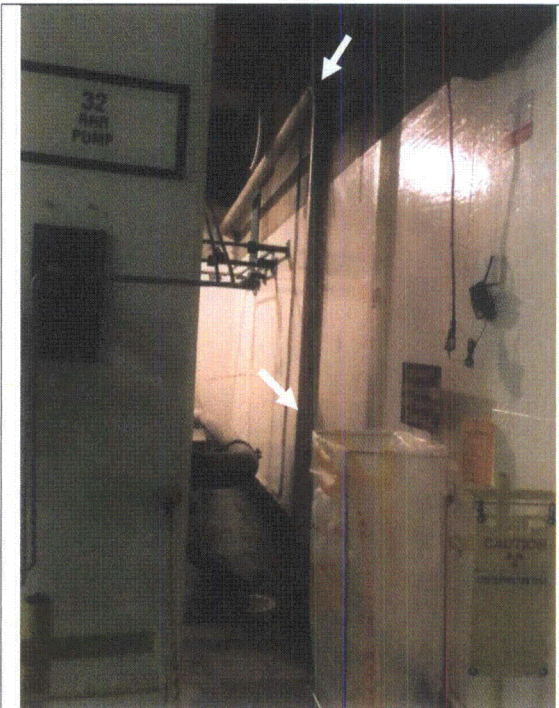
Note: piping with an unsupported length of approximately 25 ft to 30 ft

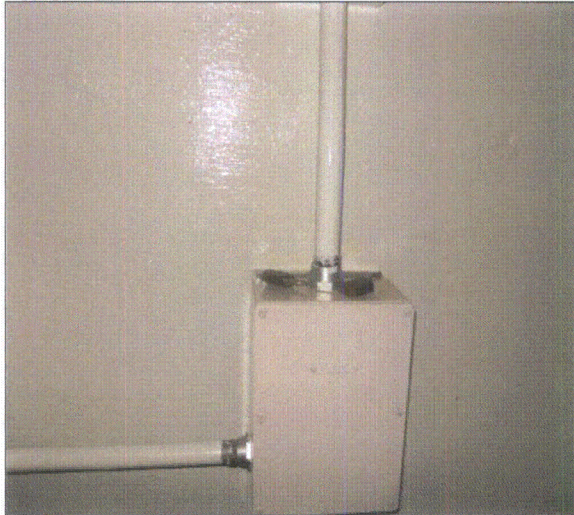
Note: Loose padlocks on top of cabinet

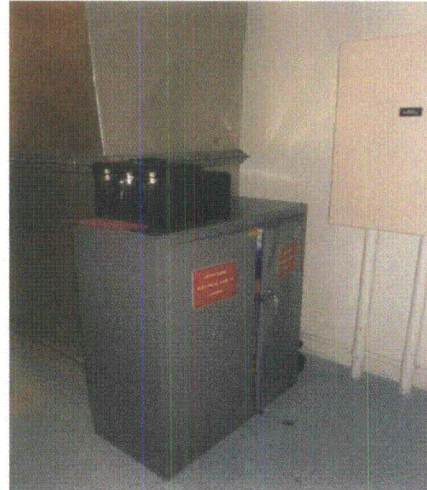
Note: Unsecured tool box on top of cabinet and cabinet door not closed.

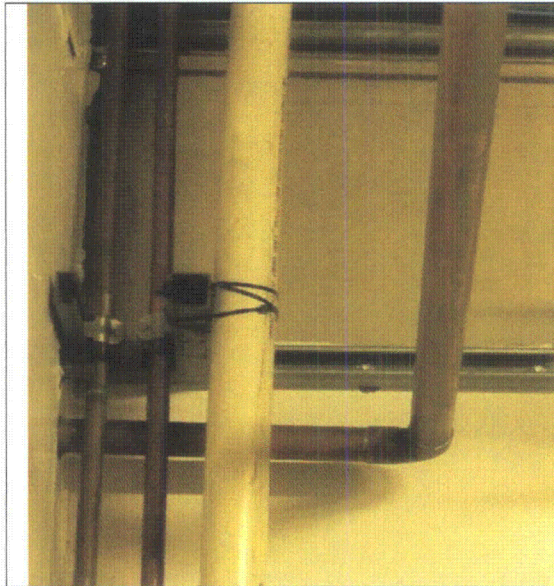
Note: PVC zip tied to unistrut

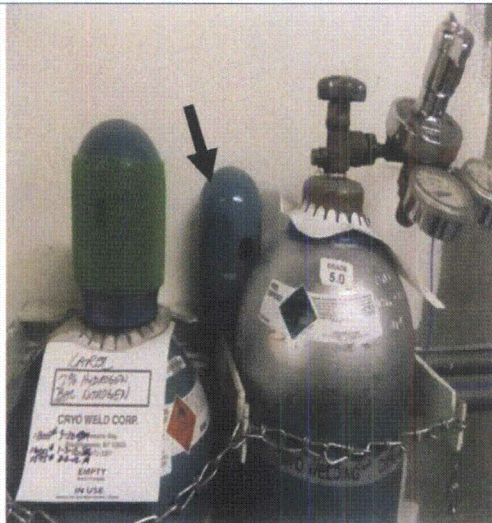
Note: Loose cap behind the compressed air bottles.

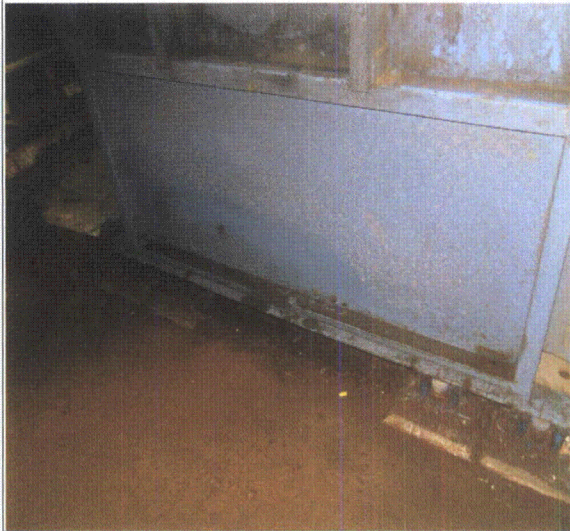
Note: *There is a considerable amount of water on the floor indicating potential leakage from piping in the area.*

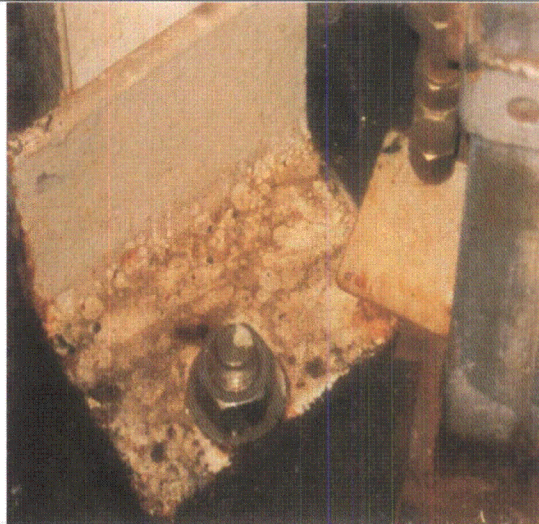
Note: Anchor bolt for strainer (stainless steel) with some corrosion of base angle.

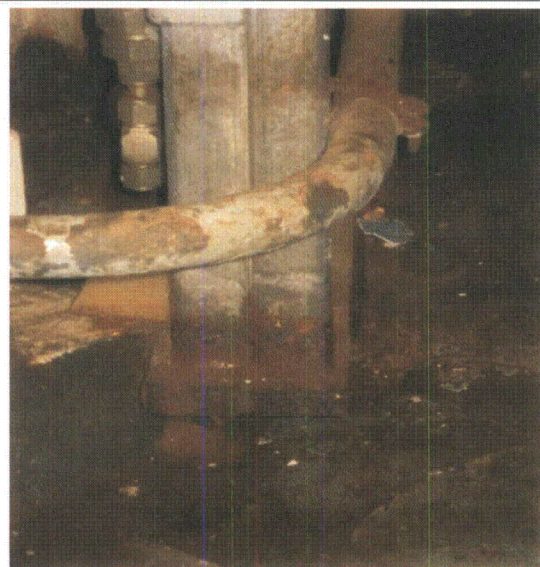
Note: Corrosion at the base of a Unistrut column

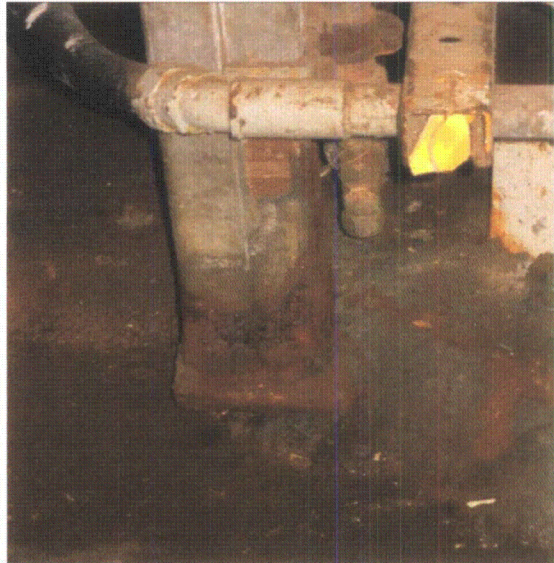
Note: Corrosion at the base of a Unistrut column

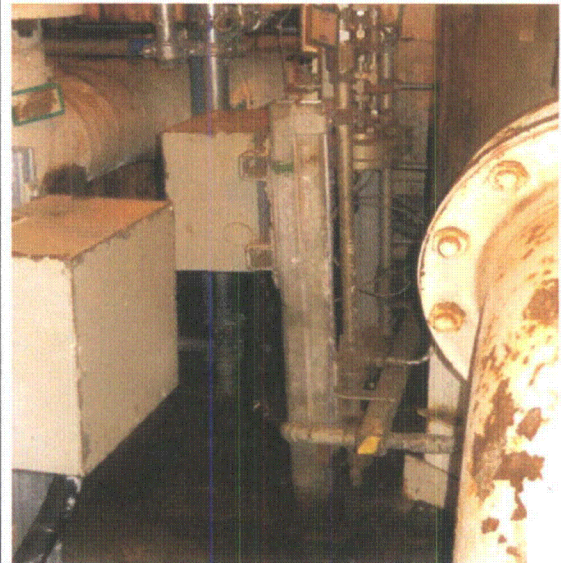
Note: Unistrut column which is beginning to tilt

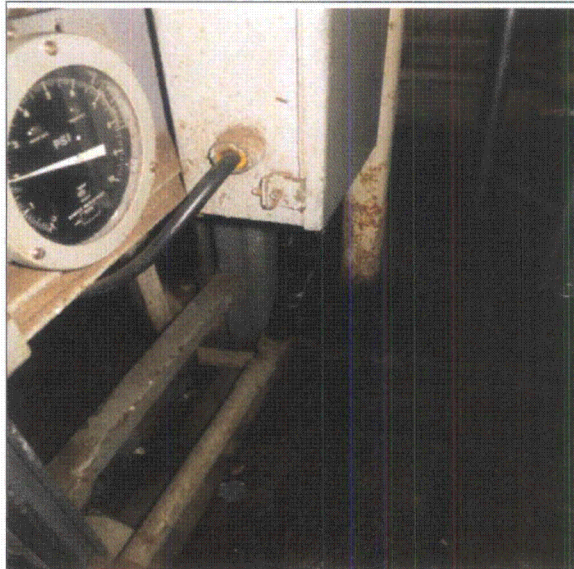
Note: Pipe support stanchion showing considerable corrosion

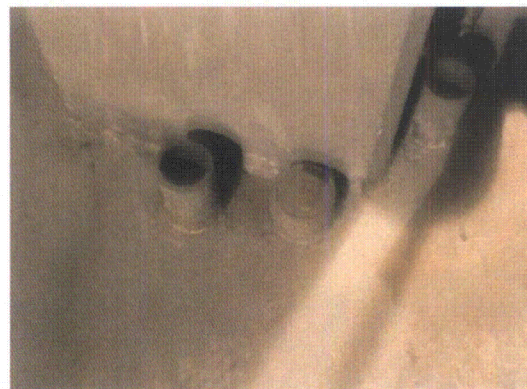
Note: Loose plug and unplugged piping.

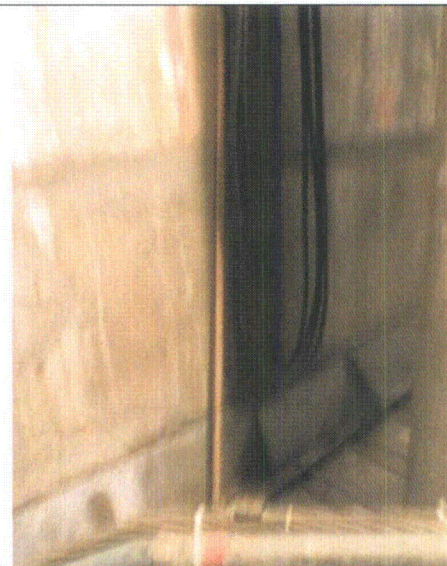
Note: unrestrained broom stick

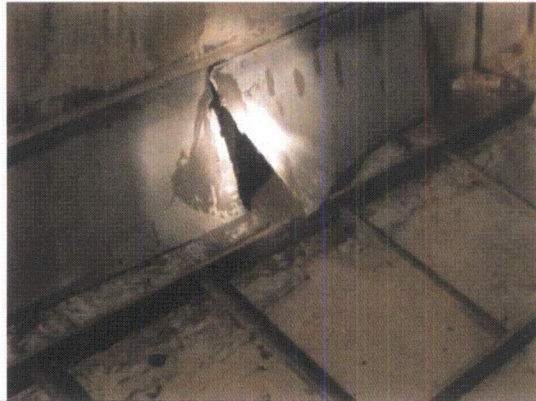
Note: Broken flashing

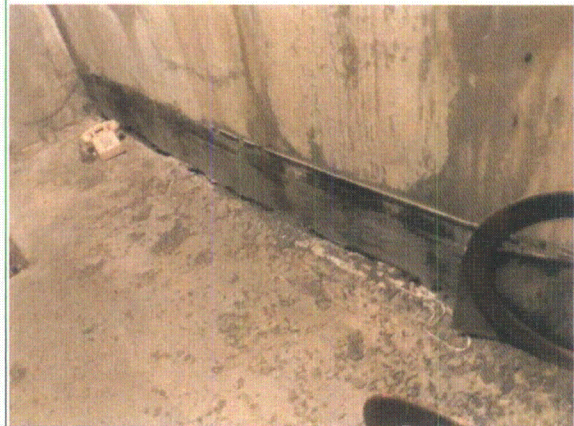
Note: Missing flashing along the wall

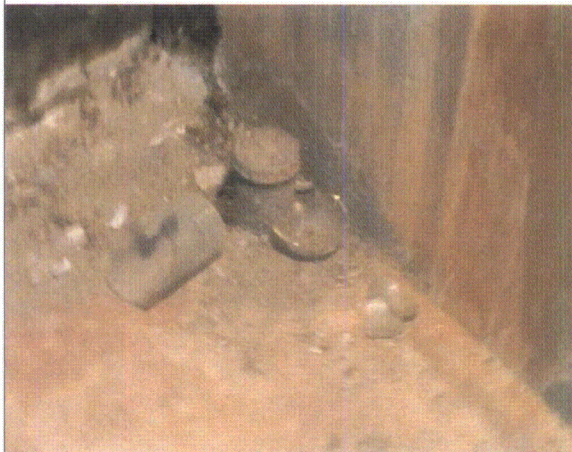
Note: Broken glass in the east corner of the room.

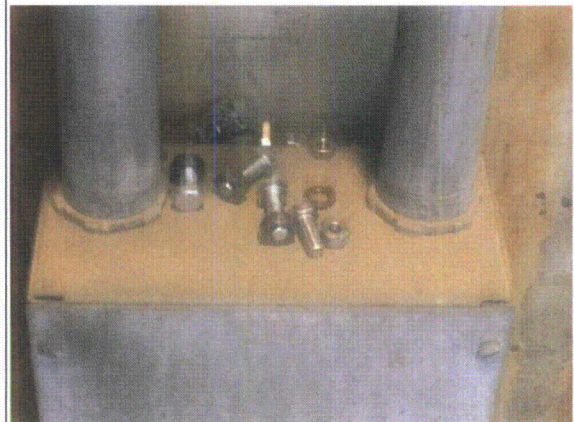
Note: Bolts and nuts on top of electrical box for GAI-Tronics.

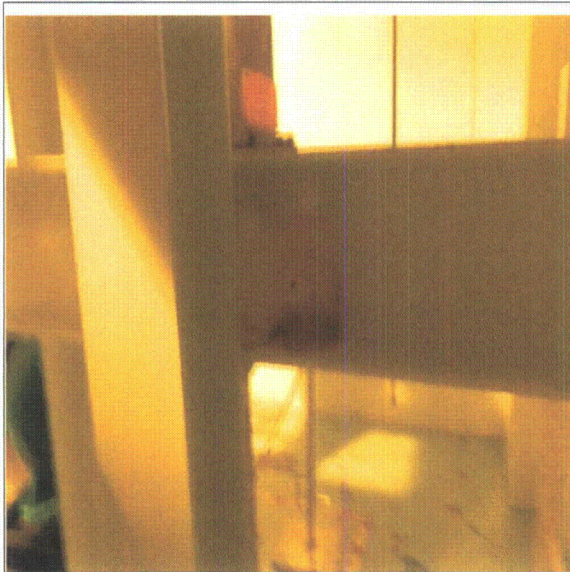
Note: bottle sitting on a beam

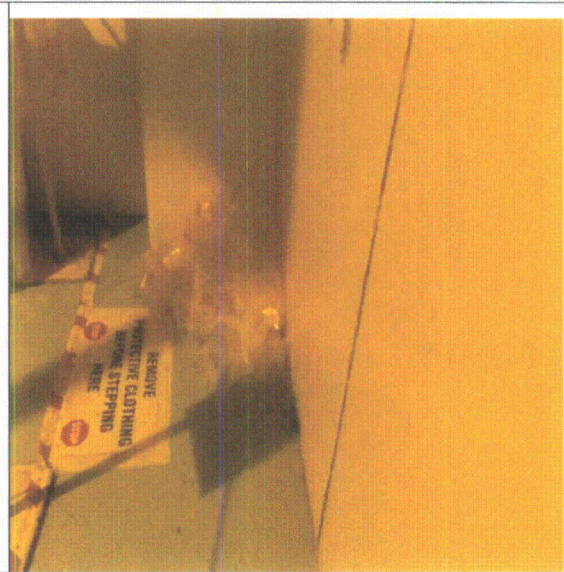
Note: waste bag on the floor

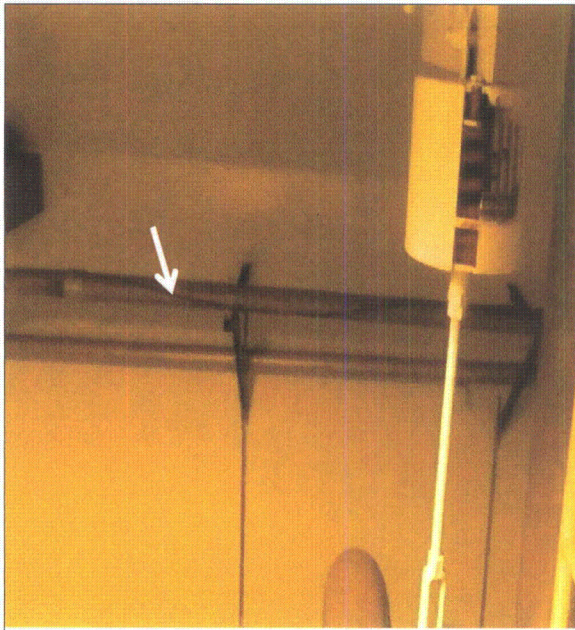
Note: bare wire attached to a conduit

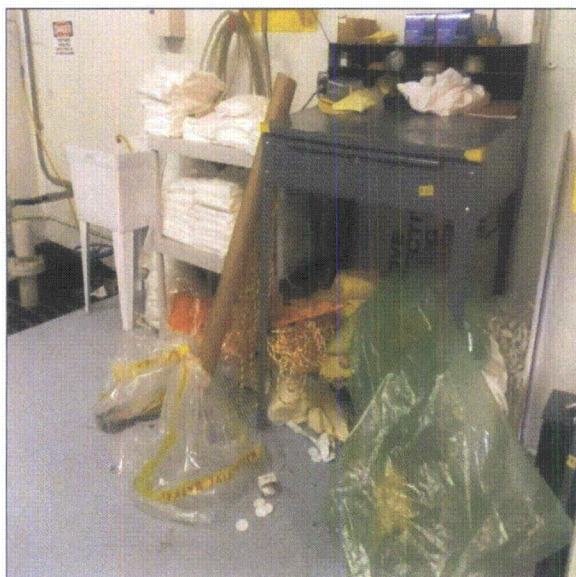
Note: waste bags on the floor
