ATTACHMENT E – POTENTIALLY ADVERSE SEISMIC CONDITIONS

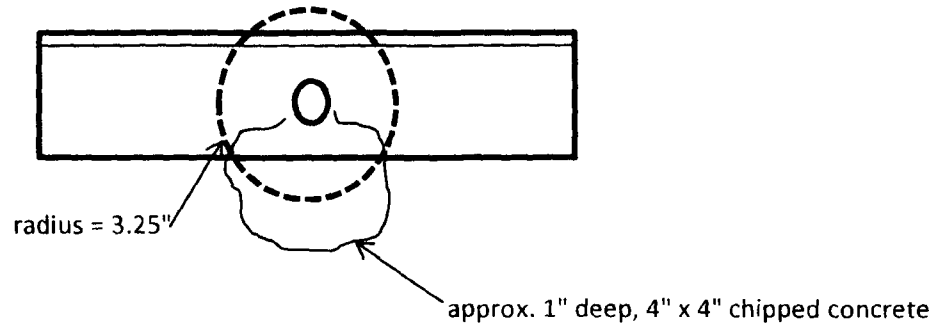
SWEL1-070

A 1" deep, 4"x4" chip concrete area adjacent to Hilti bolt

The 1" deep concrete chipped area is conservatively treated to cover 35% of the shear cone area for a 3.25" embedment expansion bolt. The 1" deep, chipped area still has capacity and can be considered as 35% of a shear cone area of a (3.25"-1") = 2.25" embedment anchor.

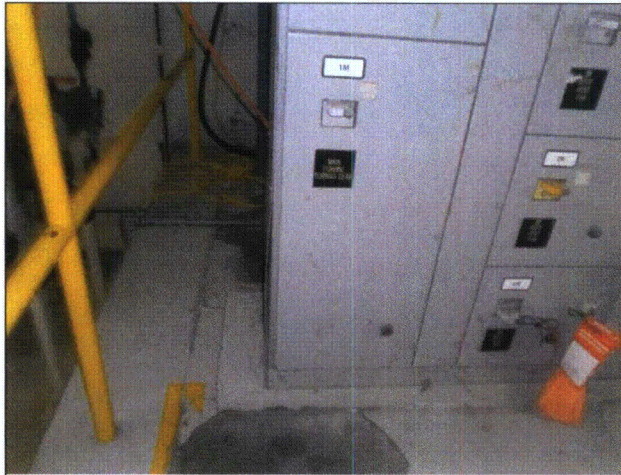
*Slight bulging at the lower part of the north panel.*

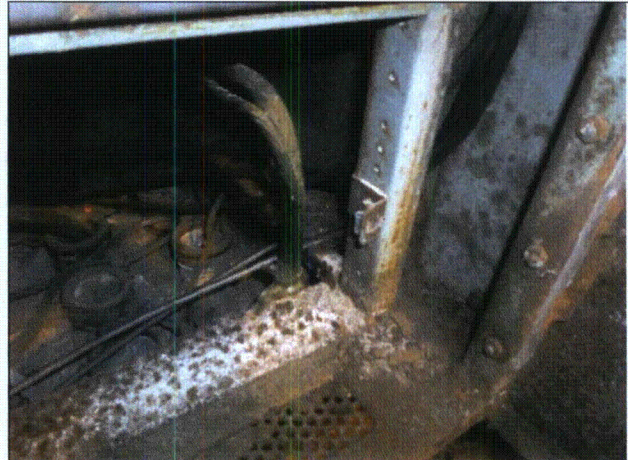
*Bottom panel opened for inspection of anchorage. Mild surface corrosion was observed.*

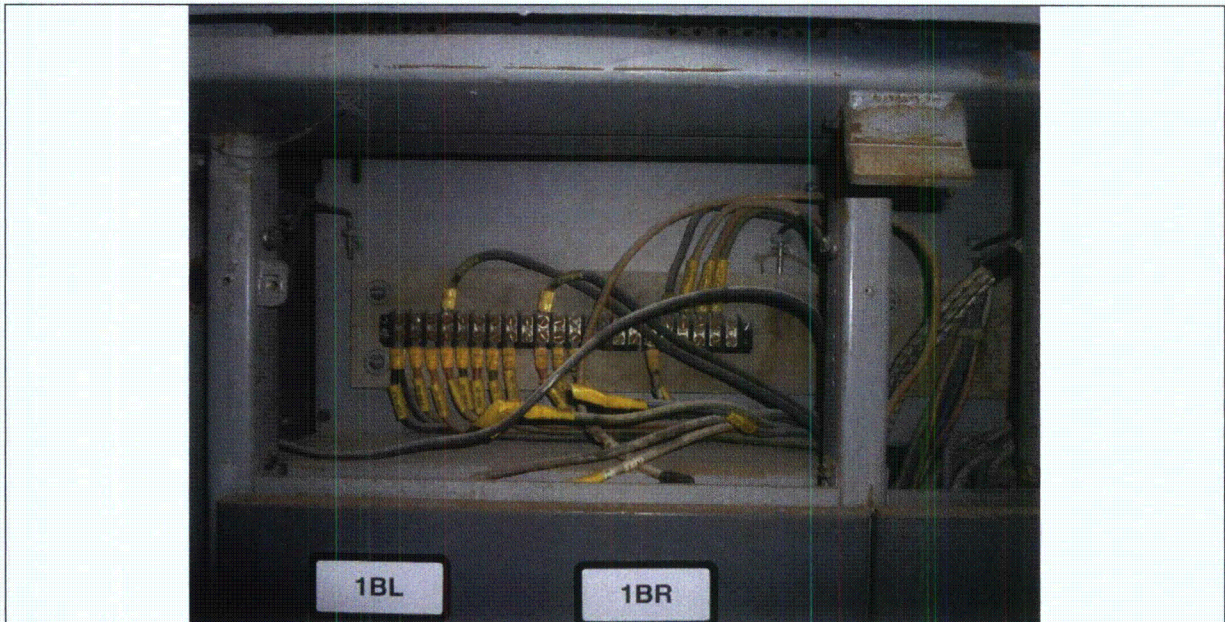
*Top panel opened for inspection of internals. Mild surface corrosion was observed on screw heads.*

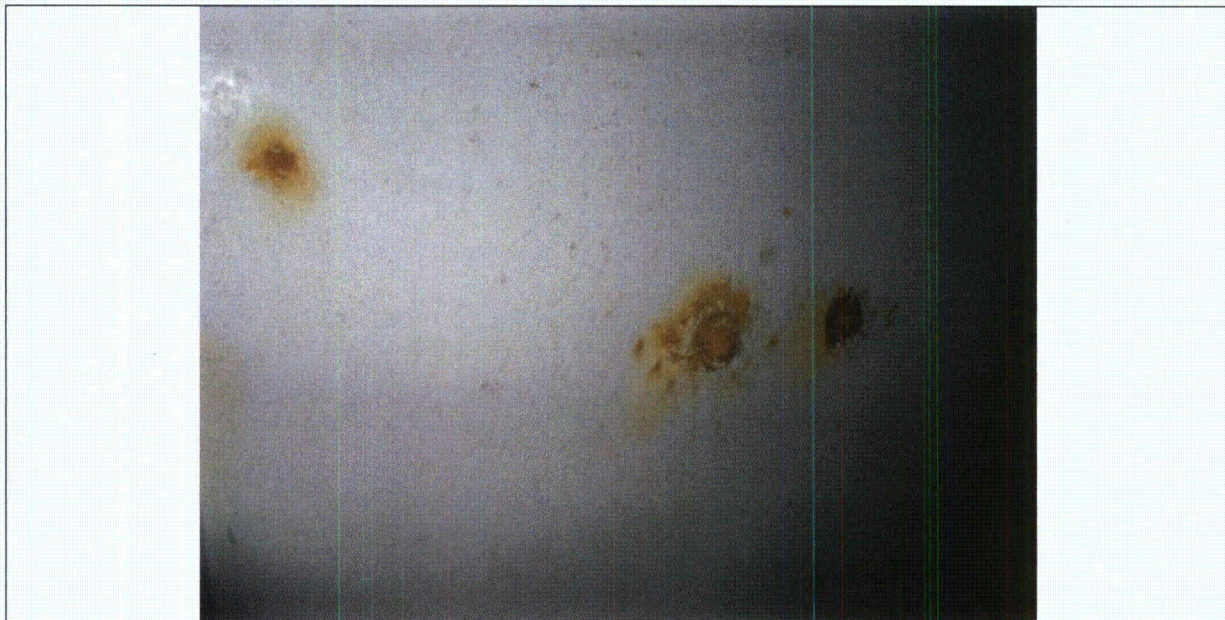
*Mild surface corrosion was observed on screw heads and panel surface.*

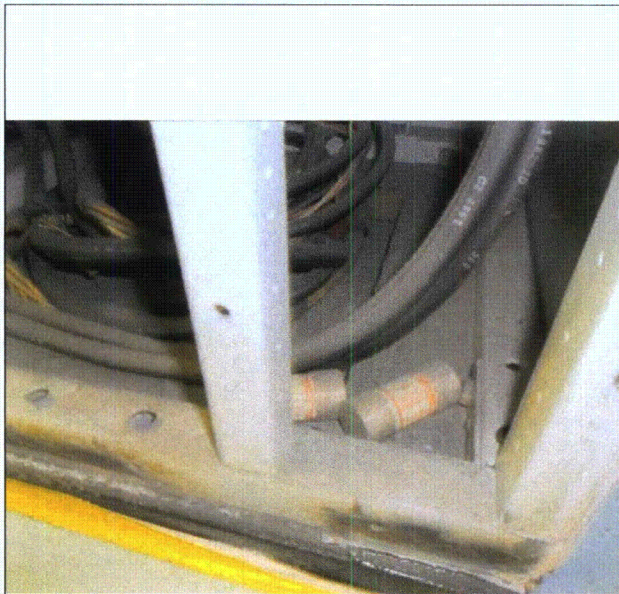
Housekeeping issue  
Fuse left inside the floor space

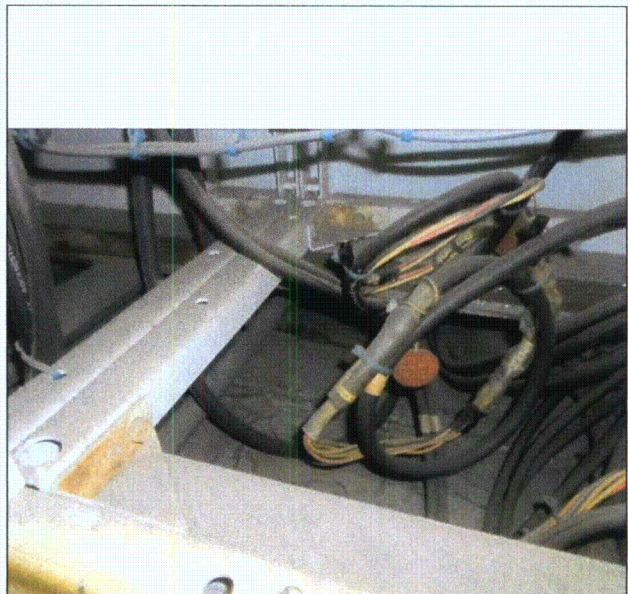
Housekeeping issue  
Tie wraps left inside the floor space

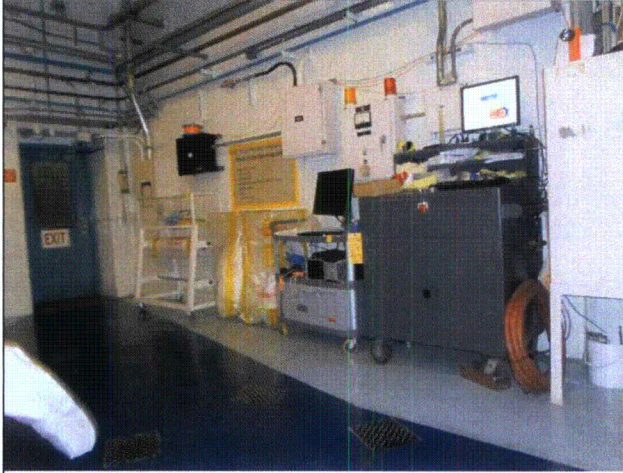
Two carts by HP desks have wheels that are not blocked/choked

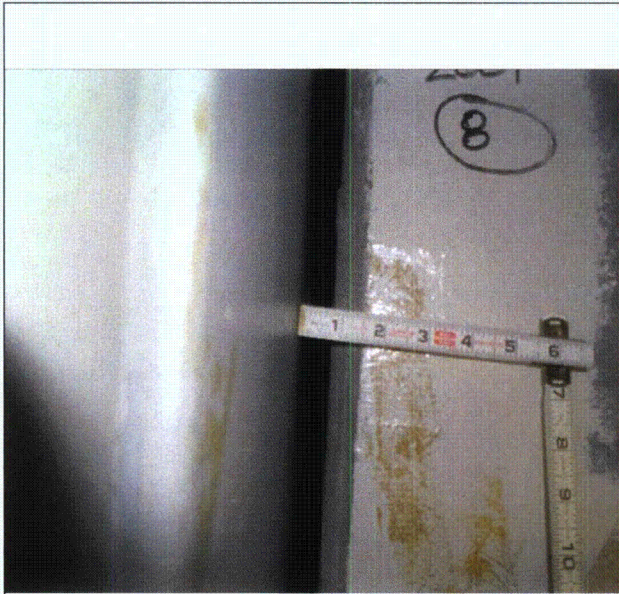
**Note:**  $\frac{3}{4}$ " gap between top of MCC and concrete wall

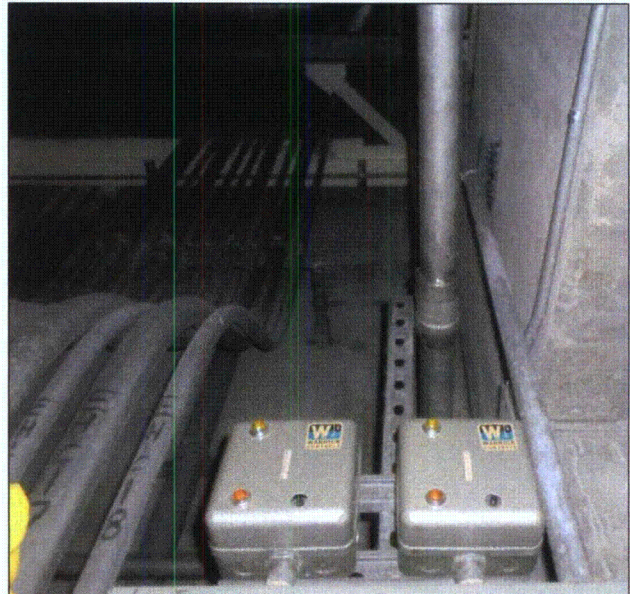
**Note:** Unistrut support for an instrument serving the 38MCC is touching a DW pipe (for fire protection)

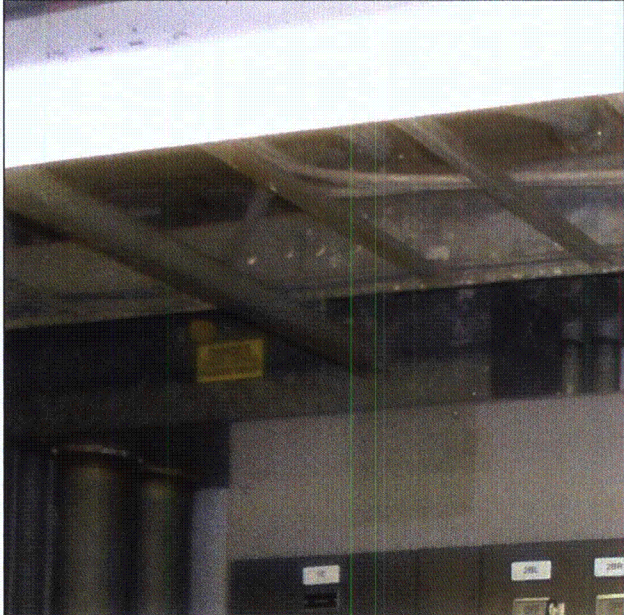
**Note:** Box XZ21 above the MCC is missing 1 out of 8 screws

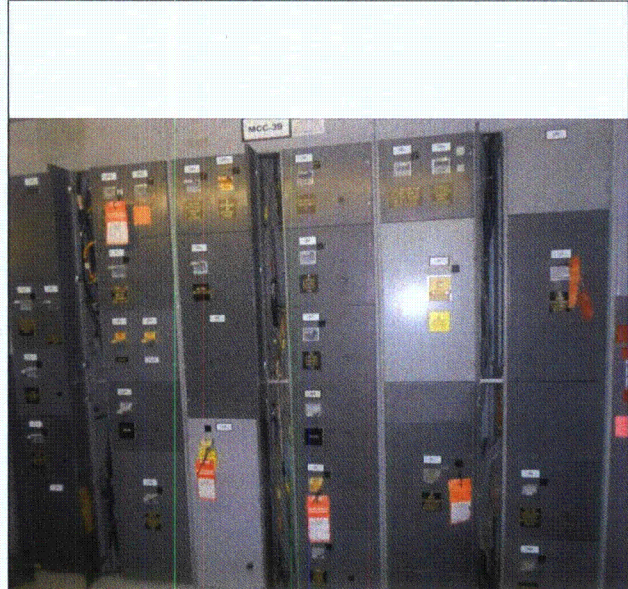
**Note:** Enlarges view of cubicle 3G and the cubicle above 6K will show the missing screws.

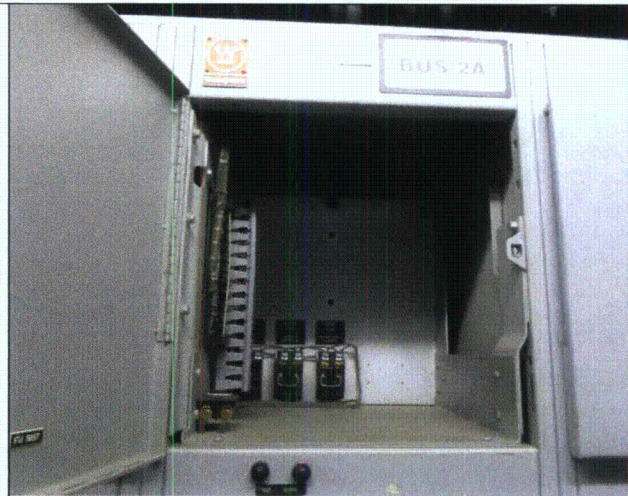
*Cubicle door opened with fuse blocks lying on the shelf.*

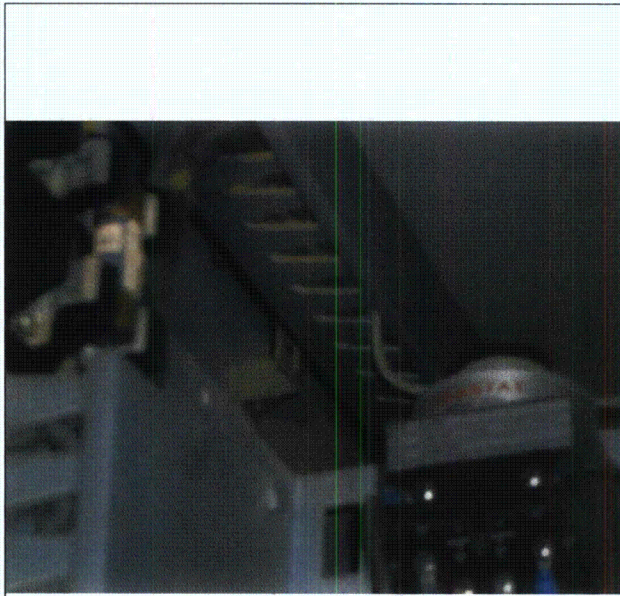
*Wireway has no clip connection.*

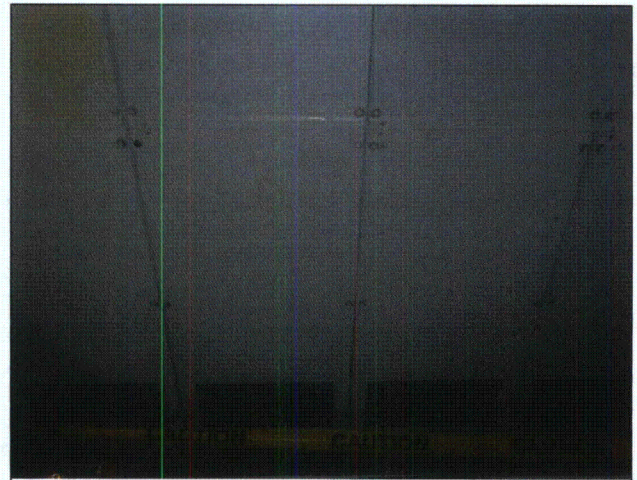
*Missing screws on the panel cover.*

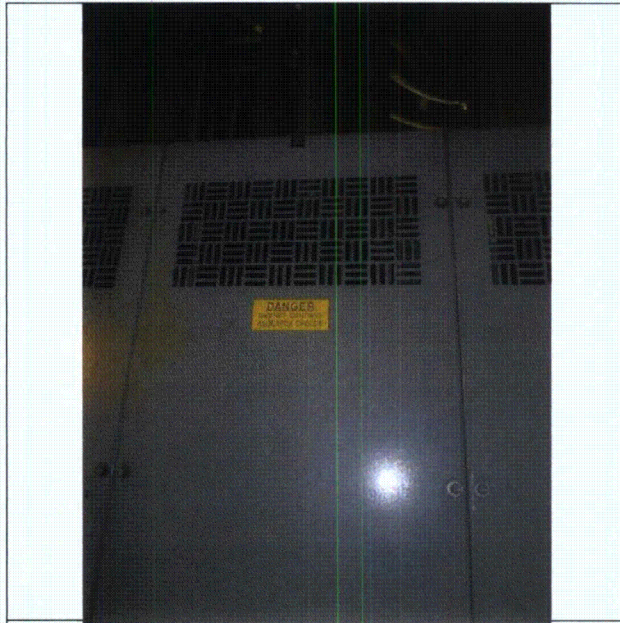
*Missing screws on the panel cover.*

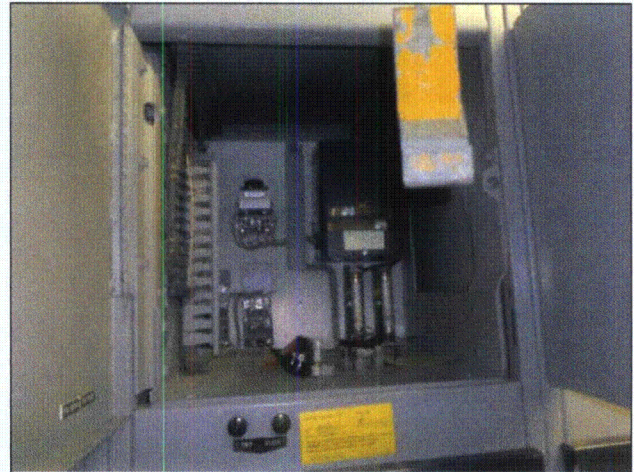
*Fuse blocks were lying on the shelf of the upper cubicles because the Switchgear was being serviced.*

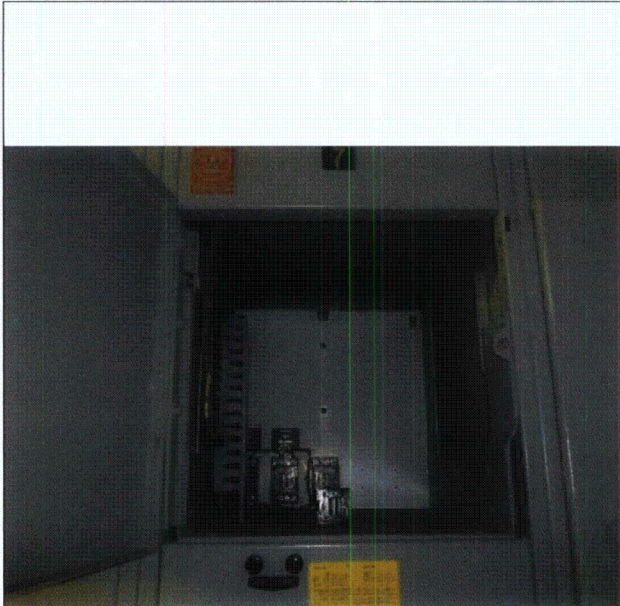
*Fuse block lying on the shelf.*
