Seismic Walkdown Checklist (SWC) SWEL1-064

Equipment ID No. 31PP

Equipment Description 125VDC POWER PANEL 31

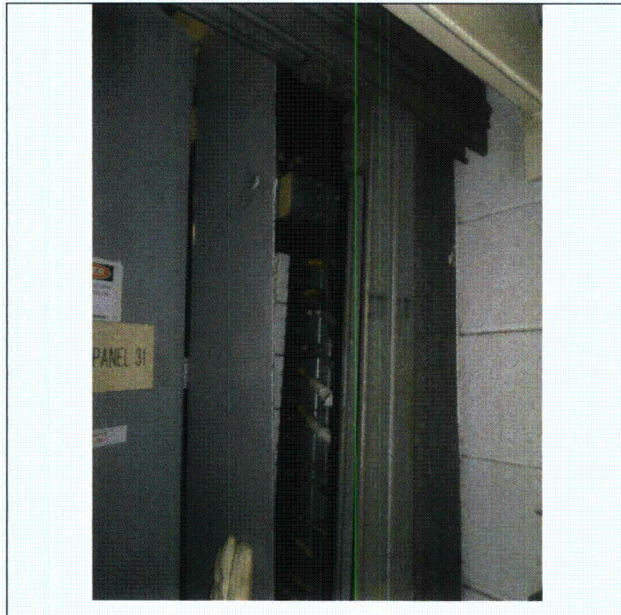
Note:
31PP

The panel is mounted to the wall and the anchorage cannot be visually inspected since the anchorage is behind a panel cover. The panel cover is secured with 3 bolts on each side. Panel was removed in 3R17 to allow for inspection of the anchorage and interiors. No bent, broken, missing, or loose hardware was observed.

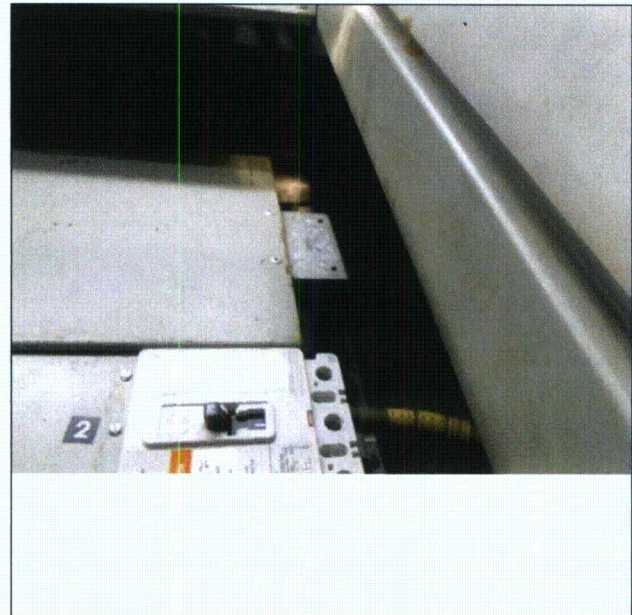
Panel was removed in 3R17 to allow for inspection of the anchorage and interiors. The anchorage is the through bolt type and is free of visible cracks in the masonry block near the anchors.

Note:
Through bolts from panel side

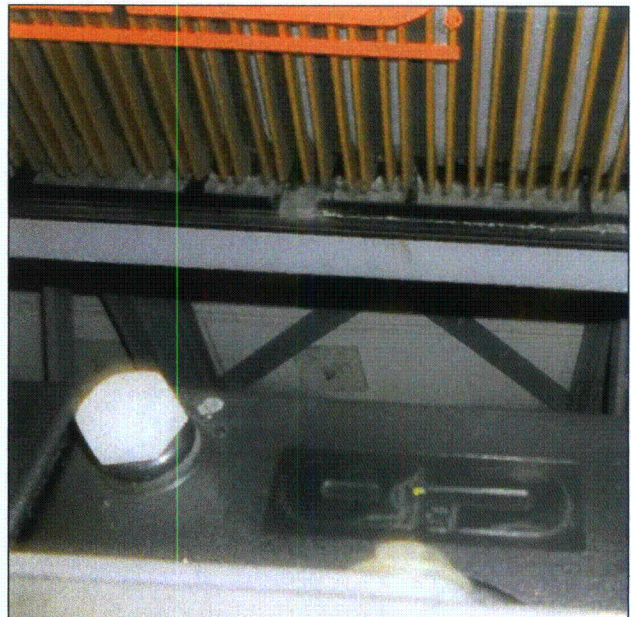
Through bolts from inside of Battery Room 31

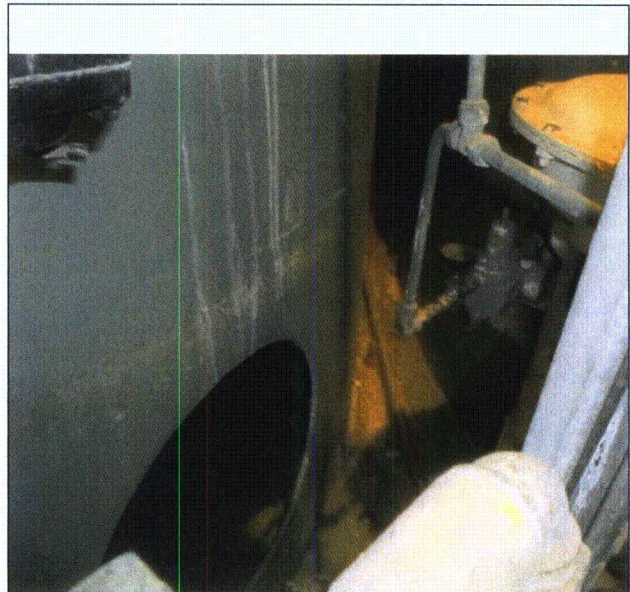
Mild surface corrosion on the anchor bolts.

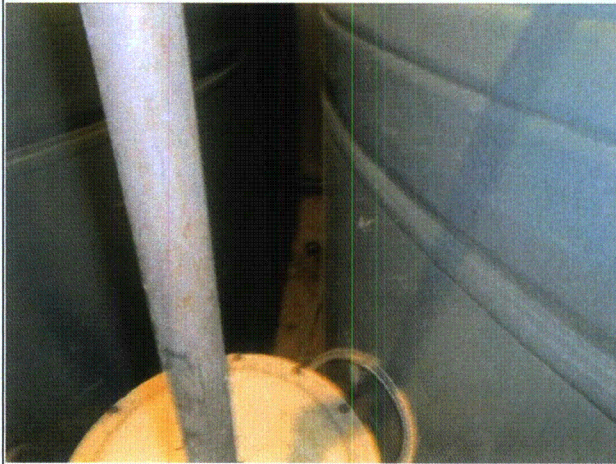
Mild surface corrosion on the anchor bolt (near outer wall)

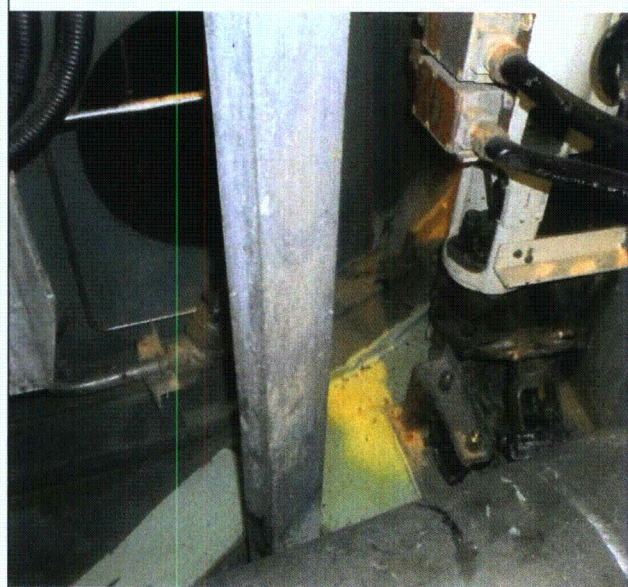
Mild surface corrosion on the supports' hex nuts and bolts.

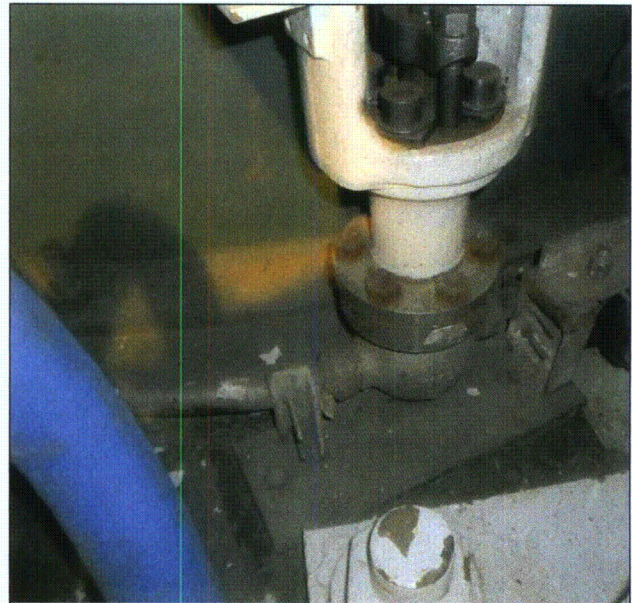
Mild surface corrosion on the valve's nuts and bolts.

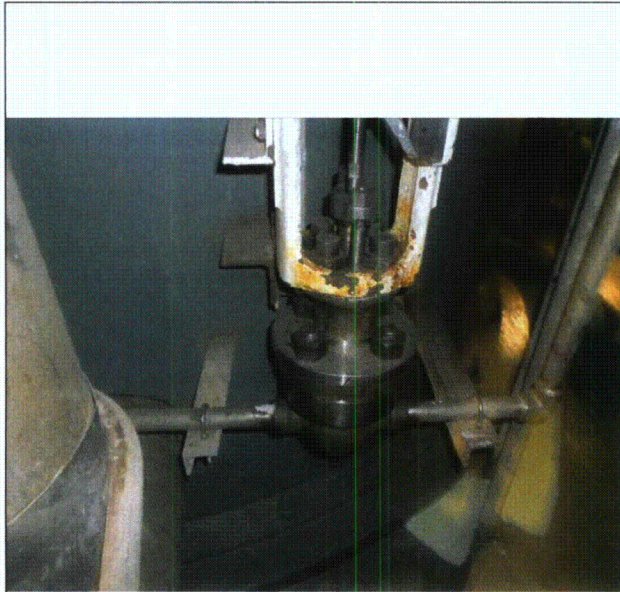
Mild surface corrosion observed on the angle iron support, valve body, bonnet, nuts and bolts

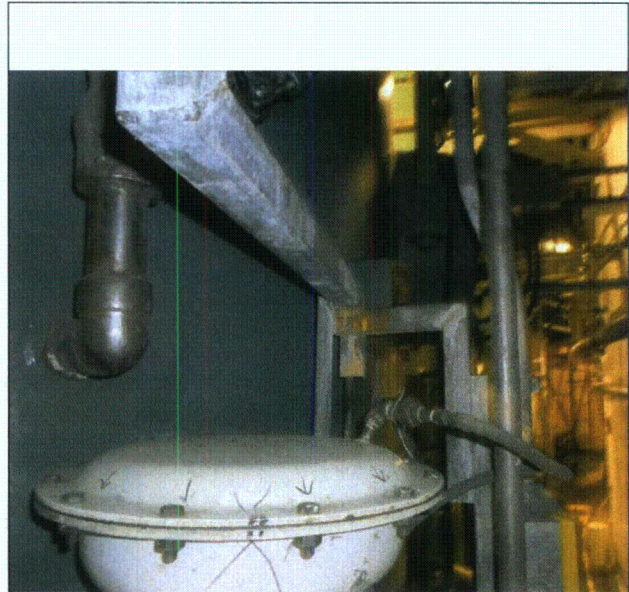
Mild surface corrosion observed on the tube track support.

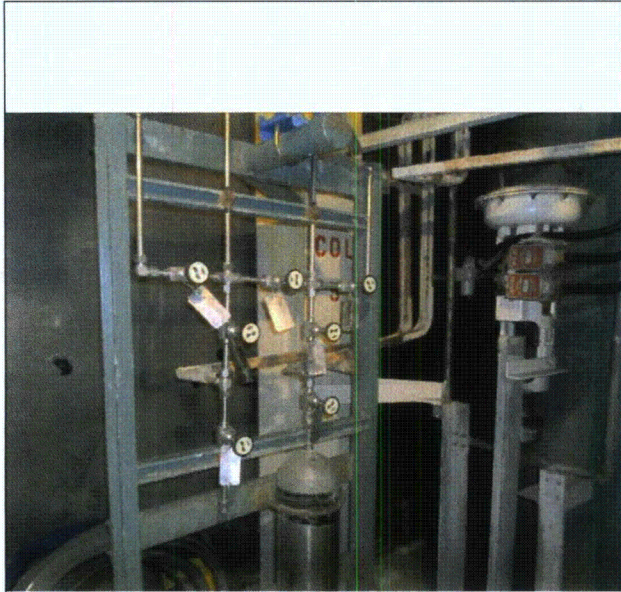
Mild surface corrosion observed on the tube track, tubing clamp, and U-bolt.

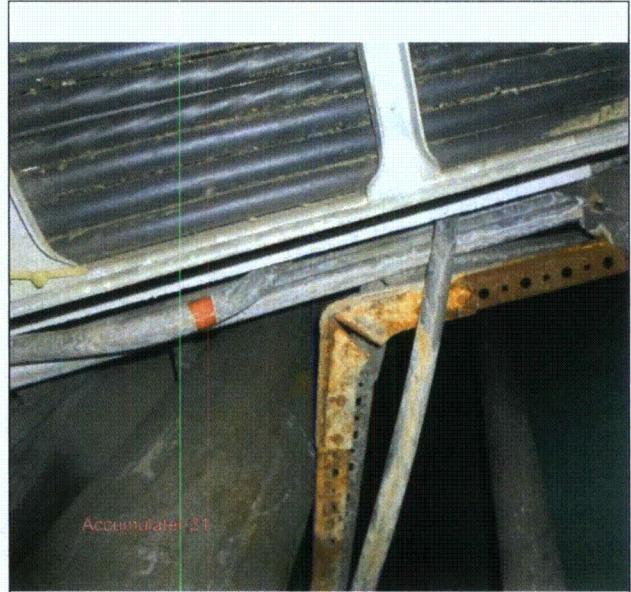
Pronounced corrosion on an abandoned strut and strut corner fitting.

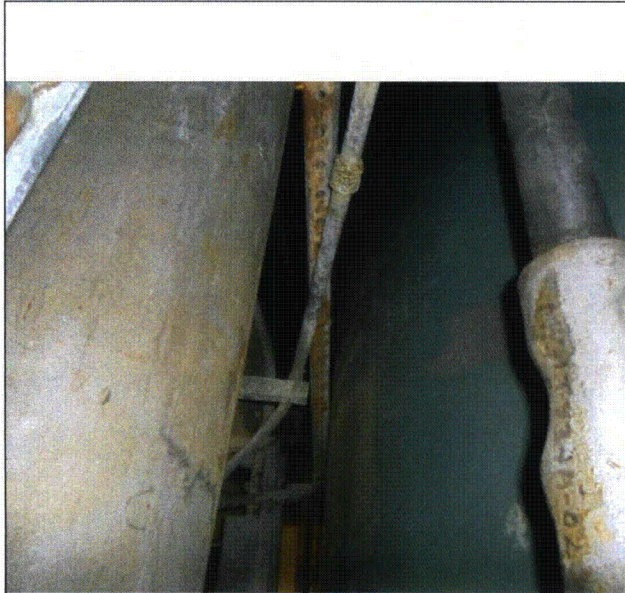
Abandoned strut is in contact with Accumulator.

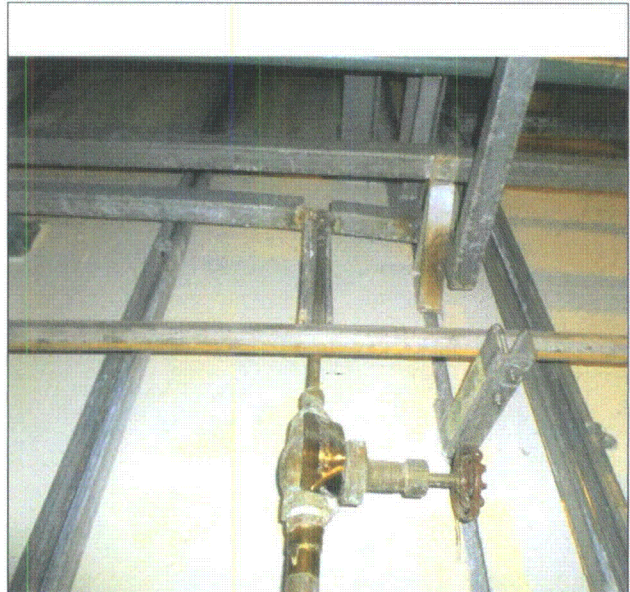
Localized mild surface corrosion, see AWC-53.

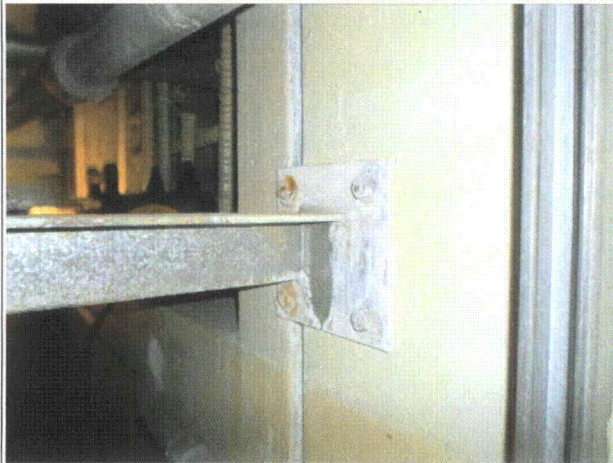
Mild surface corrosion at two nuts on the base plate.

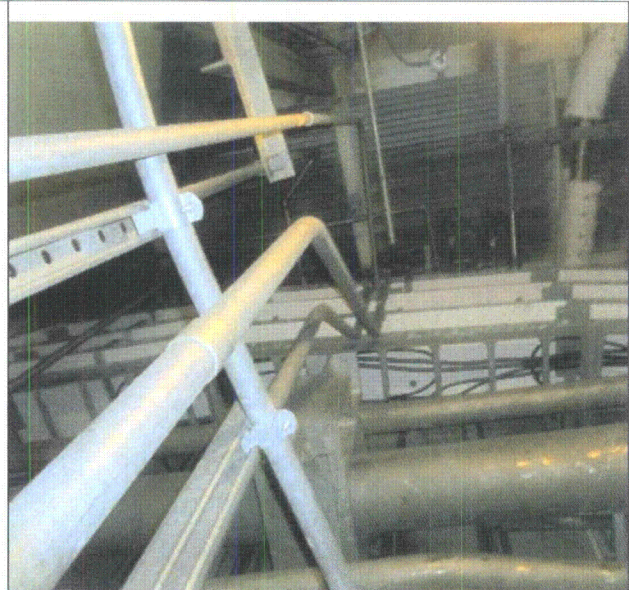
Mild surface corrosion at ceiling building steel.

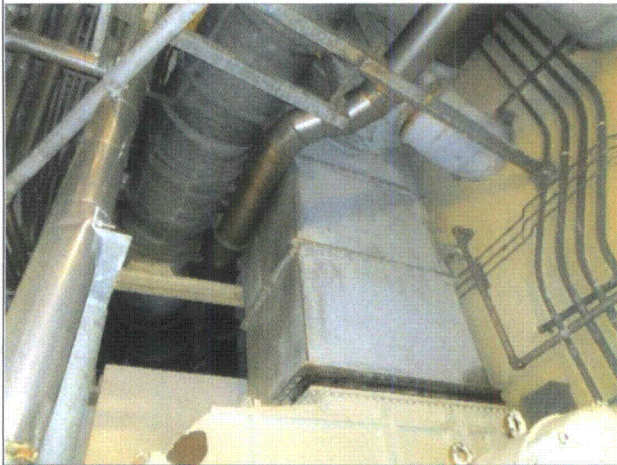
1. Mild surface corrosion on the 12" circular duct surface and duct flange joint.
2. Mild surface corrosion on the rectangular duct flange joint.

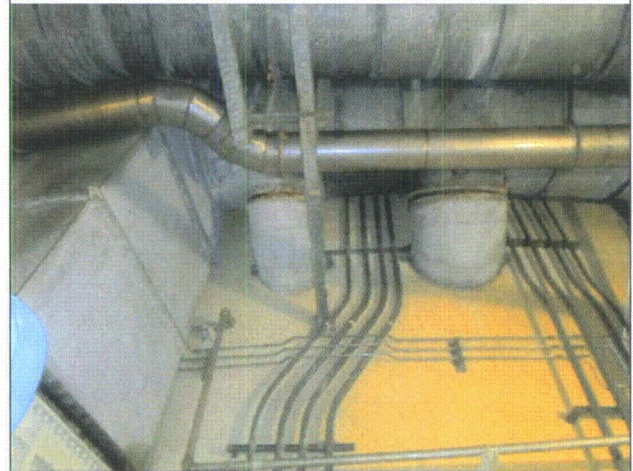
1. Mild surface corrosion on the 30" circular duct flange joint.

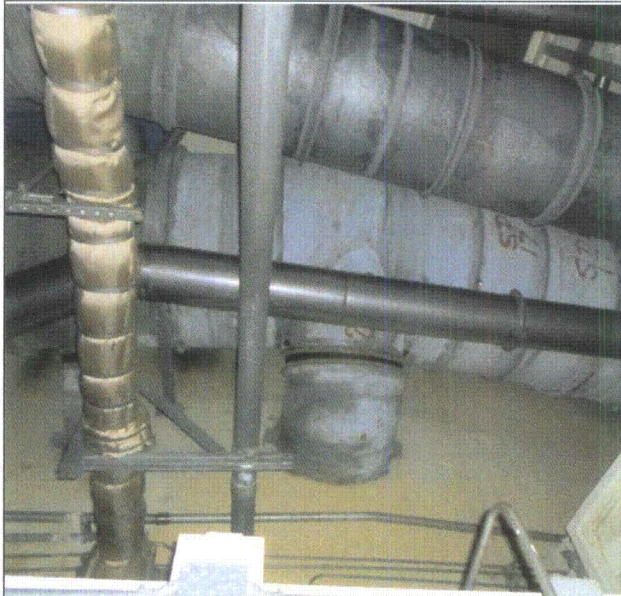
Note: *Mild surface corrosion on the 60" circular duct flange*

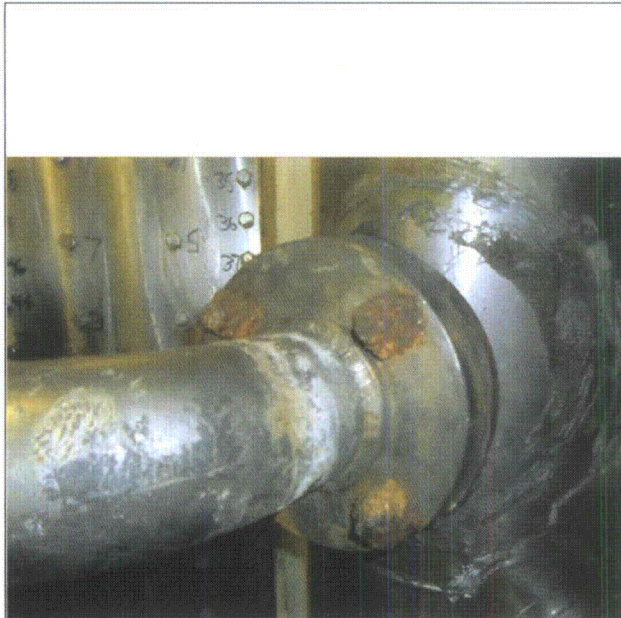
CS Nuts on 3" SW pipe flange have pronounced surface corrosion.

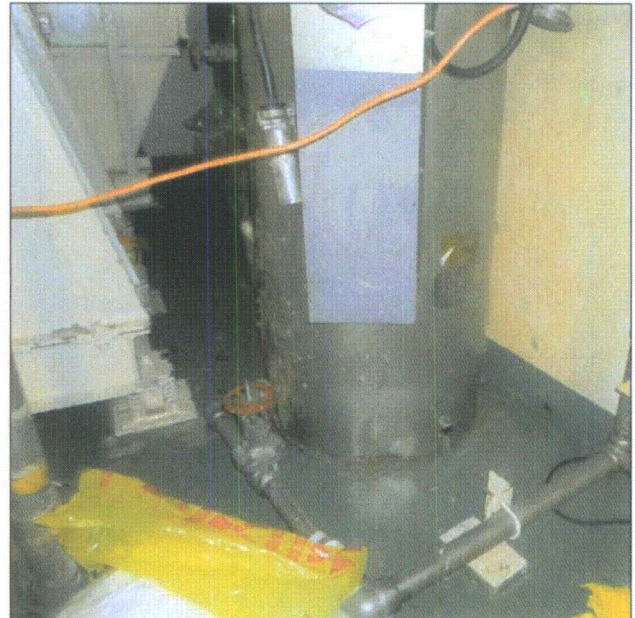
Fire protection tank sheet metal enclosure's base has mild surface corrosion and slight buckling.

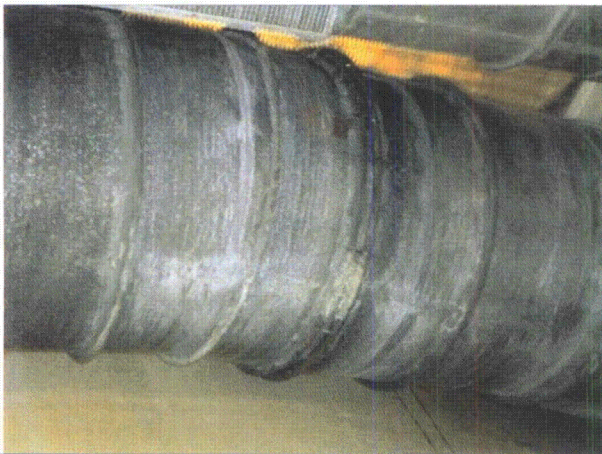
Circular duct flange joint has mild surface corrosion.

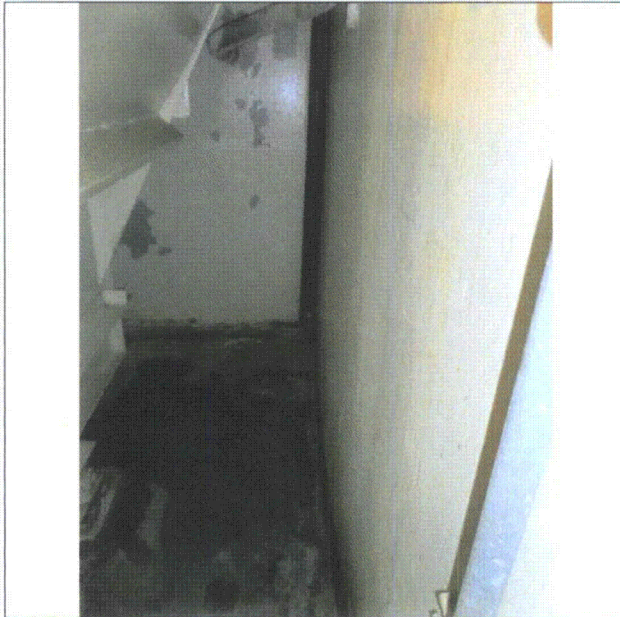
Boric acid deposit on the floor between fan inlet enclosure and motor frame..

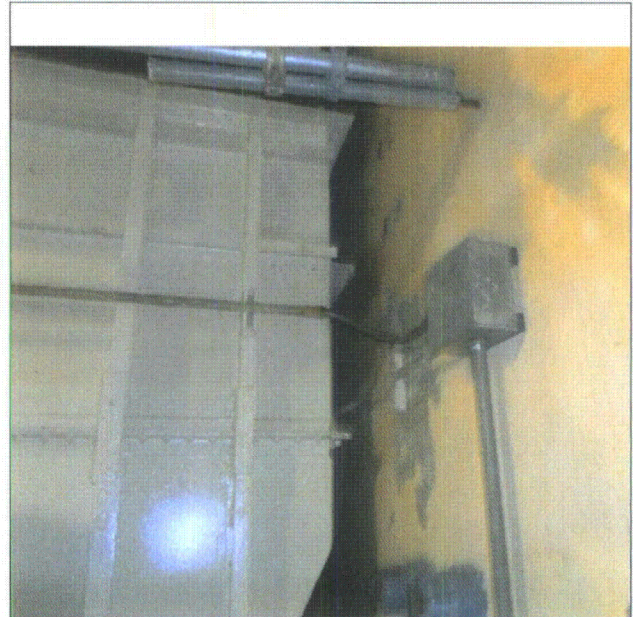
Coating (estimated to be 2'x4') on concrete wall.

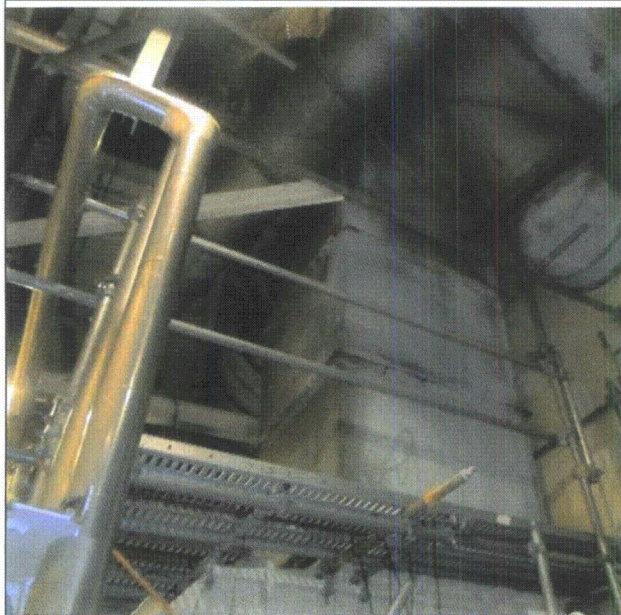
Mild surface corrosion at the rectangular duct flange joint.

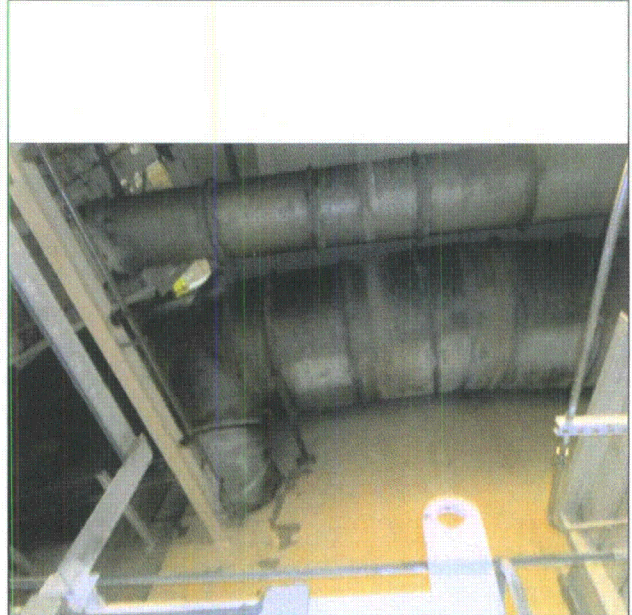
Minor surface corrosion was found at the duct flange joint at the following locations:

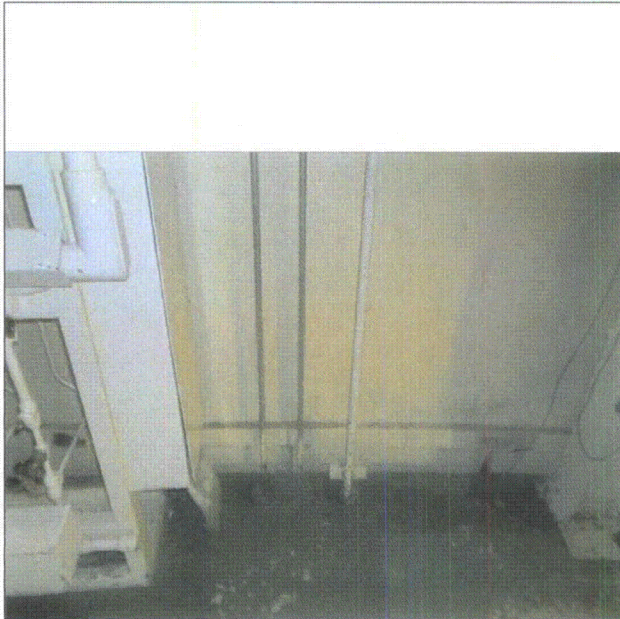
3/4" (1.05" OD) riser, Station Air piping has support at EL. 68' and 93'.

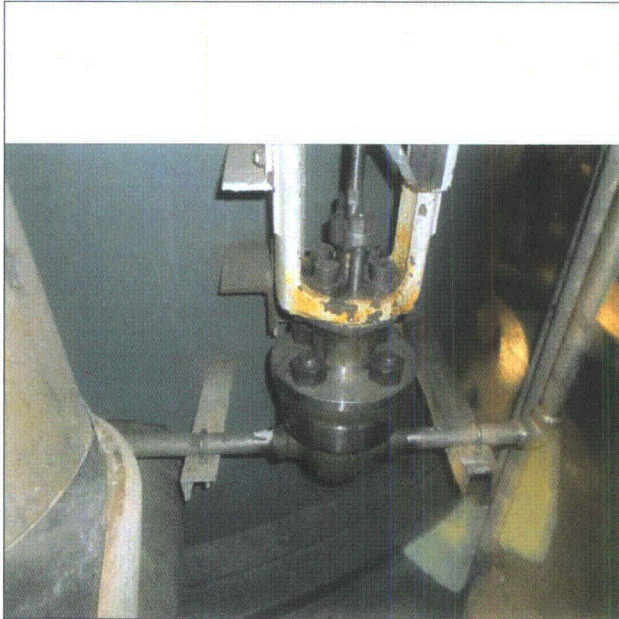
Mild surface corrosion observed on the angle iron support, valve body, bonnet, nuts and bolts

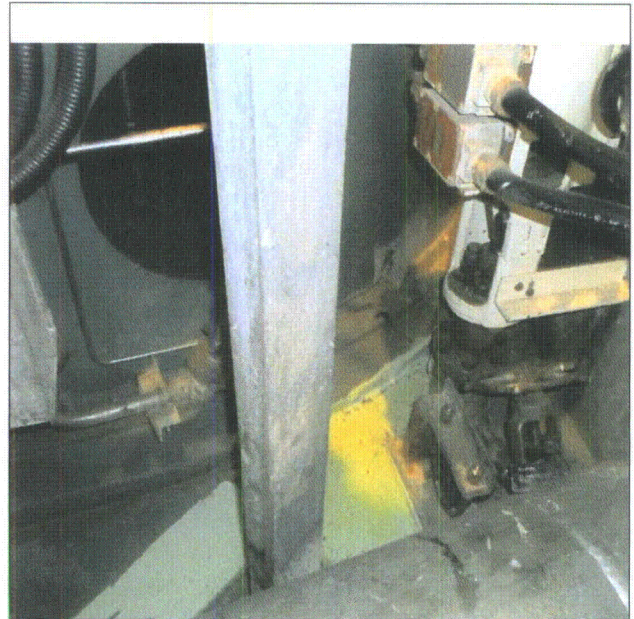
Mild surface corrosion on the supports' hex nuts and bolts.

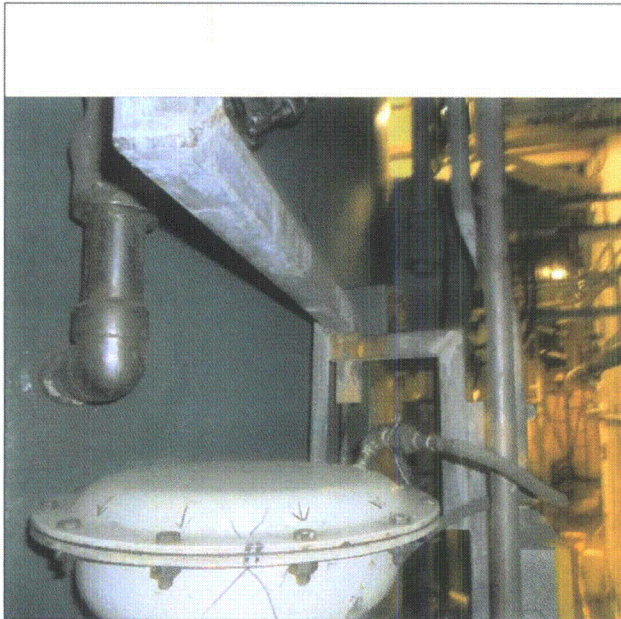
Note:
Mild surface corrosion observed on the tube track support.

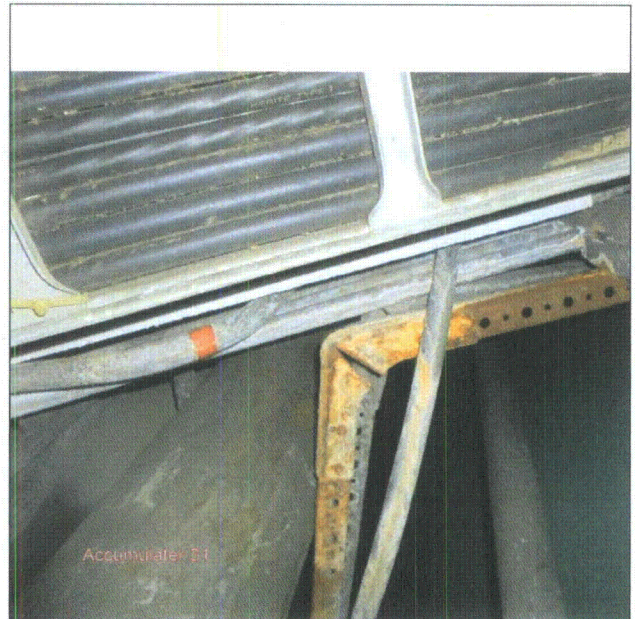
Note:
Pronounced corrosion on an abandoned strut and strut corner fitting.

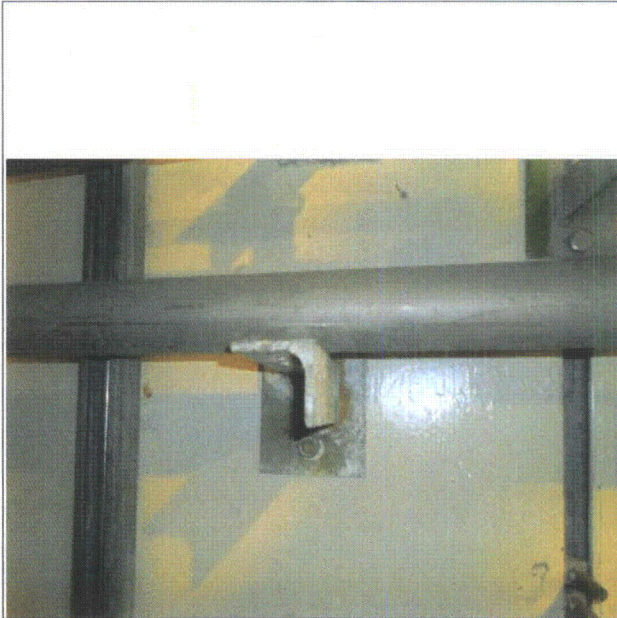
Mild surface corrosion on the weld and the base plate of a pipe support.

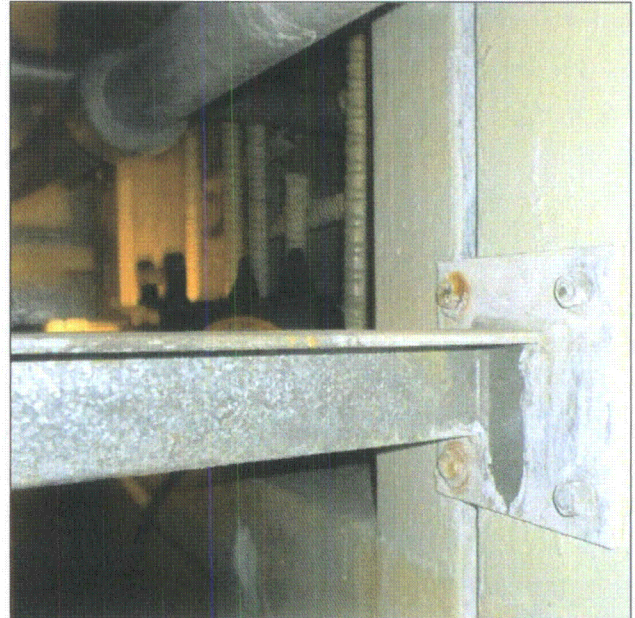
1. *Mild surface corrosion on two anchor bolts, nuts and the area surrounding those 2 bolts.*

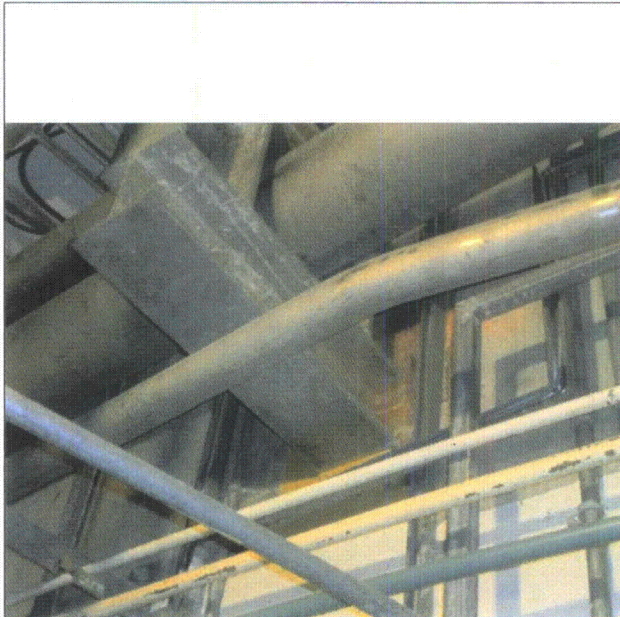
Mild surface corrosion on pipe support and the embedded plate.

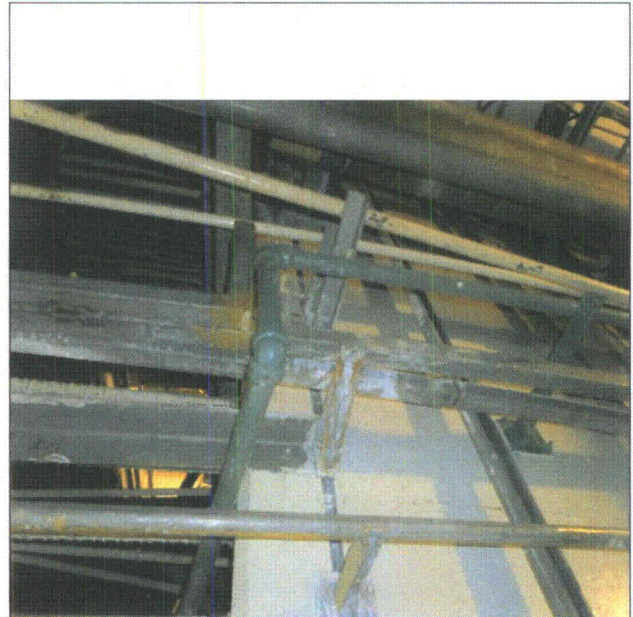
Mild surface corrosion was found on the following locations:

- *On a pipe and its angle steel support.*
- *On a tube track support.*
- *On a tube track.*

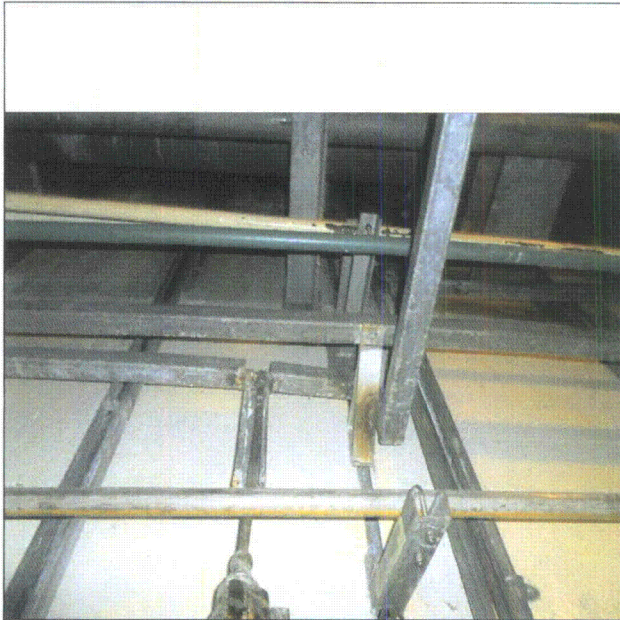
Mild surface corrosion was found on the following locations:

- On the tube track bracket support and its weld.
- On the tube track.

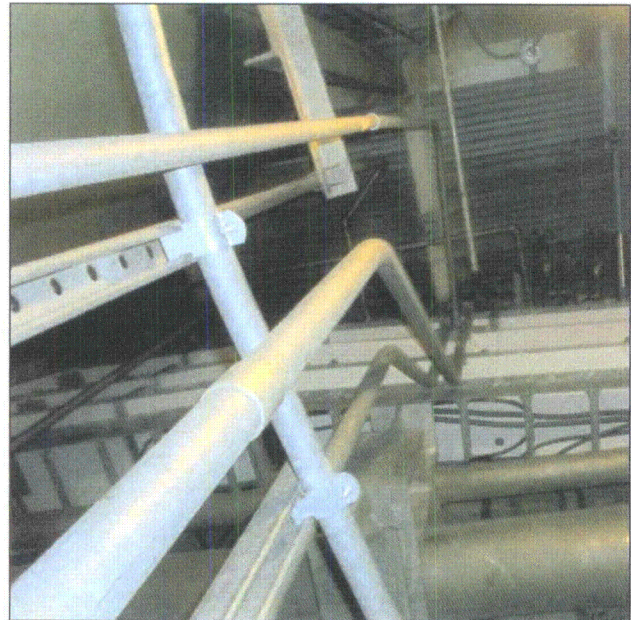
On the bottom flange of the structural steel on EL. 68'.

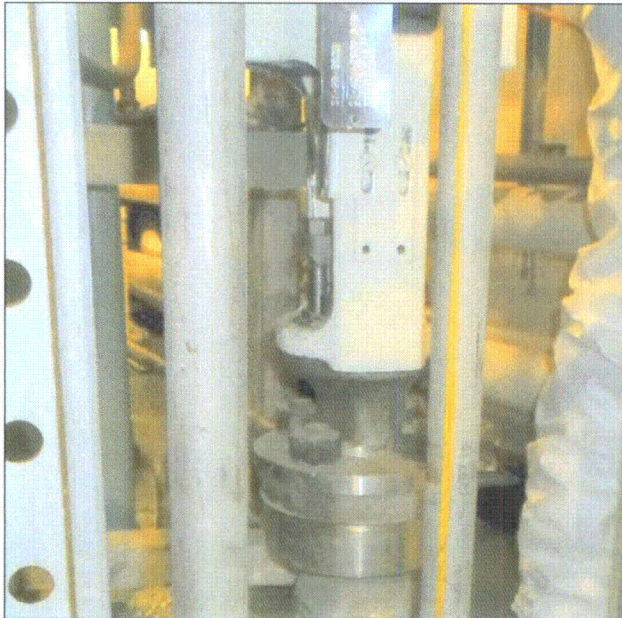
Mild surface corrosion on the valve's bonnet.

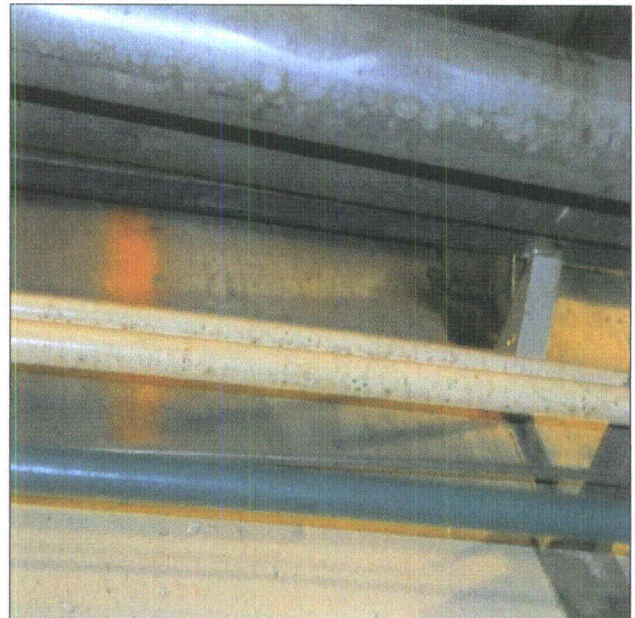
Rust stain on the concrete wall.

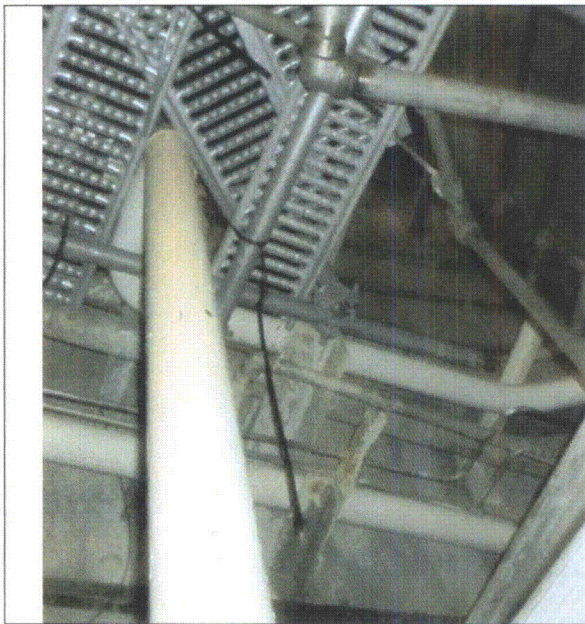
Minor surface corrosion on a angle steel support

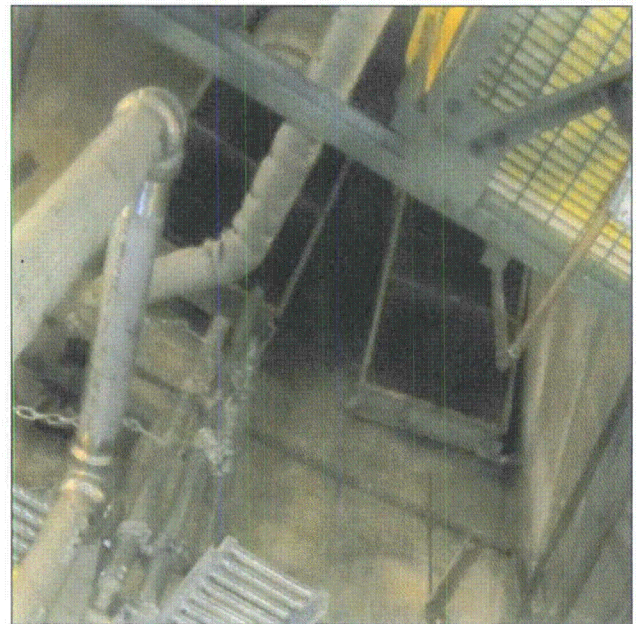
*Duct louvers above have mild surface corrosion.
(See photo)*

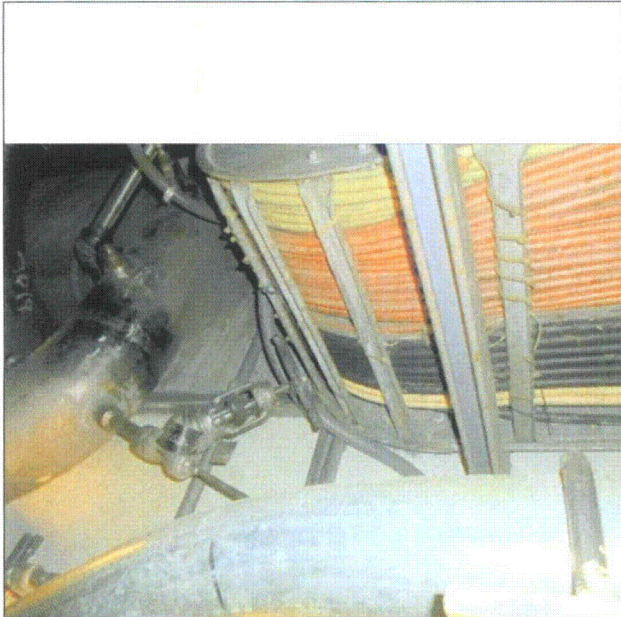
1" spacing between the valve's flywheel and cable tray.

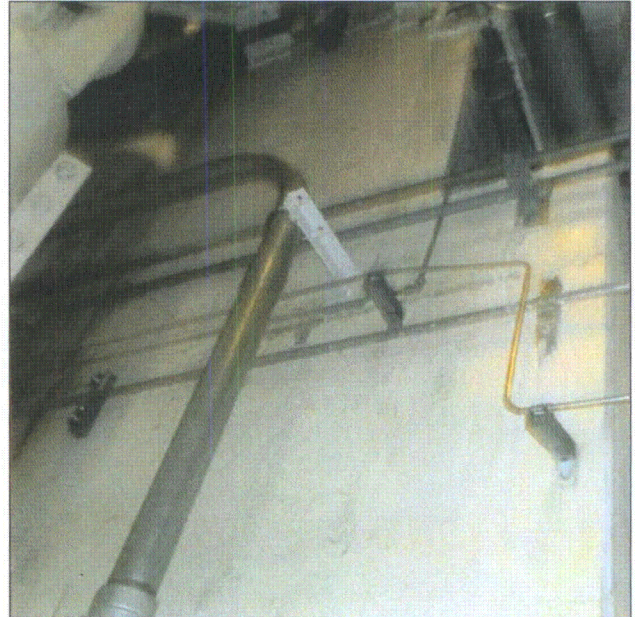
Minor surface corrosion was observed on the Uni-Strut anchorage.
