Monticello Nuclear Generating Plant
2807 W County Road 75
Monticello, MN 55362

Supplemental Information Regarding Cycle 25 Inservice Inspection Summary Report –
Core Shroud Support Flaw Evaluation

**SUPPLEMENTAL INFORMATION REGARDING
CYCLE 25 INSERVICE INSPECTION SUMMARY REPORT –
CORE SHROUD SUPPORT FLAW EVALUATION**

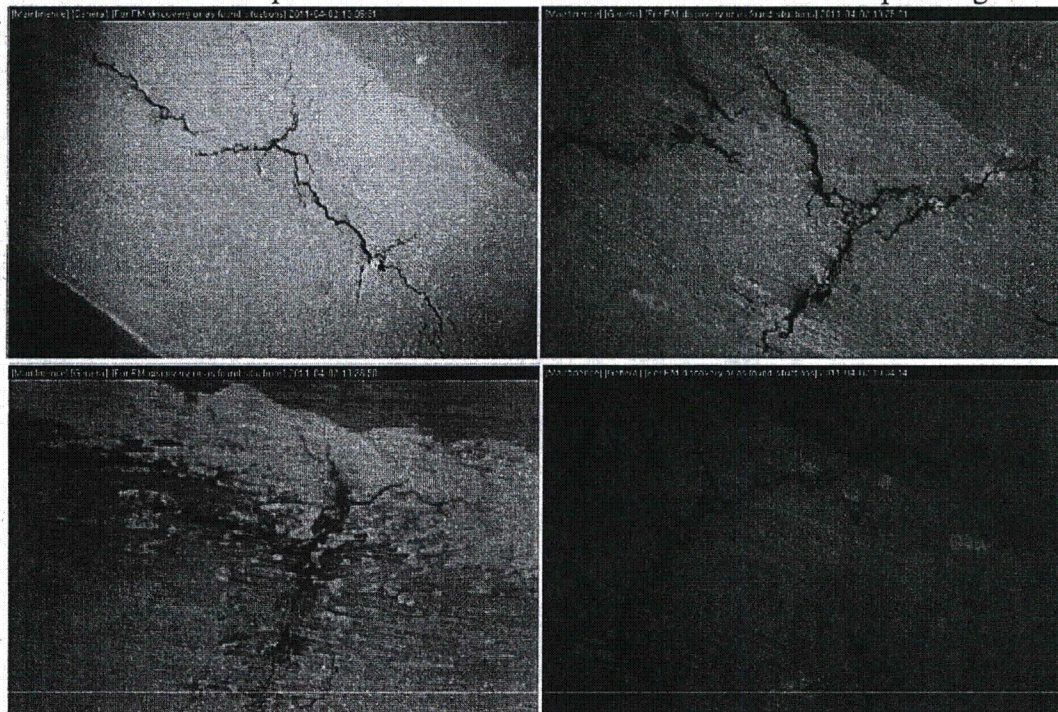
Figure 3: As Found H9 Images

While performing inspection of the H10 weld, the bottom side of the H8 and H9 welds could be seen in the background. This would have been dependant upon camera positioning. With the enhanced camera resolution and the ability to change focal length, indications on the bottom side of the shroud support plate were visible at the H8 and H9 welds. Upon further investigation from jet pump diffuser area, it could be seen that crack like indications were present on the surface of the weld. Below are sample images.

With reference to the as found images of the H9 weld (figure 3), the images present a lack of contrast. Much greater contrast would be expected between the weld metal and the base metal weld with the scale removed from the base metal. The similarity in contrast between the weld metal and base metal would tend to indicate a heavy deposit build up.

While one could surmise that portions of the type of indication seen figure 3 are not present in post scraping images. What cannot be said is that the surface is free of indication. Additionally, if the indications present in figure 3 were being 1) driven by a real surface condition or 2) created an local crevice to act as an ion trap, the surface condition would need further improvement to state the initial indications are no longer present.

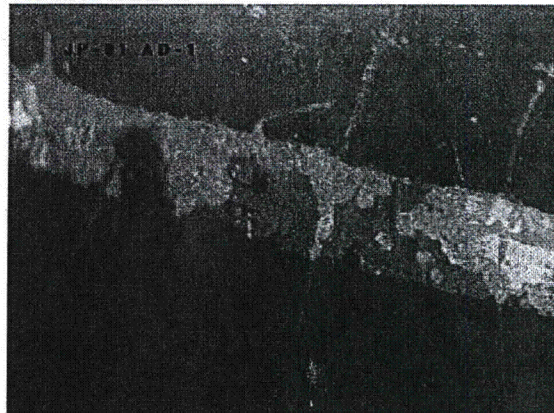
Figure 4: Post Cleaning Images of JP-1 AD-1 weld from 2007

It is well known in the industry that the scale build up on nickel based welds is aggressive and difficult to remove. For example, MNGP did a first time inspection of the AD-1 weld on the jet pumps in 2007. AD-1 is nickel based weld that is machined flush. The presence of scale completely masked its existence. The image is from the data collection video from 2007.

It is plainly visible that the cleaning had an effect at AD-1. Areas adjacent to the weld remain coated with a red oxide layer while a layer of scale is removed on the weld revealing the yellowish hue of the nickel based alloy. A portion of the weld still has areas where the scale intrudes into the weld metal (left half of image above). It can also be seen where the tip of the cleaning tool travelled vertically through the weld area into the base metal. The base metal has a different color than the weld. Lastly, it can be observed that the cleaned area edges are bounded with an irregular interface between the cleaned and uncleaned surfaces. This would tend to indicate scale existed on the surface and removed in brittle flakes.

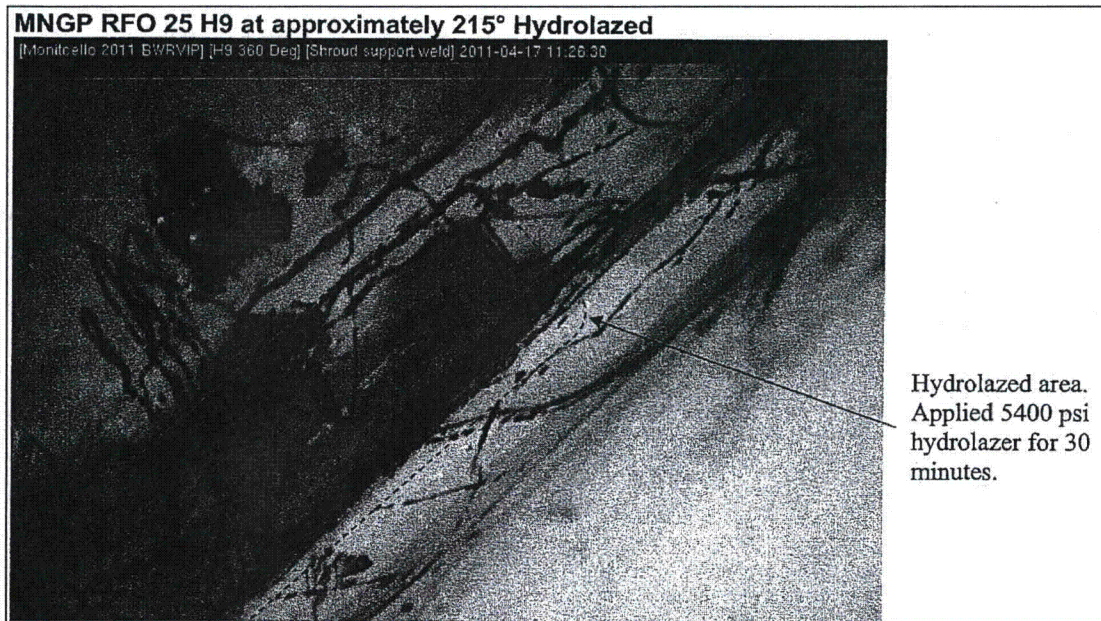
Figure 5: Post Hydrolazing Image from H9

Due to access limitations, a cleaning nozzle similar to the nozzle used on AD-1 was unable to be deployed. A small wand fabricated in stock 1/4" stainless steel Swagelock fittings and stainless steel tubing was used for hydrolazing the bottom side of the H9 weld. The ends of the tubes were open and did not contain "engineered fittings" to enhance the jet forces. The cleaning action from this tool was closer to a high intensity flush rather than a water pick. The image below shows the results of those cleaning actions after 30 minutes in a very isolated area.

While it can be seen there was some effect, the deepening in color would indicate the removal a crud layer. Therefore, the only effect on the surface was the removal of surface deposits.

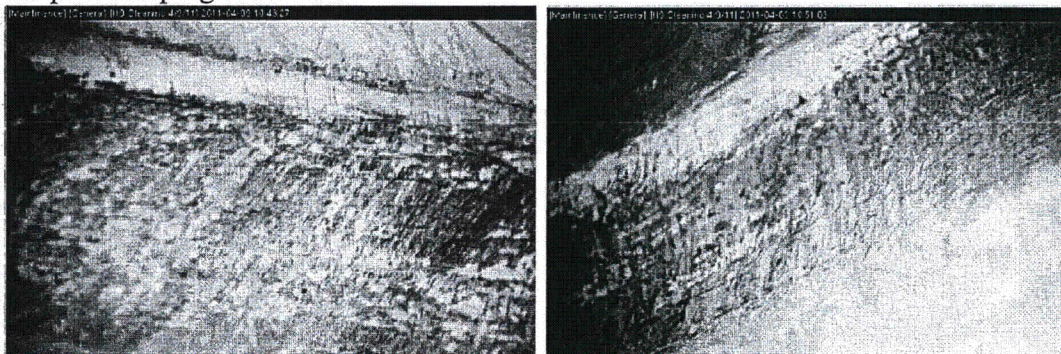
Figure 6: Post Scraping Image of H9 Weld

Another tool was fabricated to attempt to scrape the surface layer of scale from the surface. The tool consisted of a pipe fittings with a nozzle providing thrust to a stainless steel spire. This tool was powered by the hydrolazer pump. The following are images of the post scraping weld area.

While is clear there is an effect on the surface (as was evidenced by the bursts of debris from the surface), the surface condition is not ideal for inspection. The surface is not in a condition that meets the requirements for a surface exam per PEI.02.05.05 (Excerpts below).

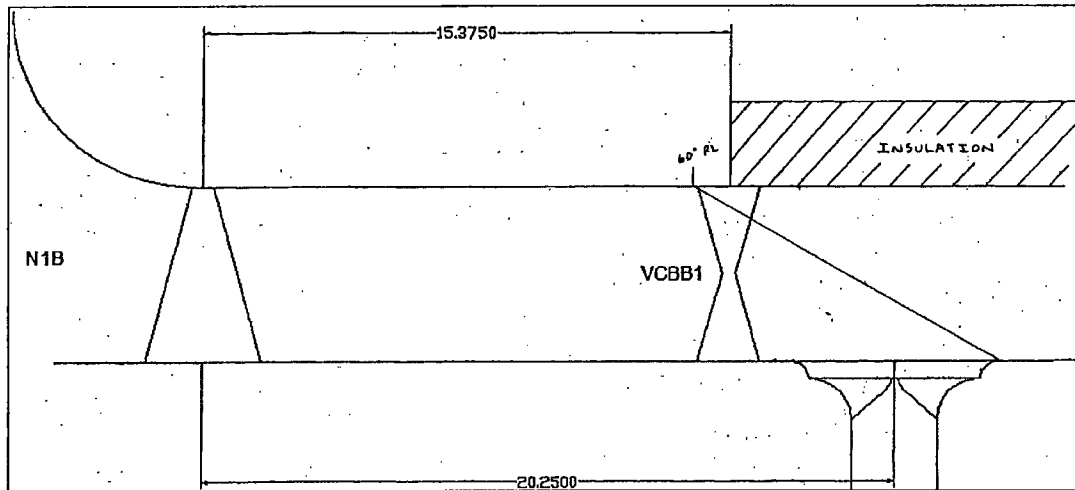
Figure 7: Accessibility of H9 from N1B Nozzle Window

As a means of better understanding the material condition of the H9 weld, UT options were explored. However, MNGP has limited access to the RPV OD adjacent to the H9 welds. Below is a schematic of the access made available by Removable Insulation Panels (RIPs) at the N1B nozzle. Proximity of the vessel welds to the H9 weld was taken from reference 5. (Image rotated 90 degrees CCW from in field configuration).

As-built dimensions were taken for UT inspection accessibility. The gap between in the insulation package and the vessel was measured and is minimal. Relative to the space required by a UT package, there is no gap and therefore vessel OD access adjacent to the H9 is not accessible. Additionally, images taken during the access study show restraining bands around the insulation panels. The affect of removing the banding from the insulation panels were unknown with several courses of insulation remaining stacked on top of the row in question. Due to the risk of collapse, the insulation banding was not removed. There is no ability to force the insulation package from the vessel wall to gain the 3" clearance needed for demonstrated H9 inspection tool. Insulation was removed from N1B window to allow for 72" of lateral access to the reactor vessel surface above the H9 weld and perform the required ISI inspections.

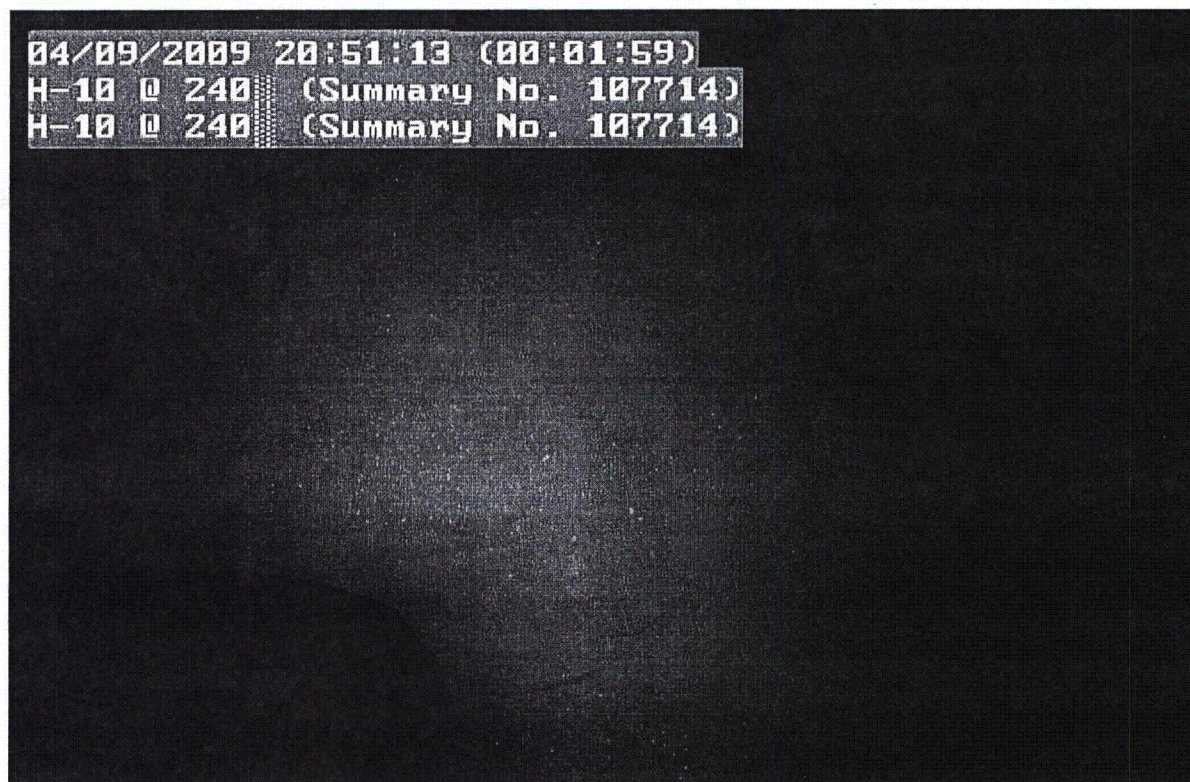
Figure 3. Indication Found in Shroud Support Leg H-10 at 240° [1]

Indications were observed in one or both ends of the H10 welds at the top end of the support legs, Figure 3 [1]. The indication shown in Figure 3 runs across the Alloy 182 fillet weld. However, it is very important to note that these flaws exist in the fillet welds that were installed to reduce the stress between the H10 weld and support cylinder. While full characterization of the indications in the H9, Figure 4, (and H8) weld is not currently available, a recent stress evaluation took no credit for integrity of either of these welds to demonstrate structural acceptability of the shroud [2].

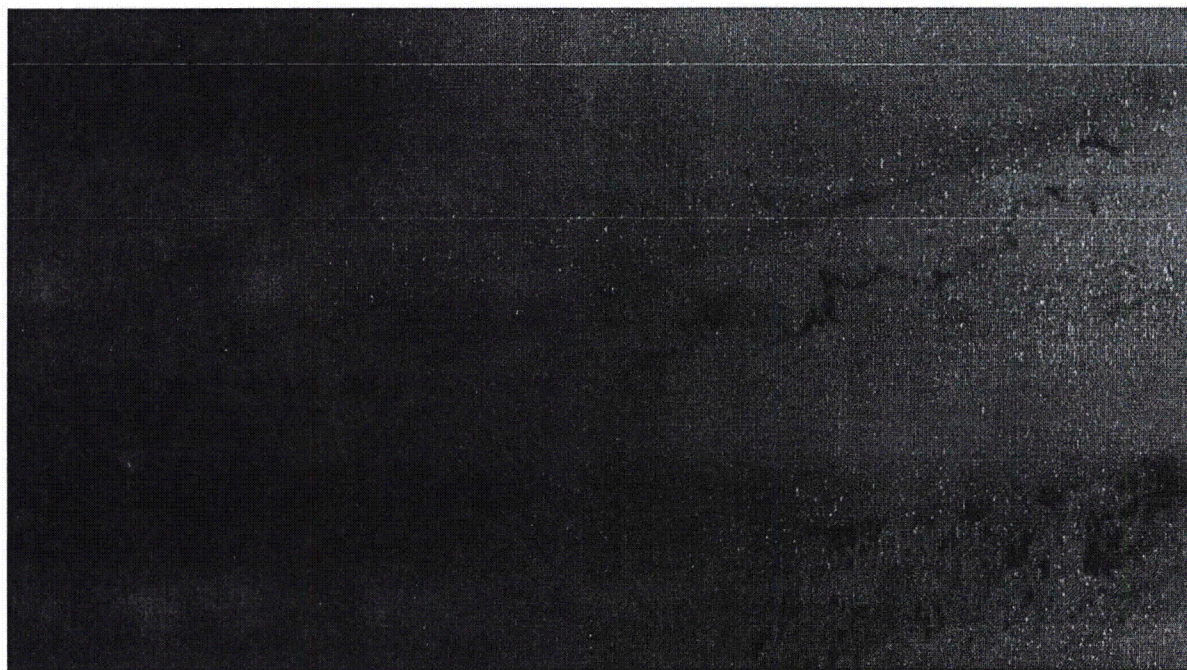
Figure 4. Indications at the H9 Weld

During the spring 2011 inspections of the reactor internals at the Monticello BWR, Xcel Energy visually discovered indications at the H8 (shroud support-to-shroud) weld and the H9 (shroud support-to-vessel) weld as shown in Figures 1 and 2. Previously, in spring 2009, indications had been observed in 11 of the 14 shroud support legs. Monticello is a BWR-3 and fabricated by CB&I. For this vessel, the H8 and H9 welds are full penetration double V welds. Figure 2 shows a schematic of the configuration for Monticello [11, Figure 5-59]. The indications observed were located on the bottom side of the shroud support plate thus exposing them to the water environment of the lower plenum.

Because of the proximity of the indications at the H9 weld to the vessel, although unlikely, the potential impact of propagation into the vessel must be considered. This letter report provides a qualitative discussion as to why the impact of these indications on the reactor pressure vessel is not a concern. The evaluation considers the material characteristics, inspection information, fracture mechanics and stress information to justify the conclusion.

Continued monitoring of the indications during future operation will provide assurance that the cracking is minimal.
