UNITED STATES
NUCLEAR REGULATORY COMMISSION
OFFICE OF NUCLEAR REACTOR REGULATION
OFFICE OF NEW REACTORS
WASHINGTON, DC 20555-0001

NRC INFORMATION NOTICE 2013-17: SIGNIFICANT PLANT TRANSIENT INDUCED BY
SAFETY-RELATED DIRECT CURRENT BUS
MAINTENANCE AT POWER

Palisades Nuclear Plant

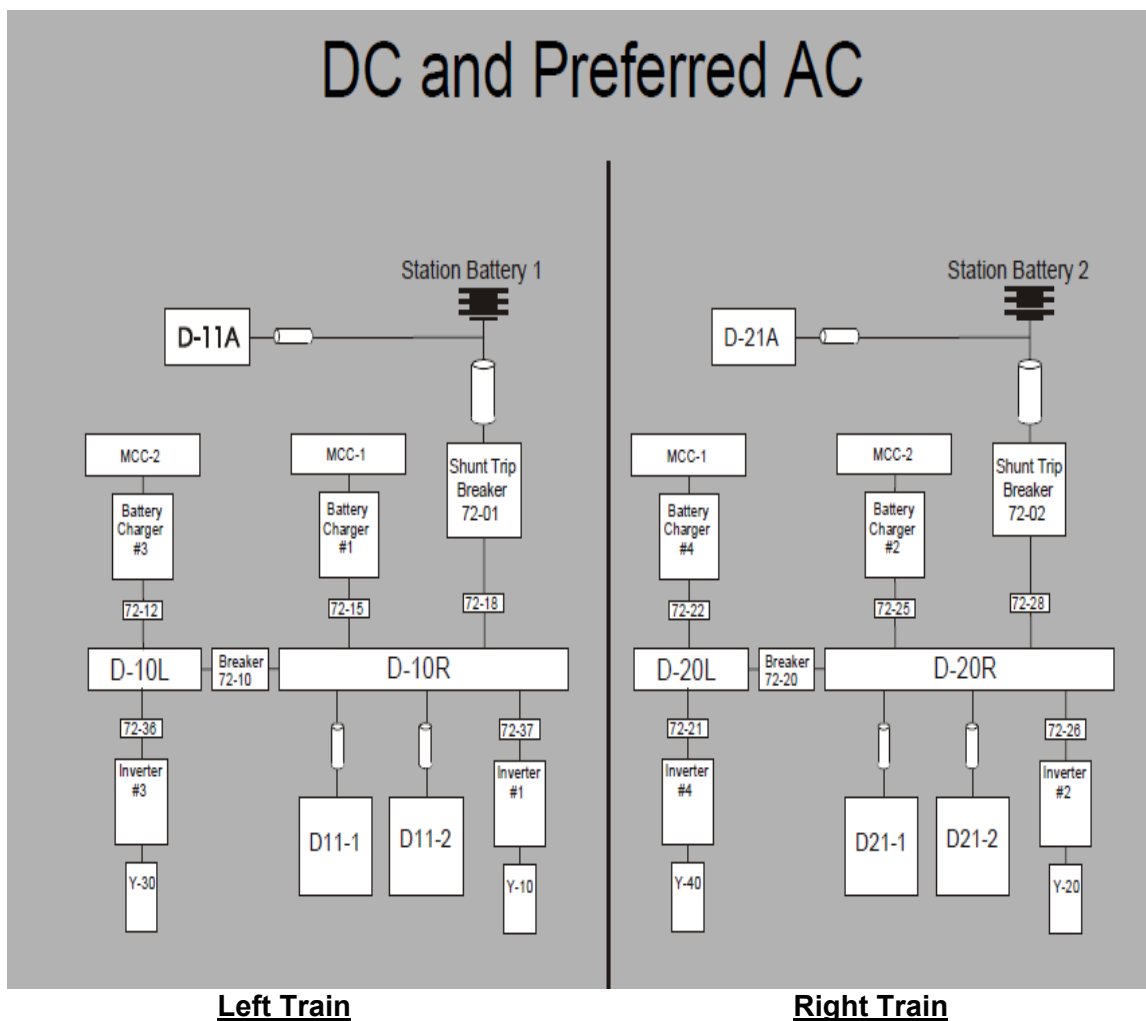
Palisades Nuclear Plant was operating in Mode 1 at approximately 98 percent power on September 25, 2011. An electrician was performing maintenance on the energized left train 125-volt DC distribution Panel D11-2 (reference figure on next page). While in the process of removing a breaker bus connector in safety-related Panel D11-2, without proper insulation of adjacent bus connectors, a maintenance technician inadvertently lost control of the energized positive copper bus connector, which swung down and contacted the negative copper bus connector. This resulted in an electrical fault in the panel and upstream shunt trip Breaker 72-01 (between the DC bus and the battery) opened on over-current, disconnecting the battery from the DC bus. By design, the fuse to Panel D11-2 was expected to isolate Panel D11-2 from the entire DC bus upon a fault in Panel D11-2. However, the shunt trip breaker was incorrectly installed in 1981 with thermal and instantaneous over-current protection features (latent design issue) and the over-current breaker trip device was at a current setting lower than the fuse current rating. Therefore, the shunt trip breaker opened quicker than the fuse could isolate the fault in Panel D11-2 and the entire left train 125-volt DC bus was lost (reference figure below).

The electrical transient resulted in the failure of the in-service left train battery charger and associated left train inverters. This led to the loss of two preferred 120-volt alternating current (AC) power sources (busses Y-10 and Y-30) that supply power for the left train of annunciation and instrumentation in the control room. The failure resulted in the operators having only the right train of equipment available for annunciation and instrumentation in the control room.

The loss of the left train 125-volt DC bus and two preferred AC power sources resulted in an instantaneous reactor and turbine trip caused by a reactor protection system actuation. These trips were coincident with the automatic actuation of the following systems and components: a safety injection actuation signal (automatically started right train emergency core cooling systems); main steam isolation signal (closed main steam isolation valves and main feedwater regulating valves); containment high radiation signal (switched control room heating, ventilation, and air conditioning system to emergency mode); containment isolation signal (closed left channel containment isolation valves); auxiliary feedwater (AFW) actuation signal (started one motor driven AFW pump and the turbine driven AFW pump with full flow); and a containment high pressure alarm (no actuation signal). The protection circuitry actuated as a result of the loss of the left train of DC power and was not required to mitigate a degraded or abnormal
