UNITED STATES
NUCLEAR REGULATORY COMMISSION
OFFICE OF NUCLEAR REACTOR REGULATION
OFFICE OF NEW REACTORS
WASHINGTON, DC 20555-0001

September 6, 2013

NRC INFORMATION NOTICE 2013-17: SIGNIFICANT PLANT TRANSIENT INDUCED BY
SAFETY-RELATED DIRECT CURRENT BUS
MAINTENANCE AT POWER

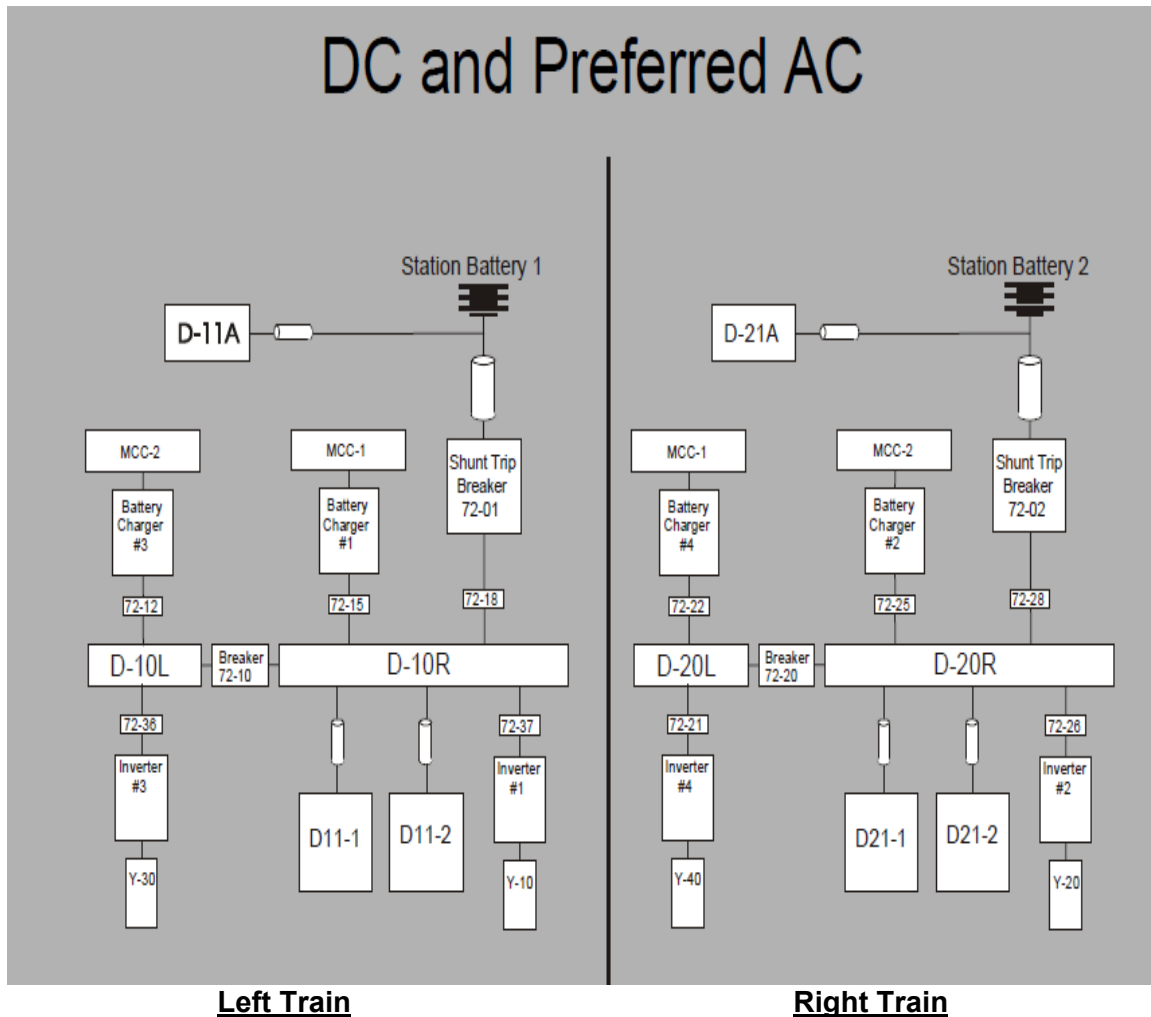
Palisades Nuclear Plant was operating in Mode 1 at approximately 98 percent power on September 25, 2011. An electrician was performing maintenance on the energized left train 125-volt DC distribution Panel D11-2 (reference figure on next page). While in the process of removing a breaker bus connector in safety-related Panel D11-2, without proper insulation of adjacent bus connectors, a maintenance technician inadvertently lost control of the energized positive copper bus connector, which swung down and contacted the negative copper bus connector. This resulted in an electrical fault in the panel and upstream shunt trip Breaker 72-01 (between the DC bus and the battery) opened on over-current, disconnecting the battery from the DC bus. By design, the fuse to Panel D11-2 was expected to isolate Panel D11-2 from the entire DC bus upon a fault in Panel D11-2. However, the shunt trip breaker was incorrectly installed in 1981 with thermal and instantaneous over-current protection features (latent design issue) and the over-current breaker trip device was at a current setting lower than the fuse current rating. Therefore, the shunt trip breaker opened quicker than the fuse could isolate the fault in Panel D11-2 and the entire left train 125-volt DC bus was lost (reference figure below).

The electrical transient resulted in the failure of the in-service left train battery charger and associated left train inverters. This led to the loss of two preferred 120-volt alternating current (AC) power sources (busses Y-10 and Y-30) that supply power for the left train of annunciation and instrumentation in the control room. The failure resulted in the operators having only the right train of equipment available for annunciation and instrumentation in the control room.

The loss of the left train 125-volt DC bus and two preferred AC power sources resulted in an instantaneous reactor and turbine trip caused by a reactor protection system actuation. These trips were coincident with the automatic actuation of the following systems and components: a safety injection actuation signal (automatically started right train emergency core cooling systems); main steam isolation signal (closed main steam isolation valves and main feedwater regulating valves); containment high radiation signal (switched control room heating, ventilation, and air conditioning system to emergency mode); containment isolation signal (closed left channel containment isolation valves); auxiliary feedwater (AFW) actuation signal (started one motor driven AFW pump and the turbine driven AFW pump with full flow); and a containment high pressure alarm (no actuation signal). The protection circuitry actuated as a result of the loss of the left train of DC power and was not required to mitigate a degraded or abnormal

Several operating experience lessons learned for emergent safety-related work on plant equipment were identified as a result of this plant transient. The following are applicable to all NRC licensees:

- In-field, engaged management oversight that reinforces worker behaviors and approved procedures is critical when working safely on risk significant, safety-related equipment.

- Ensure operations procedures exist for the response to all design basis events and licensed operators are trained on those scenarios as part of initial or continuing training.

- All employees are essential and responsible for ensuring work control processes and procedures are followed for all aspects of a maintenance evolution including work order planning, pre-job brief level determination, operational risk assessment of the work to be performed, conducting pre-job briefs and in-field changes to work orders or procedures.

- Noncovered nuclear workers (i.e., not covered under 10 CFR Part 26, "Fitness for Duty Programs"), including department-level managers and above, are required to follow applicable work hour guidance for noncovered workers as prescribed in licensee procedures.

- Before performing maintenance activities, an effective operational risk assessment typically includes worse-case scenarios, the importance of the work, and specified measures for working safely on risk significant equipment.
