SUBJECT: **Calvert Cliffs Nuclear Power Plant, Unit 2**
Renewed Facility Operating License No. DPR-69
Docket No. 50-318

Supplemental Response to 10 CFR 50.54(f) Request for Information,
Recommendation 2.3, Seismic

**IN RESPONSE TO THE 50.54(f) INFORMATION
REQUEST REGARDING
FUKUSHIMA NEAR-TERM TASK FORCE
RECOMMENDATION 2.3: SEISMIC**

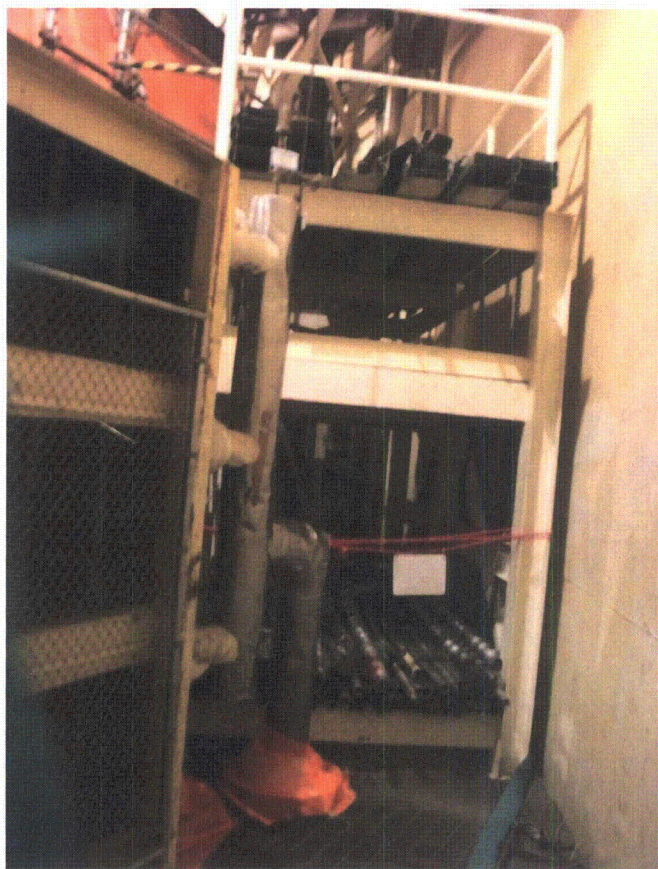
Scaffold Rack near 21 Containment Air Cooler EL. 45-FT
Screens are temporarily attached to the Cooler Housing to protect their coils during outages.

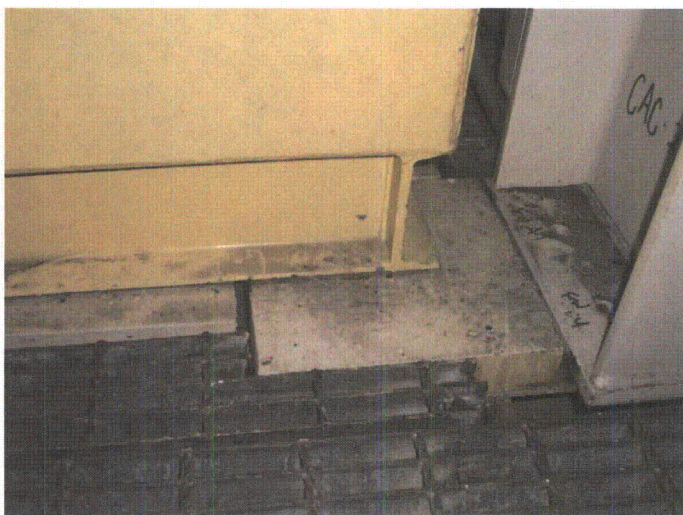
Missing welds from 21 Iodine Removal Unit base

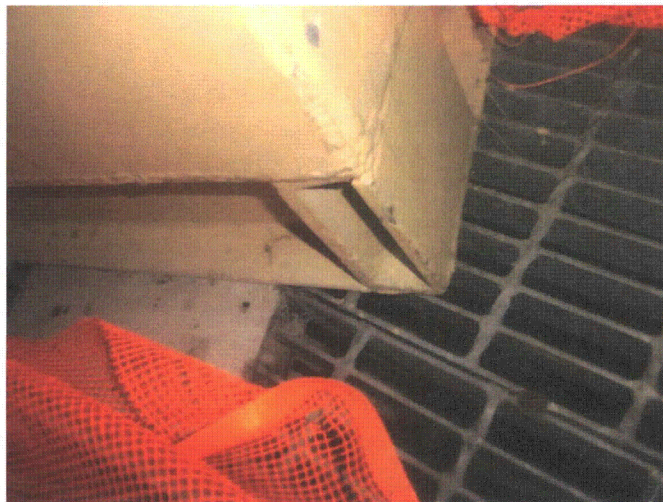
Missing welds from 23 Iodine Removal Unit base
