NRC Internet Event Briefing

**Palisades SIRWT Leak Repair and
Inspections**

July 16, 2013

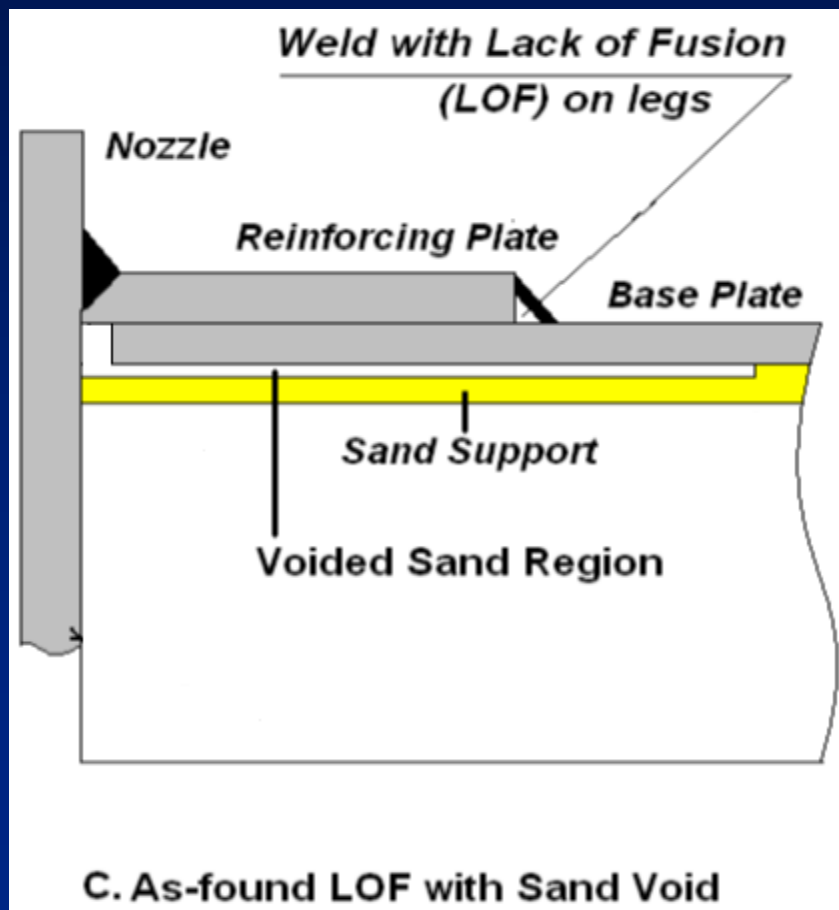
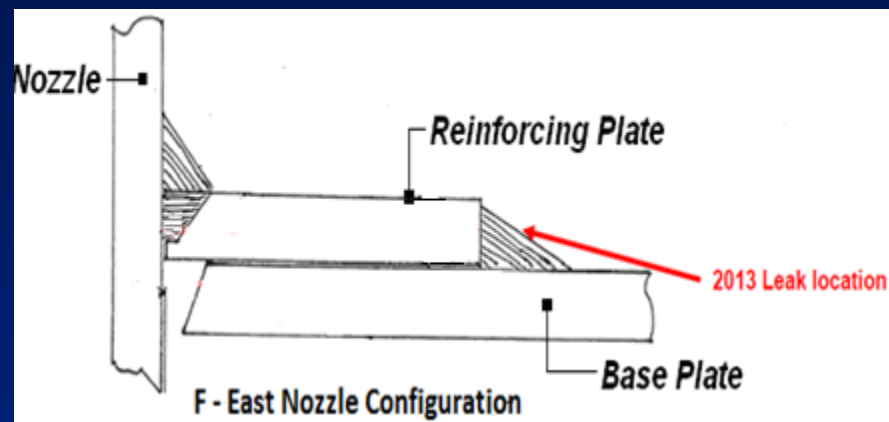
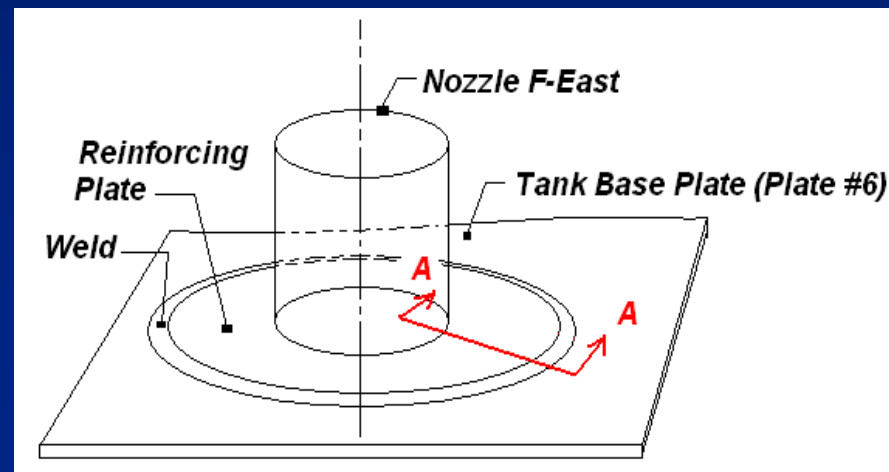
Licensee determined the root cause of the SIRWT leak to be a failure of a nozzle weld resulting from an inadequate fusion at the weld root, i.e., a poorly performed weld from 2012

- The NRC reviewed the following actions by the Licensee:
 - Tank bottom replacement
 - Replacement of all welds associated with the floor inside the tank
 - Nozzle replacement
 - Installed a layer of fiber board between the concrete slab and new aluminum plating
