NRC Internet Event Briefing

Palisades SIRWT Leak Repair and
Inspections

July 16, 2013

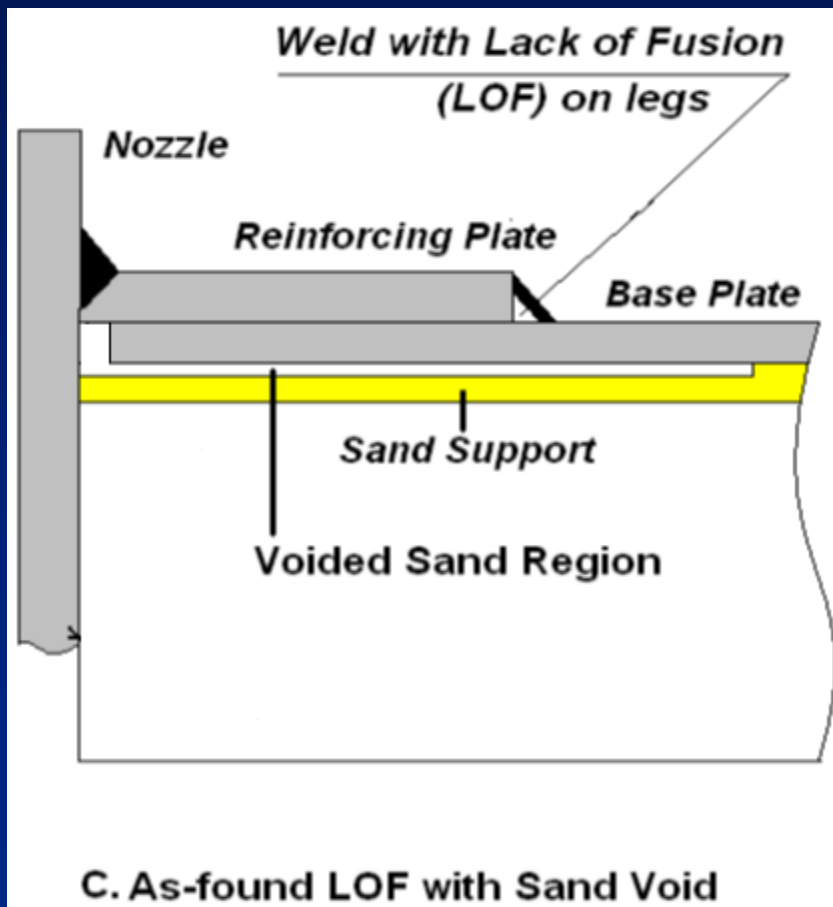
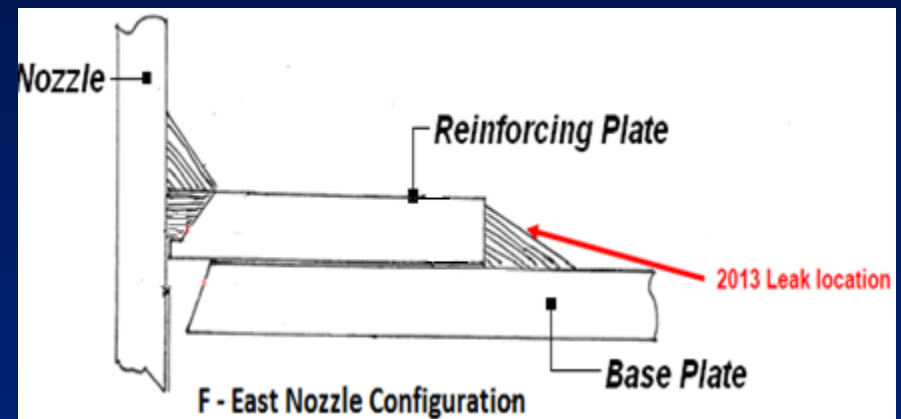
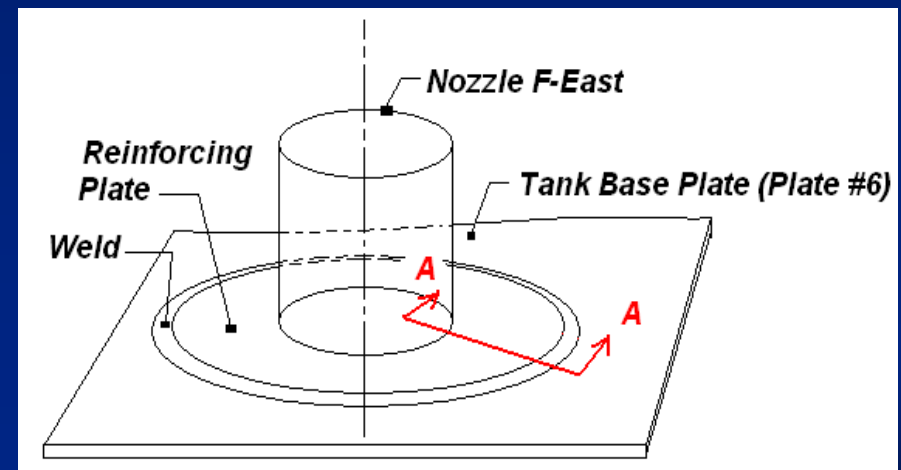
Licensee determined the root cause of the SIRWT leak to be a failure of a nozzle weld resulting from an inadequate fusion at the weld root, i.e., a poorly performed weld from 2012

- The NRC reviewed the following actions by the Licensee:
 - Tank bottom replacement
 - Replacement of all welds associated with the floor inside the tank
 - Nozzle replacement
 - Installed a layer of fiber board between the concrete slab and new aluminum plating
