Map Panel Georectification Process

WILLIAM STATES LEE III NUCLEAR STATION UNITS 1 & 2

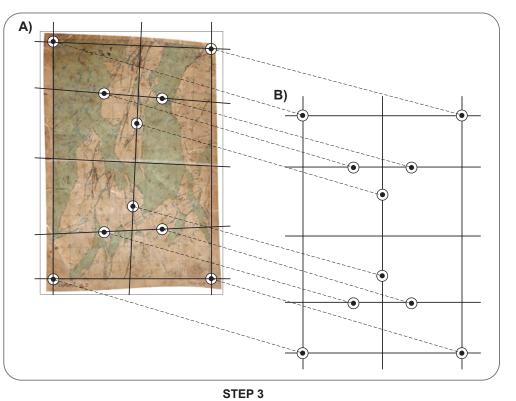
Map panel scan (A) referenced to coordinates in geographic space (B) to eliminate distortions during archiving and scanning

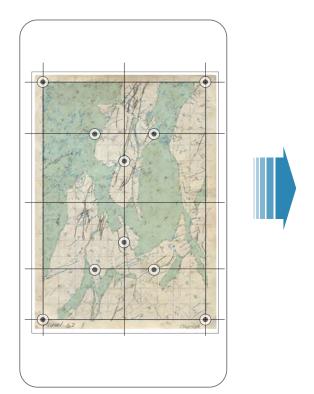
STEP 4
Georectified scan of CNS hand-drawn
11"x17" vellum map panel
(IMG 62_CK10-10B_GR.tiff)

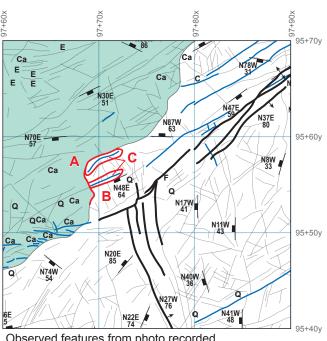
Mapped Features from Panel 52 (CK10-07D) Observed in Photograph

Contact between mafic gneiss and felsic gneiss with quartz veins. 6" ruler for scale.

Observed features from photo recorded on digitized map Panel 52, CK10_07D

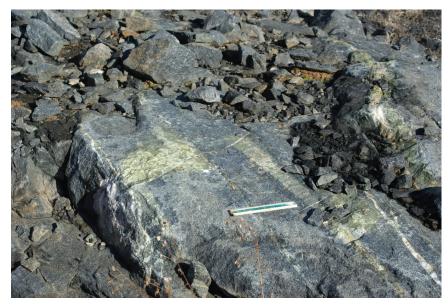
Typical mafic gneiss with calcite and epidote infilled joints. 6" ruler for apporixmate scale. View towards north, January 19, 2011.

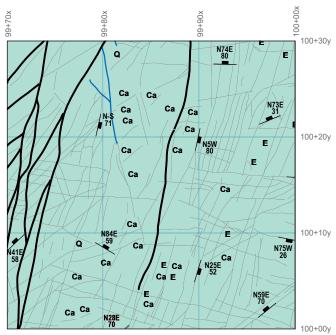
Mapped Features from Panel 63 (CK10-10A) Observed in Photograph

Calcite and epidote infilled joints observed on digitized map Panel 63, CK10_10A

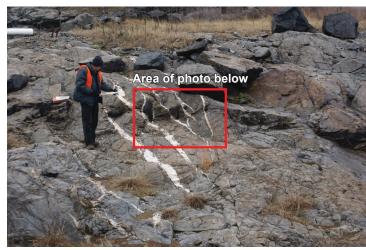
Photograph of foundation rock (felsic gneiss) observed in Panel 72, CK10_11A. View towards southwest, January 19, 2011.

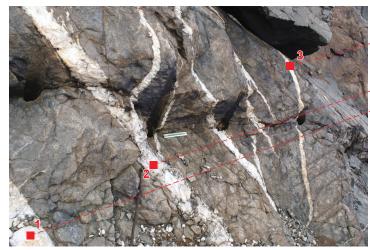
Observed quartz veins. View towards southwest, January 19, 2011.
