Global Nuclear Fuel

SPM 13-036

Subject: Addendum to GNF-A10 CFR 71.95 Report Dated 6/15/12 – UX-30 Certificate Condition Not Followed

Attachment 1
10 CFR 71.95- Type B Transportation Package Report (USA/9196/B(U)F-96)

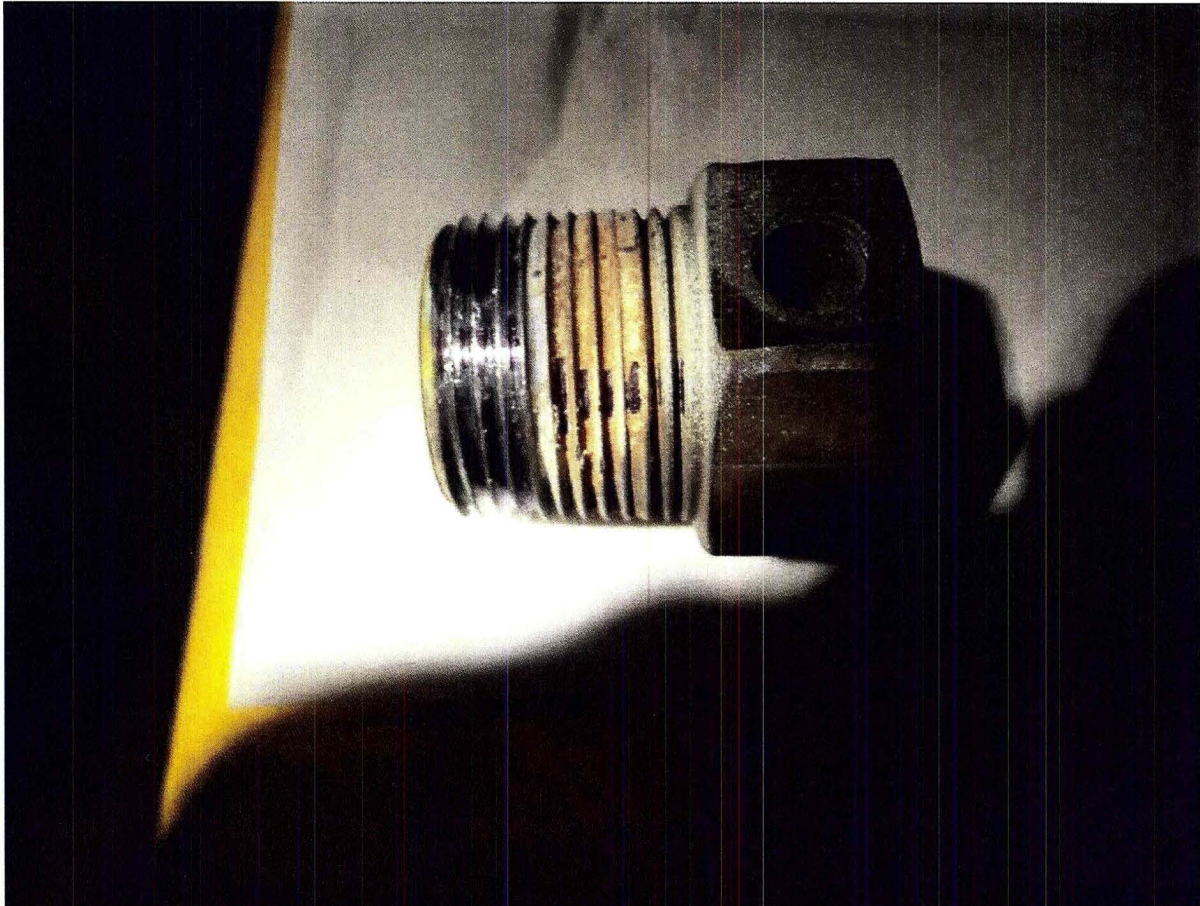
Removed Plug from GEW357

After UF₆ removal, the cylinder contains approximately 2 kg or less of solid low enriched uranium hexafluoride "heel" material and was last shipped by GNF-A to USEC in 2010 for re-filling. There was no indication of any leakage of UF₆ from this cylinder on receipt. Photographs taken of the removed plug from cylinder GEW357 indicated between 4 and 5 threads had been engaged. The plug had been stamped to indicate it had 10 threads.

According to AREVA NP, the cause has been determined to be a non-conservative plug thread marking process in that the technique used to mark the fifth thread on the plug did not guarantee that five full threads would actually be engaged when the plug was installed in the cylinder.

During these shipments, there were no indications of uranium hexafluoride leakage from the plug thread engagement area. Even though the plug thread engagement was slightly less than five threads, the plug installation performed its intended safety function and there were no safety consequences.

1. Cylinder GEW357 was taken out of service and sent to AREVA NP on February 20, 2013 for re-certification.
2. GNF-A has opened a condition report (CR) to document further communications needed to the cylinder service provider (AREVA NP) and to document the re-certification of the cylinder.

3. GNF-A has been advised by its cylinder recertification services supplier of corrective actions that are designed to address the cylinder plug installation concerns. (According to AREVA NP, at the time when this cylinder was recertified a new plug was not installed and the plug thread engagement was not verified; this practice was changed after the valve thread engagement issue was first identified by USEC in April 2011.)
