**NETCO Report NET-30054-01, Revision 0
"Inspection and Testing of Fast Start Surveillance Coupons F22-F11
from the LaSalle County Unit 2 Station"**

**Inspection and Testing of Fast Start
Surveillance Coupons F22-F11 from the
LaSalle County Unit 2 Station**

January 2013

Prepared
for
Exelon Generation

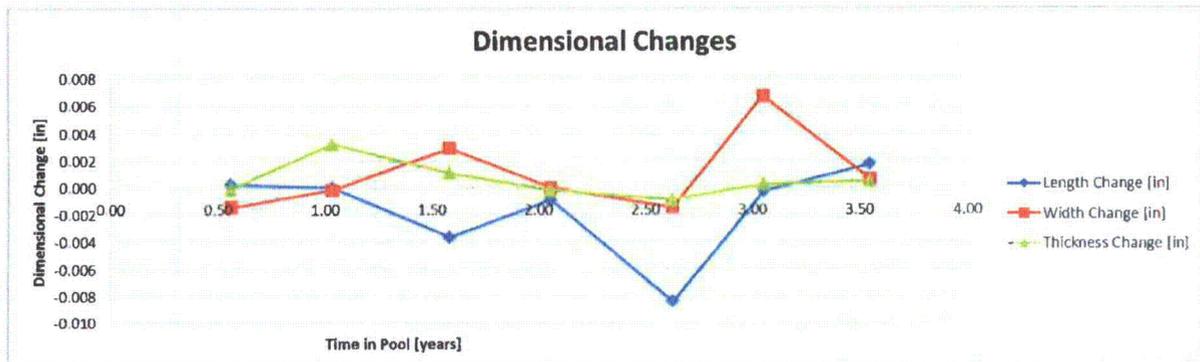
Figure 3-1- Graphical display of pair averaged dimensional changes over SFP exposure time.

Changes in the dimensional measurements were minimal. Since the changes are small and vary between losses and gains with no particular pattern, it is reasonable to assume that for lengths and widths this variance is likely due to roughness of the coupon edges and slight variation in the location at which the measurements were taken. The variation in the change of the thickness is due to the use of the nominal "as rolled" material thickness for the pre-irradiated thickness measurement. These changes in the thickness thus represent variation in rolling, and show that there was no significant material loss.

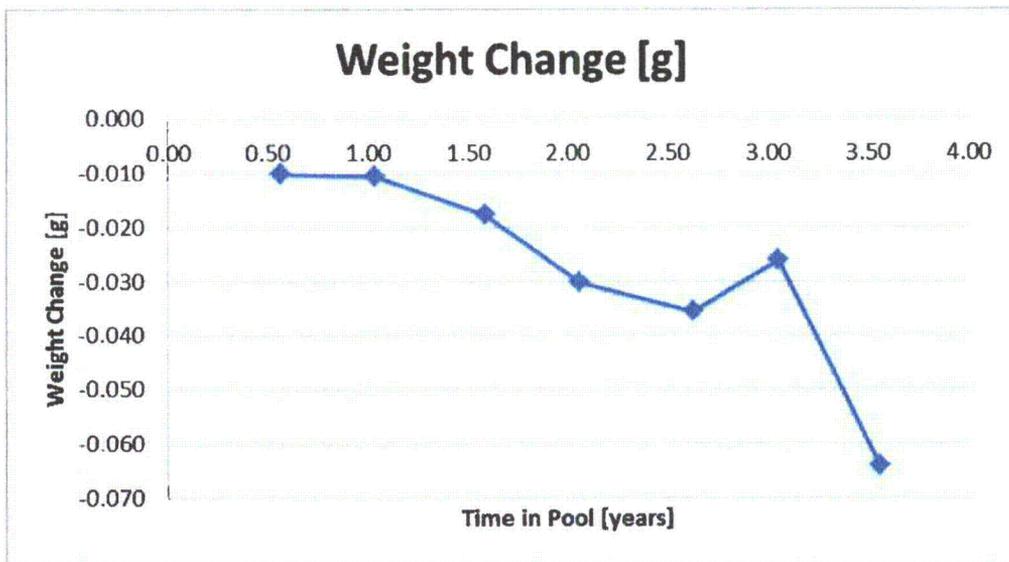
Figure 3-2- Graphical display of the pair averaged weight change for each coupon pair over SFP exposure time.

Since the fast start coupons are fully dense (negligible porosity), they were dried for 1 hour at 220° F to remove surface moisture. Coupons were then washed in Nitric Acid to remove only the corrosion products and leave the base metal undamaged. The weight was then again taken. This “clean weight” is the weight measurement used to compare to pre-irradiation weight. There has not been a large loss in coupon weight, but as expected the coupon weight loss increases with the duration of the test.

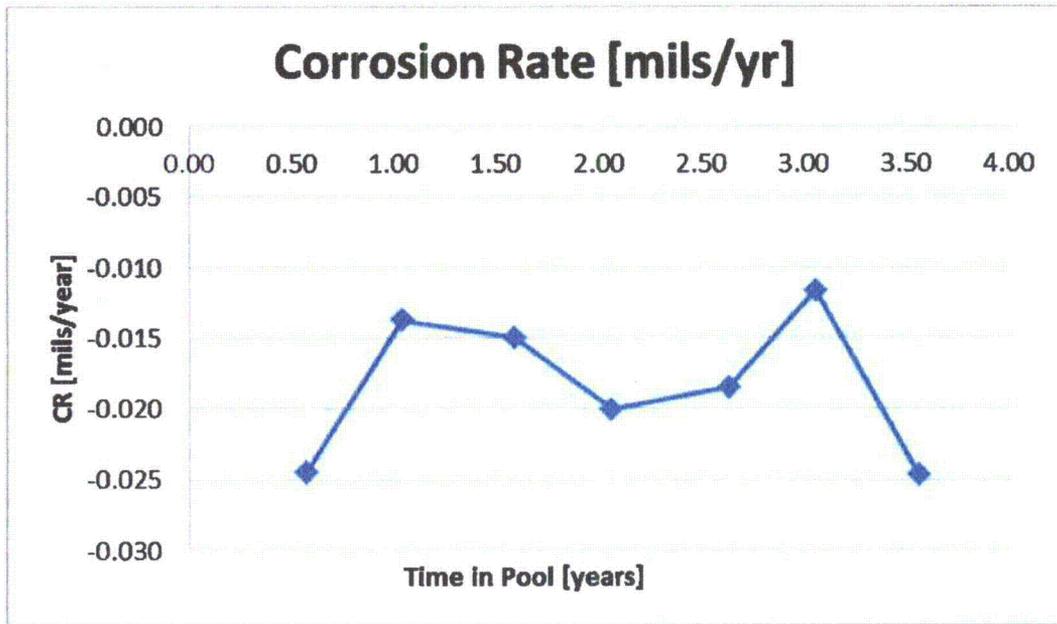
Figure 3-3 Graphical display of coupon corrosion rates over the SFP exposure time.

These corrosion rates are extremely low and confirm the visual observation that all coupons were essentially devoid of corrosion products. Though the corrosion rate varies, it varies only slightly and is consistent over the period of SFP exposure. The average corrosion rate of -0.018 mils/yr is lower than the corrosion rate as determined from accelerated corrosion testing at 195° F, performed during RTA material qualification testing NET-259, RTA Material Qualification [2].

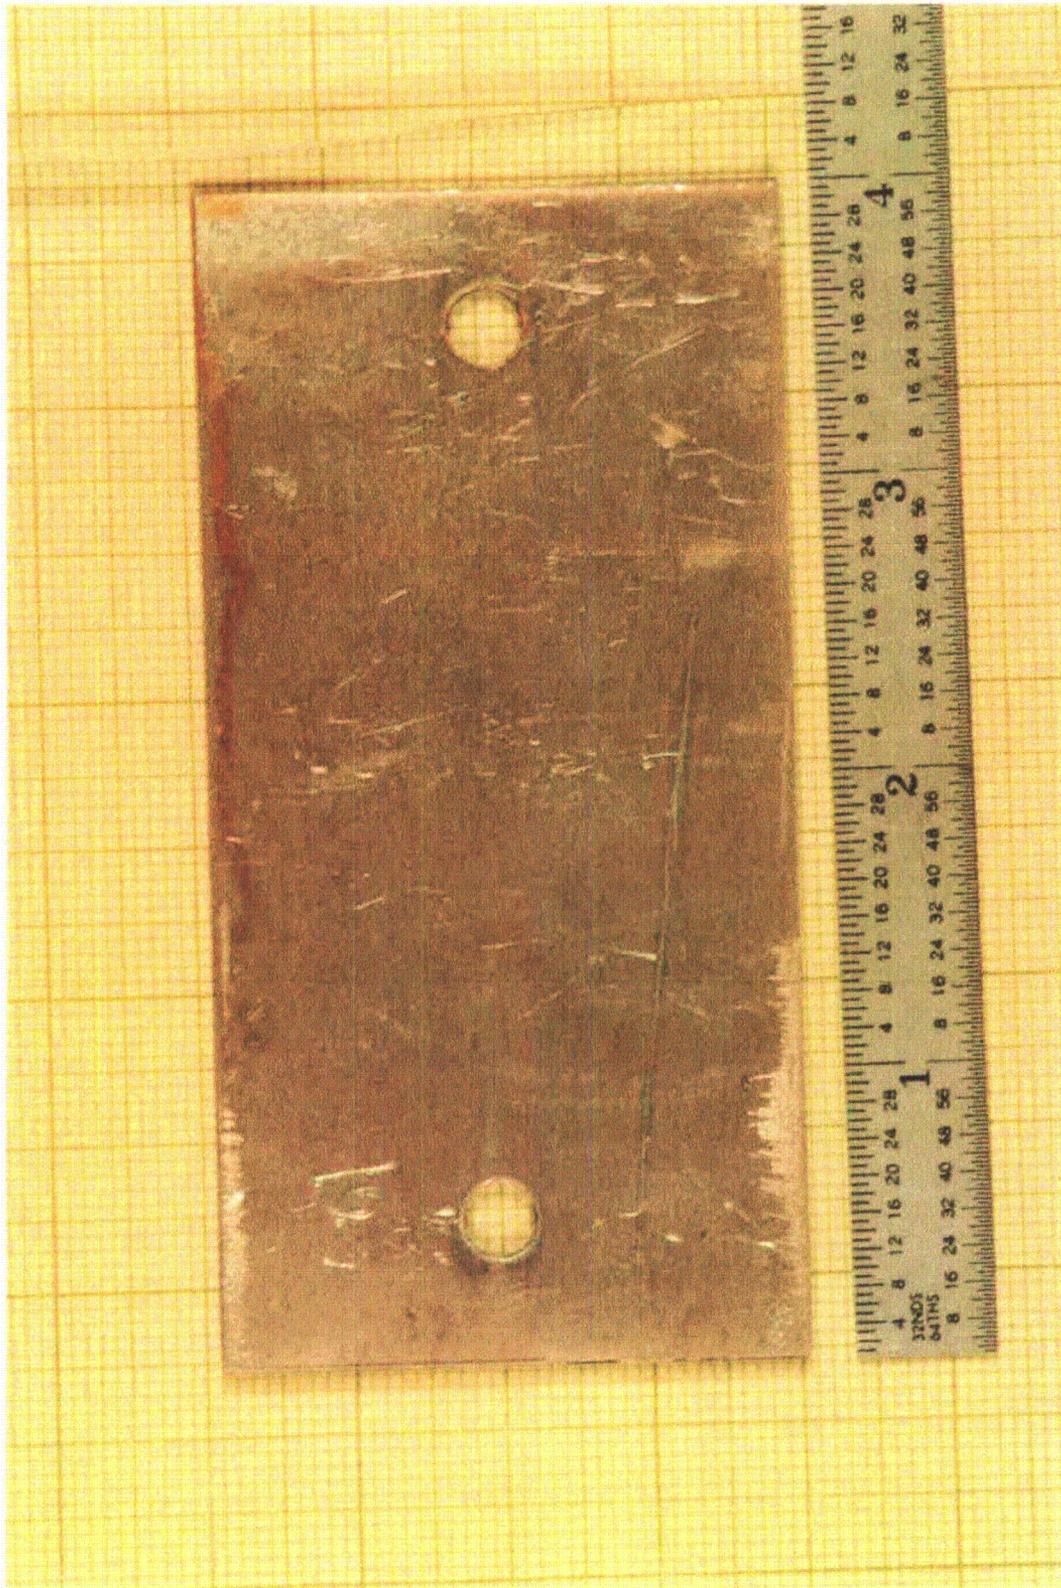
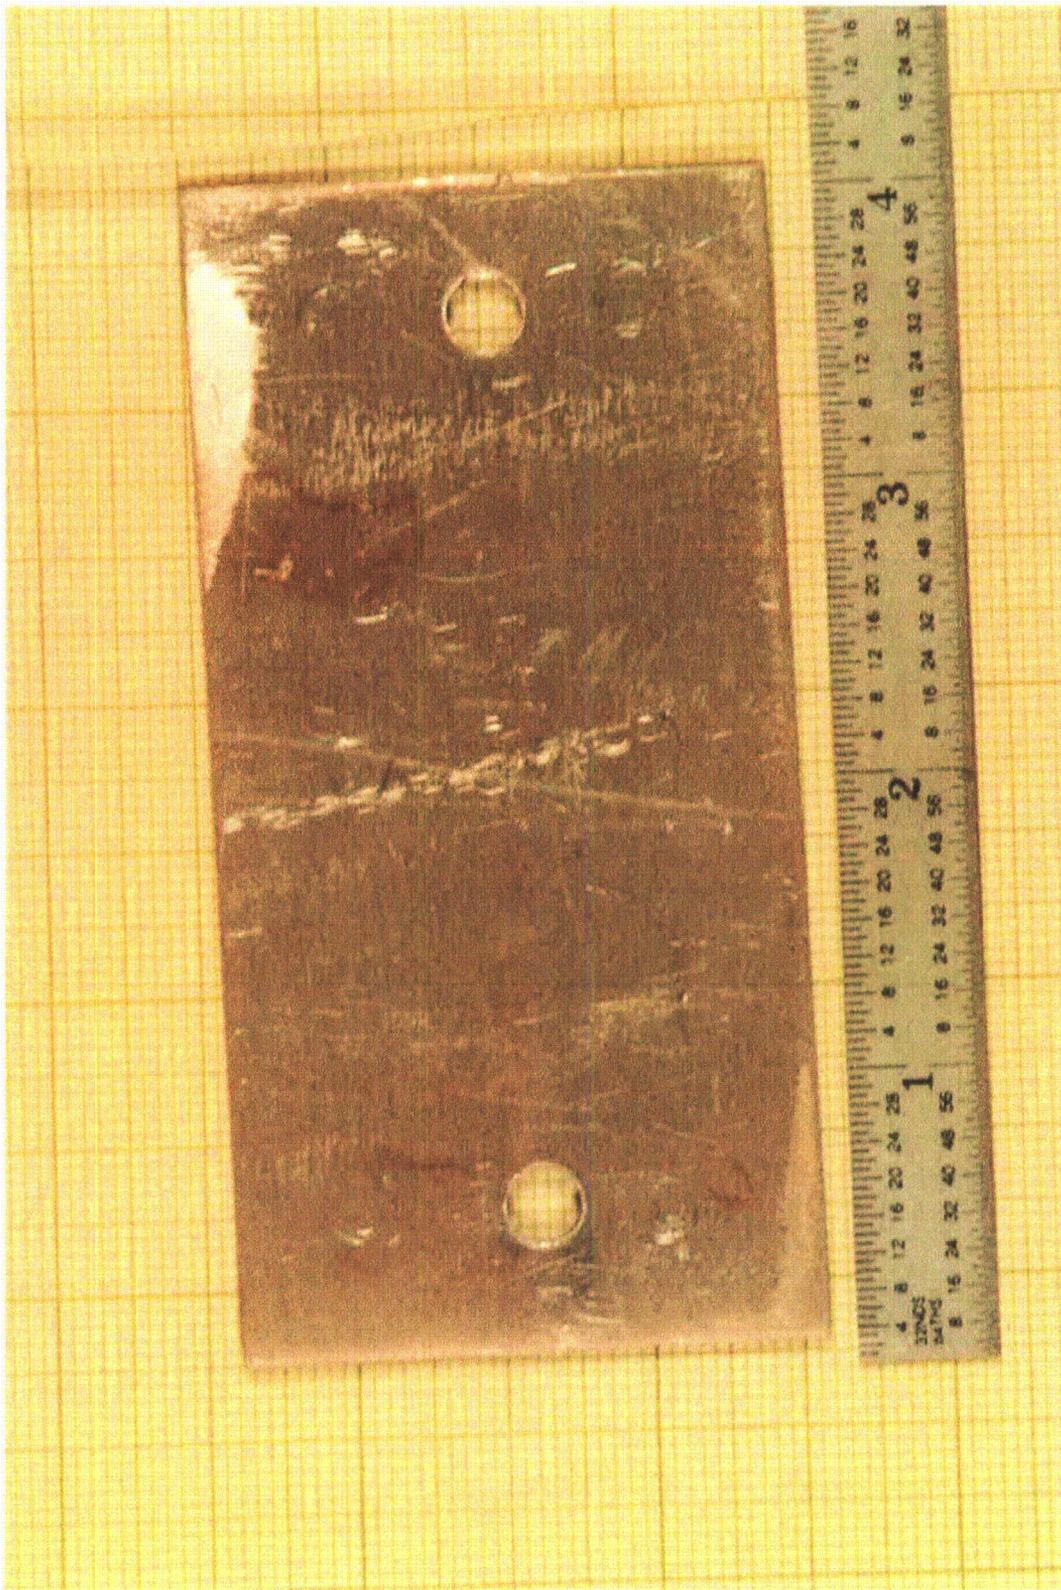
F22	<p>General: The ID F22 is inscribed in the upper right corner of the front side. The coupon is fully intact and is in pristine condition. There is no evidence of a light colored oxide film when viewed with the naked eye or under a microscope. Coupon F22 is similar in appearance to coupon F21. Coupon F22 is darker and less reflective than archive coupon FA4.</p> <p>Front side: The background color of this side is a medium grey. Against this background there are some scratches that appear lighter.</p> <p>Back side: The back side appears similar to the front with different scratch patterns.</p>
F21	<p>General: The inscription F21 appears in the upper right corner of the front side. The coupon is intact and is in pristine condition. To the naked eye there is no evidence of a corrosion film. F21 appears slightly darker and reflects less light than archive material not exposed to the pool water. Examination under a microscope showed no evidence of a light colored oxide. Side-by-side microscopic examination indicates the archive coupon is more reflective than F21.</p> <p>Front Side: The color of this side is uniform except where there are scratches where the color is lighter.</p> <p>Back Side: The appearance of the back side is similar to the front side.</p>

Photo 1- F22 Front View

Photo 2- F22 Back View

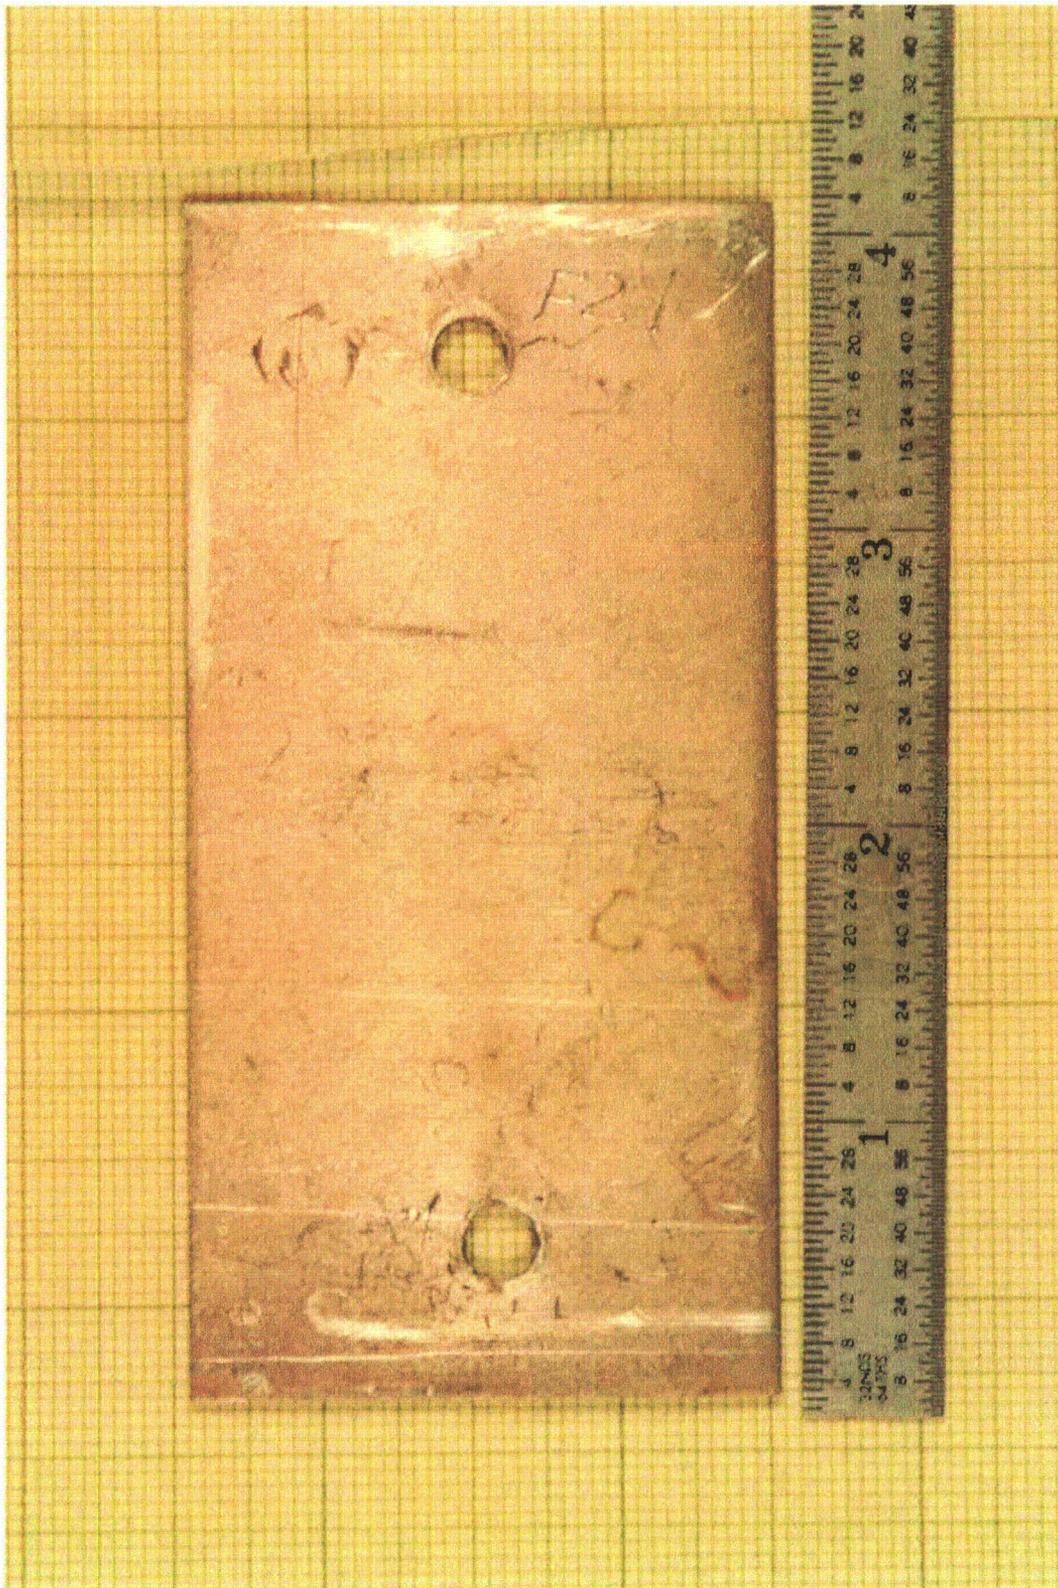
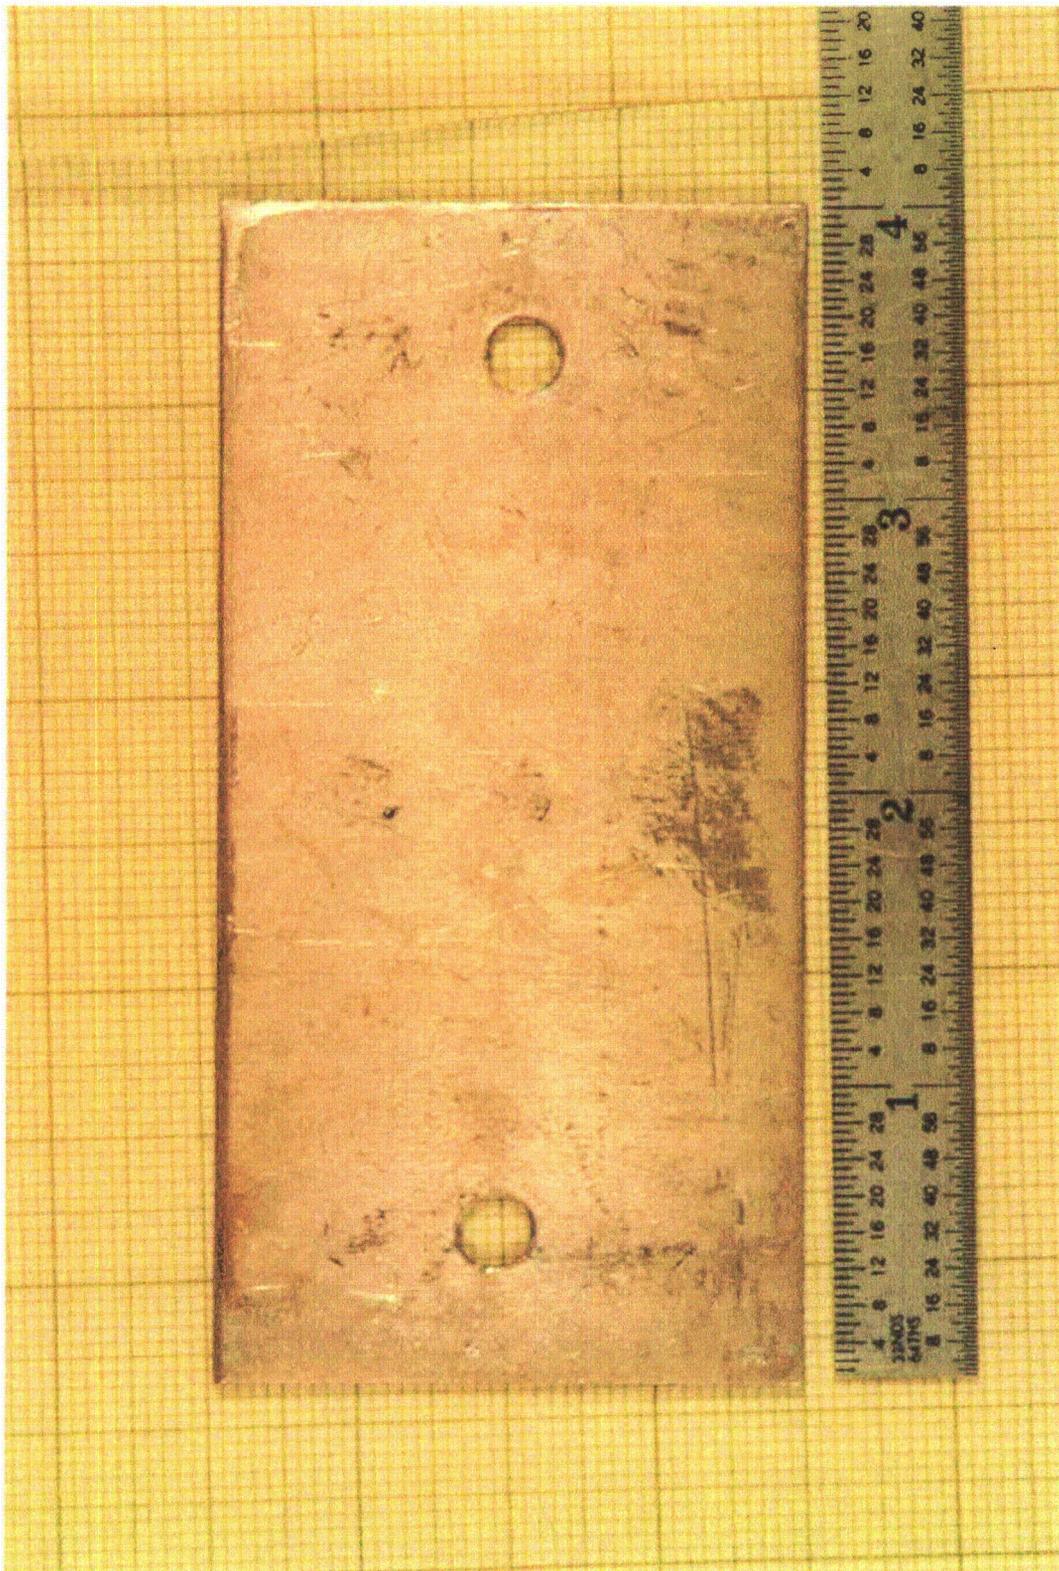
Photo 3- F21 Front View

Photo 4- F21 Back View

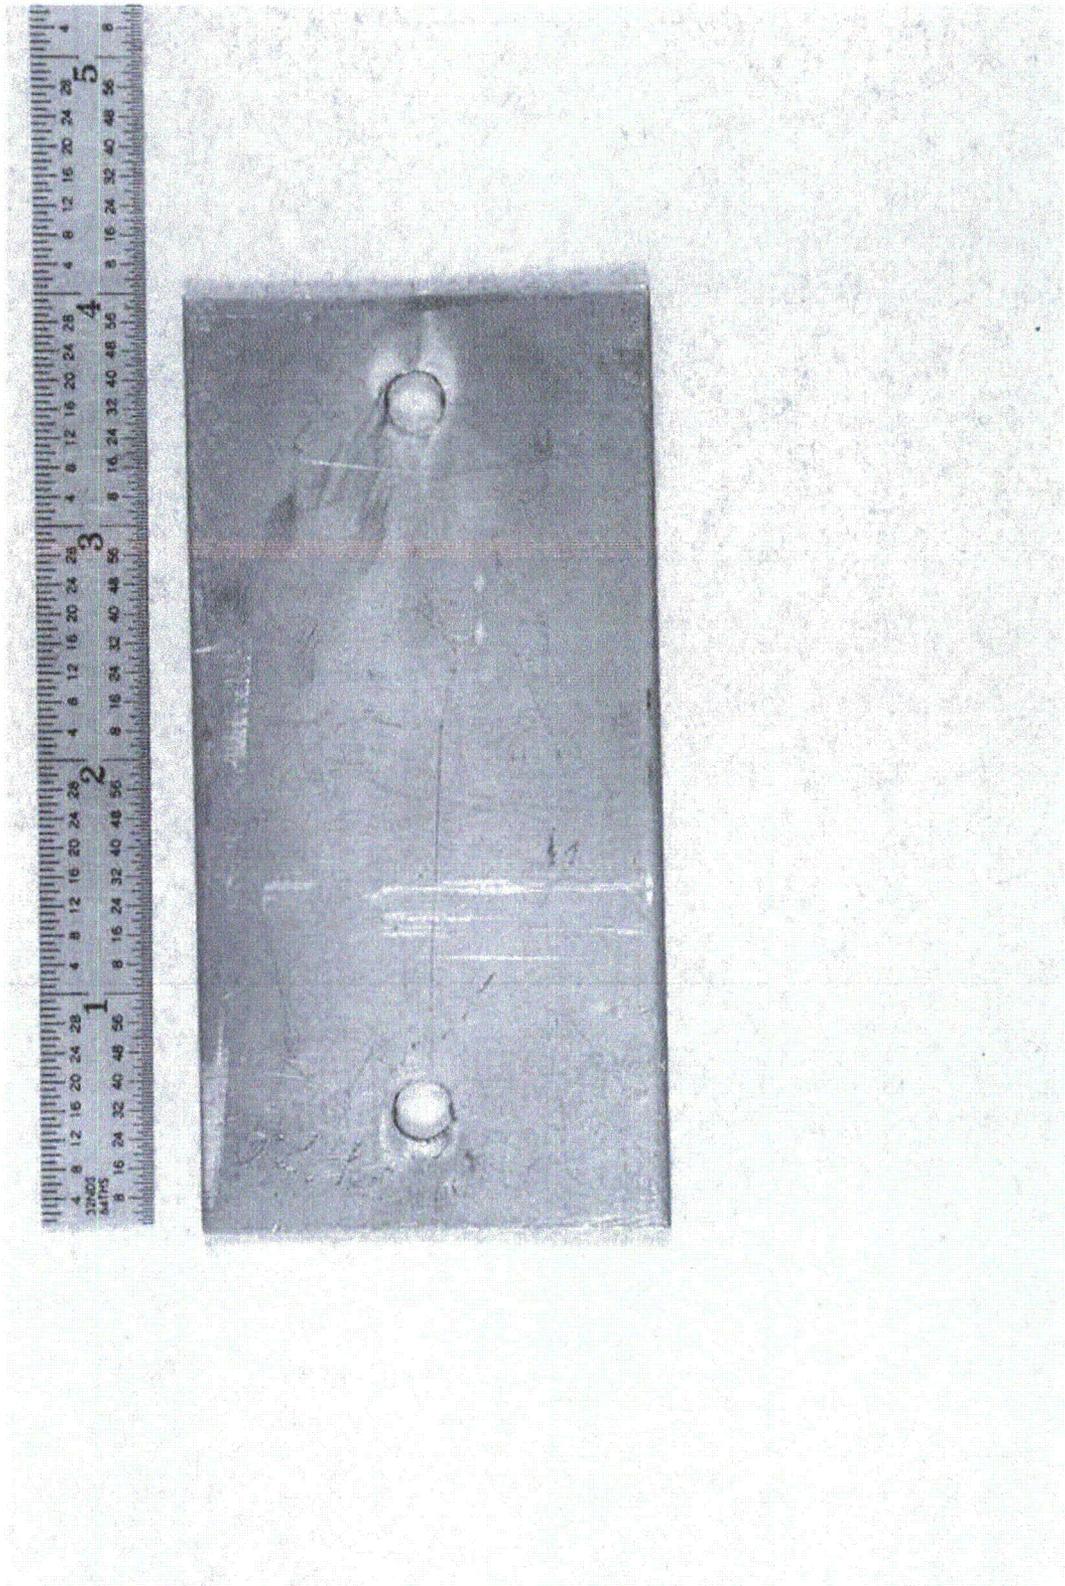
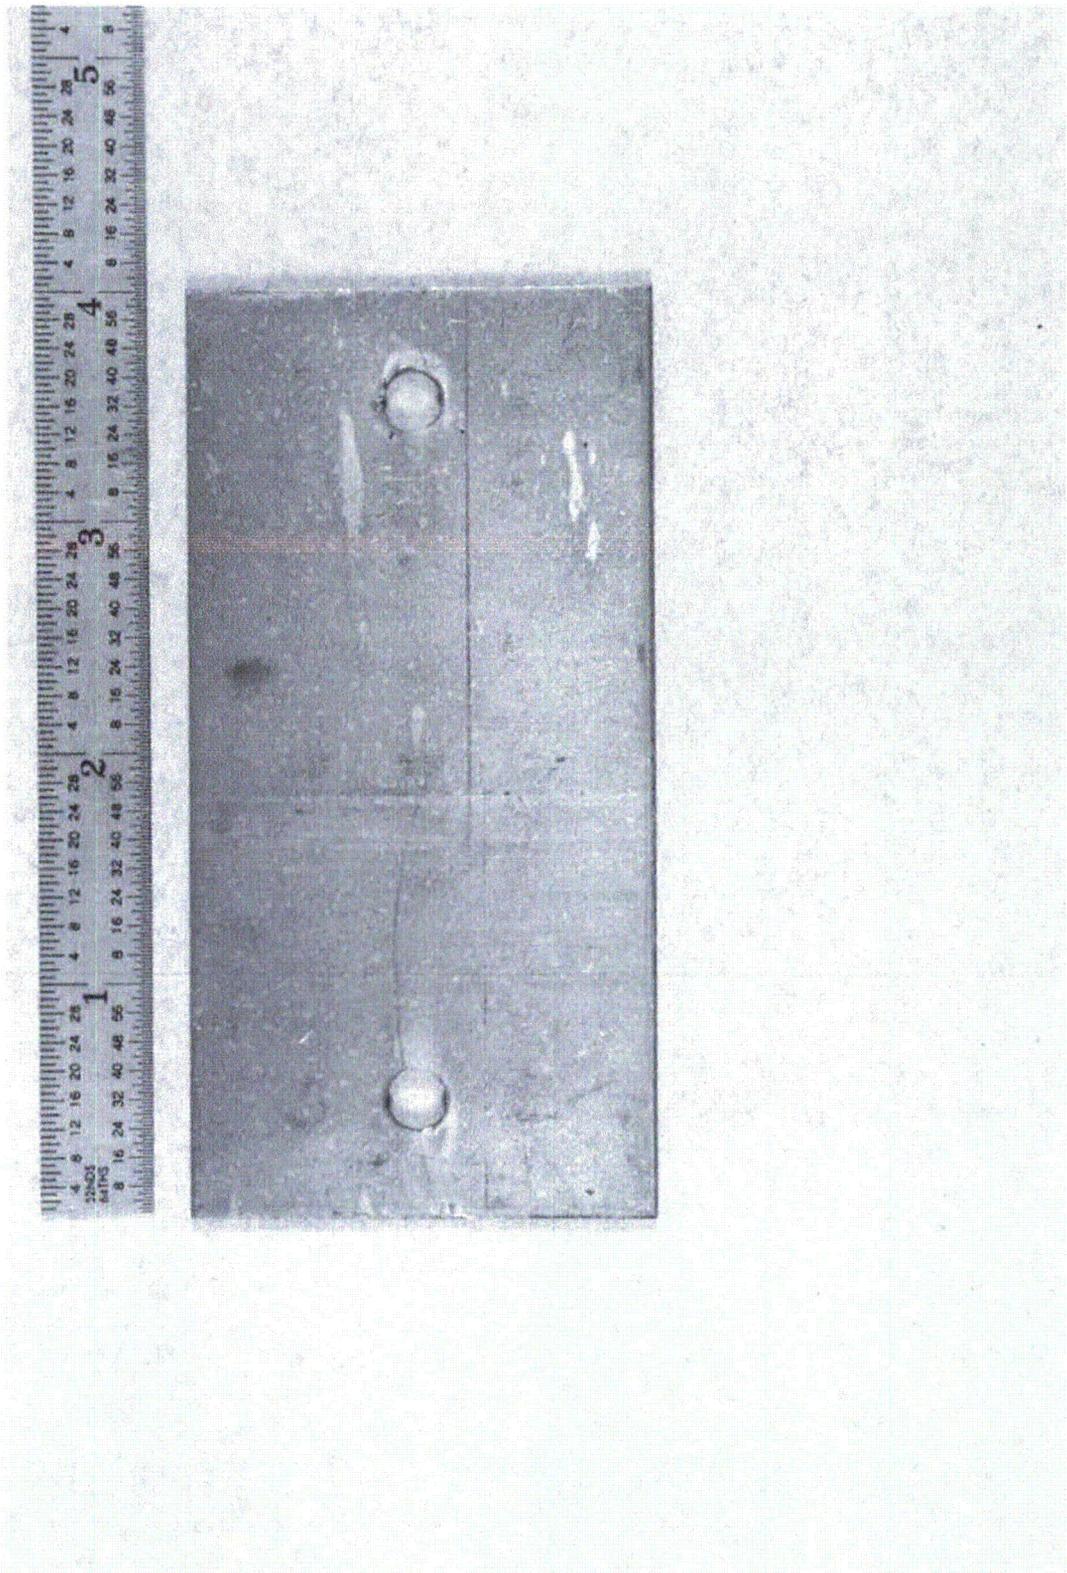
F20	<p>General: The coupon ID F20 is inscribed in the upper right corner of the front side. The color of the coupon has darkened as a result of the time in the spent fuel pool. The coupon is slightly warped symmetrically along the longest axis, more so than F19.</p> <p>Front side: There are some scratches on the front side where the exposed area is similar to mill finish aluminum.</p> <p>Back side: Similar in appearance to the front side. There are a few more scratches on the backside; otherwise there are no other anomalies.</p>
F19	<p>General: The coupon ID number F19 is inscribed in the upper right corner of the front side. Color of the coupon has darkened after 1.5 years in the spent fuel pool. The coupon is slightly warped symmetrically along its longest axis.</p> <p>Front side: There are numerous scratches where the surface appears shiny, not unlike mill finish aluminum. Scratching is likely to have occurred when the coupon string was removed to remove the coupon. There are no other anomalies.</p> <p>Back side: Color is similar to front side; there are fewer scratches on the back side.</p>

Photo 6- F20 Front View

Photo 7- F20 Back View

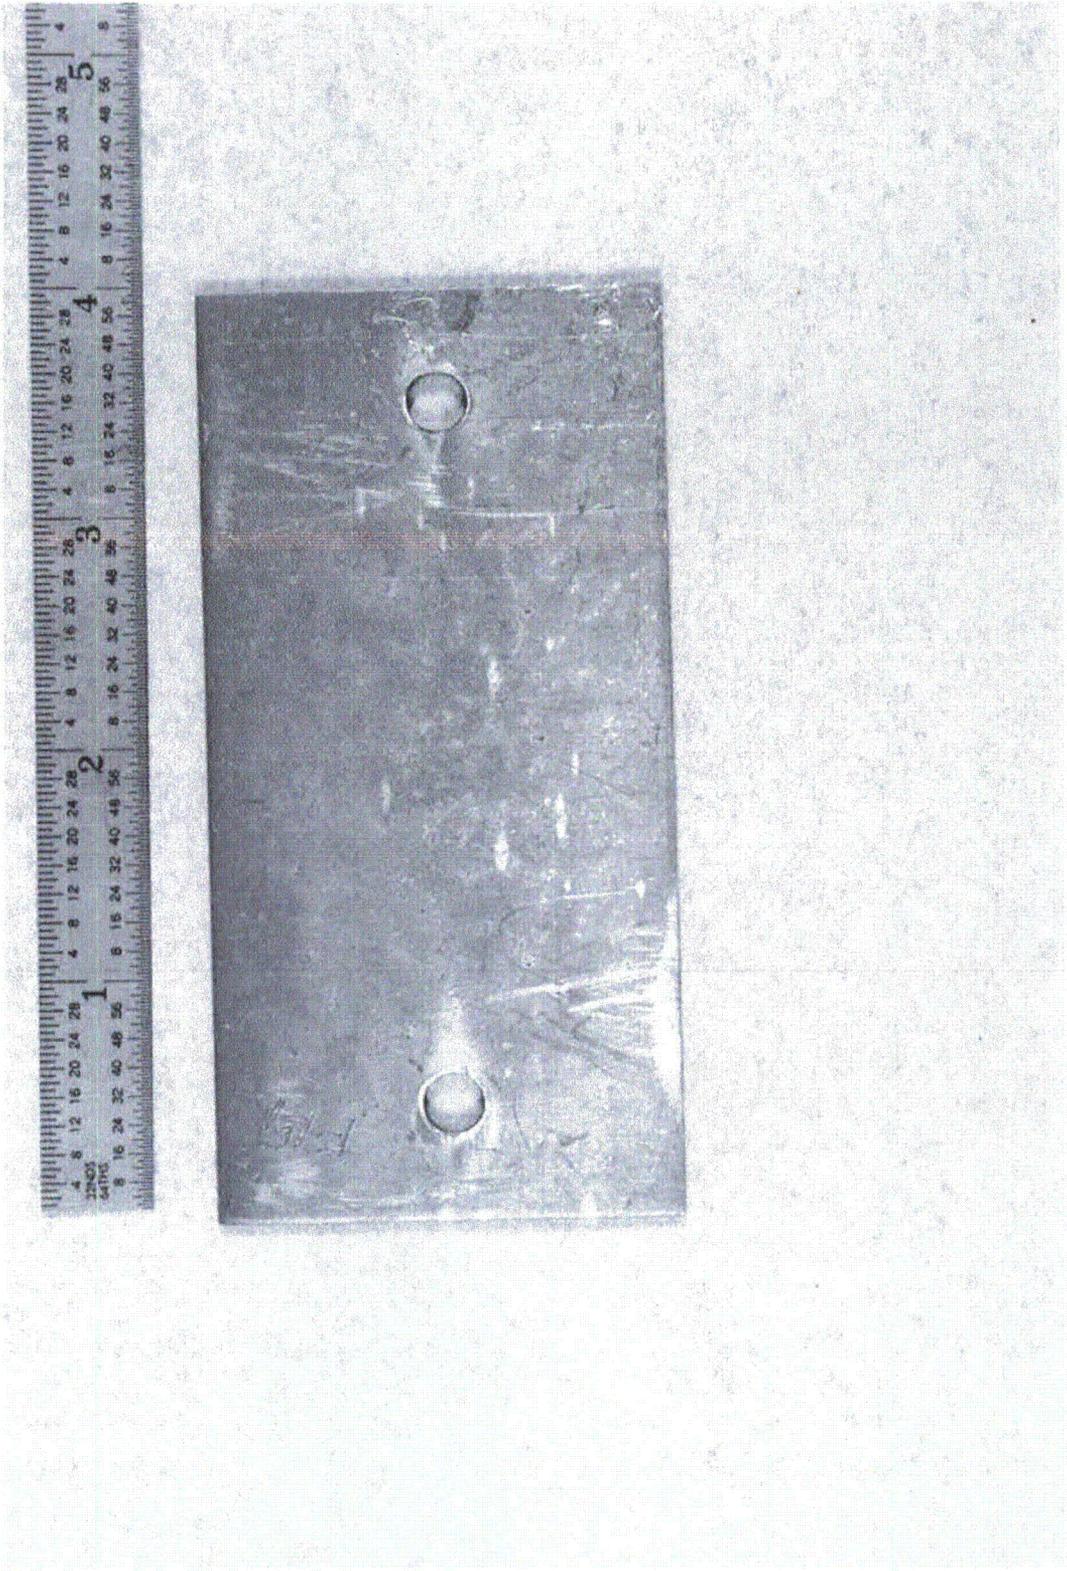
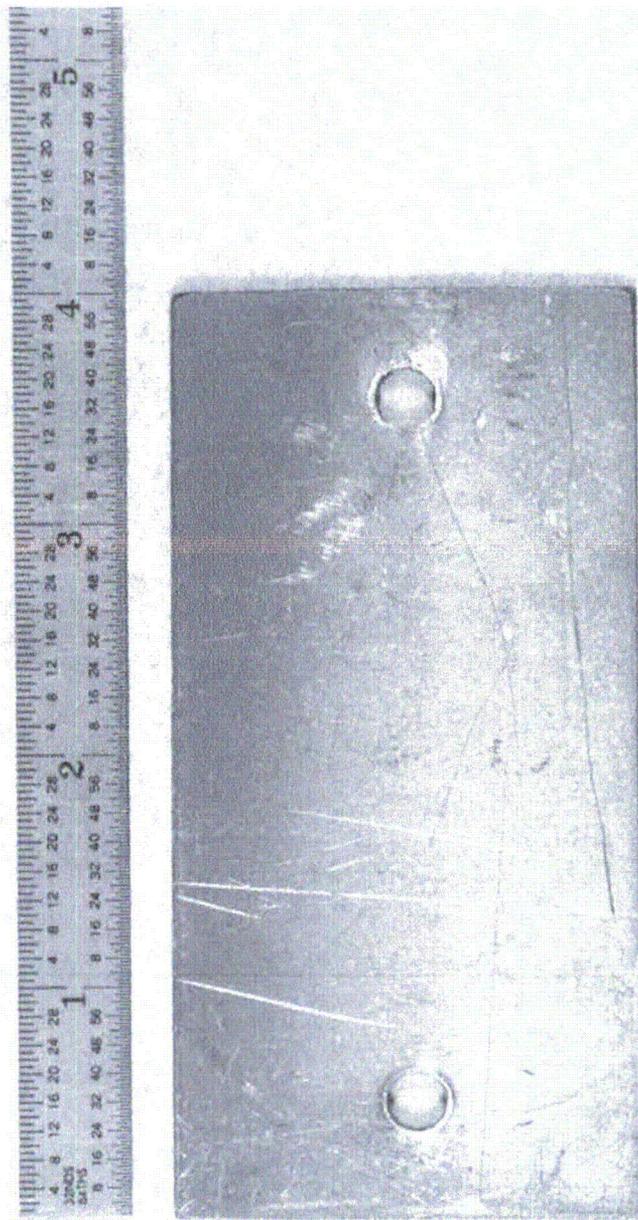
Photo 8- F19 Front View

Photo 9- F19 Back View

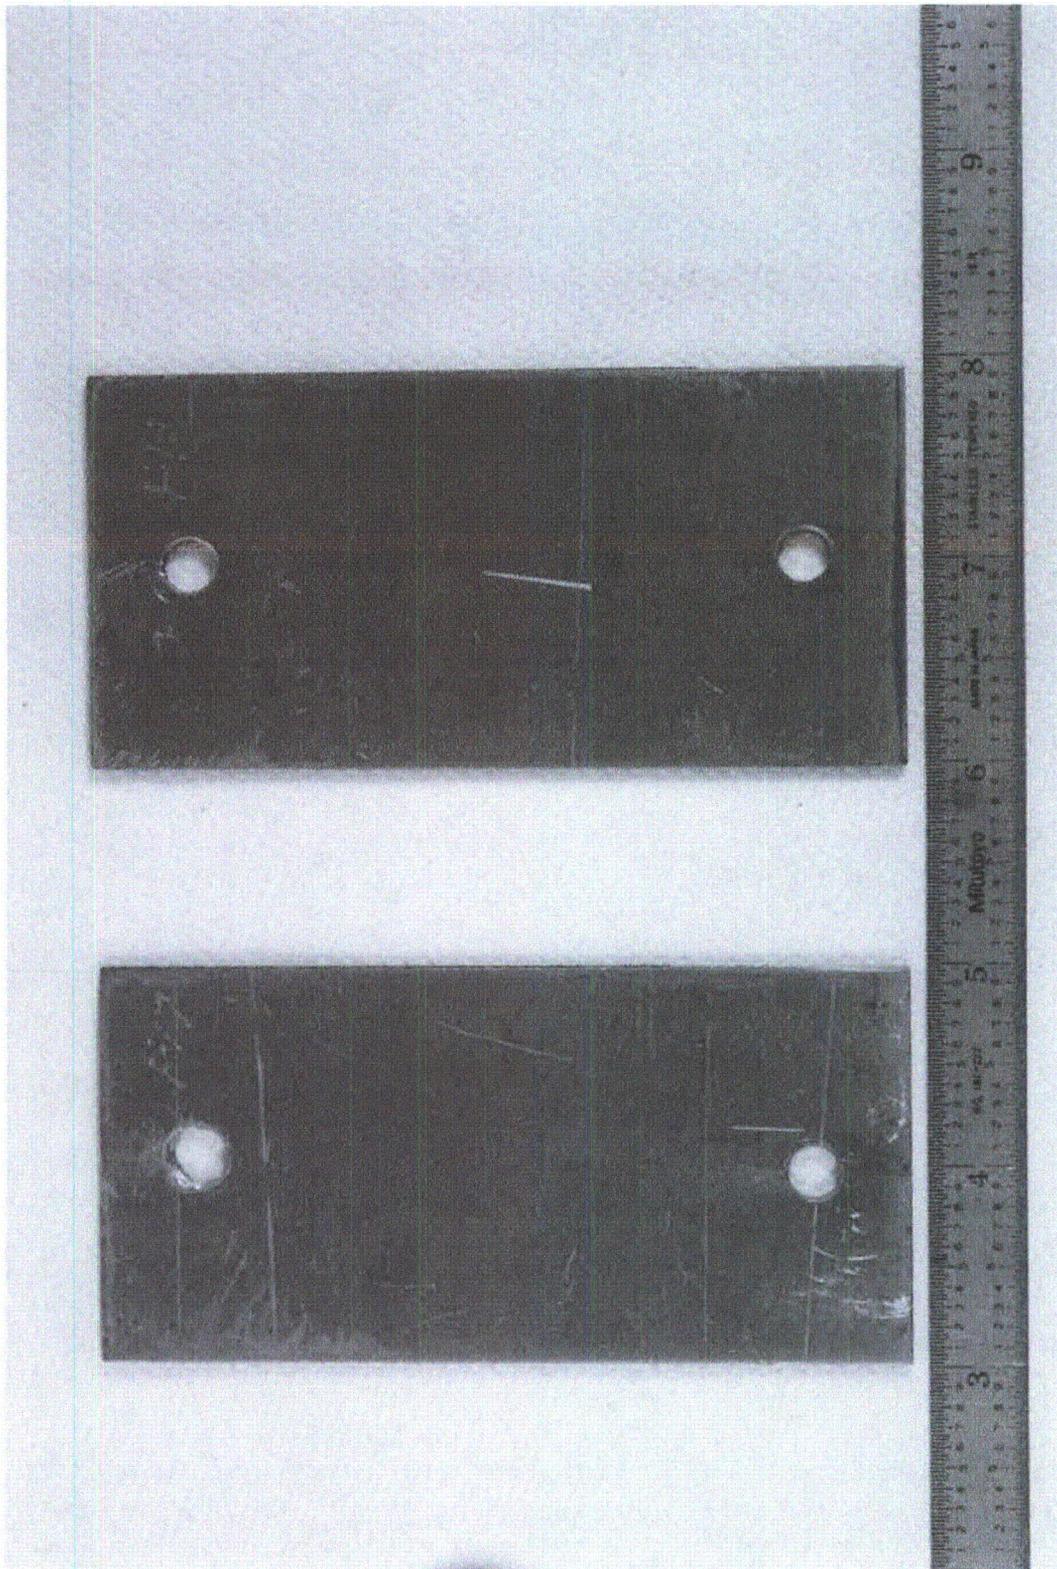
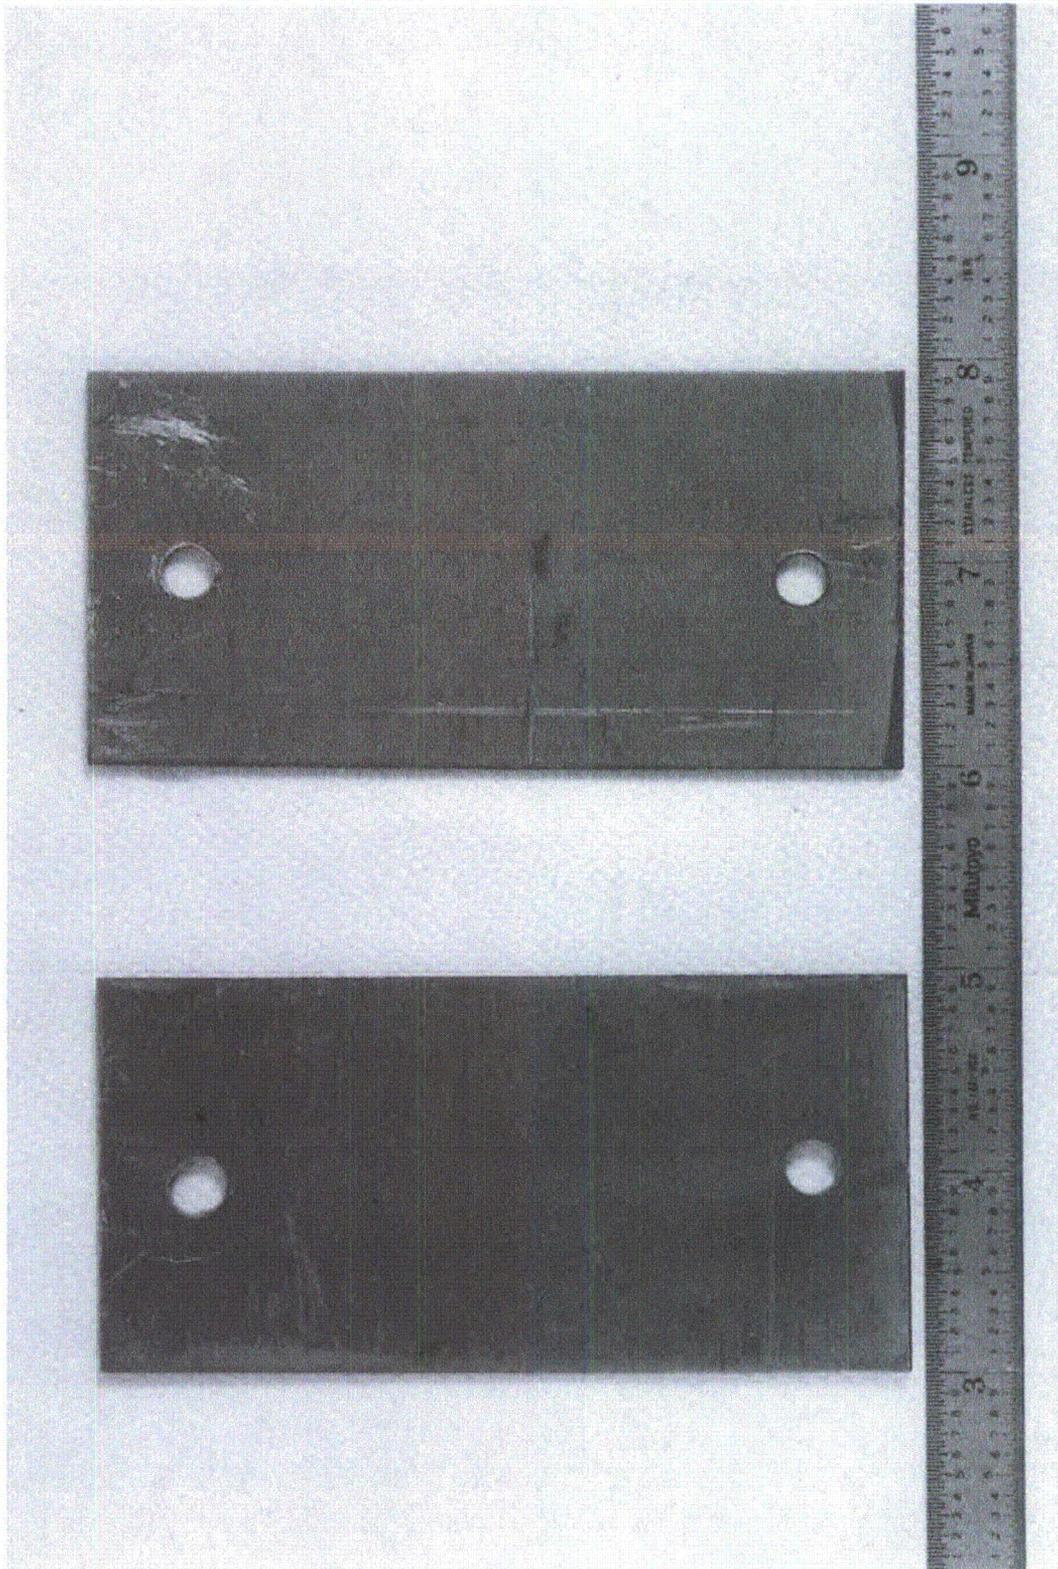
F18	Coupon ID F18 is inscribed in the upper right corner. Appearance is about the same as F12.
F17	Coupon ID F17 is inscribed in the upper right corner. Appearance is about the same as F12.

Photo 11- F18 & F17 Front View

Photo 12- F18 & F17 Back View

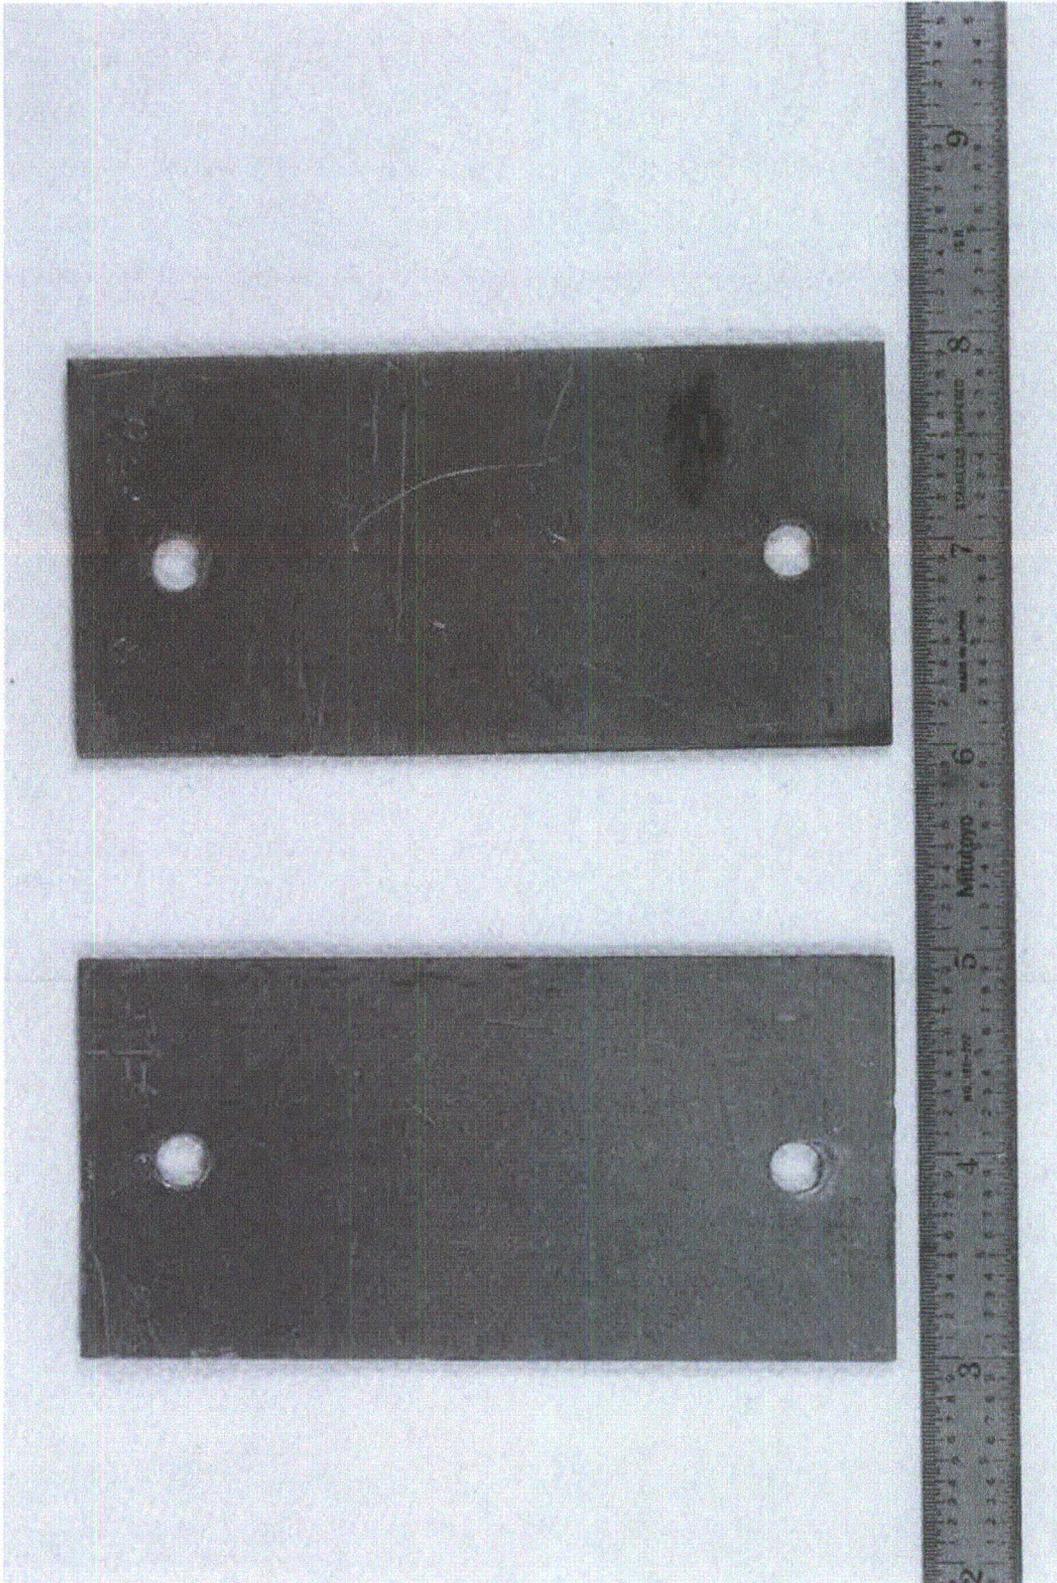
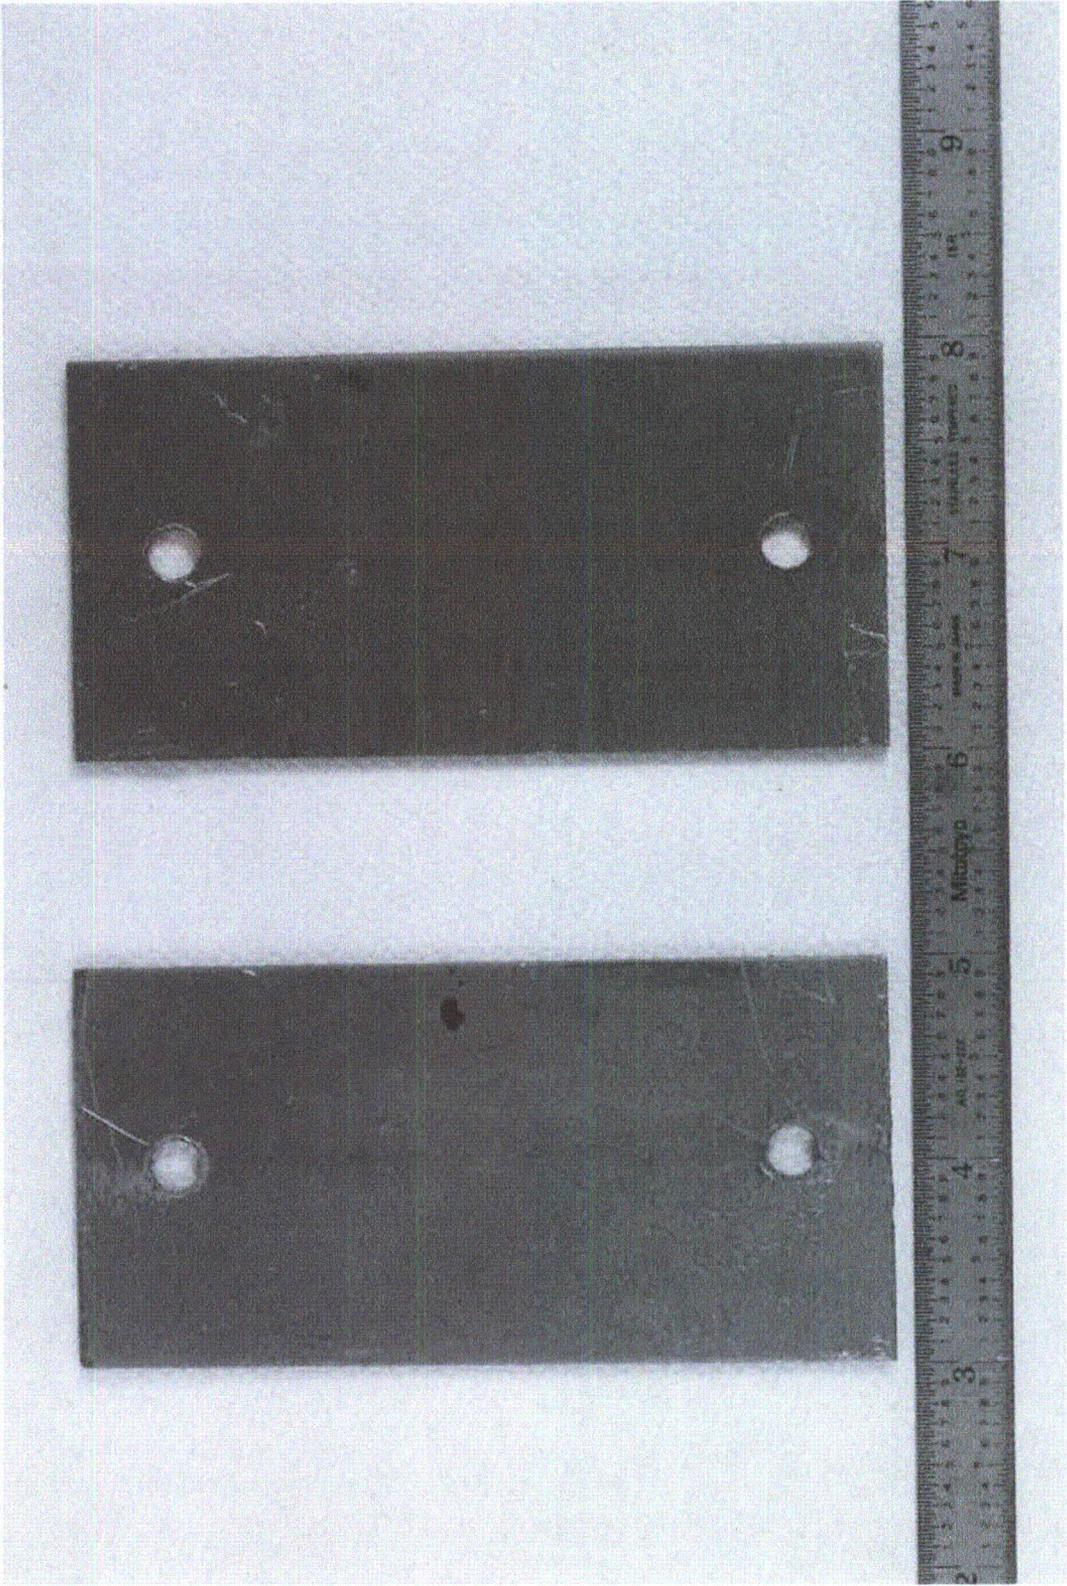
F16	Coupon ID F16 is inscribed in the upper right corner. Appearance is about the same as F12. There is a rust colored pit above the lower link hole on front side.
F15	Coupon ID F15 is inscribed in the upper right corner. Appearance is about the same as F12. There is a dark spot on the back side midway up the right edge

Photo 13- F16 & F15 Front View

Photo 14- F16 & F15 Back View
