**NETCO Report NET-30054-01, Revision 0
"Inspection and Testing of Fast Start Surveillance Coupons F22-F11
from the LaSalle County Unit 2 Station"**

**Inspection and Testing of Fast Start
Surveillance Coupons F22-F11 from the
LaSalle County Unit 2 Station**

January 2013

Prepared
for
Exelon Generation

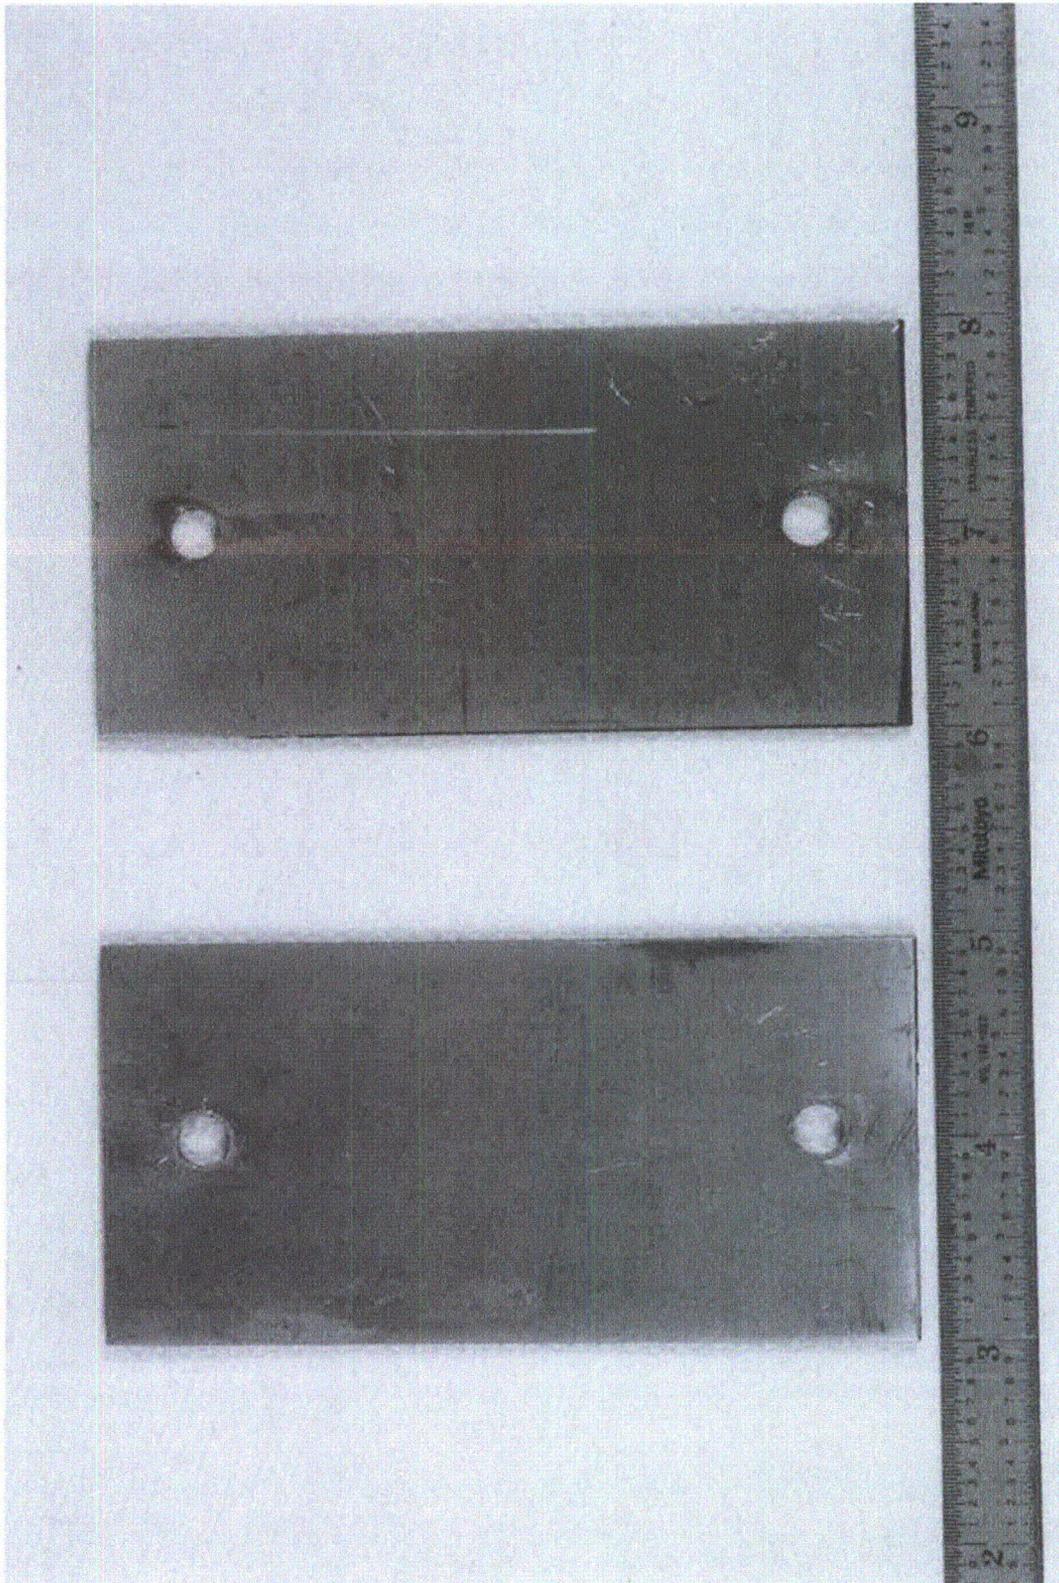
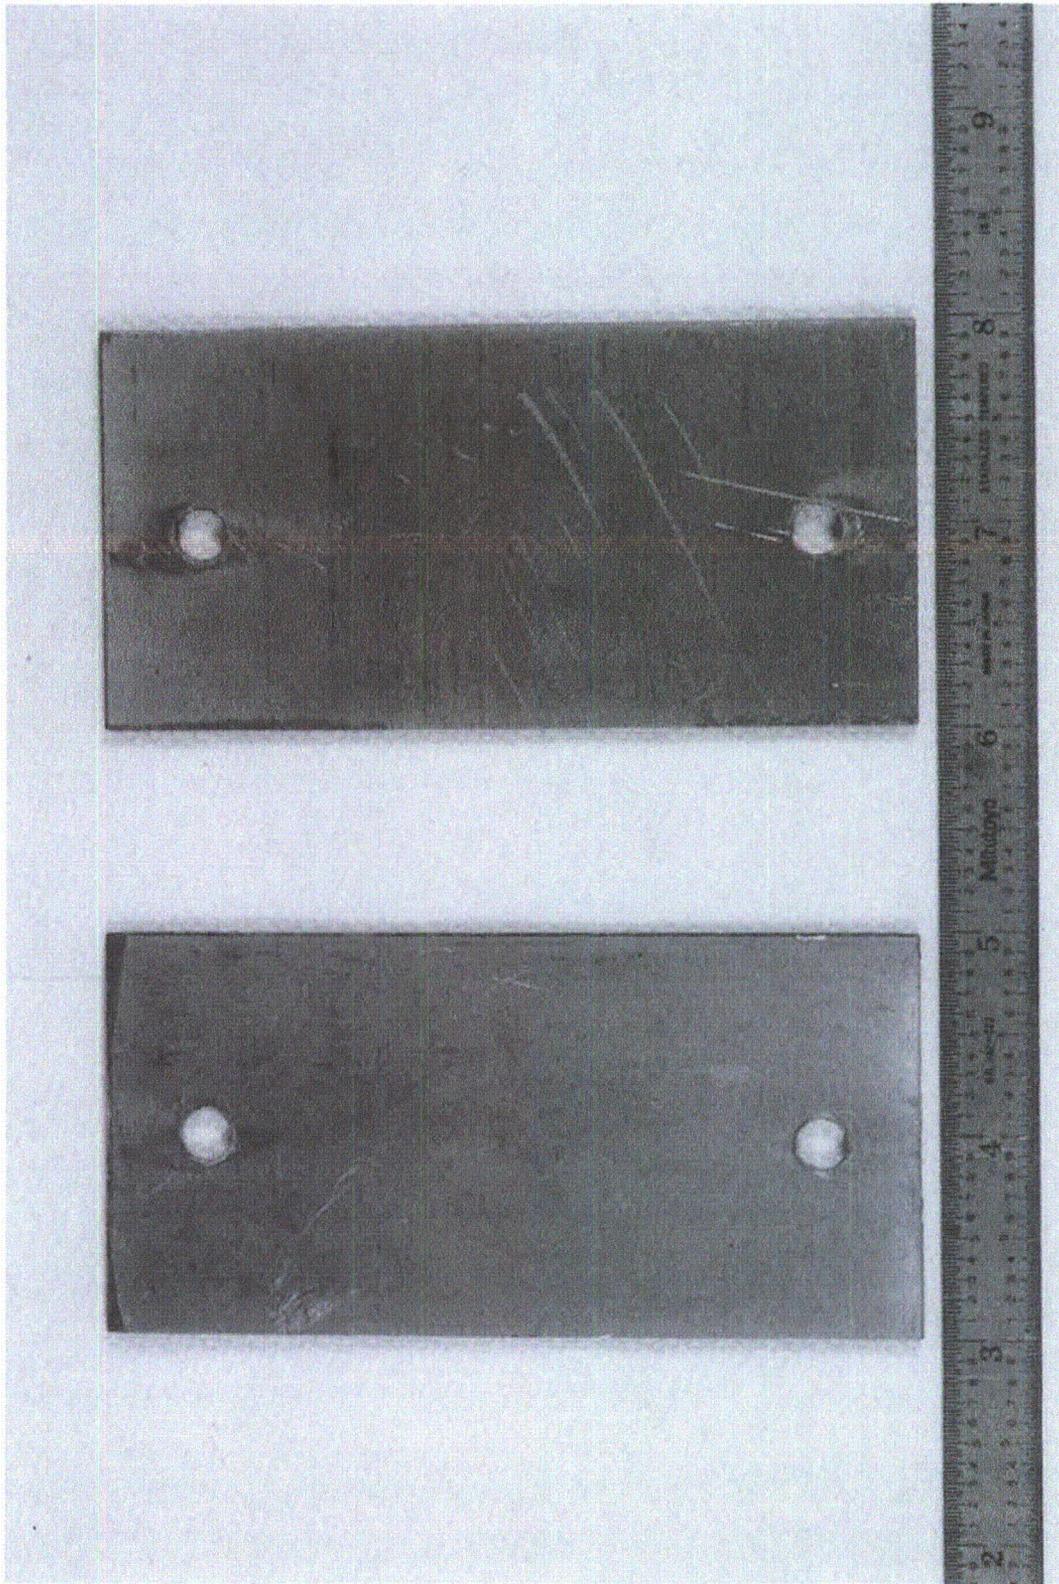
F14	Coupon ID F14 is inscribed in the upper right corner. Appearance is about the same as F12.
F13	Coupon ID F13 is inscribed in the upper right corner. Appearance is about the same as F12.

Photo 15- F14 & F13 Front View

Photo 15- F14 & F13 Back View

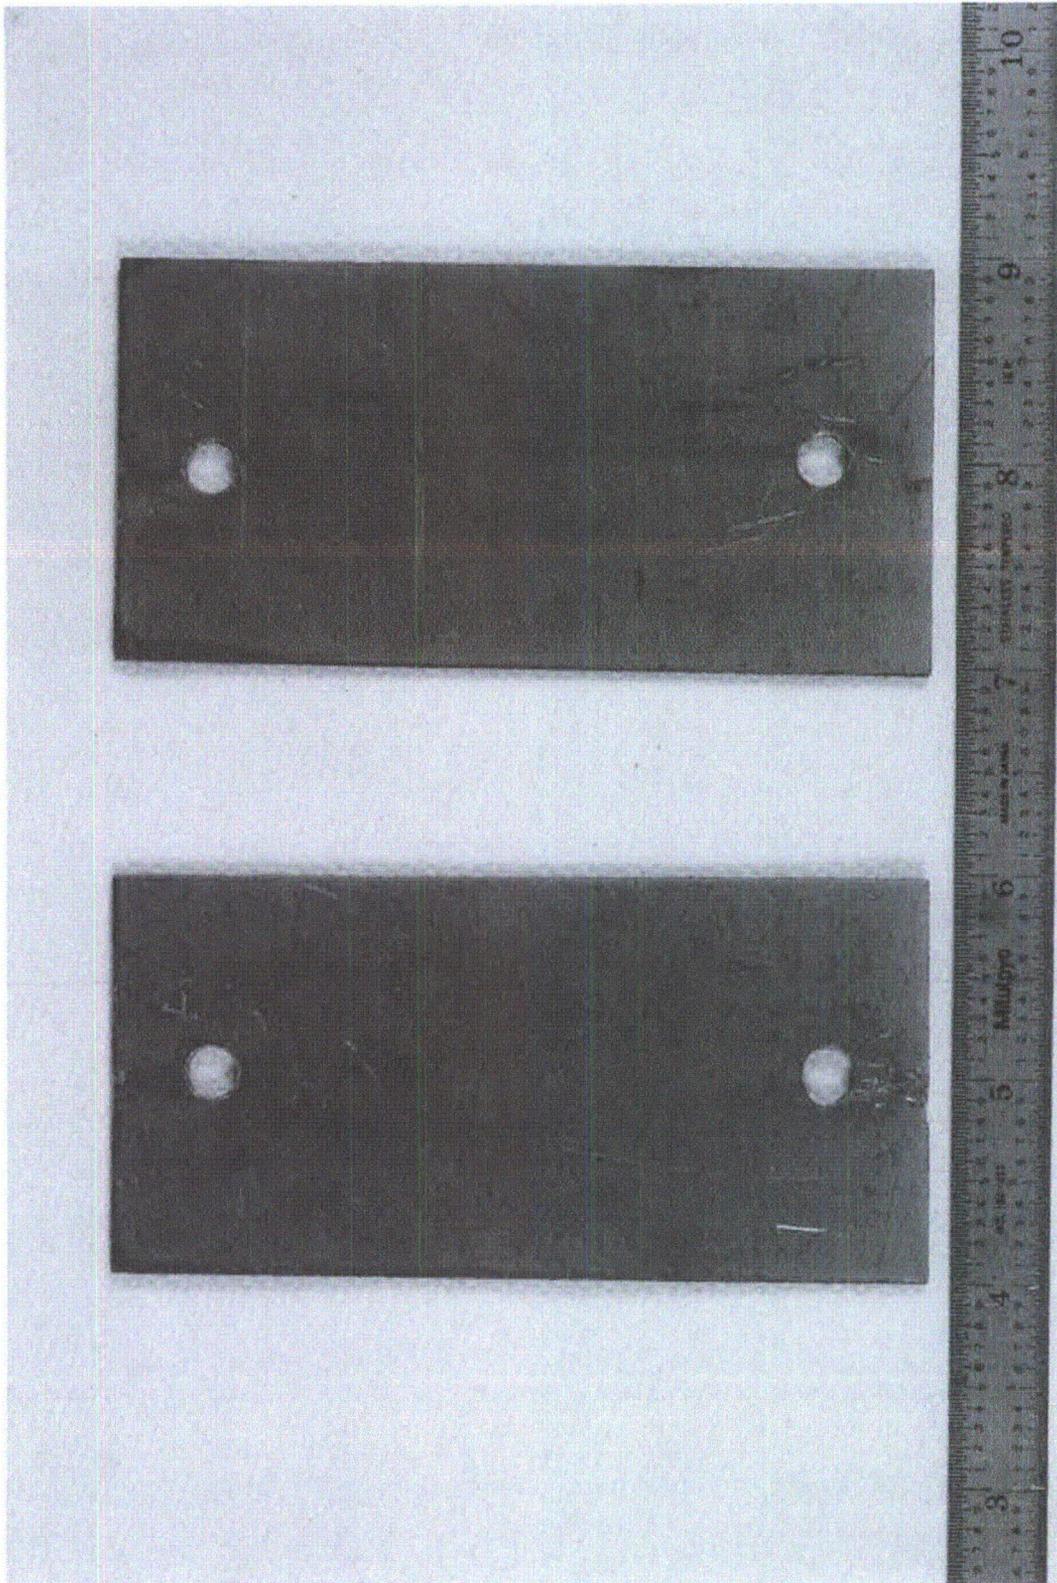
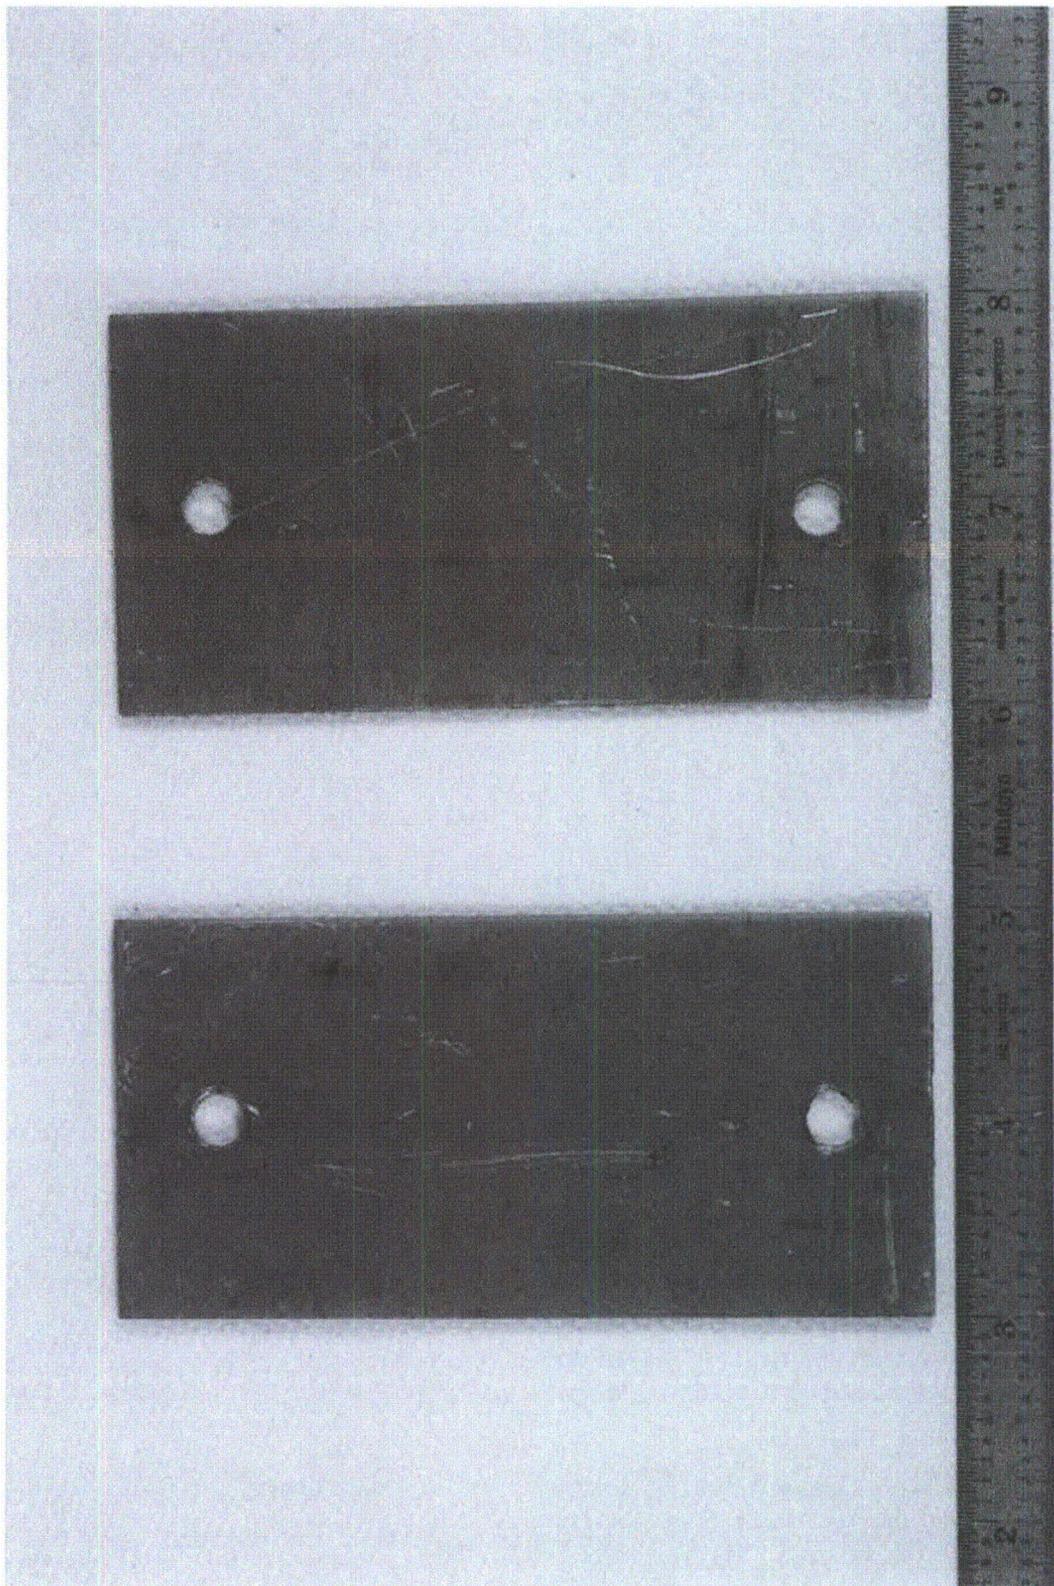
F12	The coupon ID is F12 is inscribed in upper right corner of front side. Color of all surfaces is grey with randomly distributed scratches.
F11	The coupon ID is F11 is inscribed in upper right corner below the top edge. The color of the coupon is a more or less uniform grey color with random scratches on the surfaces. The back side is similar in appearance. Hematite rust spots in the lower left quadrant. It surrounds a relatively large pit which looks like it came from a carbon steel tool chain.

Photo 16- F12 & F11 Front View

Photo 17- F12 & F11 Back View
