<b>ENTERGY</b>	<b>ENGINEERING STANDARD</b>	<b>EN-EP-S-002-MULTI</b>	<b>REV. 1</b>
	<b>Underground Piping and Tanks General Visual Inspection</b>		<b>PAGE 15 OF 15</b>

**ATTACHMENT 7.3 PIPE/TANK BASE MATERIAL VISUAL INSPECTION CHECKLIST**  
**Sheet 1 of 2**

Line/Tank ID & Name: 3-SI-161-3, 3-SI-161-4 / 3-in SI Line 161 Work Order: 279577-02

Location: IP3 NW WHUT PIT Thickness: 0.216" Inspector: J. Peterson

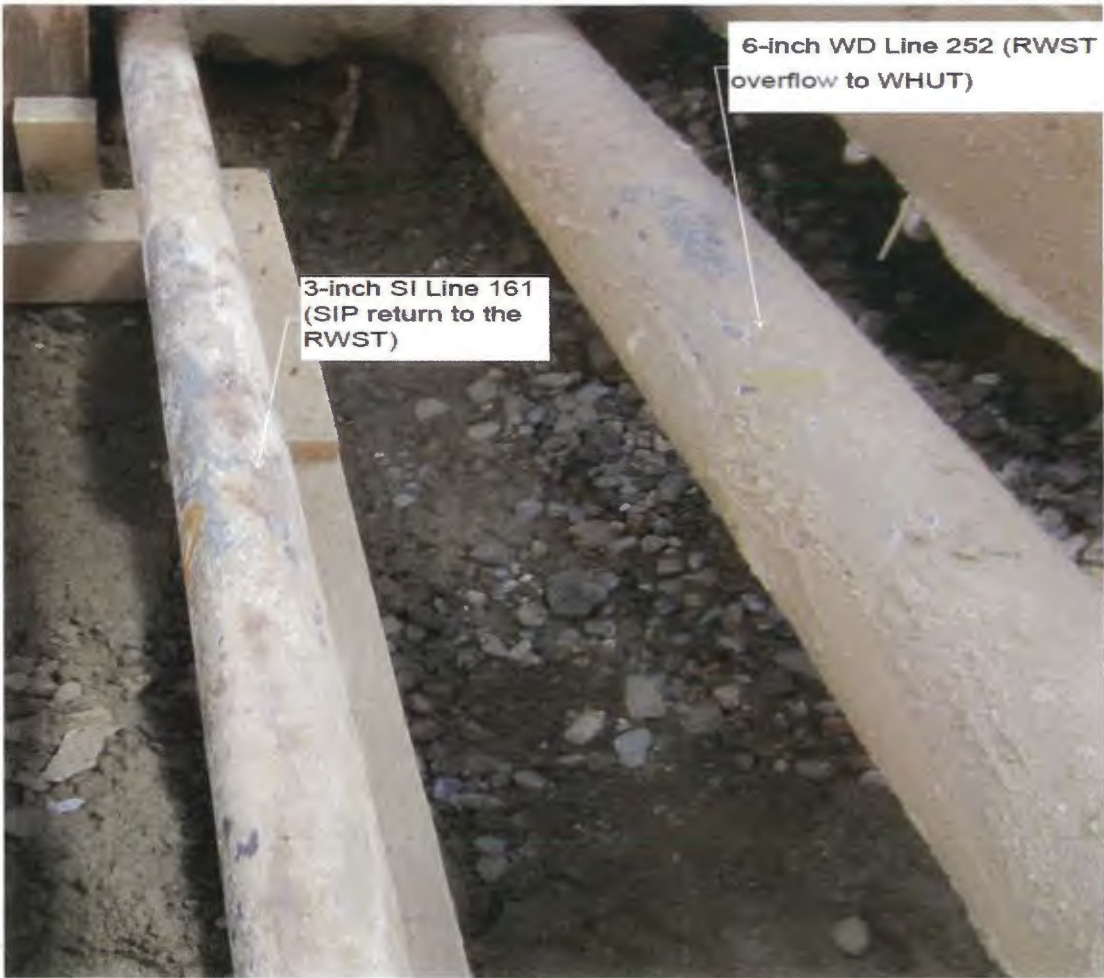
6-inch WD Line 252 (RWST overflow to WHUT)

3-inch SI Line 161 (SIP return to the RWST)

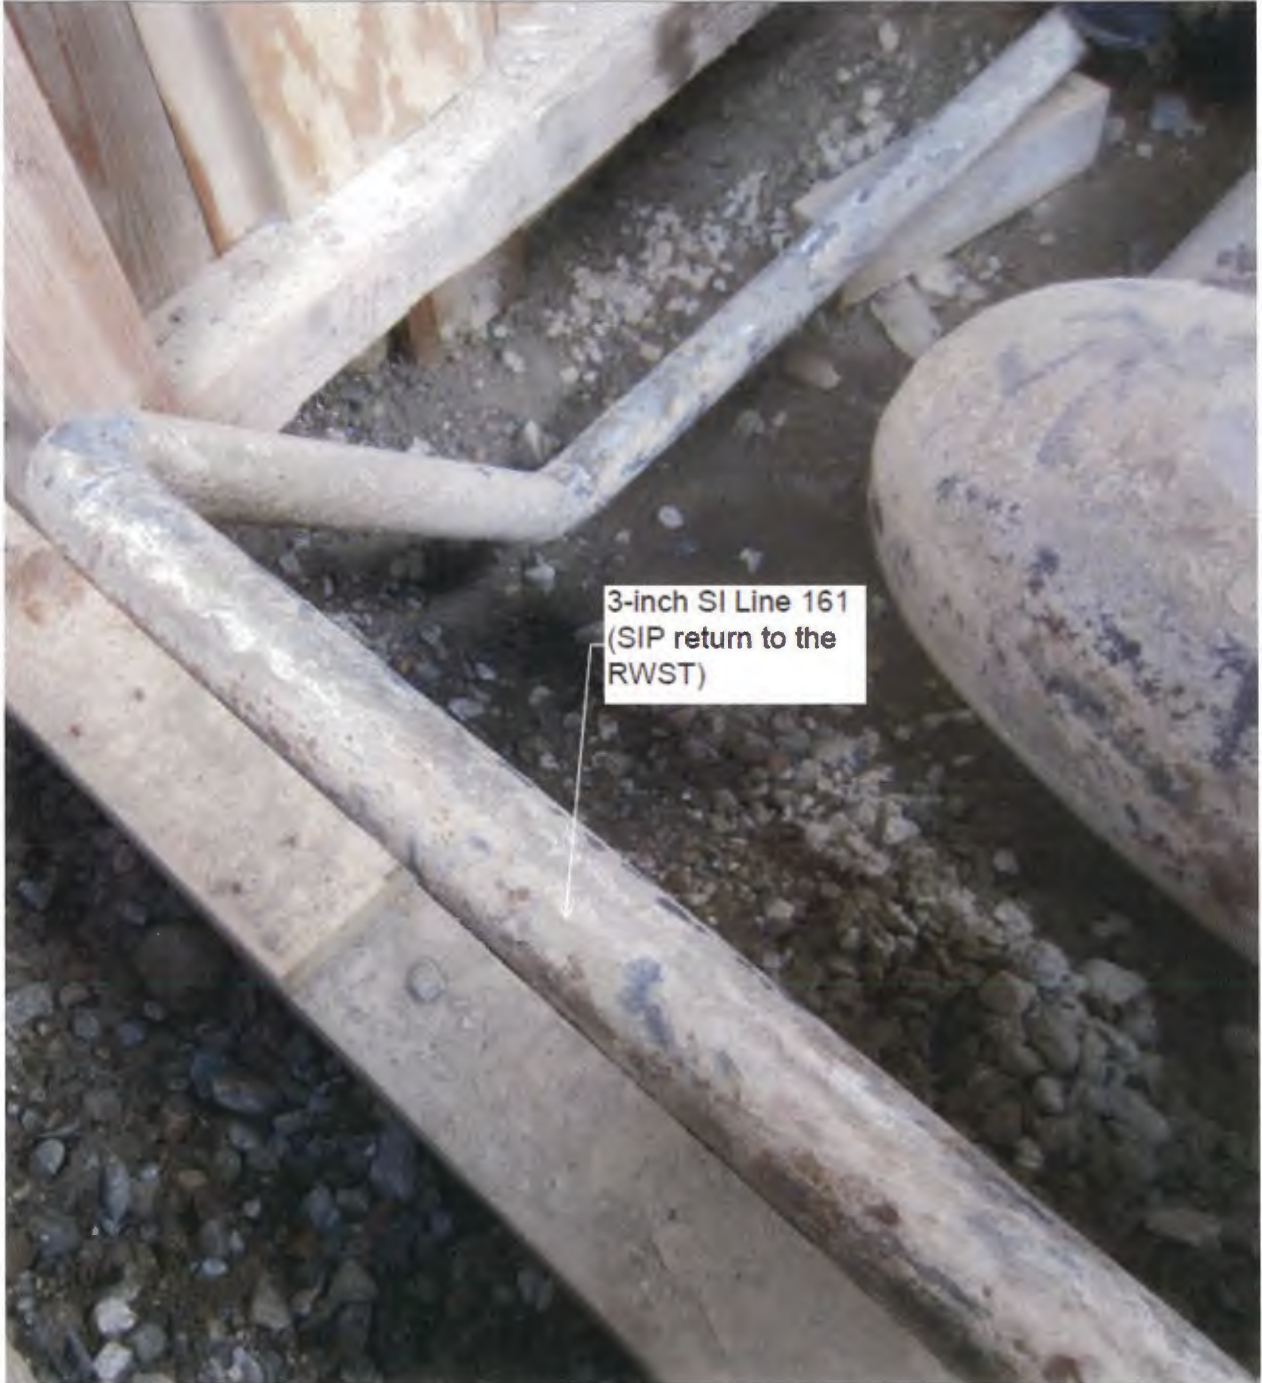
3-inch SI Line 161  
(SIP return to the  
RWST)

General Appearance: A portion of the 3-inch Safety Injection line 161 (SIP return to the RWST) was excavated and visually inspected. The total length of the Safety Injection line inspected was at least 16 ft. The exposed piping was in good condition. No damage noted.

Comments: Some discoloration exists along with what seems to be a light coating of concrete potentially from original construction. Even though no anomalies were found on this pipe still recommend performing UT thickness readings in selected sections of the pipe to verify that wall thickness is within the acceptance criteria, Photos and sketch attached. Ref: Drawings 9321- 26313.
